2014-2016 Urban Nonpoint Source & Storm Water Program Planning Grant Summary Report Village of Little Chute, Outagamie County, WI

Prepared for the Village of Little Chute

REL Project Number: 4987-021

Date: December 22, 2016

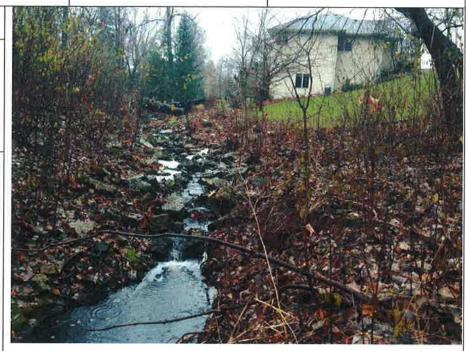
Description:
NE Portion, near
creek headwaters.
House in foreground
has had repeated
basement flooding.

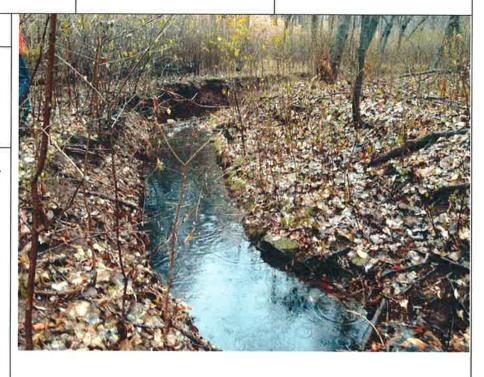
Description: NE section of creek near headwaters running adjacent to Lincoln Ave.

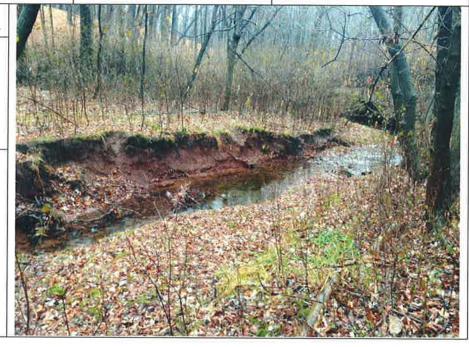
Description: significant bank erosion and failure near headwaters

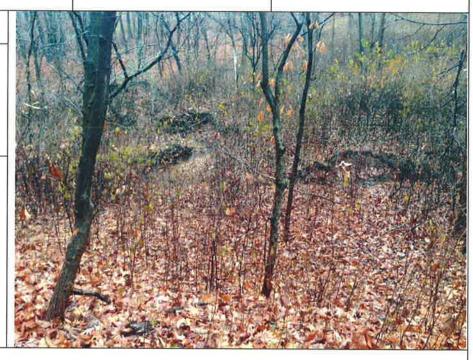
Description: meandering stream channel, high density of buckthorn, little herbaceous layer

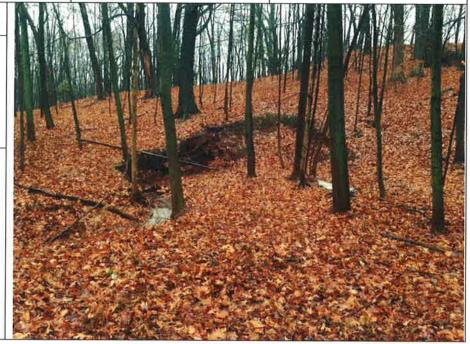
Description: exposed roots, bank failure.
Buckthorn has been removed, herbaceous layer needs to be restored.

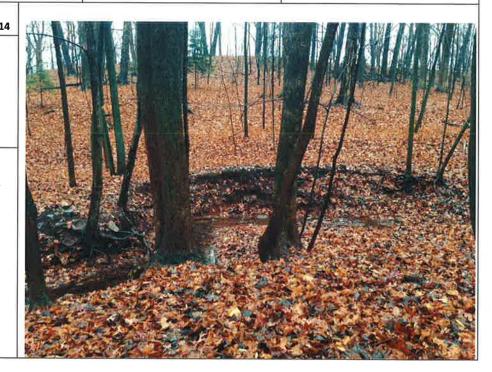
Description: Significant channel erosion with loss of vegetation

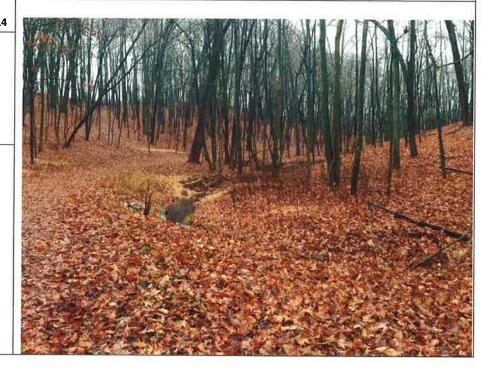
Description: Area of creek with minimal erosion

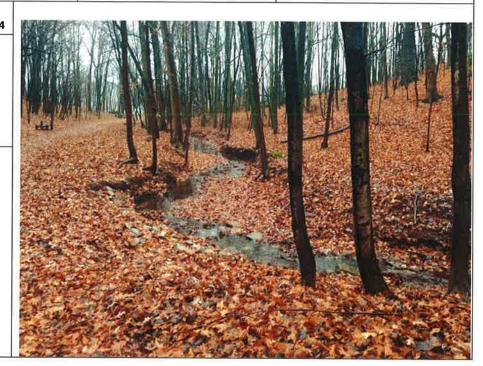
Description: Creek following path East towards outfall

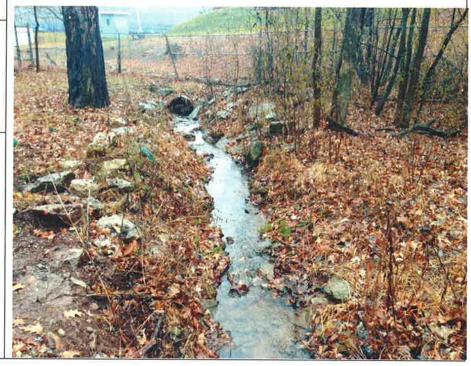
F5

Description: Outfall

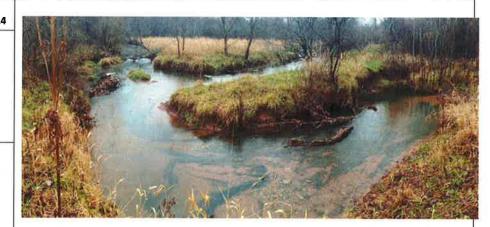
Description: Confluence directly west of P2 panoramic

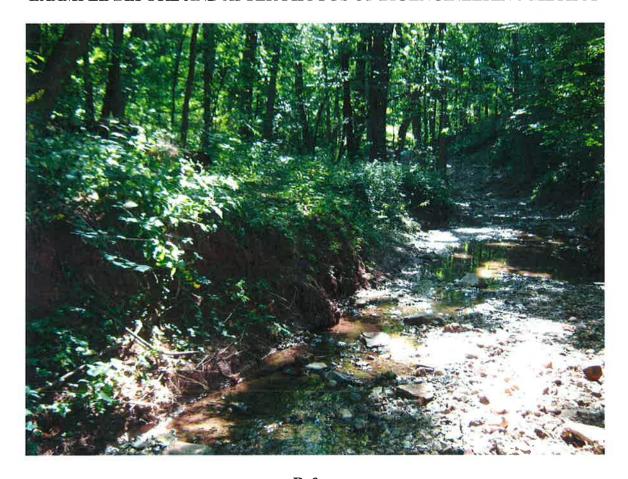
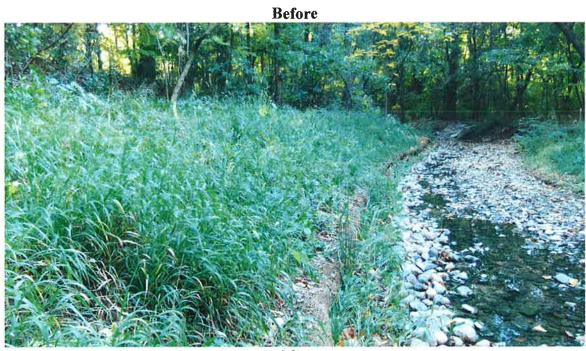
EXAMPLE BEFORE AND AFTER PHOTOS OF BIOENGINEERING METHOD
