2016 Water Quality Monitoring Report

Badger-Rapide Croche
Hydroelectric Project
FERC No. 2677-030
Kaukauna, Wisconsin

GEI Consultants, Inc.
3159 Voyager Drive
Green Bay, Wisconsin 54311

December 29, 2016
Project No. 1602010

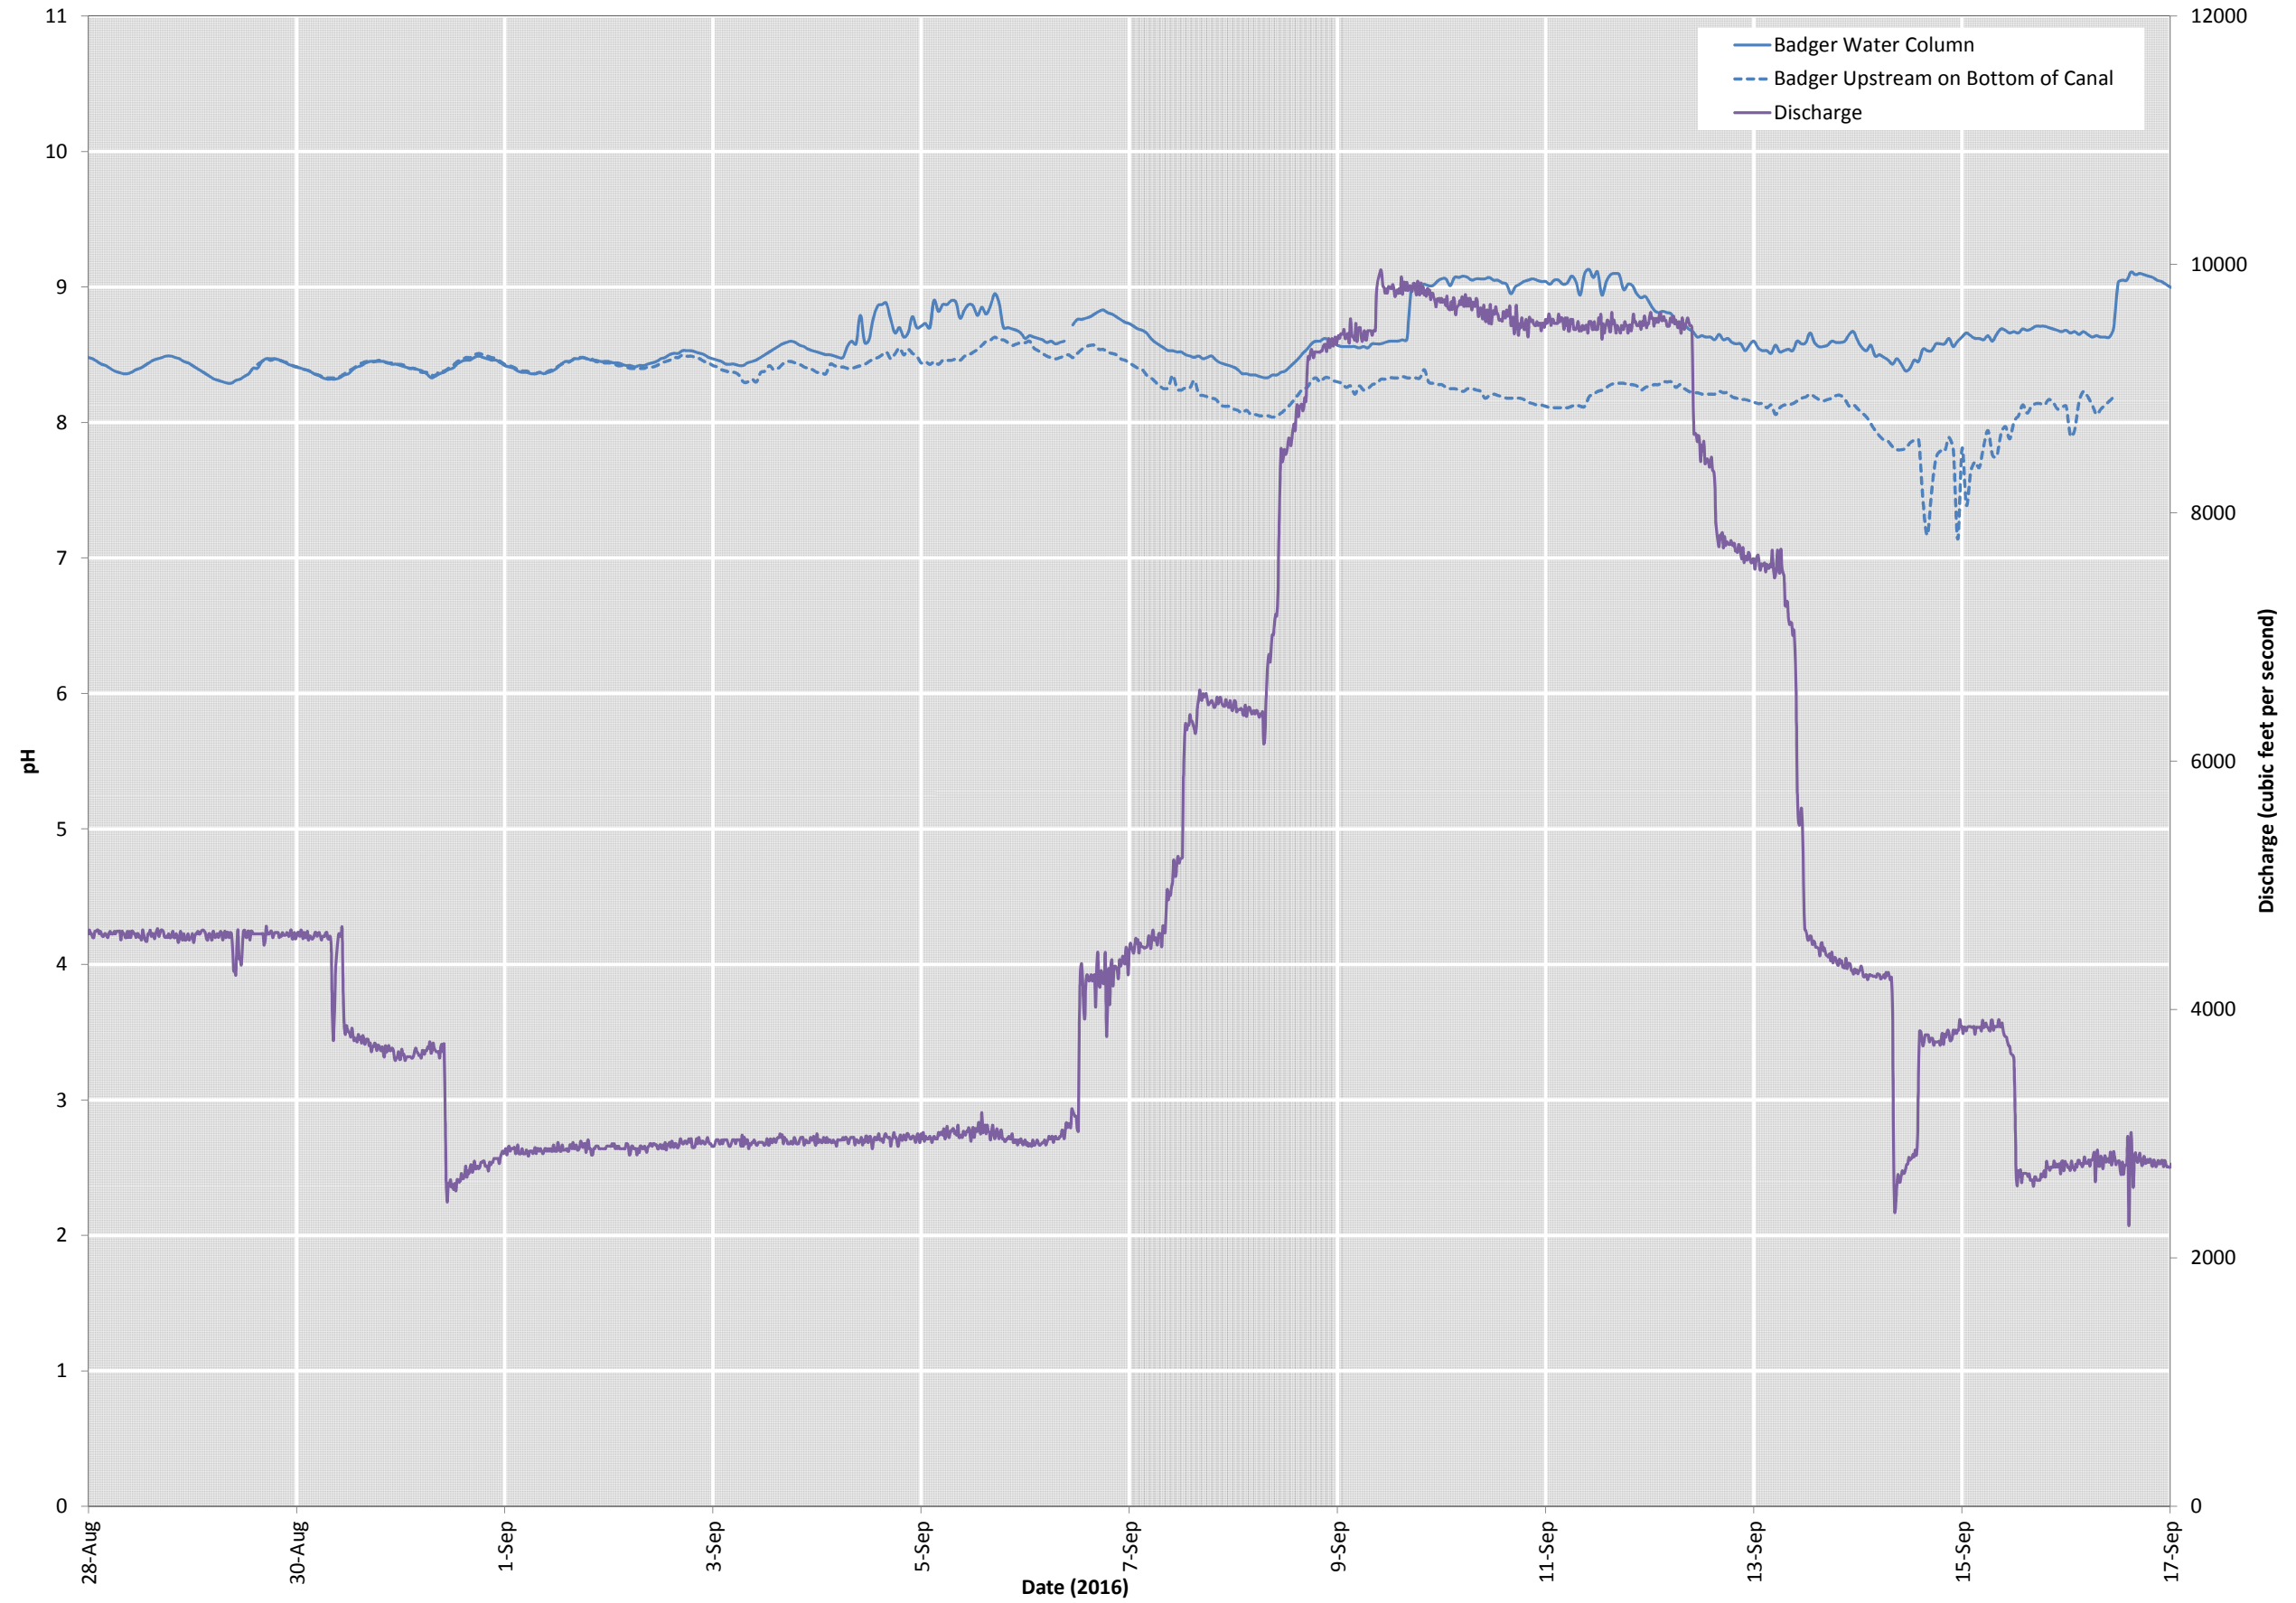
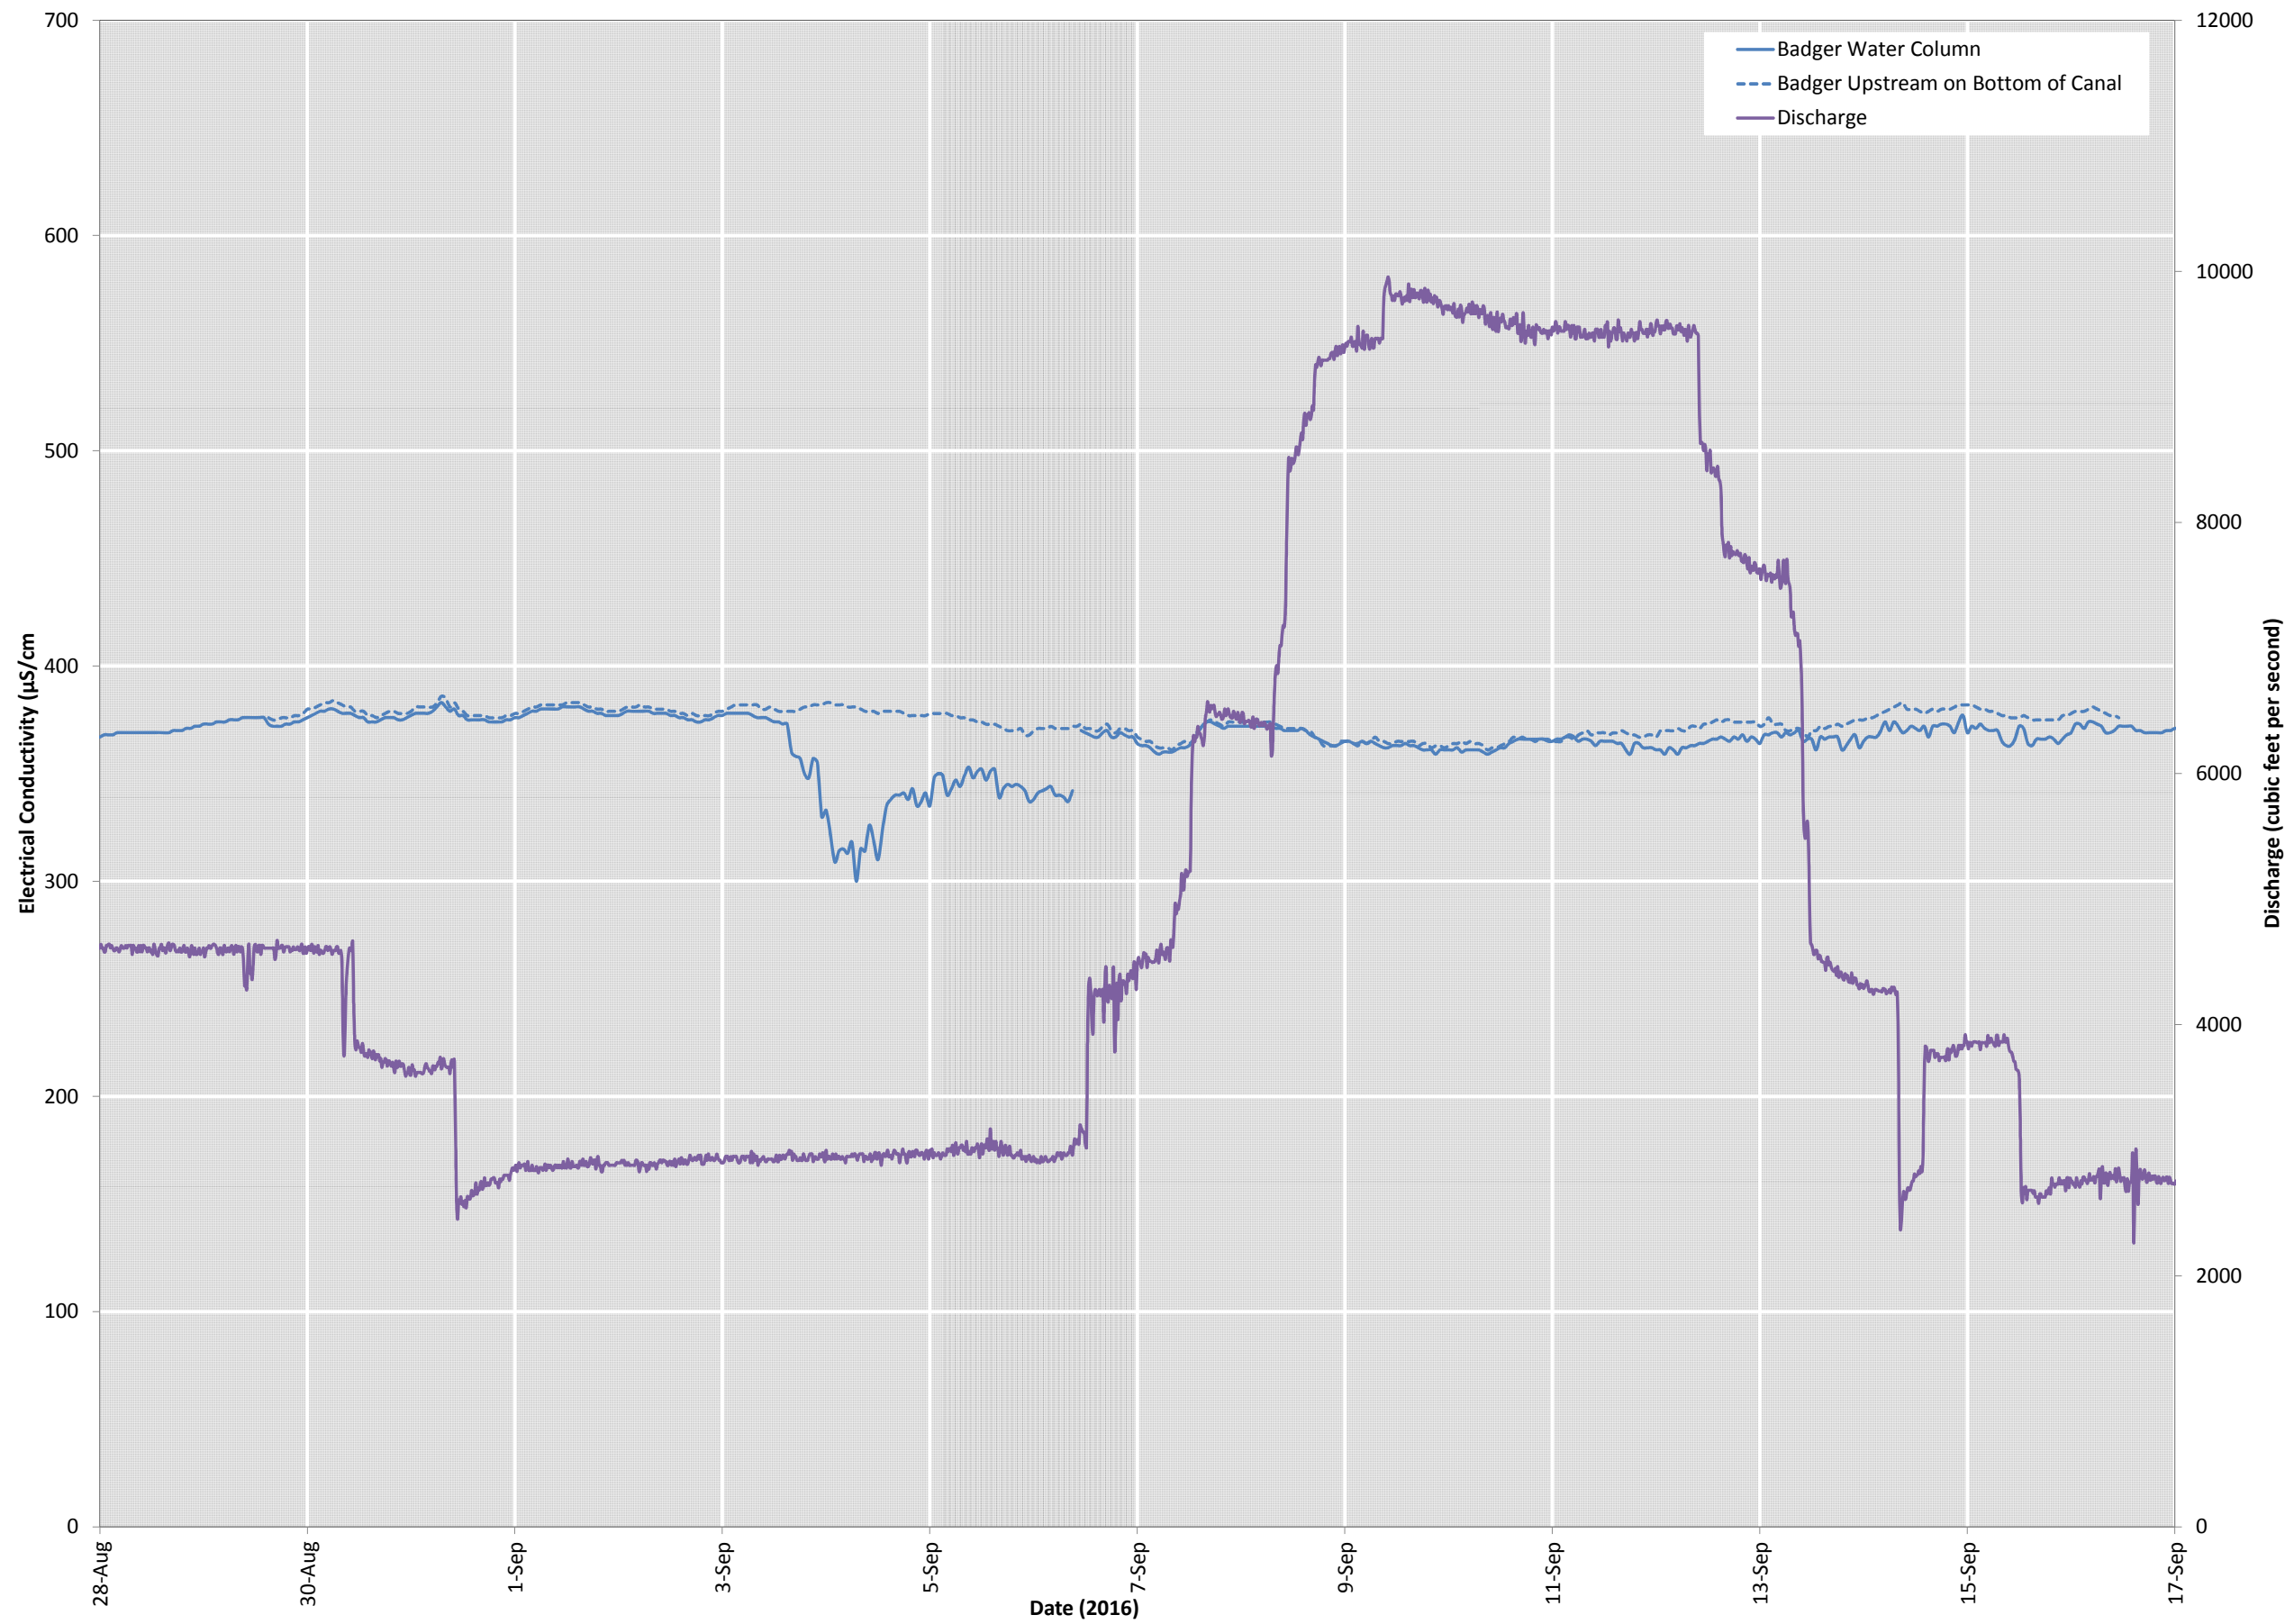
Figure 10. Comparison of Dissolved Oxygen Readings, Upstream Surface and Upstream Bottom of Canal of the Badger Hydroelectric Plant
FERC No. 2677 on the Fox River in Kaukauna, Wisconsin

Figure 11. Comparison of Temperature Readings, Upstream Water Column and Upstream Bottom of Canal of the Badger Hydroelectric Plant
FERC No. 2677 on the Fox River in Kaukauna, Wisconsin

Figure 12. Comparison of pH Readings, Upstream Water Column and Upstream Bottom of Canal of the Badger Hydroelectric Plant
FERC No. 2677 on the Fox River in Kaukauna, Wisconsin

Figure 13. Comparison of Electrical Conductivity Readings, Upstream Water Column and Upstream Bottom of Canal of the Badger Hydroelectric Plant
FERC No. 2677 on the Fox River in Kaukauna, Wisconsin

downstream from the monitoring station. The sonde was also found to have continued recording water quality data from August 22 until it was retrieved on September 16. Figures 10, 11, 12, and 13 compare hourly DO, temperature, pH, and electrical conductivity, respectively, between the upstream sonde which sank to the channel bottom and the replacement sonde deployed at this monitoring station starting on August 29. Hourly temperature data are identical for the two sondes. DO varied consistently for both units, although the unit resting on the bottom of the channel recorded about 0.1 to 0.5 mg/L less than the replacement unit suspended in the channel at the monitoring station. The pH readings for the two sondes were identical for the first several days, then pH for the detached unit began to drift slightly lower than the replacement sonde by up to about 0.5 pH units on September 16. Electrical conductivity readings for the two sondes were generally consistent. It is common that pH and DO are typically lower near or in bottom sediments due to suppressed oxygen conditions that occur from biodegradation. We conclude both units were functioning normally albeit in different micro-environments.

Based on overall data consistency between the sonde on the channel bottom and the replacement sonde, data for August 22 to 29 from the sonde which detached from its mooring sometime during this period was included in the data summary tables and figures for the Badger Upstream station.

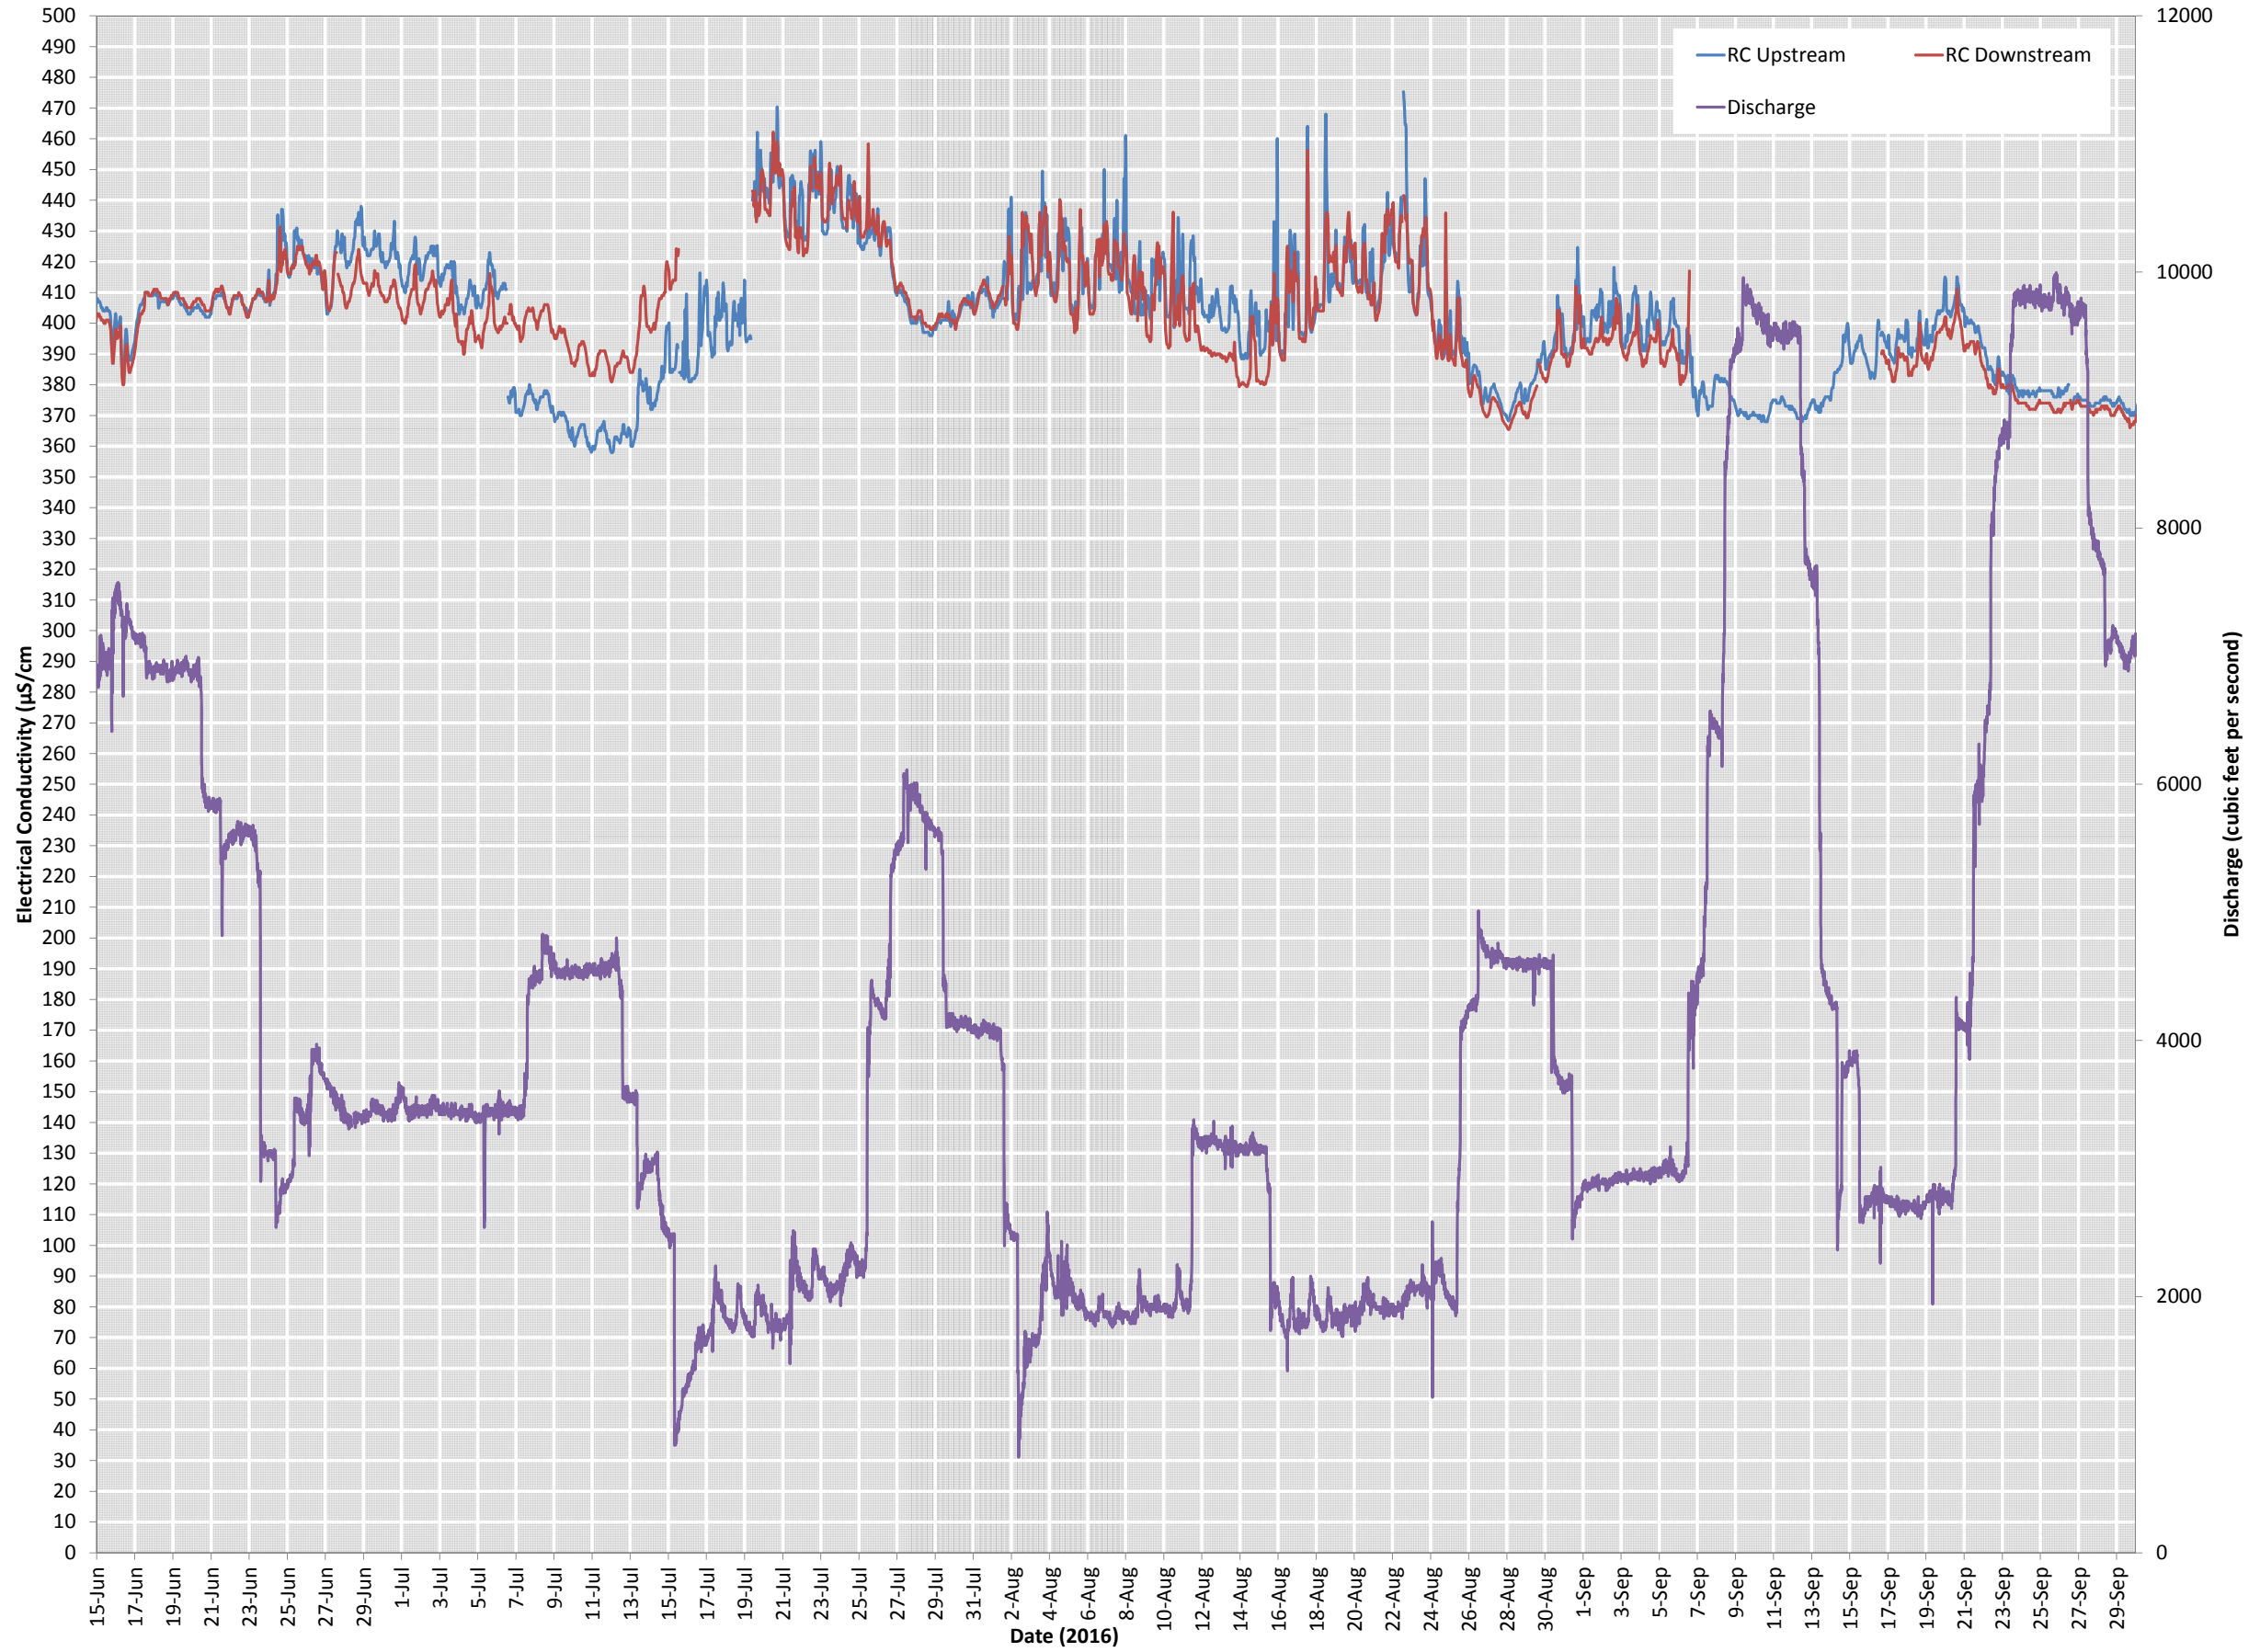
Figure 17. Hourly Electrical Conductivity Readings, Upstream and Downstream of the Rapide Croche Hydroelectric Plant
FERC No. 2677 on the Fox River in Kaukauna, Wisconsin

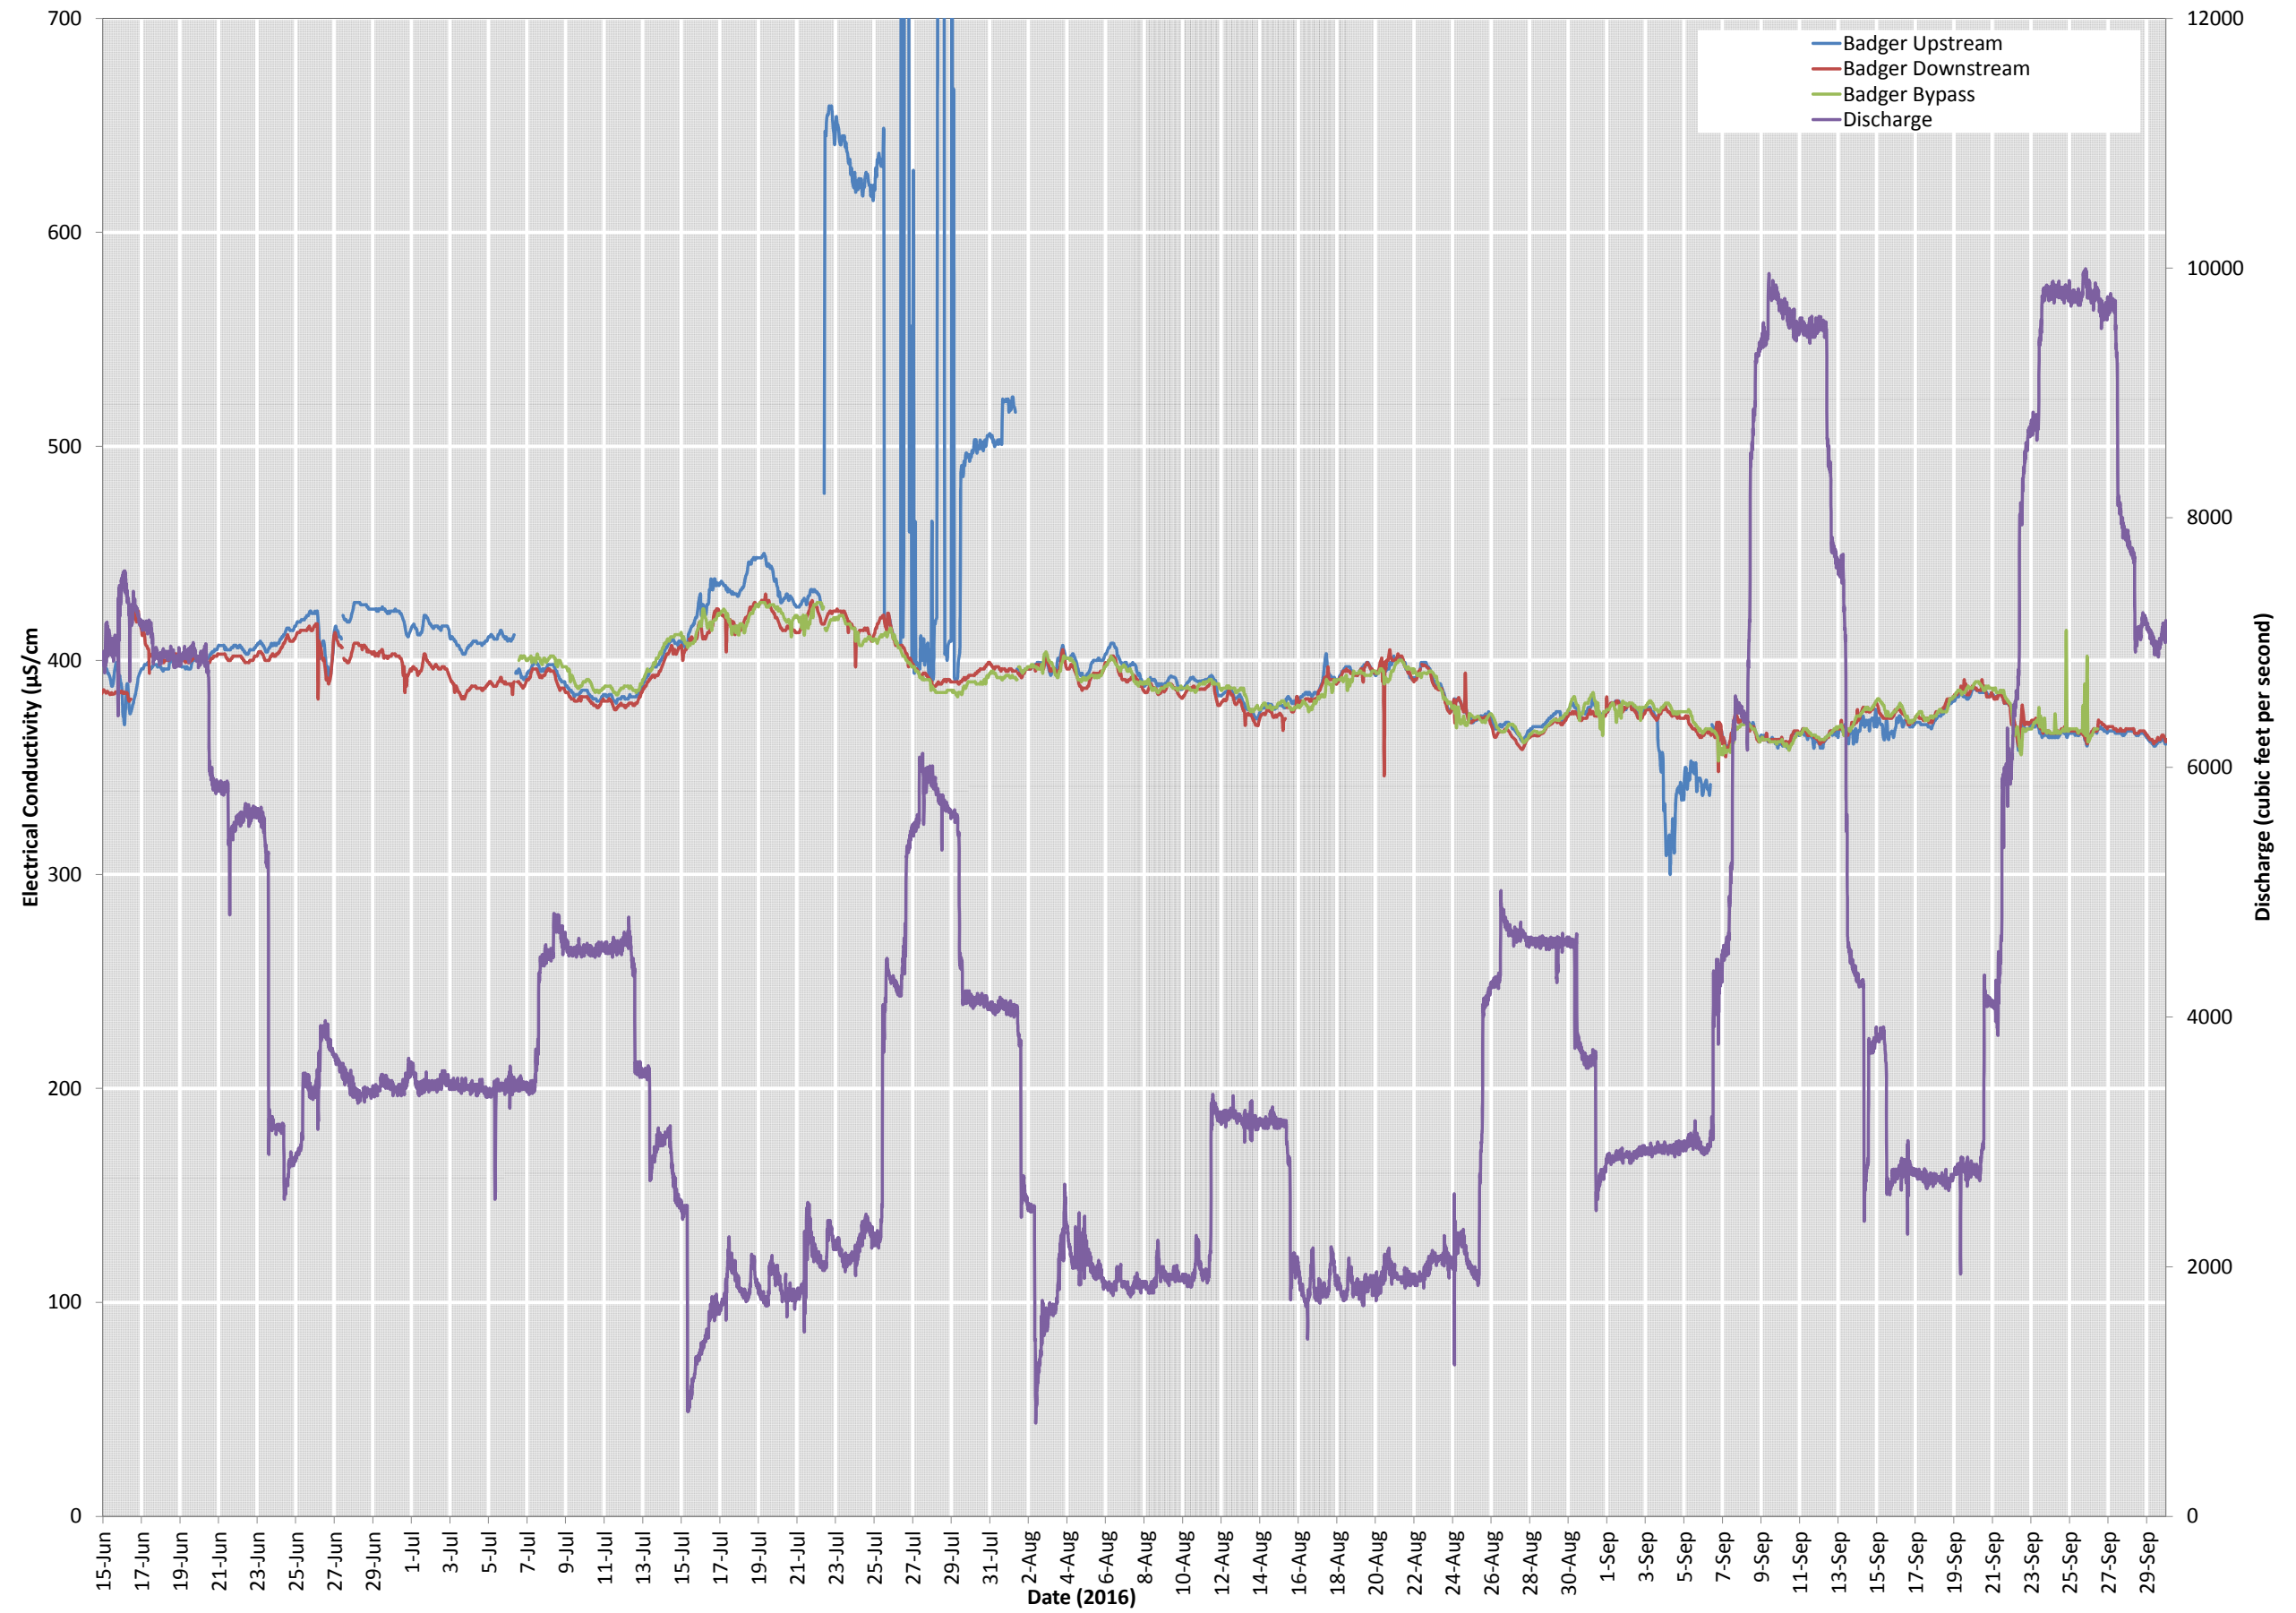
Figure 5. Hourly Electrical Conductivity Readings, Upstream, Downstream, and along the Bypass of the Badger Hydroelectric Plant
FERC No. 2677 on the Fox River in Kaukauna, Wisconsin

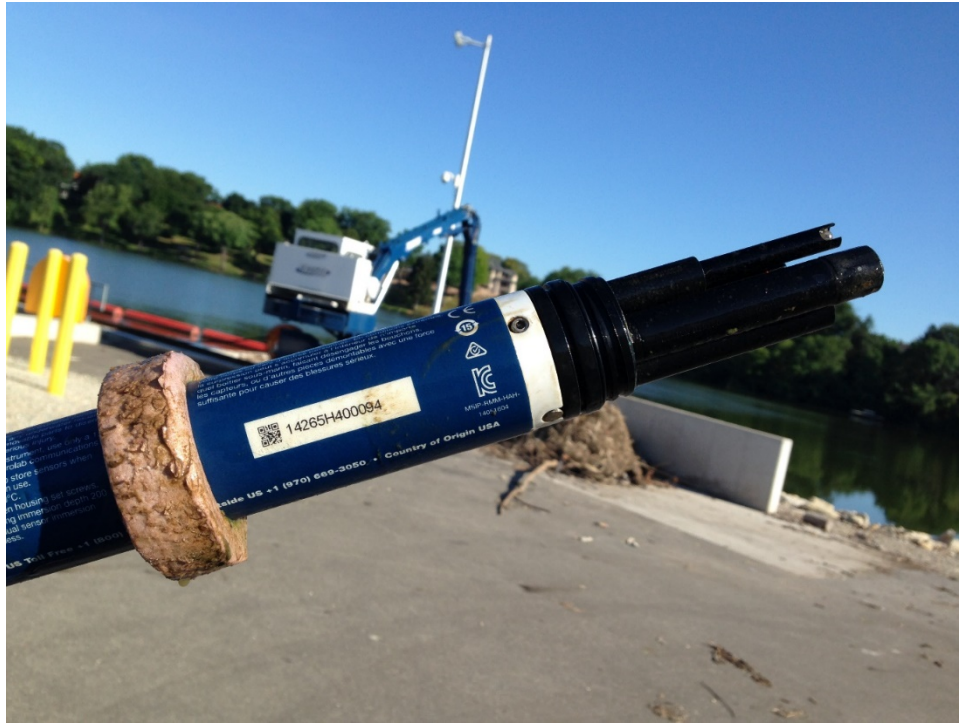
Photo No. 1 Example of moderate biofouling of sonde at Badger Upstream (8/8/16).

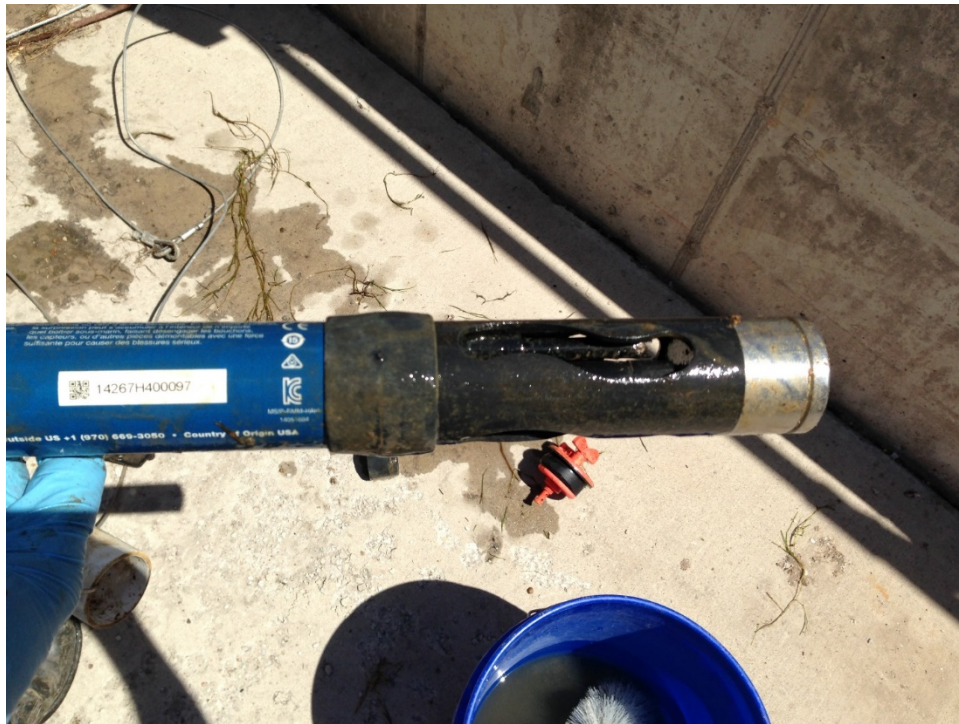
Photo No. 2 Example of sonde biofouling at Badger Downstream (8/8/16).

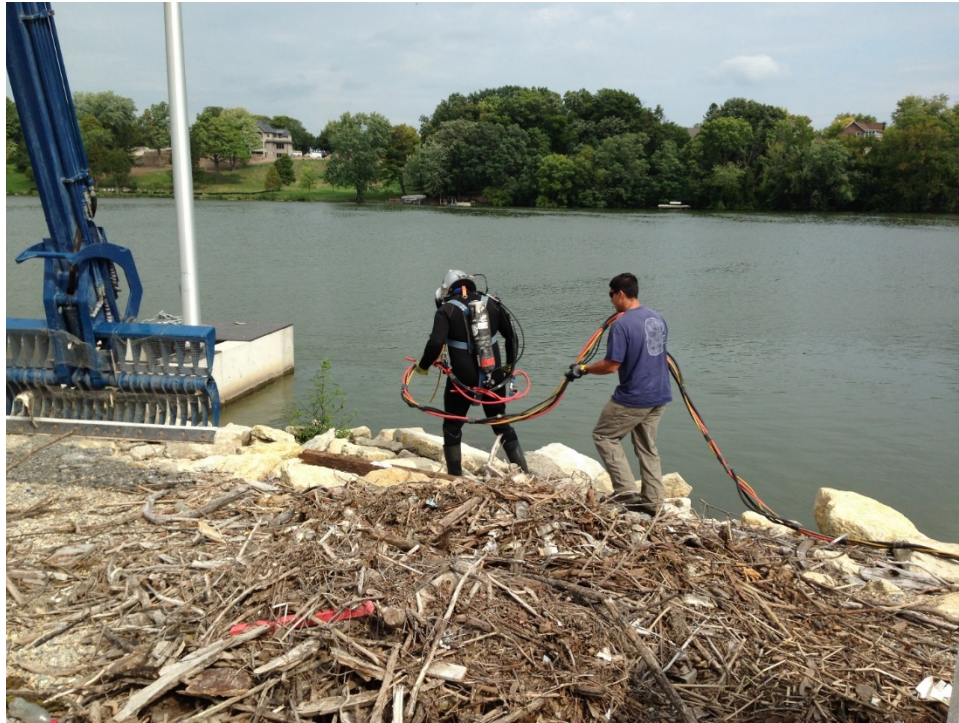
Photo No. 3 Diver preparing to retrieve detached Badger Upstream sonde on 9/16/16.

Sometime during the deployment interval from August 22 to 29, 2016, the upstream sonde detached from its anchor cable and sank to the bottom of 25-foot-deep power canal. A backup sonde was deployed at this station on August 29 and the detached sonde was recovered by a professional diving team on September 16. The original sonde was found resting on the bottom of the canal within the PVC protective shroud that remained affixed with the 20-pound downrigger weight. Accordingly, the detached sonde had not been transported significantly

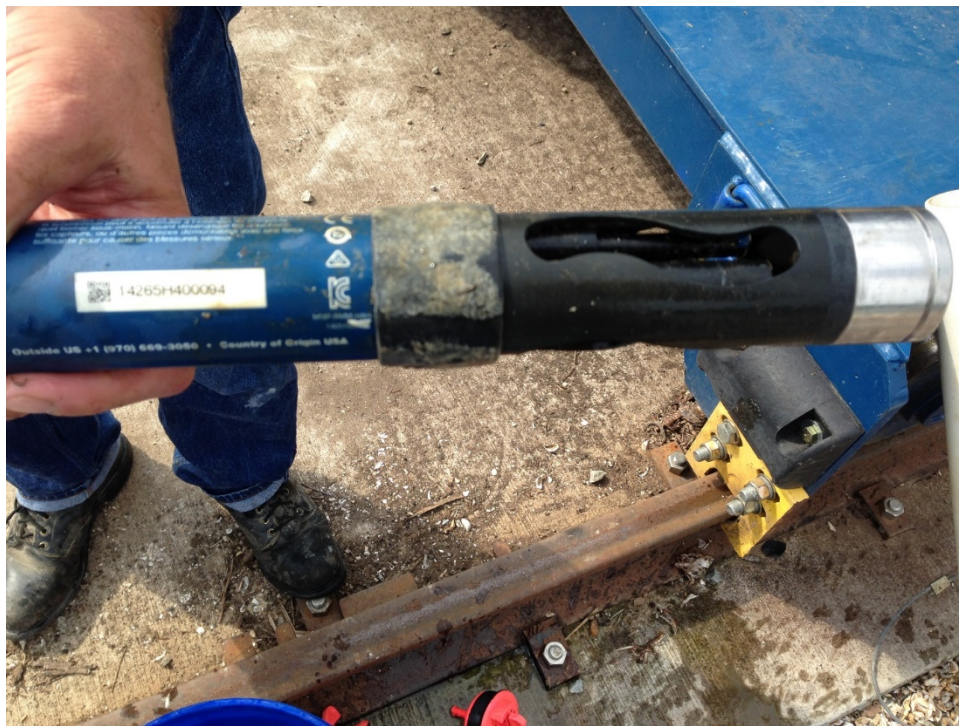
Photo No. 4 Badger Upstream sonde after retrieval by diver on 9/16/16.

8/29/16 **BADGER UPSTREAM SONDE S/N H400094**. The sonde cable was observed to be broken and presumed to be anchored to the river bottom by the 20-lb weight. A new battery casing was installed on **SONDE S/N H400365**. **SONDE S/N H400365 was deployed in its place at BADGER UPSTREAM until arrangements could be made to retrieve SONDE S/N H400094.**
