**BIG-DOUGLAS AND RATHBONE-SOPER
TWA WQM PLAN 2017**
Big and Douglas Creeks (BR03)
HUC: 070400071201, Monitored 2014

EGAD # 3200-2017-16
Water Quality Bureau,
Wisconsin DNR

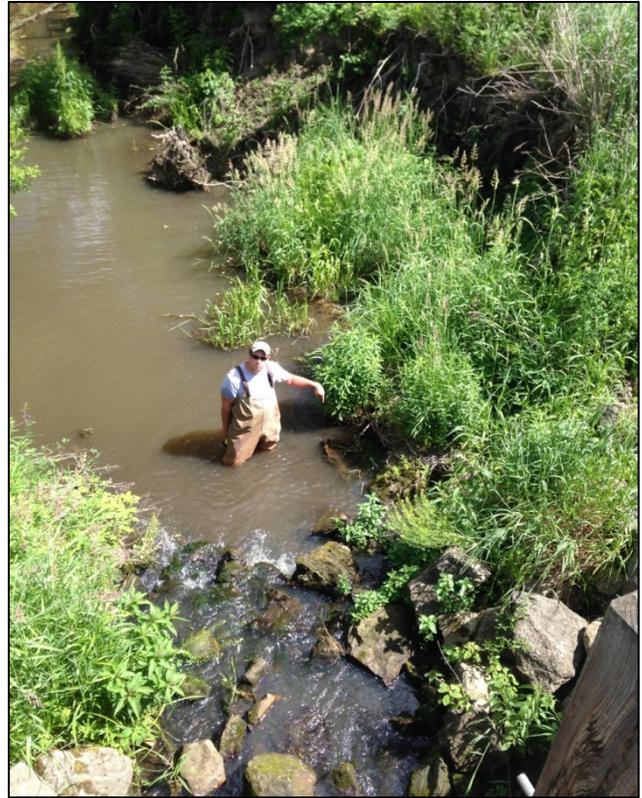
The qualitative habitat rating was fair. Field notes indicated the stream consisted of very silty substrate with highly eroding banks. Fine sediment deposition and fish cover were additional limitations of the habitat in this stream. Agricultural land uses surrounded both sides of the riparian areas as well. The HBI rating was very good indicating possible light organic pollution. The MIBI rating indicated that the macroinvertebrate community was fair. A grab total phosphorus sample had a concentration of 0.360 mg/L, which exceeds the statewide criteria. Based on the high single grab concentration of total phosphorus, follow-up phosphorus monitoring should be conducted in order to assess if this water body should be added to the impaired waters list in the next cycle.

**Jenkins Valley Creek DS from Dayton Ave
Photo by Kurt Rasmussen**
