**RE: Amendment of the Water Quality Management Plan for Dane County to  
revise Environmental Corridor Boundaries near the new Waunakee Public  
Library**

**WAUNAKEE LIBRARY**  
**EXISTING SITE CONDITIONS**  
**SNYDER & ASSOCIATES, INC.**  
CITY OF WAUNAKEE, DANE COUNTY, STATE OF WI  
5010 VOGES ROAD  
MADISON, WISCONSIN 53718  
608-838-0444 | www.snyder-associates.com  
Project No: C1.0  
116.0144.30  
C1.0

# WAUNAKEE LIBRARY

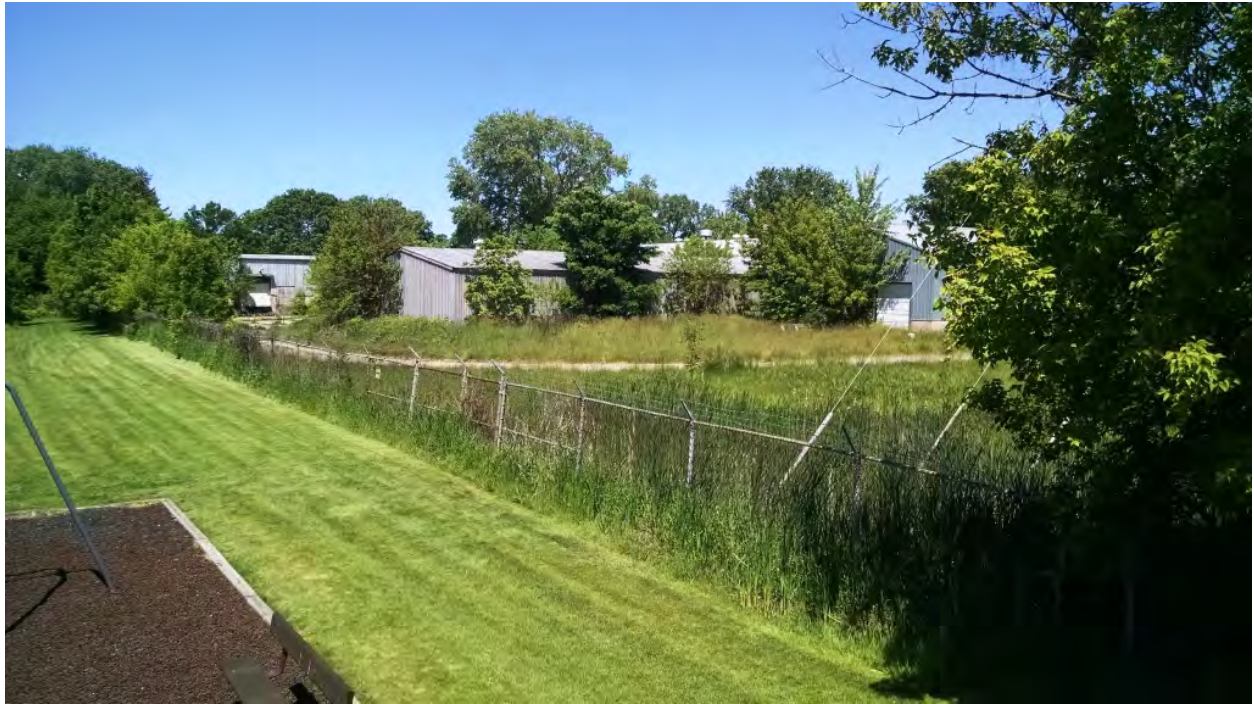
#1 - At Playground area looking inside fence at existing wetland in the southeast corner.

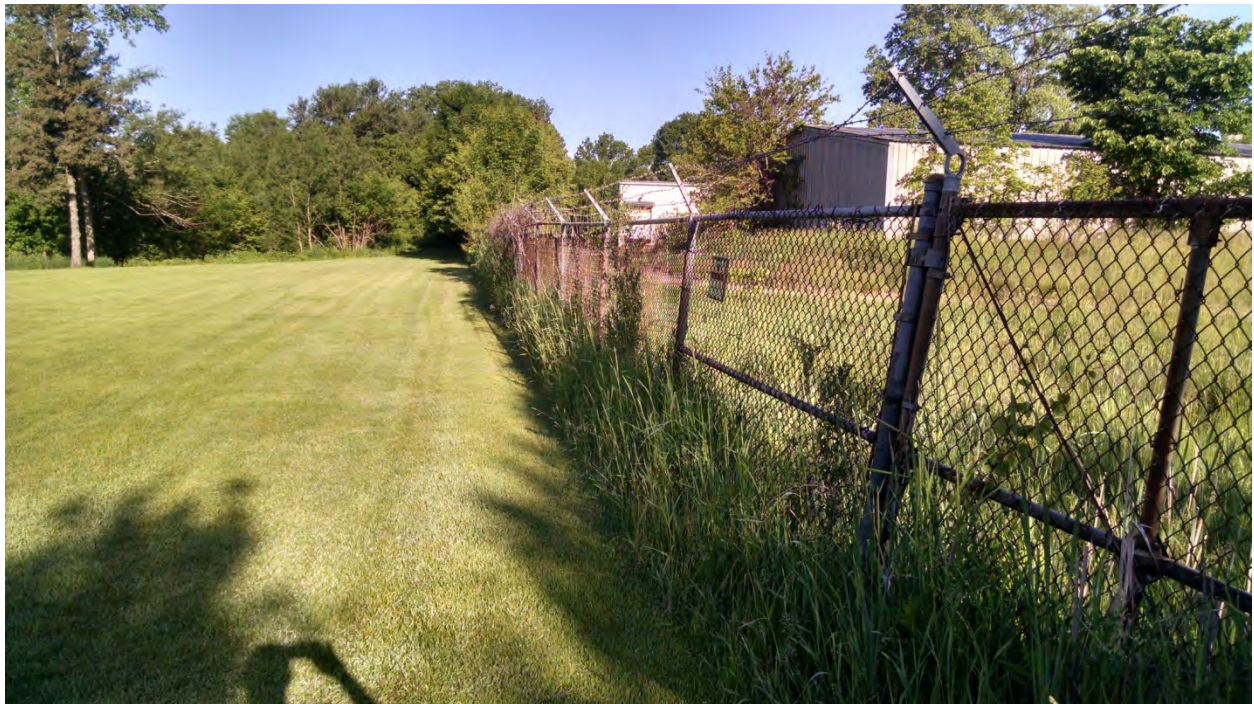
#4 – Looking east along the existing fenceline. To the left is the Six Mile Creek Corridor.

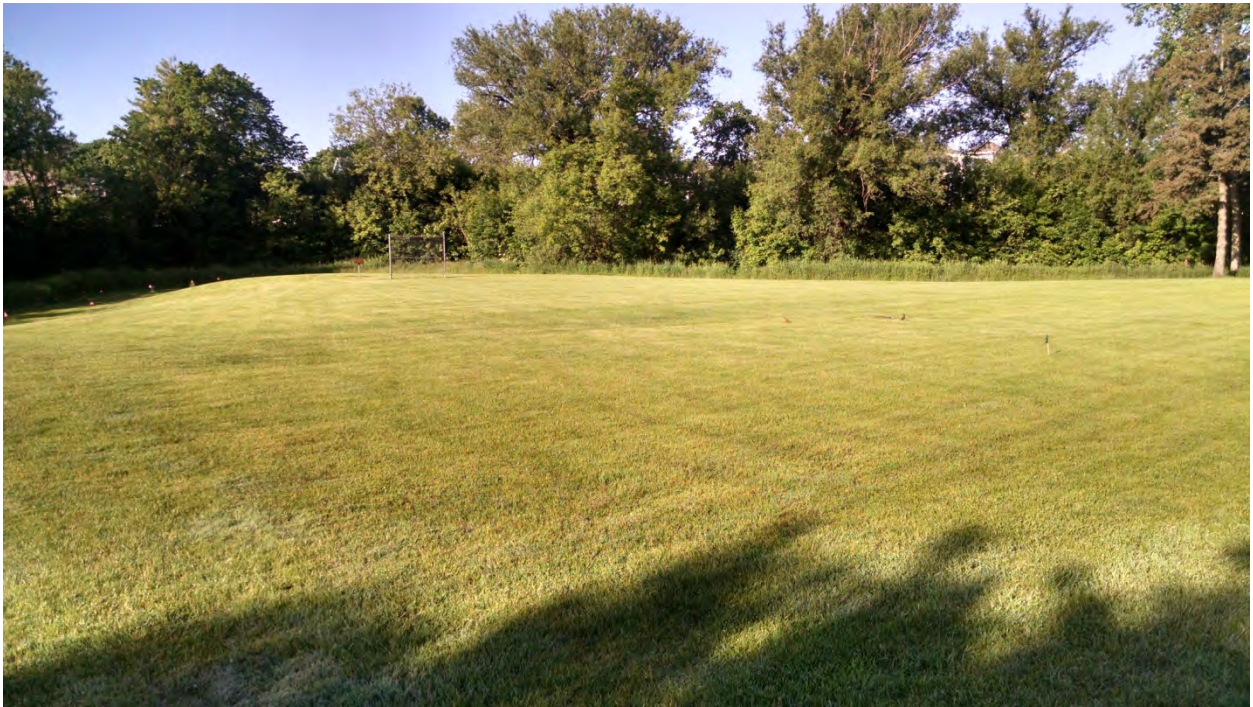
#5 – Looking to the south at Six Mile Creek at open space.

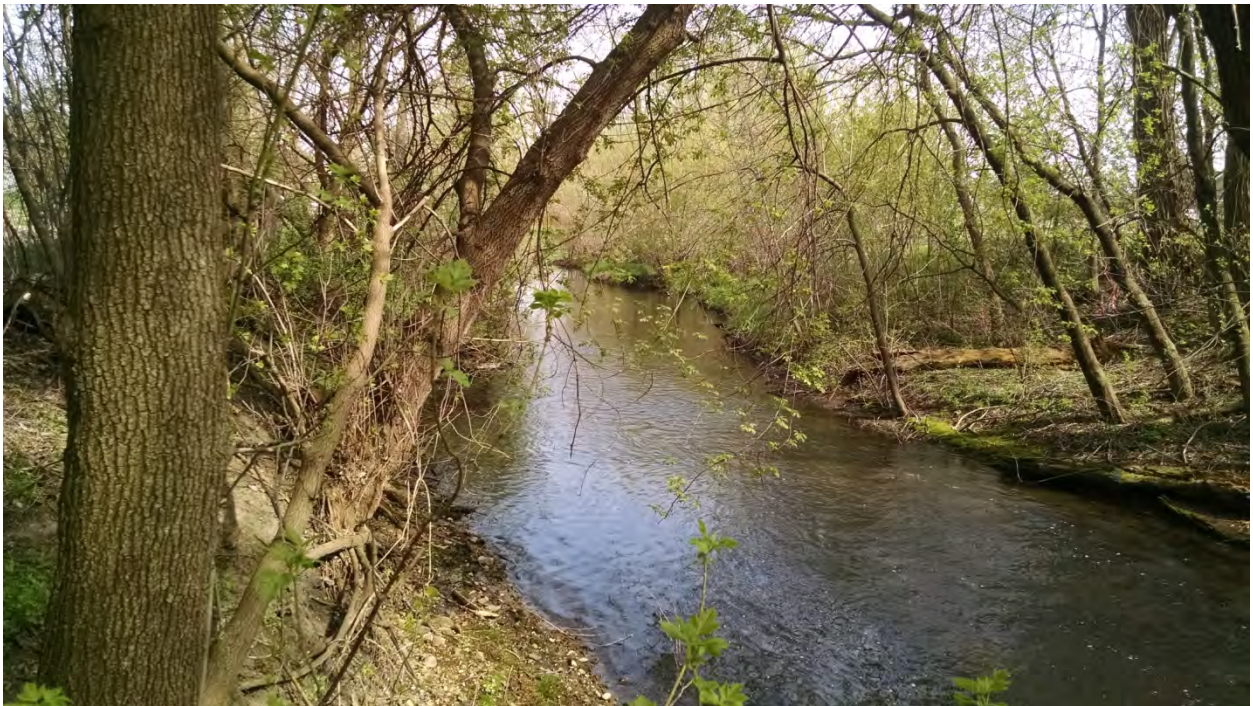
#7 – Looking at the existing Six Mile Creek corridor.

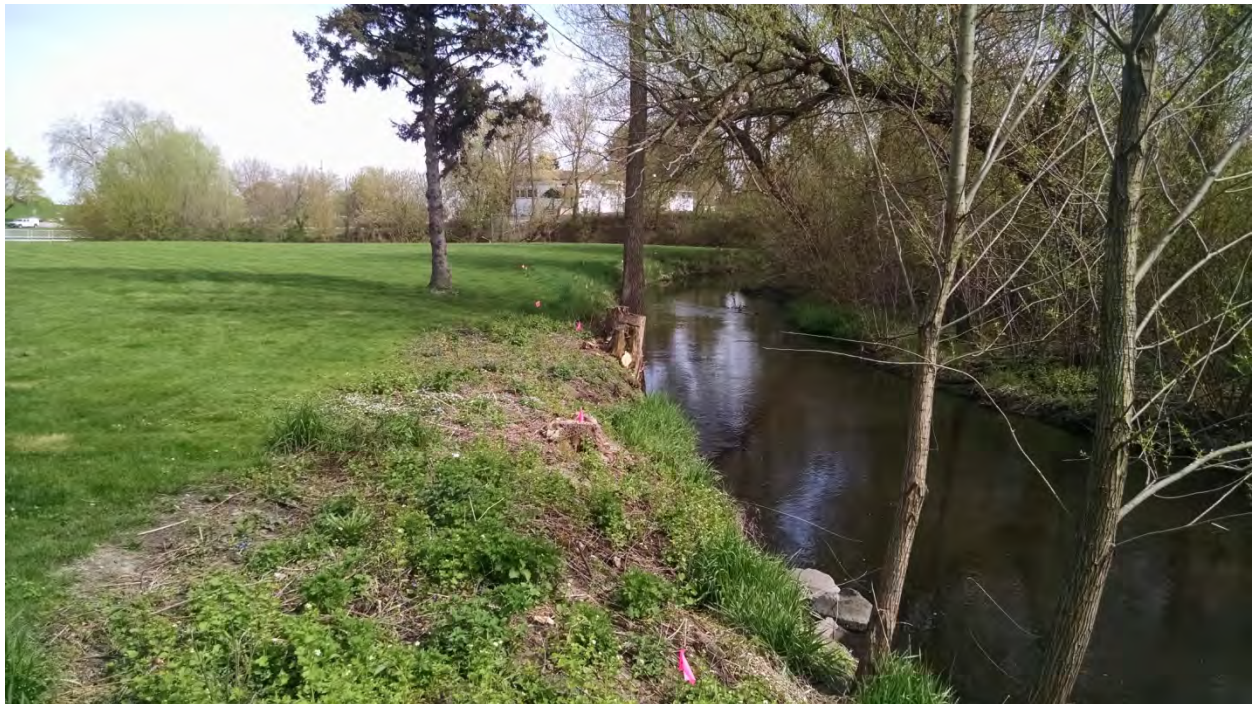
#11 – Looking southeast along Six Mile Creek, the wetland delineation flags can be seen.

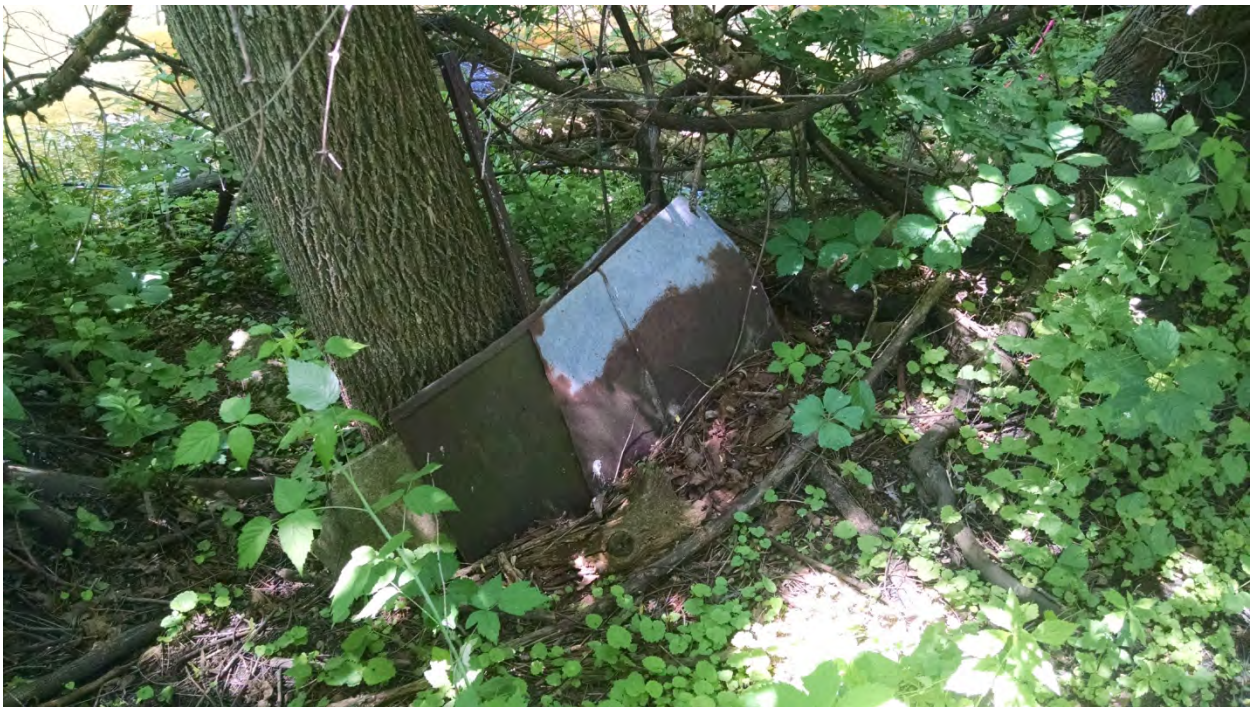
#15 – An example of some of the junk within the Six Mile Creek corridor.

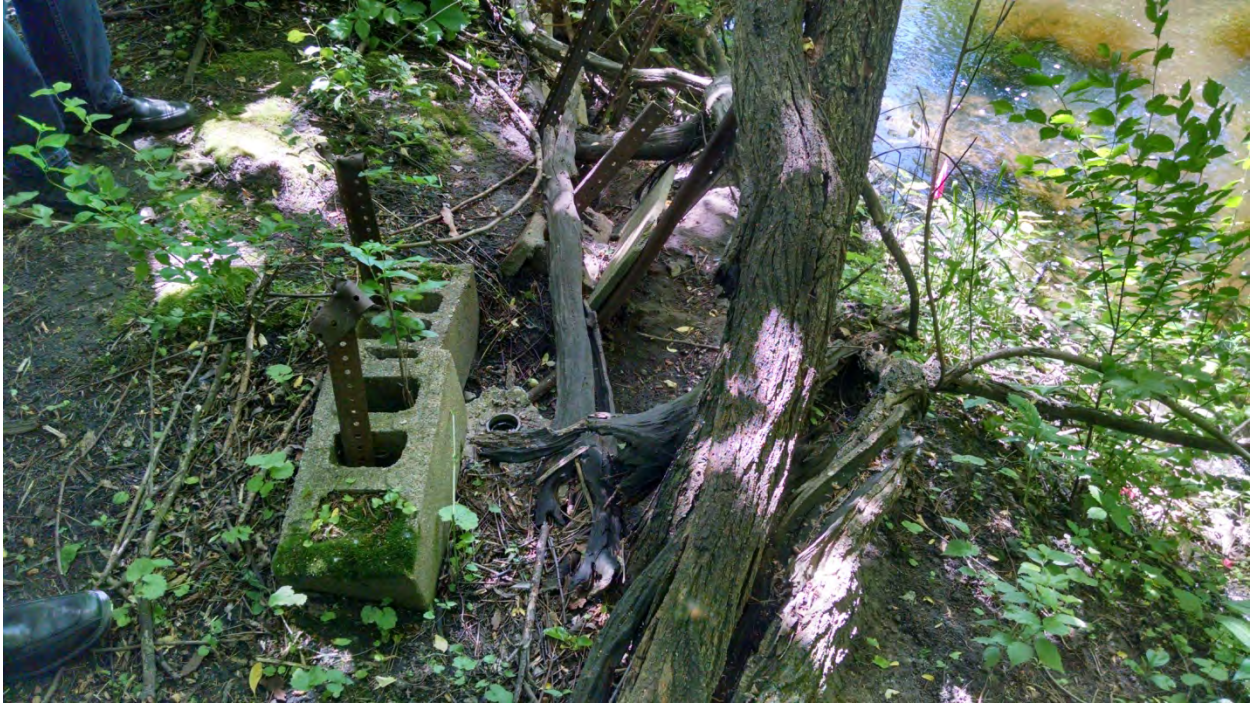
#16 – Another picture showing some junk within Six Mile Creek corridor.

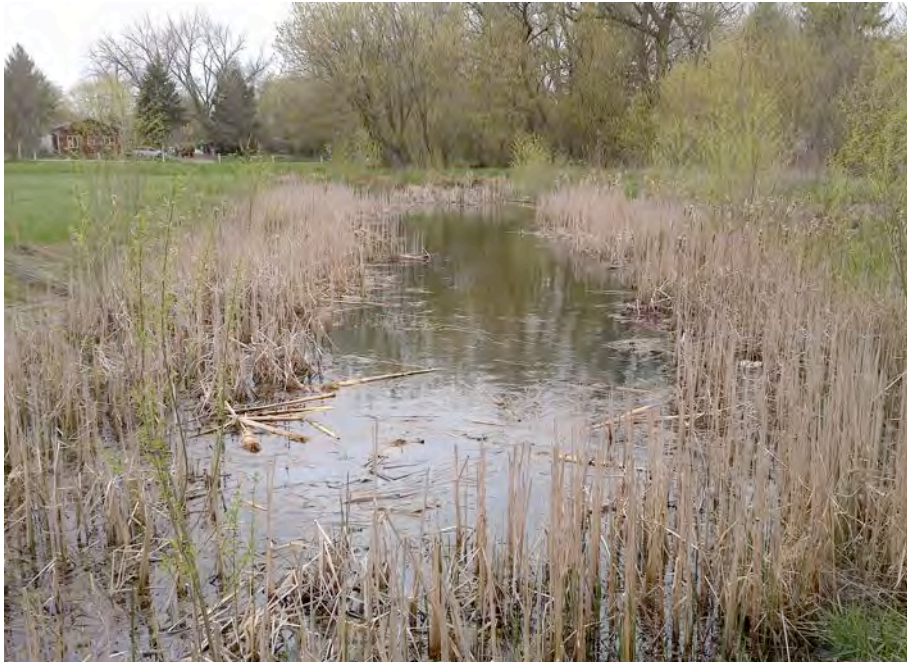
**Wetland - Plot 1A**

<b>Wetlands</b> (Plots 1A, 2A, 3A, 4A & 5A)
<b>Normal Circumstances Present?</b>	Yes
<b>Significant Disturbance?</b>	No
<b>Naturally Problematic?</b>	Yes, for all wetland plots since no hydric soil indicators were observed.

- ❖ As a result of higher than usual antecedent rainfall, the investigator did expect to directly observe a shallow water table and soil saturation in the wetlands. Accordingly, shallow soil saturation was observed in 4 of 5 wetland sample plots (1A, 2A, 4A & 5A).

- ❖ The soil surface layers in the wetland sample plots were comprised of 10 YR 2/1 & 2/2-colored silt loam and silty clay loam.
- ❖ B-horizons in riverside wetlands were not observed at the soil depths (24-30 inches) examined because these sites occupied alluvial landforms comprised of deep, dark-colored sediments.
- ❖ Wetland soil profiles in the industrial site were only inspected to depths of 12-14 inches due to the abundance of rocks. These soils were probably disturbed during development of the site.
- ❖ None of the wetland plots showed hydric soil indicators but professional judgment was used to assume the soils were hydric based on hydrophytic vegetation and wetland hydrology indicators.

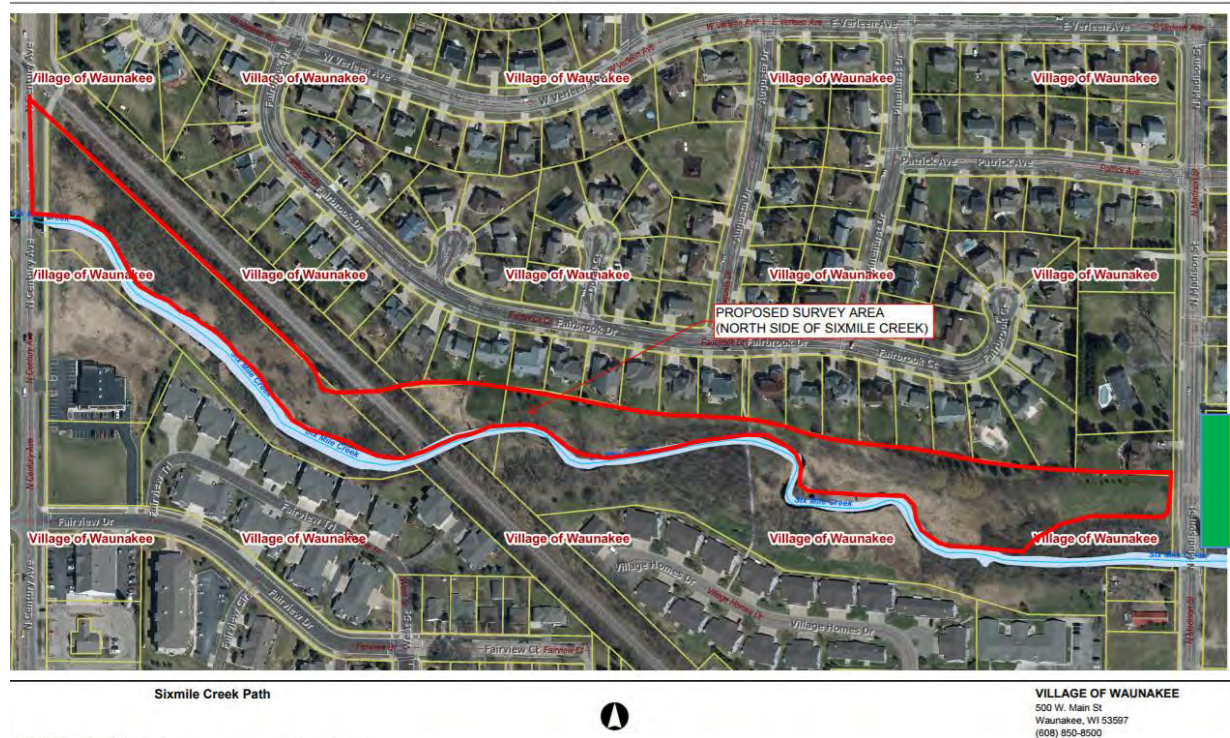
# Waunakee Library Trail Connectivity

In May of 2018, the Village commissioned Strand to investigate the feasibility of a trail along the Six Mile Creek Corridor. This would shift the previously planned out bike path from residential streets to the Six Mile Creek corridor. The Library site is in the far east of this map as shown in the green box and would provide the connection piece for this project.
