# Pine and Calvin Creek – Frontal Lake Michigan TWA WQM Plan 2017

*Sevenmile and Silver Creeks (MA01)*

**PINE & CALVIN CREEK FRONTAL  
LAKE MICHIGAN TWA WQM 2017**  
*Sevenmile and Silver Creeks (MA01)*  
HUC: 040301010702, Monitored 2016

EGAD # 3200-2017-10  
Water Quality Bureau,  
Wisconsin DNR

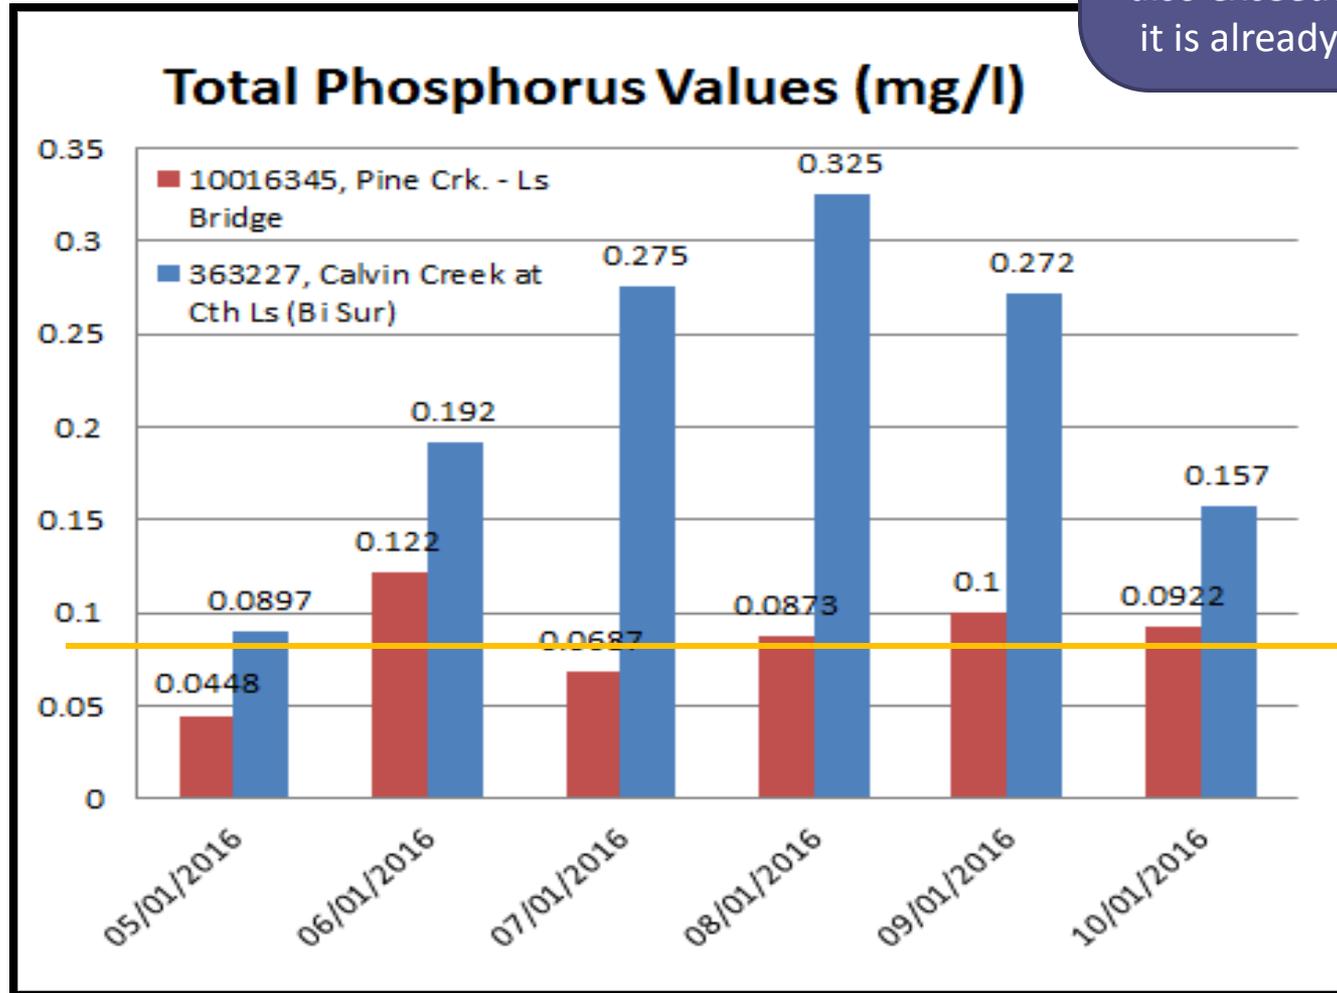
Samples from Calvin Creek exceeded the phosphorus standard with a mean value of 232 mg/l, exceeding the standard of 75 mg/L. Pine Creek also exceeded the standard but it is already listed as impaired.

Water Quality Standard = 0.075 mg/l

- Calvin Creek should be added to Wisconsin's 303d List of impaired waters for high phosphorus concentrations
- DNR work with partners to reduce phosphorus runoff
- Engage local units of governments and watershed residents in stream restoration

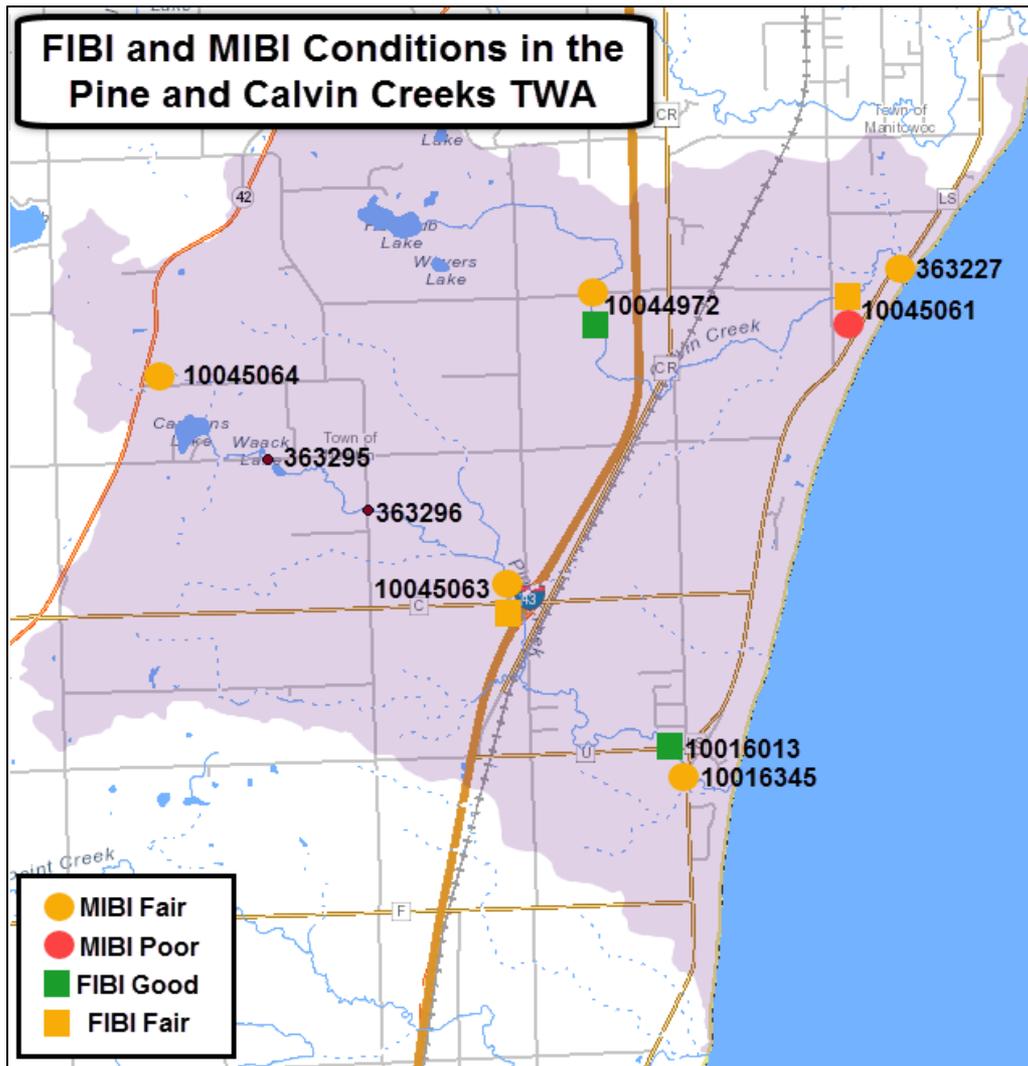
Of the five fish surveys completed two had a condition of good, two had a condition of fair and one site (Pine Creek at Carstens Road) had no fish.

The macroinvertebrate locations sampled for this project indicated watershed disturbance, with three stations sampled on each of Calvin and Pine Creek. Results indicated that mIBI values were fair for all sites sampled with the exception of Calvin Creek downstream of South 26<sup>th</sup> Street with a Poor value.

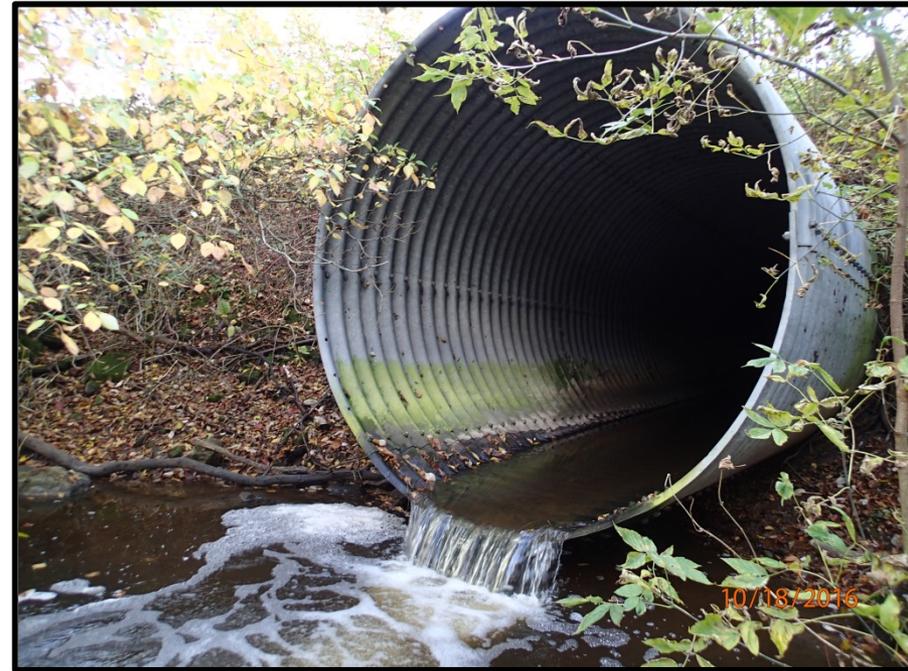
Perched Culvert on Calvin Creek

- Work with landowners to decrease the amount of agricultural runoff reaching surface and groundwater
- Establish riparian buffers to protect water quality
- Monitor and control invasive species
- Minimize fish barriers
- Restore the water quality of Pine Creek and Calvin Creek
