Project Name | Library Lake SW Wetland**Date** | 12-31-2016**To / Contact info** | Jane Malischke, Alex Smith, Wisconsin DNR**Cc / Contact info** | Tom Schroeder, BDLMD President**From / Contact info** | Jay Michels (EOR), Britta Hansen (EOR)**Regarding** | Grant Completion

Library Lake
Wetland Delineation Report

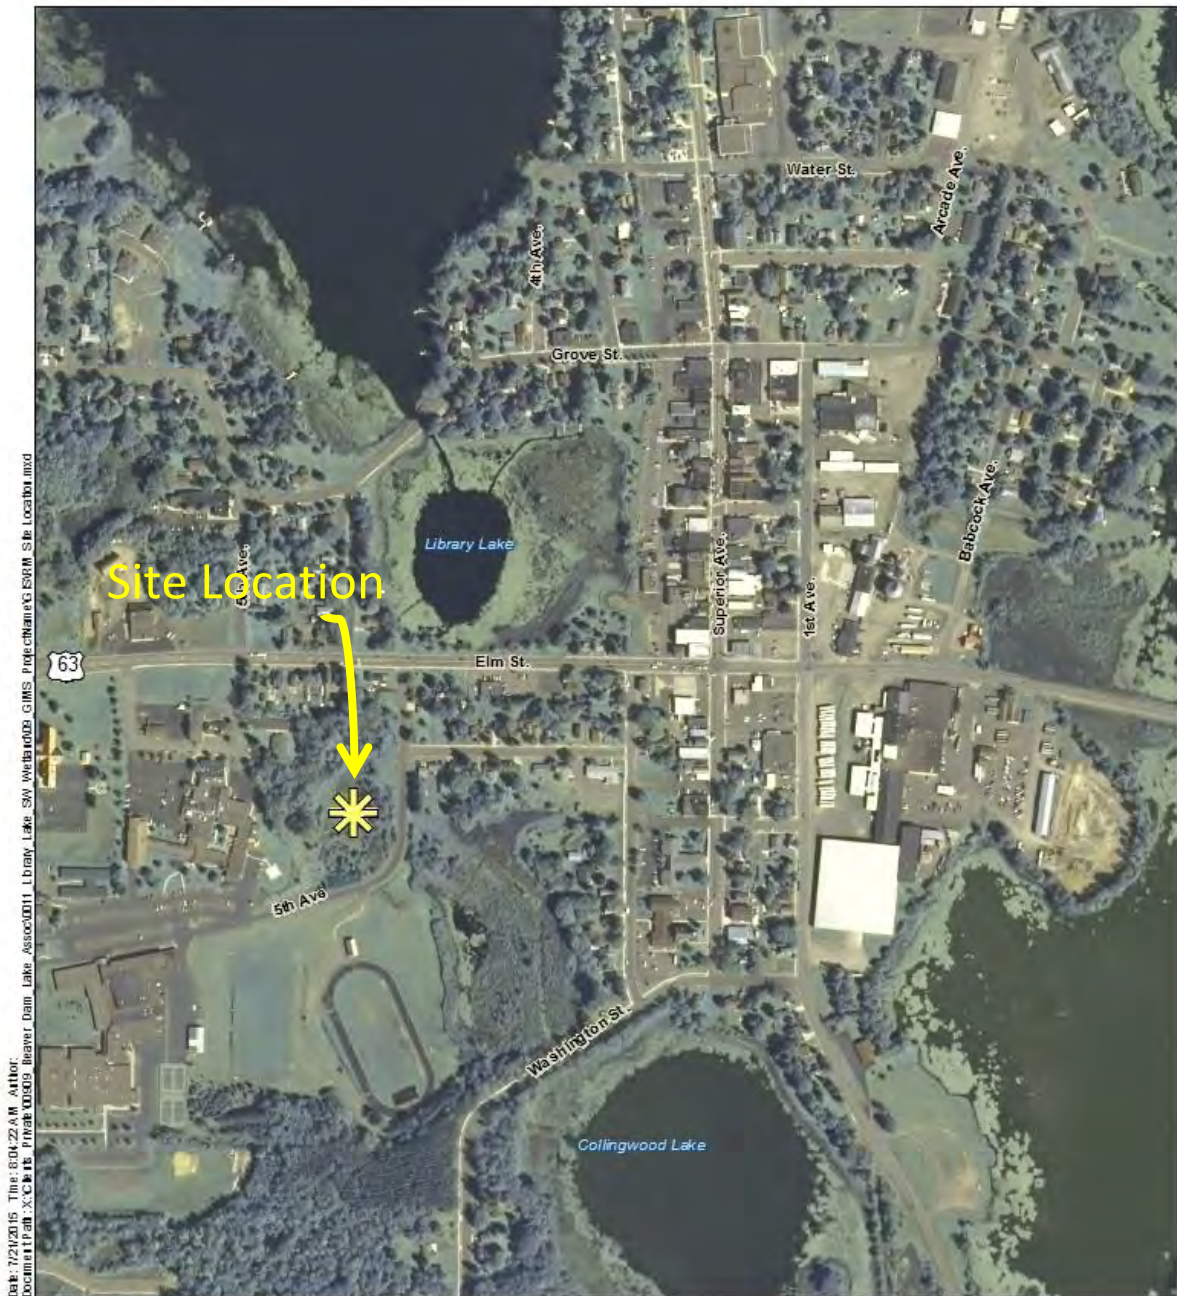
Figure 1. Site location

The purpose of this report is to document the boundaries of wetland resources at the proposed stormwater treatment facility location south of Library Lake (Figure 1). This report has been prepared to facilitate a wetland boundary and type determination by the wetland regulatory agencies.

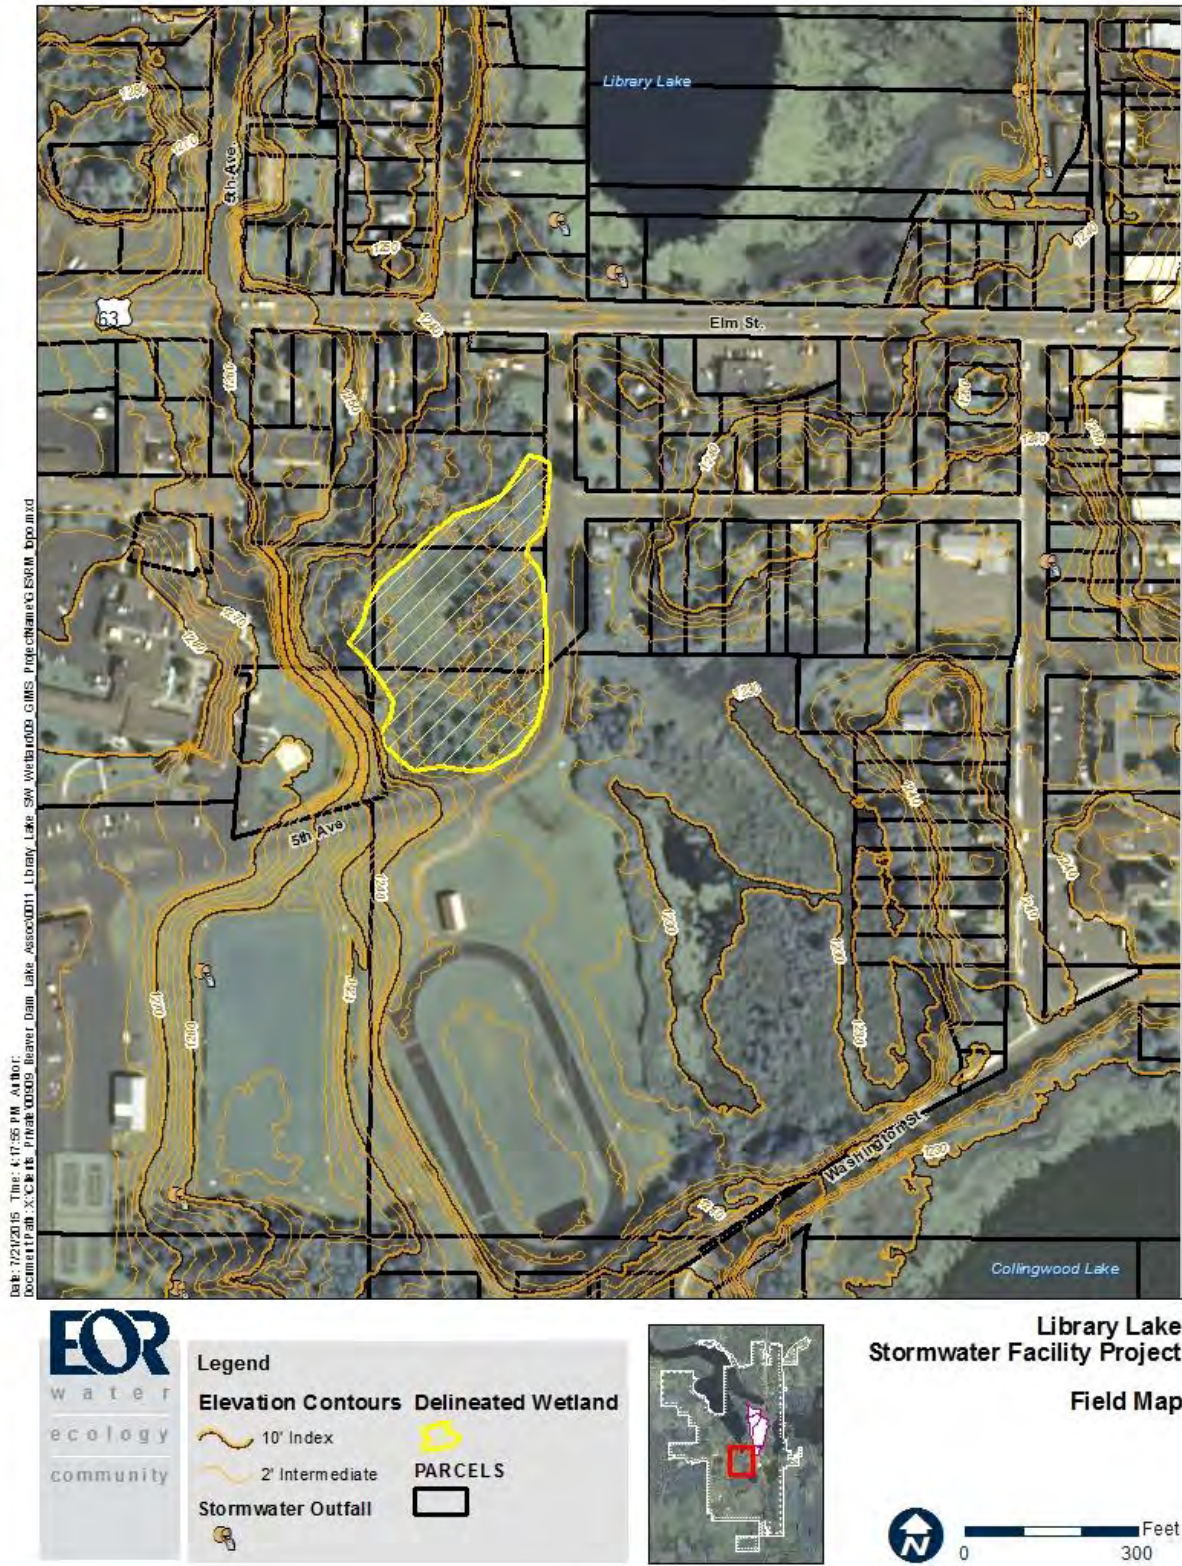
Figure 2. Topography

Topography within the vicinity of the project is comprised of a flow through wetland that is situated in a depression between uplands to the east and west (Figure 2) and lakes to the north (Library Lake) and south (Collingwood Lake). Vegetation within the project area is comprised of native and non-native species.

Prior to conducting the field wetland delineation, existing data and available maps were compiled and reviewed. Topographic maps (Figure 2), Wisconsin Wetland Inventory (WWI) (Figure 4), and WI DNR Public Waters (Figure 5) maps were reviewed to determine likely locations of existing wetlands. NRCS SSURGO soils were compiled using the Web Soil Survey site to determine potentially hydric soils in the project area (Figure 3). Lastly, precipitation data from the United States Department of Agriculture Regional Climate Center for Cumberland, Wisconsin was reviewed to determine how current precipitation at the site compares to normal conditions (Appendix E).

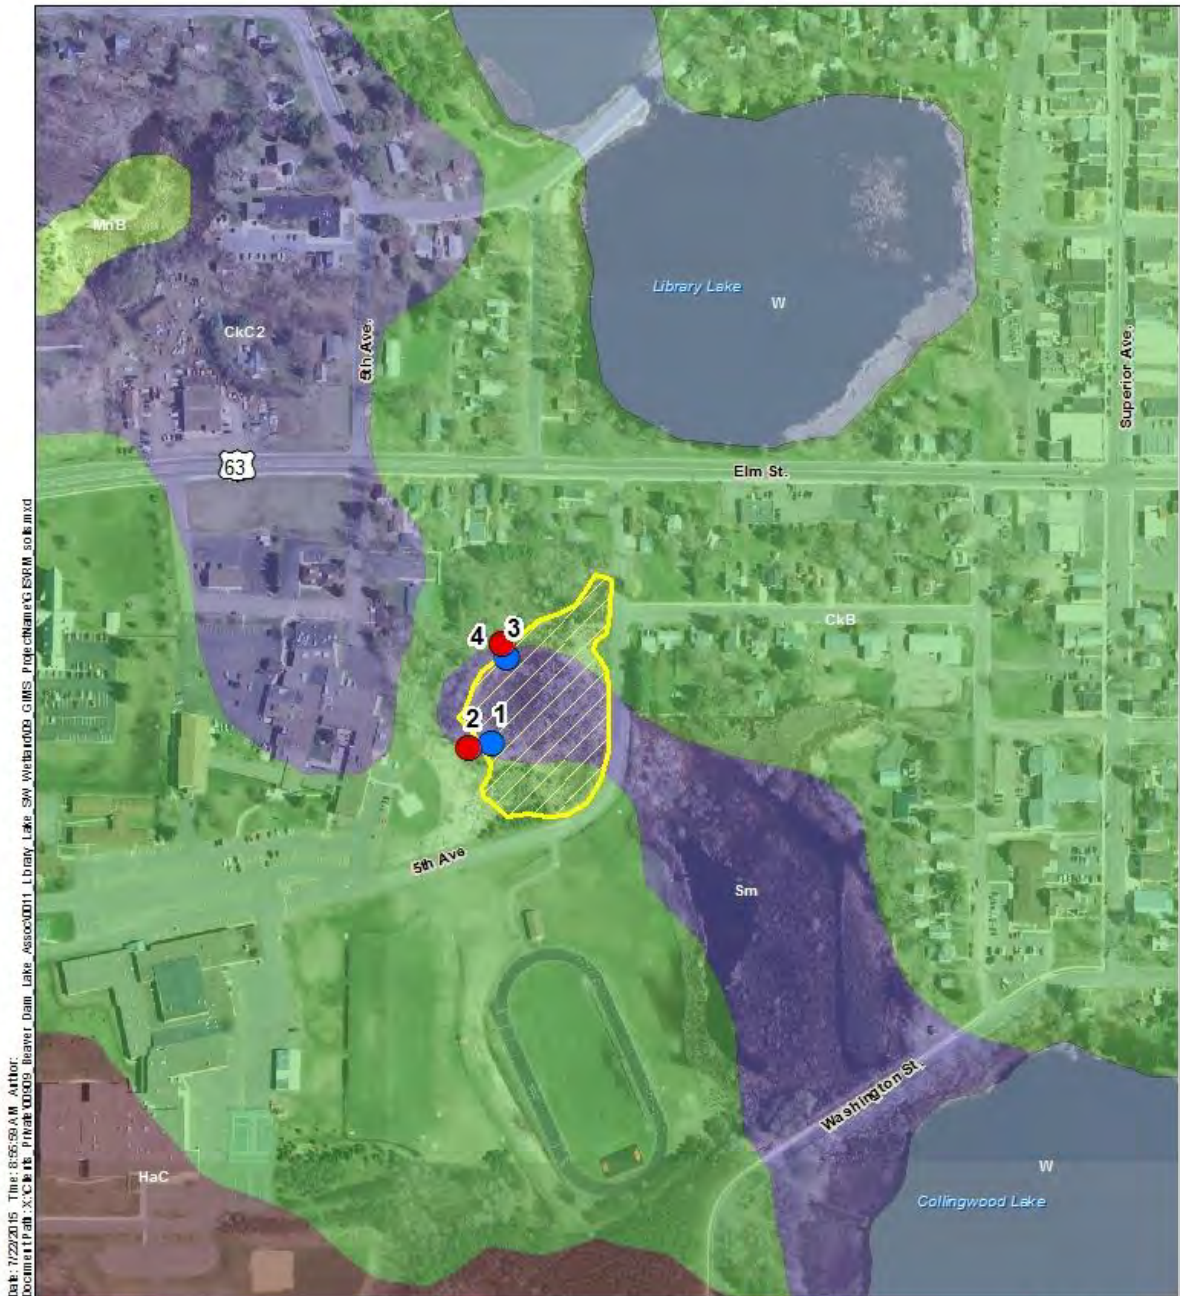
Figure 3. Soils

The upland soils within the project area are comprised of Chetek sandy loams on lands with two to twelve percent slope. The parent soil within the wetland is classified as Seelyeville and Cathro Muck with zero to one percent slope. Seelyeville-Cathro Muck is classified as a hydric soil (Table 1; Figure 3).

Table 1. Soils within project vicinity

Soil symbol	Soil Name	Surface texture	Depth to Water Table	Slope
Sm	Seelyeville-Cathro	Muck	0 cm	0-1%,
CkB	Chetek	Sandy Loam	>180	2-6%
CkB2	Chetek Eroding	Sandy Loam	>180	6-12%

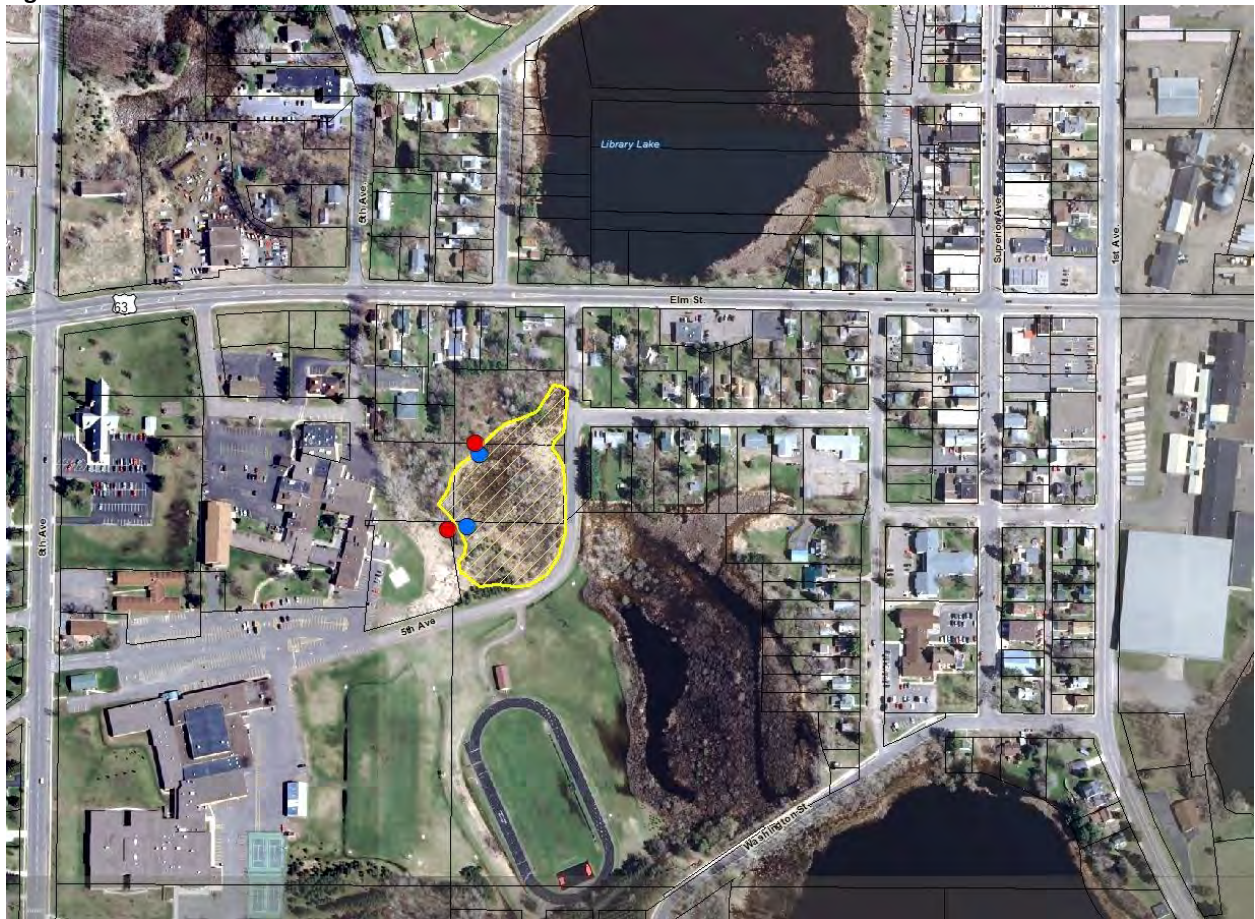
Figure 6. Delineated Wetland

A single 2.79 acre wetland complex was delineated at the project site (Figure 6). The wetland complex is comprised of three distinct communities as described below (Table 2). The shallow marsh community (wetland #1) represents the largest portion of the wetland complex. Reed Canary Grass (*Phalaris arundinacea*) and Broadleaf Cattail (*Typha latifolia*) are the dominant plant species within wetland community #1. Black Willow (*Salix nigra*) and Lake Sedge (*Carex lacustris*) are the dominant plant species within wetland community #2, while Tamarack (*Larix laricina*) and White Cedar (*Thuja occidentalis*) were the most dominant in wetland community #3. Common Buckthorn (*Rhamnus cathartica*), Box Elder (*Acer negundo*), Cottonwood (*Populus deltoides*) and Tatarian honeysuckle (*Lonicera tatarica*) were the most dominant species on the adjacent uplands.

The methodology of the 1987 Corps of Engineers Wetland Delineation Manual and regional supplements for the Northcentral and Northeast Region were used to delineate wetlands within the project area. The wetland delineation was conducted on June 16th, 2015. Figure 6 shows locations of sampling points.

Wetland ID	Wetland Type		Acres Delineated
	Circular 39 / NWI	Eggers and Reed	
Wetland Community #1	Type 3 / PEMb	Shallow Marsh	1.39
Wetland Community #2	Type 6 / PSSc	Shrub-Carr	1.12
Wetland Community #3	Type7 / PFOc	Coniferous Swamp	0.28
Total area of wetland delineated			2.79

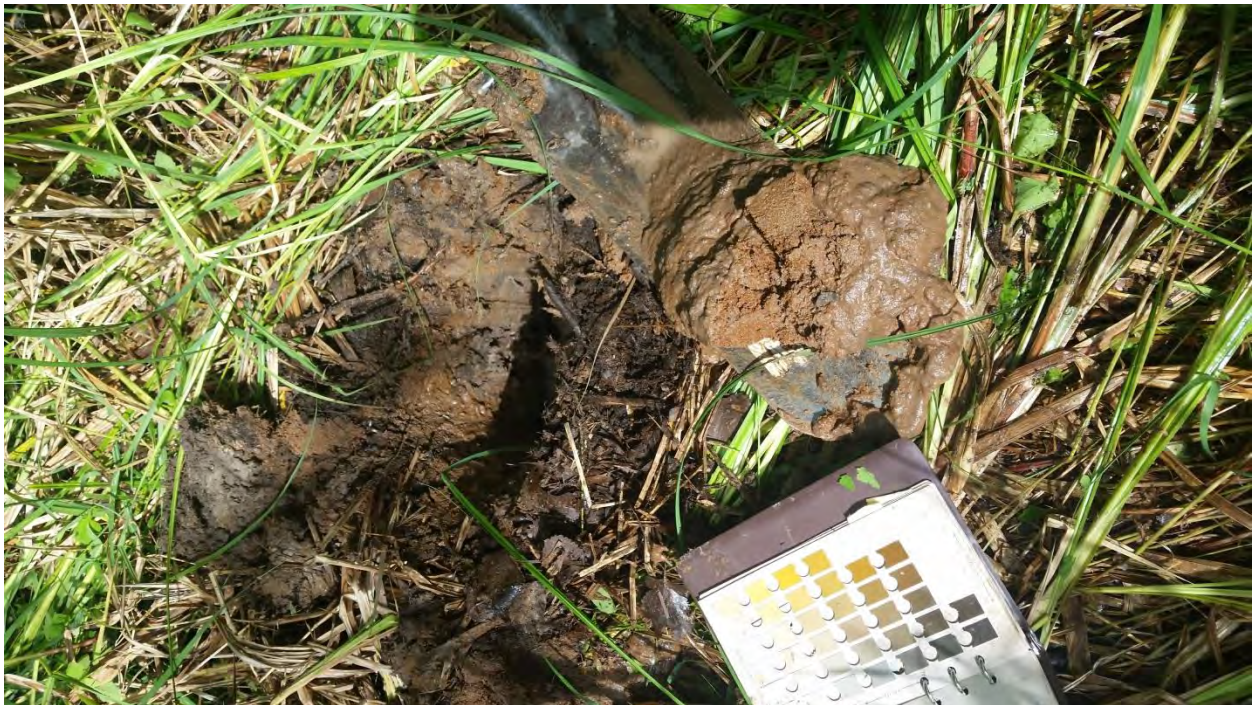
Wetland Soil Profile

Hydric soil indicators were met within the delineated wetland basin at both wetland pits. Hydric soil was met at pit #1 through Hydric Soil Indicator “Depleted Below Dark Surface (A11)” (Figure 3). Hydric soil was met at pit #3 through Hydric Soil Indicator “Depleted Matrix (F3)”:
