2014 Lake Blass Aquatic Macrophyte Survey & Plan

Performed by Aquatic Engineering, Inc.

December 21, 2015

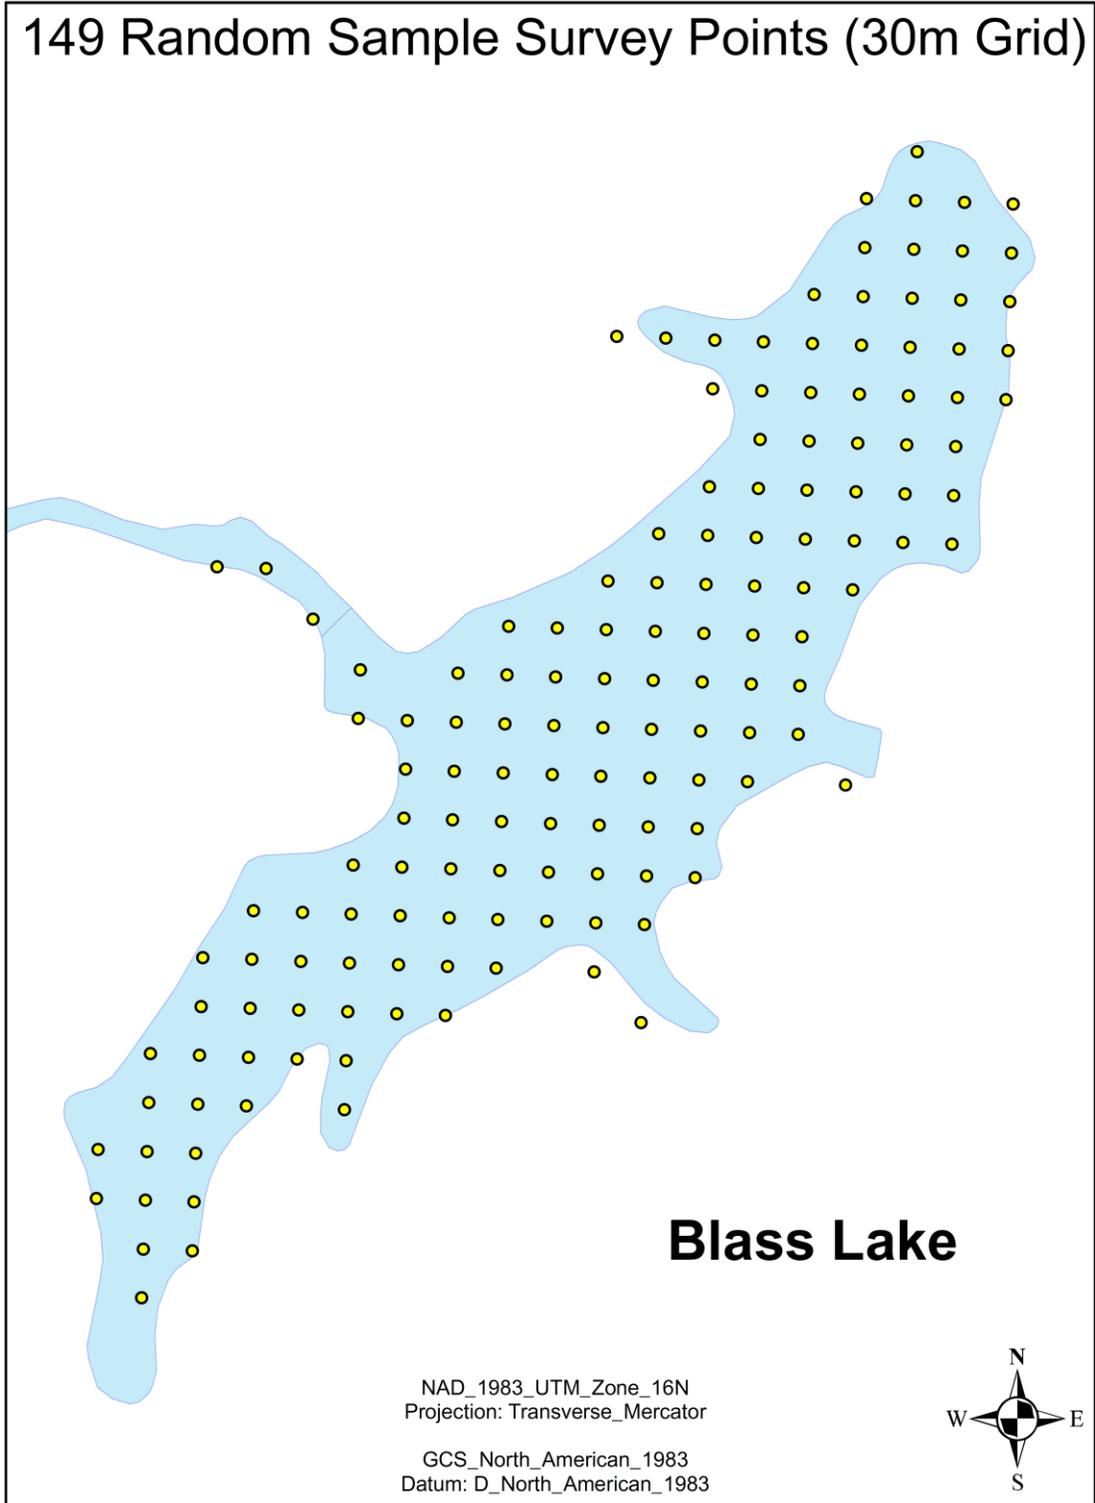
Figure 1. The 149 sampling point grid generated by the Wisconsin DNR for the Lake Blass aquatic macrophyte survey.

The technical survey study performed was based on the rake-sampling method by Hauxwell et al. (2010) using a point-intercept sampling design, with sites located on a geo-referenced sampling grid placed over the entire lake. From this method, the Wisconsin Department of Natural Resources (WI DNR) created 149 sampling points throughout the entirety of Lake Koshong (Fig. 1). Application of this methodology allows: 1) assessment of frequencies of occurrence of different plant species, as well as estimates of species richness, abundance, and maximum depth of colonization; and 2) comparisons of aquatic plant variables over time and among lakes.

To begin the study, a qualitative survey is visually completed and specimens are collected. The quantitative survey is carried out by visiting each of the 149 pre-established GPS survey locations, and dropping a rake to determine depth, sediment type by texture, rake fullness, and species present on the rake sample. Technicians also visually examined and species present within 6 feet of the sampling point and would record the data as visually observed. The rake fullness parameter is determined by the relative amount of vegetation hanging on the rake head when it is retrieved and a value of 1-3 is assigned (Fig. 2). From the vegetation hanging on the rake, a relative distribution of species collected is also determined and the same rating is assigned, with 3 being the dominant species on the rake, 2 being a moderate abundance, and 1 being the species is very minimal in the rake sample. The data is recorded by hand in the field and later entered into a database for further statistical analysis.

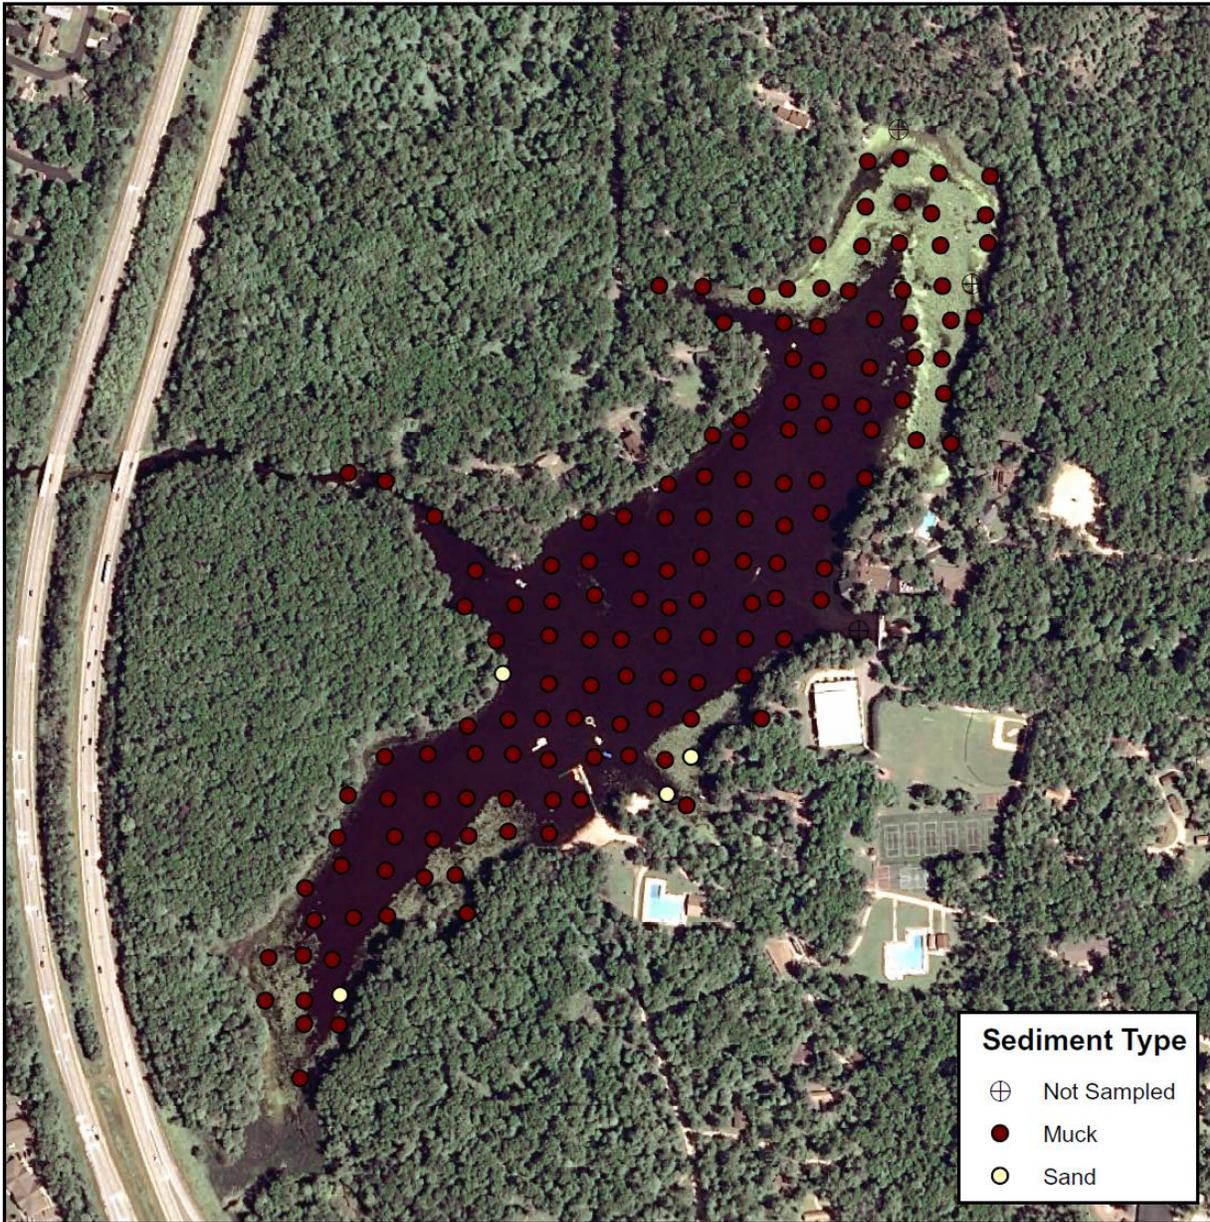
Figure 3. Sediment composition at each sampling point of the Lake Blass aquatic macrophyte survey.

The sediment composition in Lake Blass was primarily muck (Fig. 3). However, there were 4 sites around the lake that did contain sand as the primary sediment type. When determining the depths at each sample site, it was determined that the average depth in Lake Blass is 6.6 feet (Fig. 4). The maximum depth found in Lake Blass was 13.5 feet, while the median depth was 6.5 feet.

<p>www.aquaticengineering.org</p>	<p>Lake Blass Aquatic Plant Survey Sediment Type</p> <p>Lake Blass, Sauk County, Wisconsin</p> <p>Date: September 11, 2014</p> <p>0 250 500 750 1,000 1,250 Feet</p> <p>Coordinate System: GCS_North_American_1983</p>

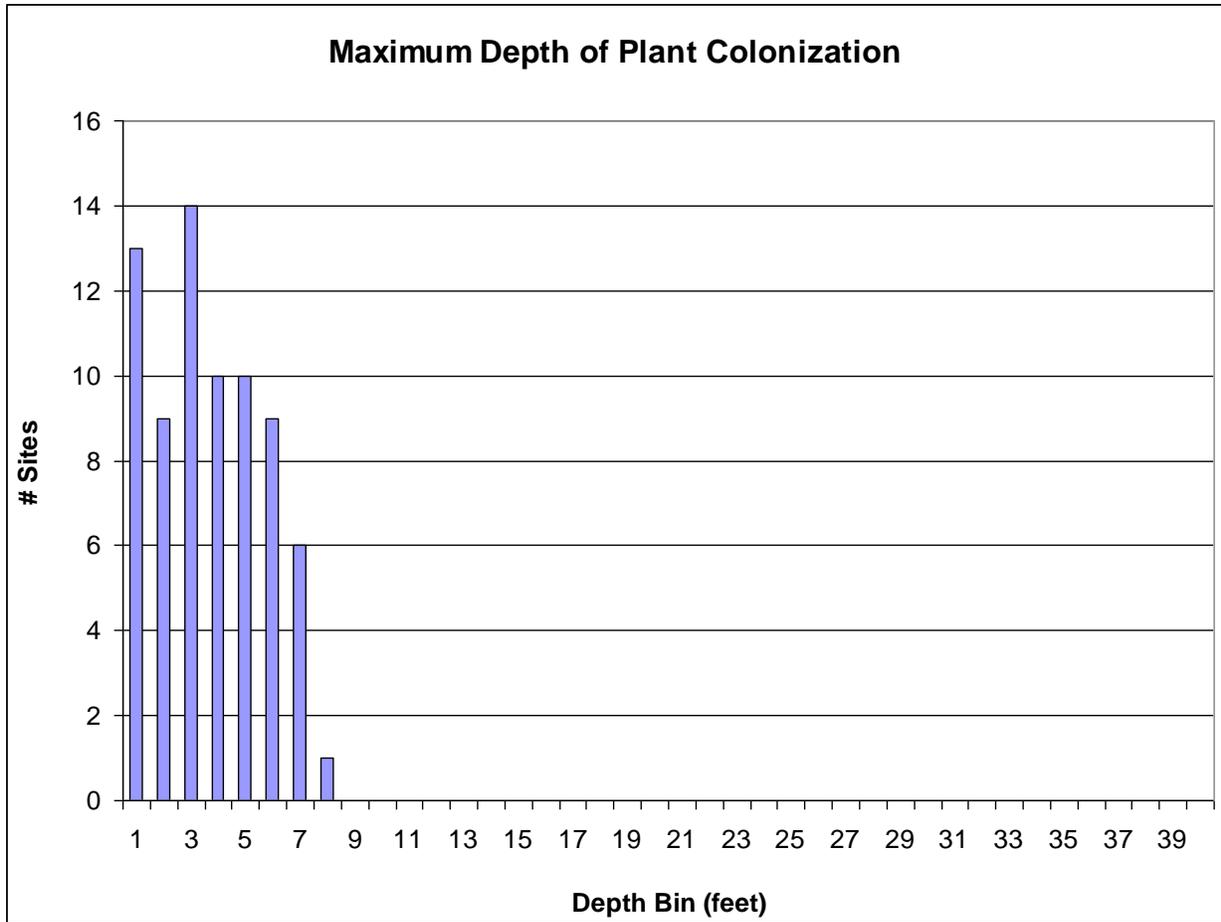
Figure 5. Maximum depth of plant colonization graph for Lake Blass calculated from the aquatic macrophyte survey.

It was calculated from the survey that the littoral zone was anywhere with a water depth of 8.0 feet or less (Fig. 5). Any location within the lake that had a depth greater than 8.0 feet did not allow for plant colonization. The survey resulted in 85 points within the lake that were less than the maximum depth of colonization and could have allowed for plant colonization. However, only 72 of these points produced a vegetation sample, resulting in a frequency of 84.71% occurrence of vegetation at sites shallower than the maximum depth of plants.

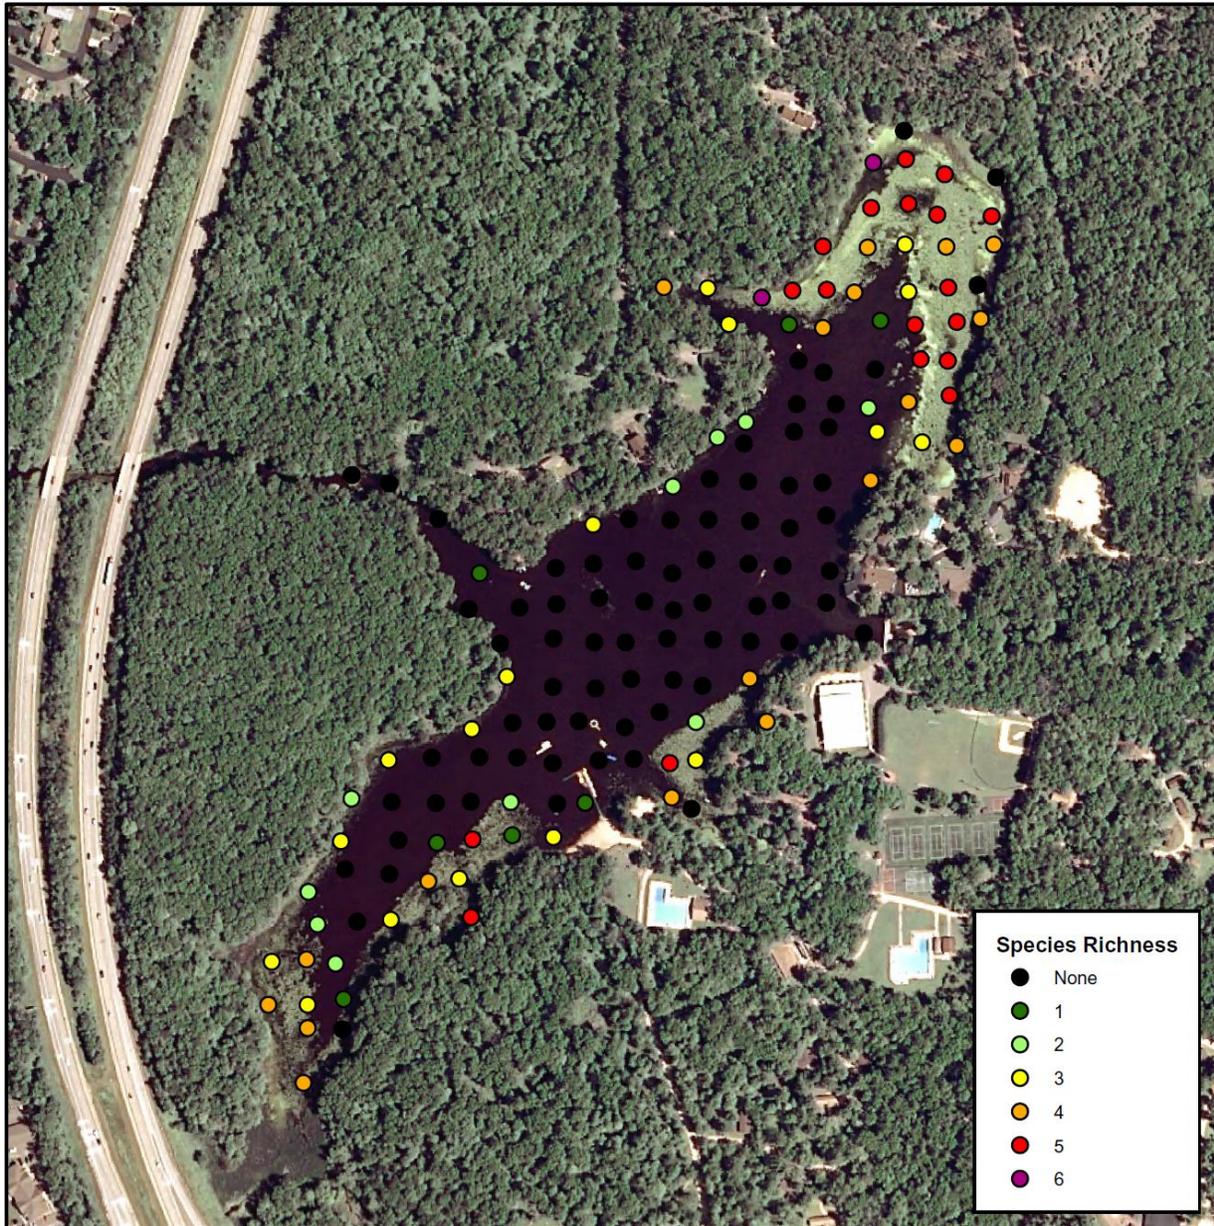
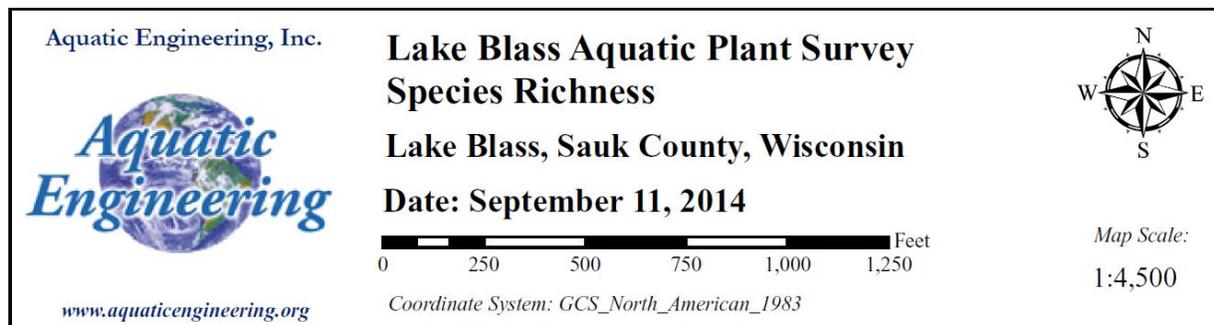
Figure 6. Map of species richness for each single sample location during the Lake Blass aquatic macrophyte survey.

Out of the 85 locations less than the maximum depth of colonization, there was an average of 3.93 species collected. However, this number jumps to an average of 4.64 species per site when looking at the 72 sites less than the maximum depth of colonization that produced a vegetation sample. There was only one exotic invasive species found within the lake, curly-leaf pondweed (CLP, *Potamogeton crispus*). This plant was only visualized at one location and never collected during a rake sample. Due to this, the calculations for average number of native species per site shallower than the max depth and vegetated sites only stay the same at 3.93 and 4.64, respectively.

Lake Blass had a relatively large species richness, with a value of 13 species collected with a rake, and 16 species collected with a rake and visual sightings. During the sampling, there was a maximum of six species encountered at one single sample location (Fig. 6). This number does not include filamentous algae, freshwater sponges, aquatic moss, or liverworts. However, only filamentous algae was the only other organism witnessed and was not included in the species richness calculations.

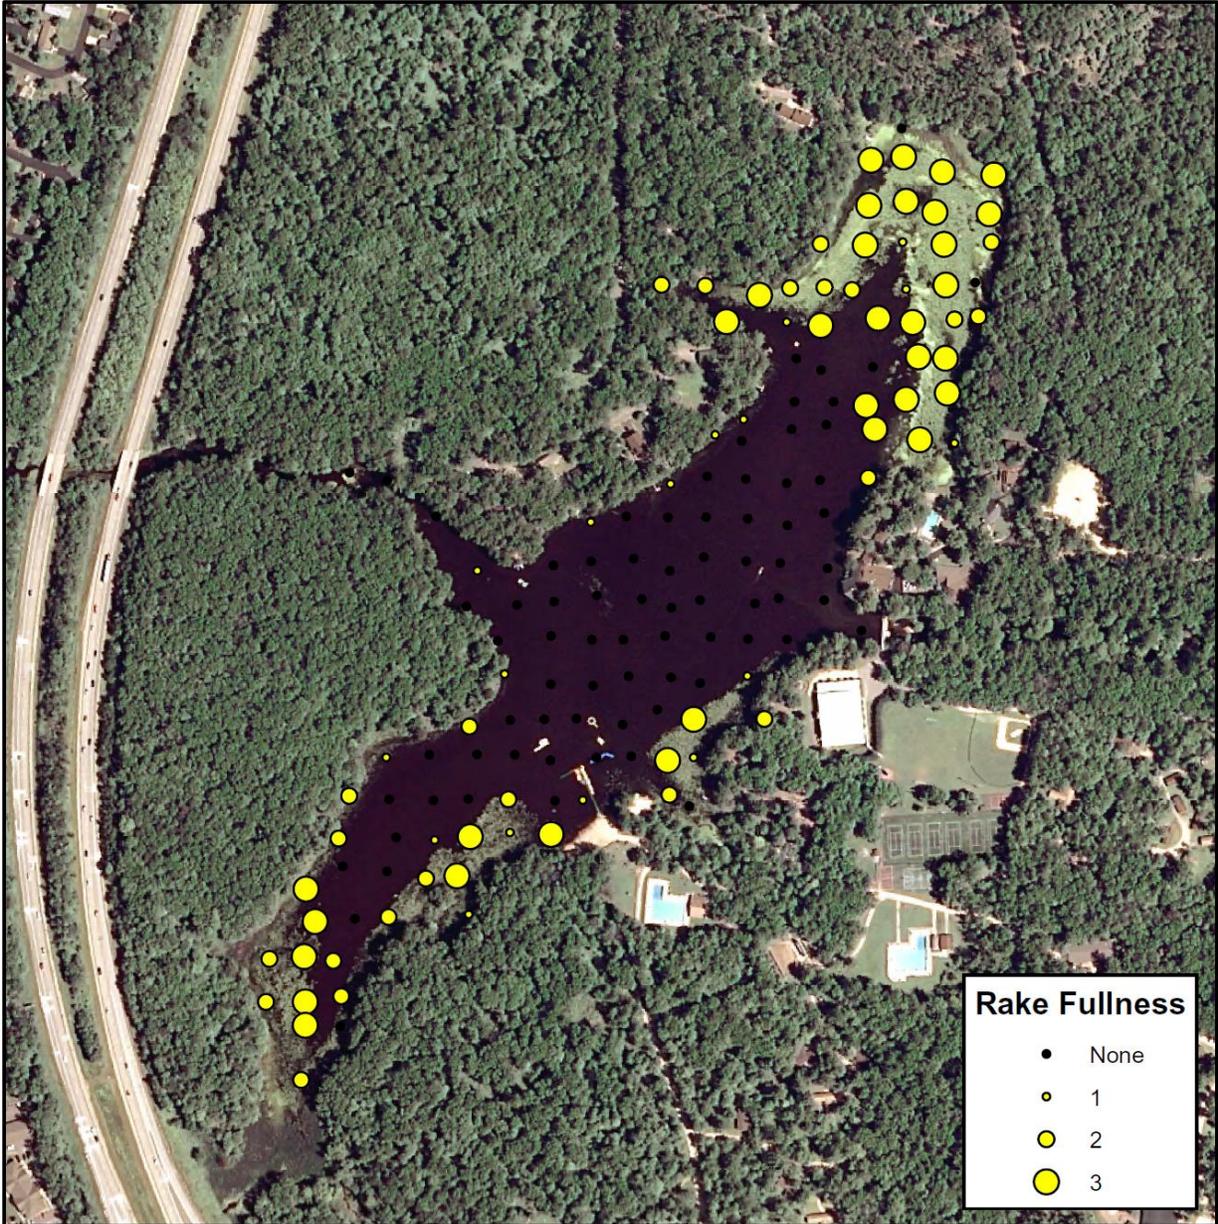
Figure 7. Rake fullness rating for all sample points of the Lake Blass aquatic macrophyte survey.

The total vegetation sampled during the Lake Blass survey, when found, was very dense (Table 3). When a rake sample was pulled during the sampling in vegetated areas, there was an average rake fullness rating of 2.22 (Fig. 7). This means that the vegetation encountered was primarily large plants with thick or dense vegetative structures. When looking at each individual species found during the survey, it is clear that coontail (*Ceratophyllum demersum*) was the dominant species within the lake. Coontail was found at 91.67% of the sites where vegetation was collected. When coontail was encountered, the vegetation was very dense and resulted in an average rake fullness of 2.44, the highest among all species.

<p>Aquatic Engineering, Inc.</p>	<p>Lake Blass Aquatic Plant Survey Rake Fullness</p>	
	<p>Lake Blass, Sauk County, Wisconsin</p>	
	<p>Date: September 11, 2014</p>	
		<p>Map Scale: 1:4,500</p>
<p>www.aquaticengineering.org</p>	<p>Coordinate System: GCS_North_American_1983</p>

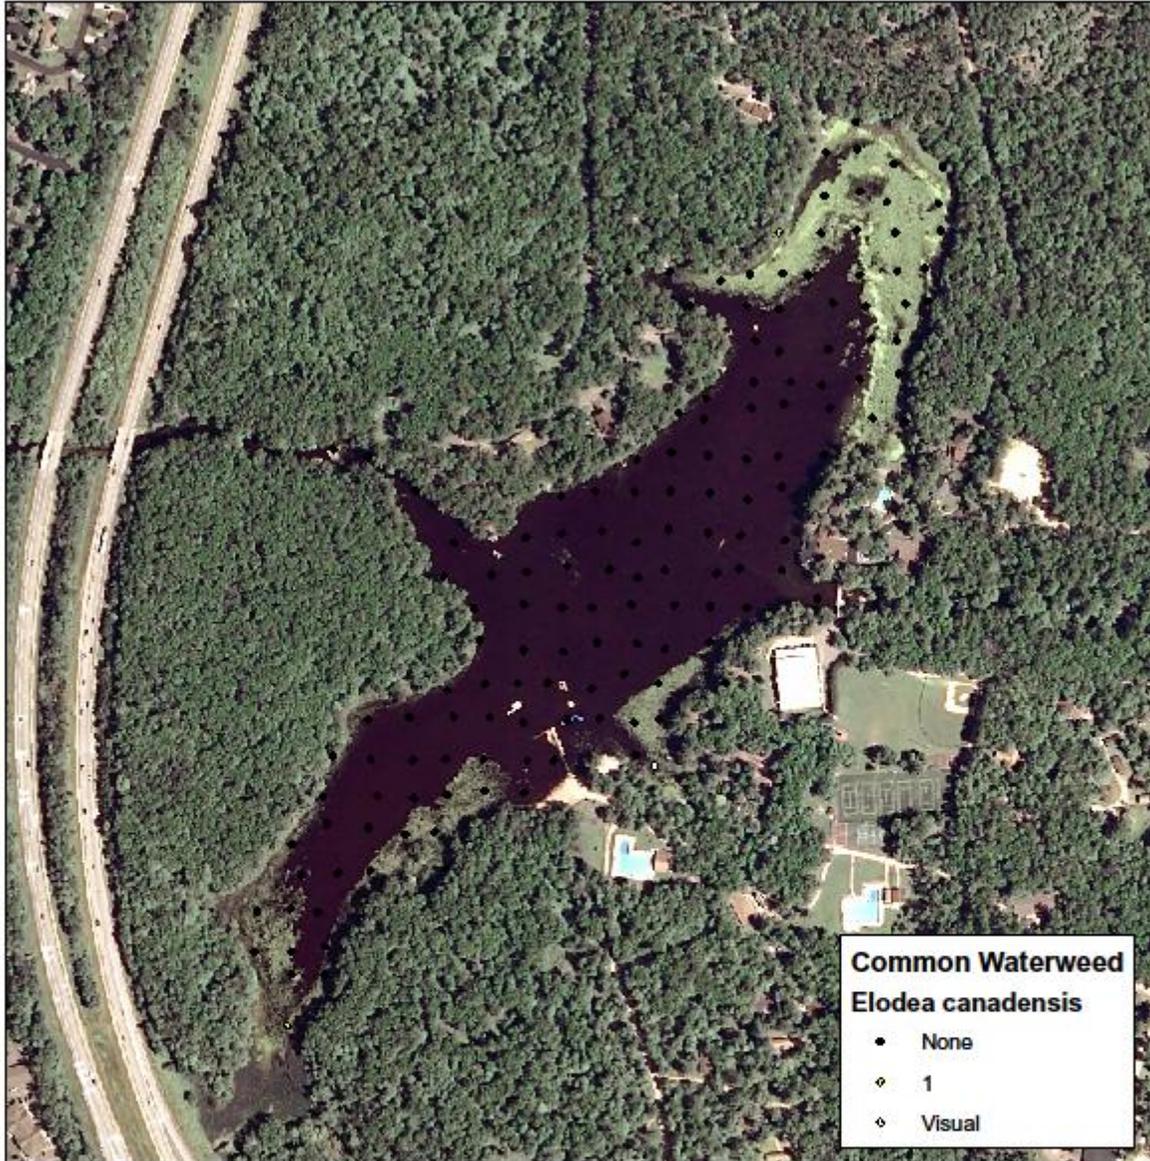
<p>Aquatic Engineering, Inc.</p>	<p>Lake Blass Aquatic Plant Survey Common Waterweed</p>	
	<p>Lake Blass, Sauk County, Wisconsin</p>	
	<p>Date: September 11, 2014</p>	
		<p>Map Scale: 1:4,500</p>
<p>www.aquaticengineering.org</p>	<p>Coordinate System: GCS_North_American_1983</p>

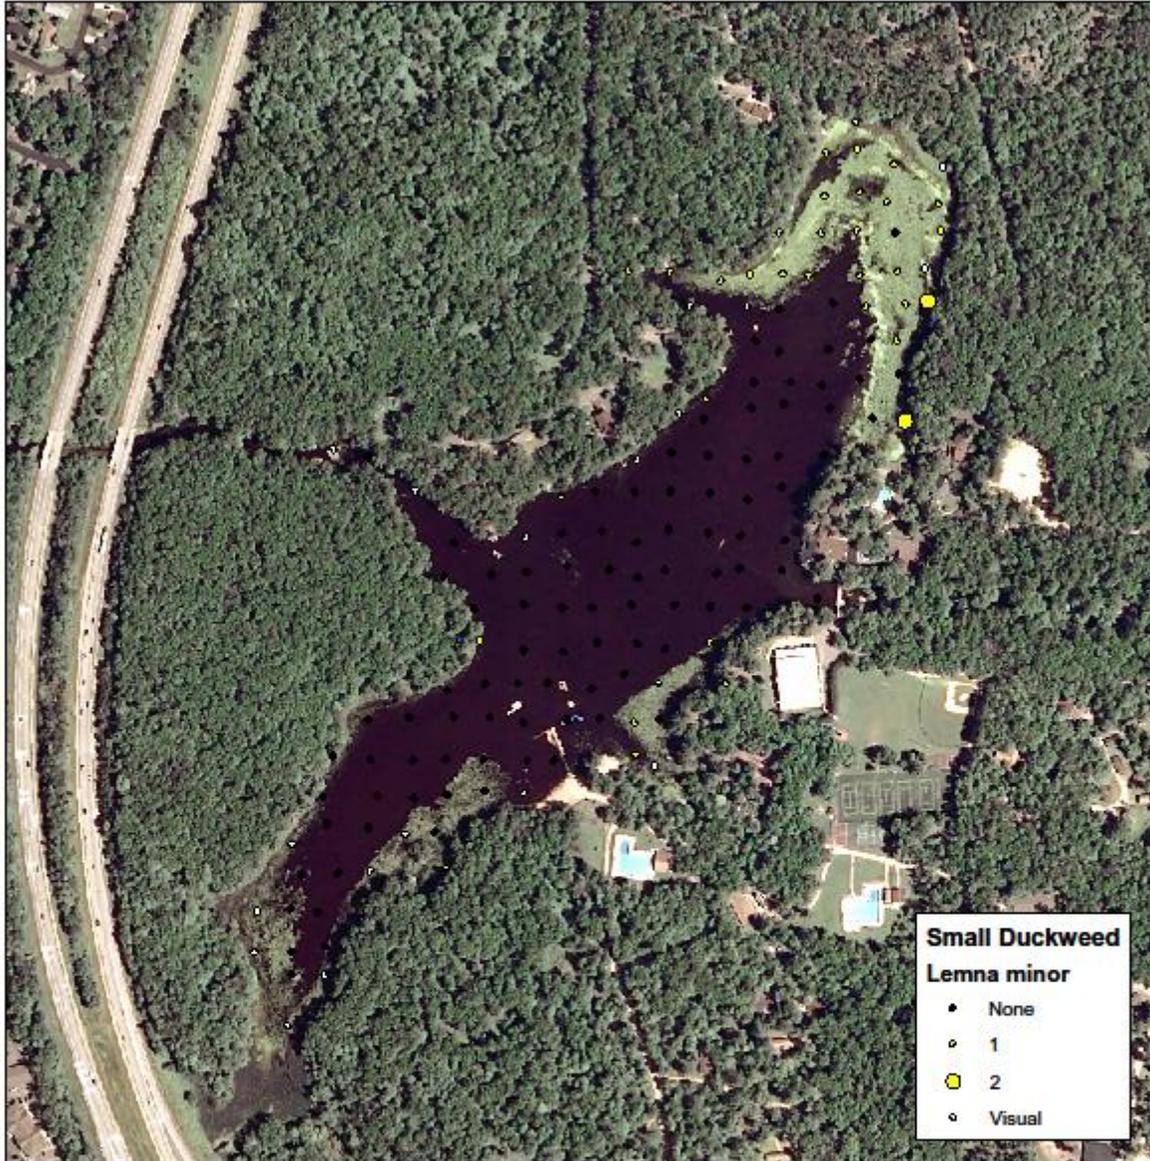
Common watermeal can also be found with very large densities, but the tiny size of the plant makes it disproportional on the rake compared to large macrophytes. The same can be said about lesser duckweed (*Lemna minor*), which was found at 44.44% of vegetated areas. Forked (starred) duckweed (*Lemna trisulca*), which was found at 41.67% of vegetated areas, contains much more vegetation material than lesser duckweed, and accounts for the higher rake fullness rating of 1.57. Large-leaf pondweed (*Potamogeton amplifolius*), Flat stem pondweed (*Potamogeton zosteriformis*), and Grassleaf mudplantain (*Heteranthera dubia.*), where all found at moderate frequencies in vegetated areas (12.5%). The only difference between these three pondweeds was that large-leaf pondweed had a higher average rake fullness rating of 1.89 compared to the 1.11 rating that the remaining two pondweed species. Large-leaf pondweed is a much larger species with large, thick vegetated structures which accounts for the higher average rake fullness rating.

<p>Aquatic Engineering, Inc.</p>	<p>Lake Blass Aquatic Plant Survey Small Duckweed</p>	
	<p>Lake Blass, Sauk County, Wisconsin</p>	
<p>www.aquaticengineering.org</p>	<p>Date: September 11, 2014</p>	<p>Map Scale:</p>
		<p>1:4,500</p>
<p>Coordinate System: GCS_North_American_1983</p>

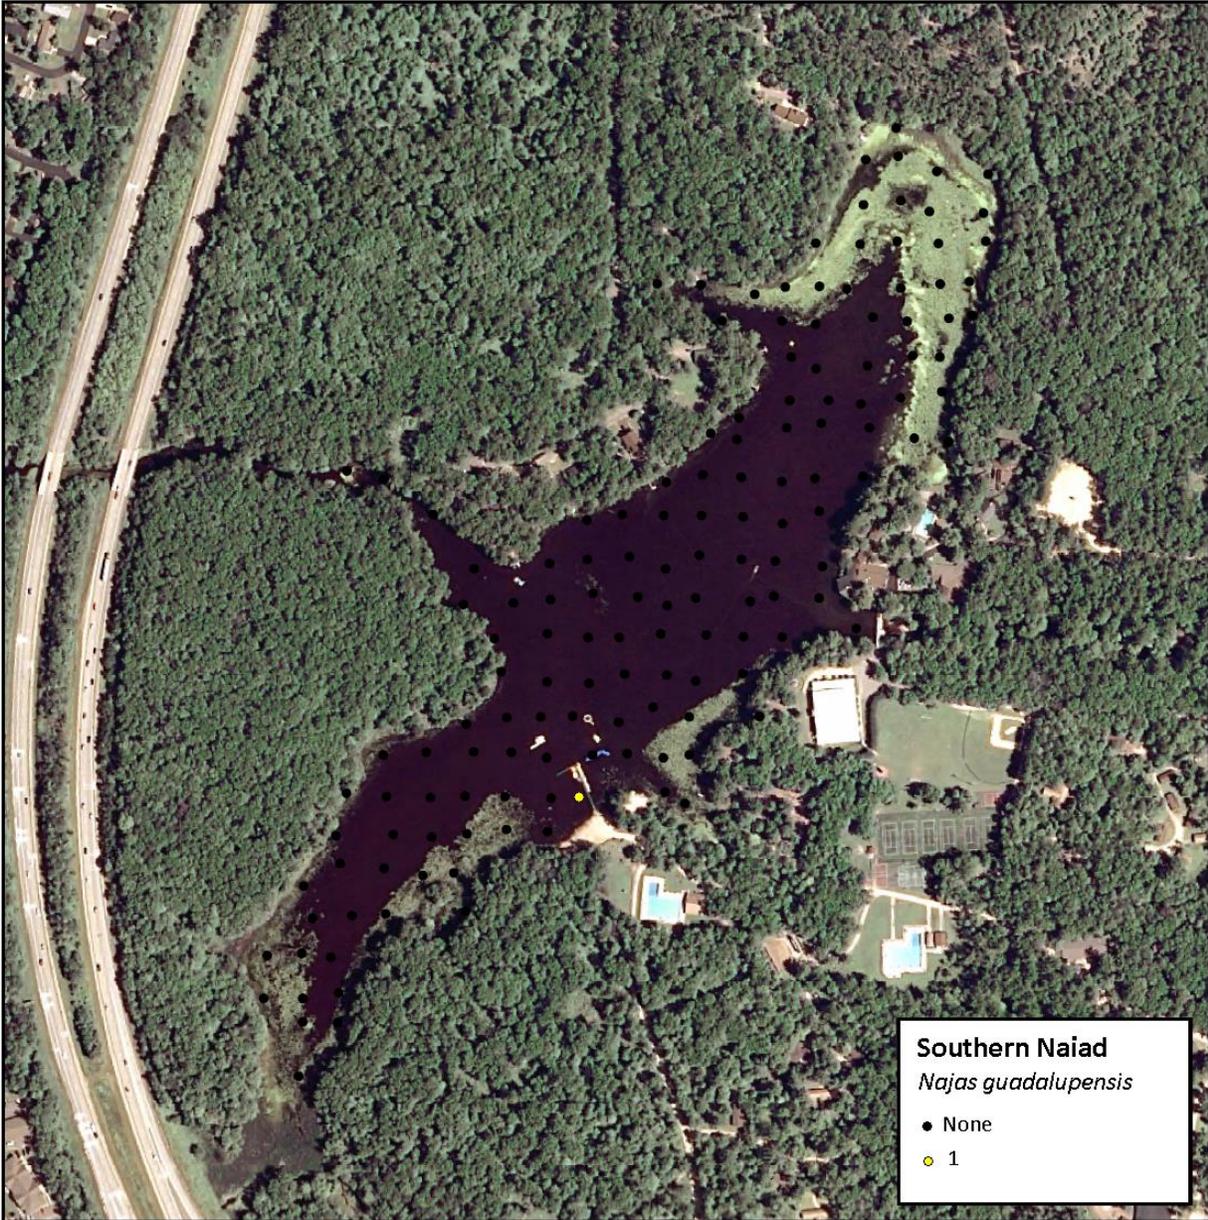
<p>Aquatic Engineering, Inc.</p>	<p>Lake Blass Aquatic Plant Survey Southern Naiad</p>	
	<p>Lake Blass, Sauk County, Wisconsin</p>	
	<p>Date: September 11, 2014</p>	
		<p>Map Scale: 1:4,500</p>
<p>www.aquaticengineering.org</p>	<p>Coordinate System: GCS_North_American_1983</p>
