**Aquatic Plant Management Plan
White Ash and North White Ash Lakes
White Ash Lake Protection and Rehabilitation District**

**AQUATIC PLANT MANAGEMENT PLAN
WHITE ASH AND NORTH WHITE ASH LAKES**

White Ash Lake Protection and Rehabilitation District

Flambeau Engineering, LLC
PO Box 273
Park Falls, WI 54552

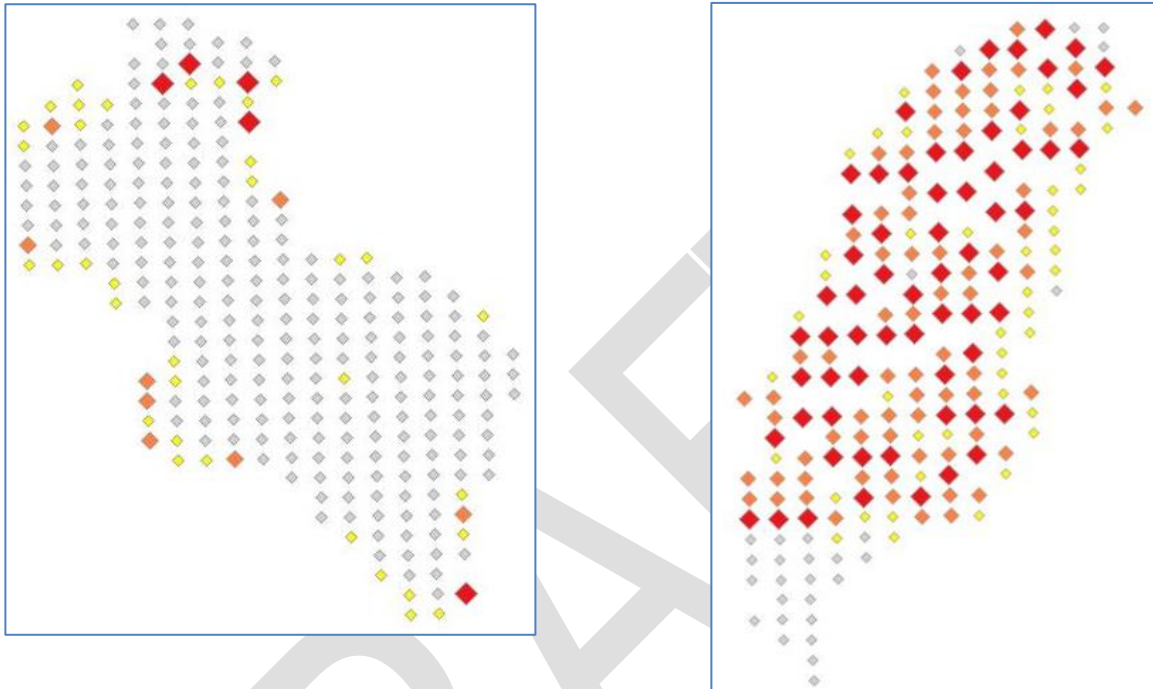
The following figures show the coverage and density of vegetation found during the 2016 surveys.

The RED symbols indicate high density vegetation (3 rake fullness), ORANGE - medium density (2 rake fullness) and YELLOW - low density (1 rake fullness). White Ash has few stands that are very dense and the vegetation is scattered around the perimeter of the lake. North White Ash has very dense stands throughout the lake with nearly 100% coverage of the lake.

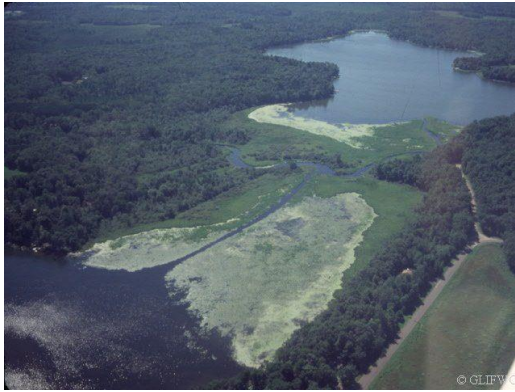
North White Ash and White Ash

Wild rice is well established in both lakes. The south end of North White Ash, the north end of White Ash and the Apple River between the two lakes and exiting White Ash has extensive beds of wild rice. Wild rice is very beneficial to the lake ecosystem but can cause navigation problems. The following photos were taken from the GLIFWC website that show the wild rice beds on the lakes and the Apple River.

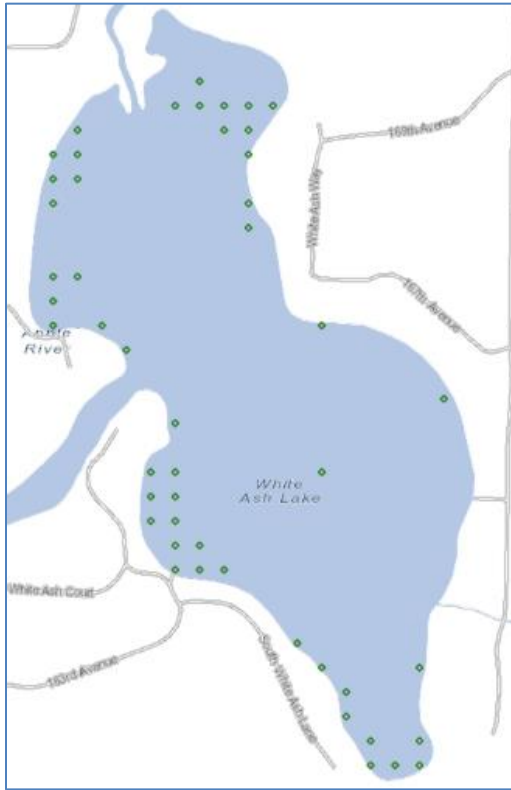
Figure 7 White Ash - CLP Bed Locations

Location of CLP

Density of CLP

Symbols: gray – visual, yellow - low density, orange – medium density, red – high density

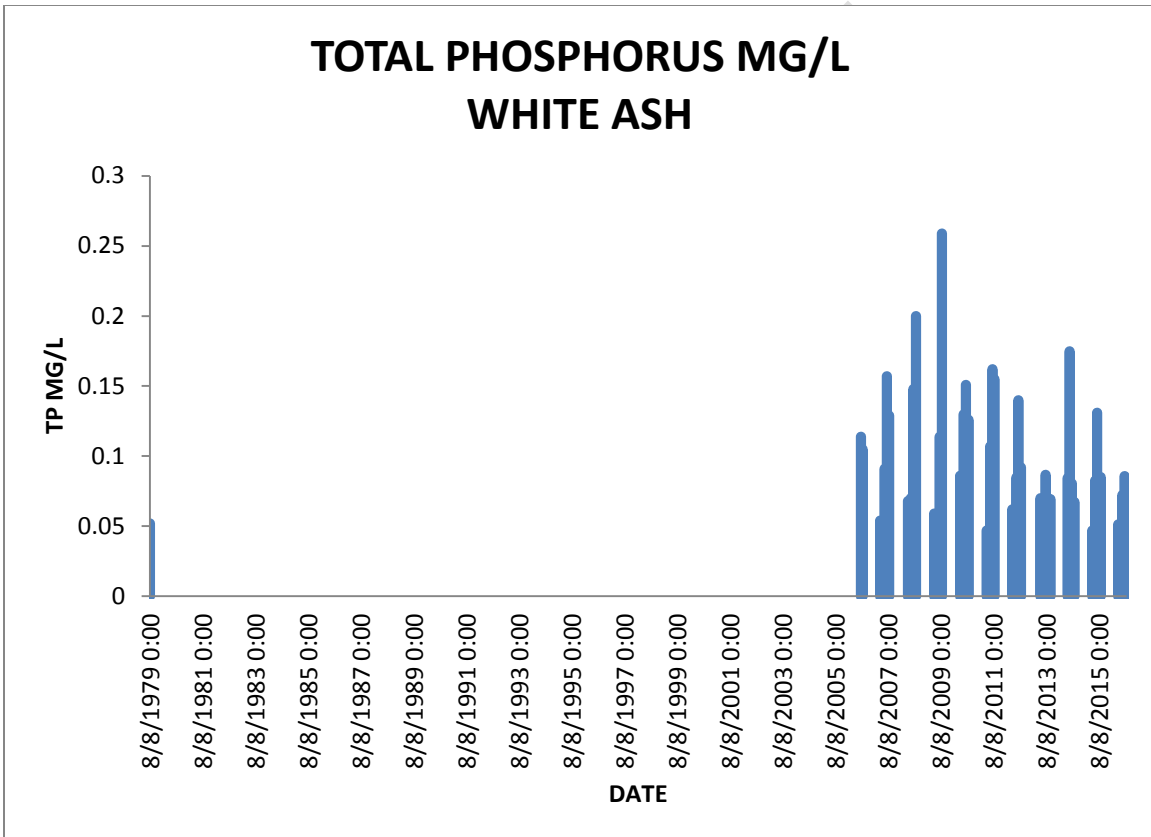
Figure 13 - White Ash – Total Phosphorous

Following is a discussion of the total phosphorous and chlorophyll a concentrations in the lakes over the years of data. Historically, White Ash has had an average phosphorus reading of 100 micrograms per liter (ug/l - parts per billion). The total phosphorus has varied from 47 ug/l to 259 ug/l indicating poor water quality and eutrophic conditions. North White Ash has had an average phosphorus reading of 50 ug/l. The total phosphorus has varied from 25 ug/l to 83 ug/l indicating fair water quality and eutrophic conditions. The following graphs illustrate the historical phosphorus measurements on the lakes.

The graph indicates the TP has been decreasing in recent years.

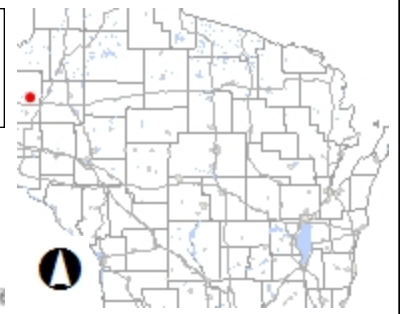
MAP 2 NORTH WHITE ASH CLP HARVESTING MAP

2016 CLP NORTH WHITE ASH

**ACTION TWO:
HARVEST CLP IN WHOLE LAKE
LATE MAY**

**ACTION FOUR:
HARVEST CLP IN
WHOLE LAKE
LATE JUNE**
