**Herbicide Treatment Analysis for  
*Potamogeton crispus* (Curly-leaf pondweed)**

**Deer Lake, Polk County Wisconsin**

**October, 2016**

***Survey and analysis conducted by: Ecological Integrity Service, LLC  
Amery, WI***

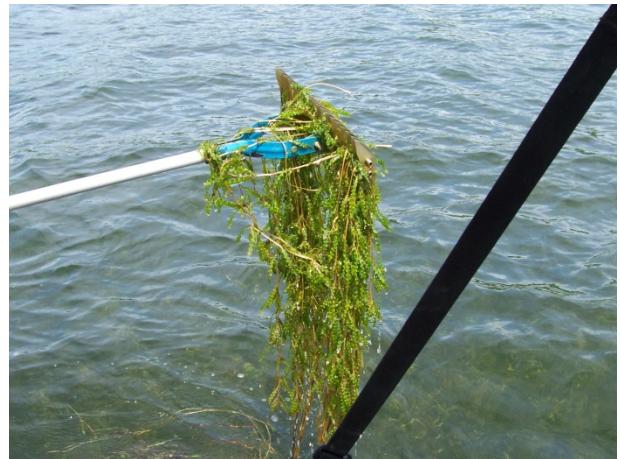
**Figure 3: Density rating system and example CLP rake sample.**

The second survey is referred to as the post treatment survey. This survey involves going to the same GPS coordinates as the pre-treatment survey and doing a rake sample at the point. If any CLP is on the rake, the density of the CLP is recorded (see Figure 3 for reference). All other species are also recorded from the rake sample in order to verify no damage to the native plants.

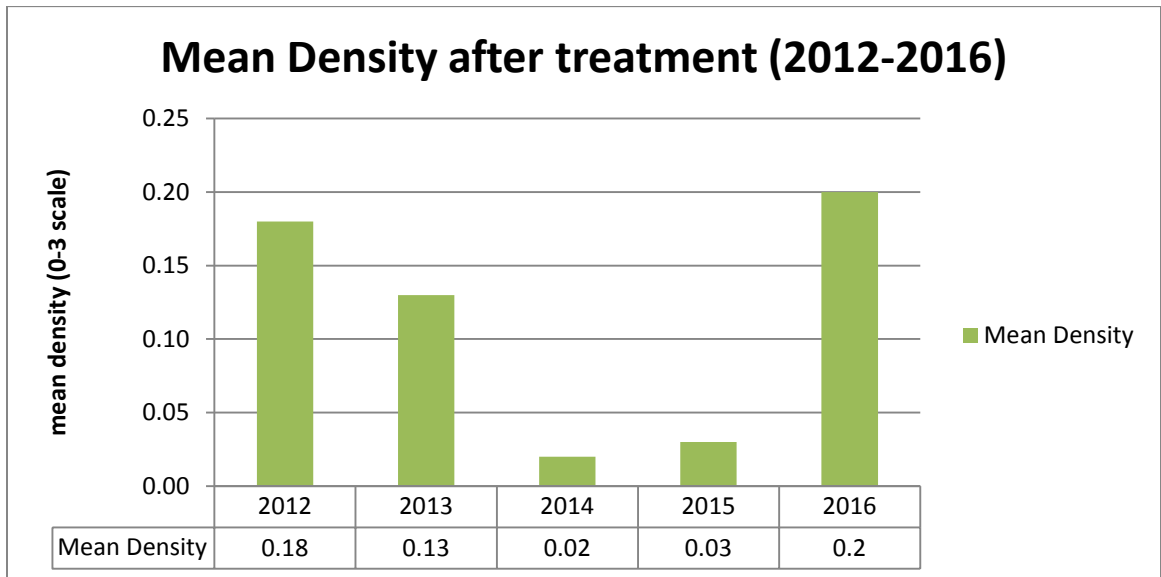
Figure 8: Comparison of post treatment mean density all beds, 2012-2016.

The mean density increased significantly from 2015 to 2016. Figure 8 shows that the mean density rose from 0.03 to 0.2 (density rated from 0-3). This occurred predominately in Beds B, C and E. Figure 8

shows that the mean density has declined since 2012, with a dramatic decline from 2013 to 2014 and small increase in 2015 and finally a large increase in 2016.

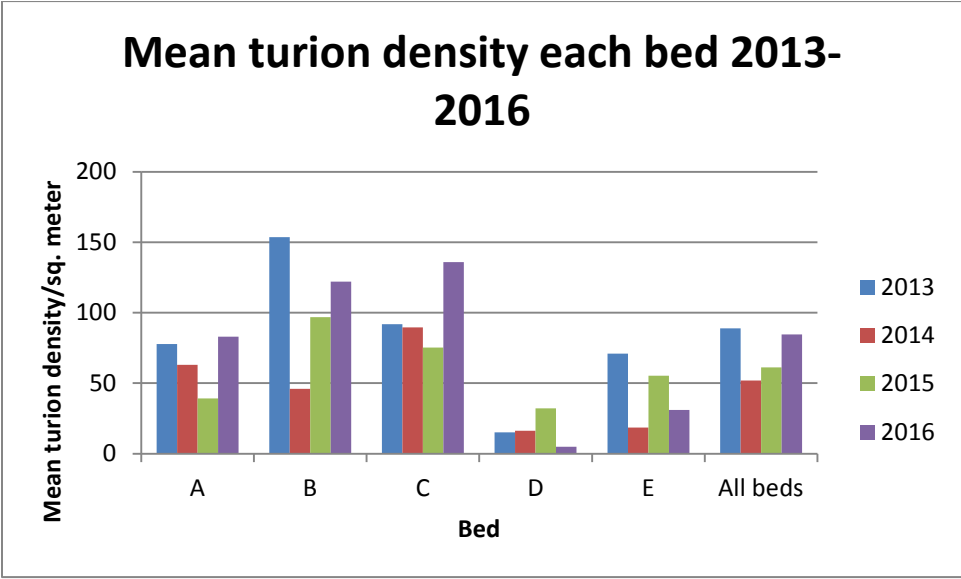
Figure 14: Turion densities by bed for comparison 2013 through 2016.

The 2016 turion analysis showed an increase in the turion density in beds A, B, and C. The increase in beds B and C may reflect the presence of CLP growing in these beds after treatment. The CLP plants likely created new turions into the beds after they died off in July. In bed A, the increase is unknown since little CLP was sampled or observed in the post treatment survey. Bed A has historically had high density of CLP and it may be that clumps of turions are present and sampling variation didn't reveal this density in previous years. In all, the overall turion density increased in 2016, which is not desirable in CLP management. It is assumed that due to these densities, CLP growth will return quite dense in these beds in 2017.

Table 6 summarizes the turion density comparison from 2013 to 2016. Figures 14 and 15 graphically show the changes.
