**Subject: 2017 Purple Loosestrife Monitoring Report  
Holcombe Hydro (P-1982), Cornell Hydro (P-2639), Jim Falls Hydro (P-2491),  
Wissota Hydro (P-2567), Chippewa Falls Hydro (P-2440) and Dells Hydro (P-  
2670)**

***PURPLE LOOSESTRIFE ASSESSMENT – 2017***

**Dells Pond, Chippewa Falls Flowage, Lake Wissota, Old Abe Flowage,  
Cornell Flowage, Holcombe Flowage, and Jim Falls Spillway Channel**

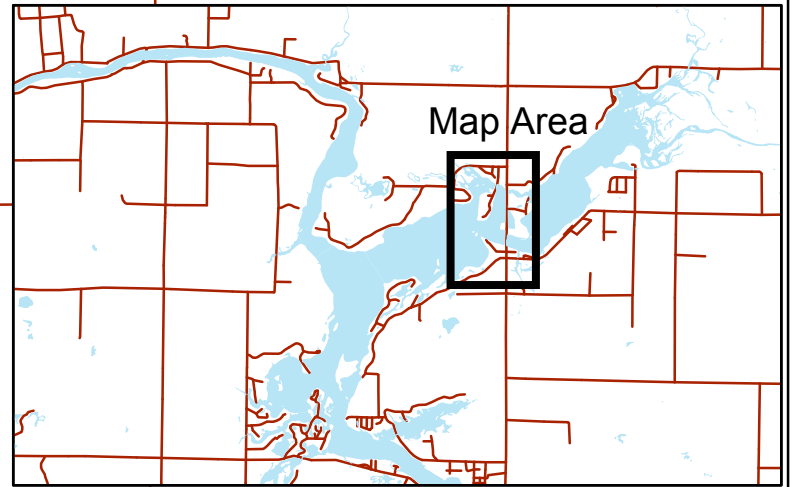
**Pine Island Area**  
Map 2 of 7

The majority of plants on Holcombe Flowage were again found in the area on and near Pine Island and along Highway 27. A comparison to the 2015 and 2016 surveys show much similarity with the overall loosestrife populations in this area (see Holcombe Map 2). Several small infestations were again found just to the east of the Highway 27 Bridge. This area had a similar degree of infestation last year. The only area of abundant plant growth this year was also classified as abundant in several previous surveys (the length of which decreased from 120 feet in 2016 to 40 feet in 2017). No purple loosestrife was found on the Pine Lake or Cranberry Lake areas of Lake Holcombe.

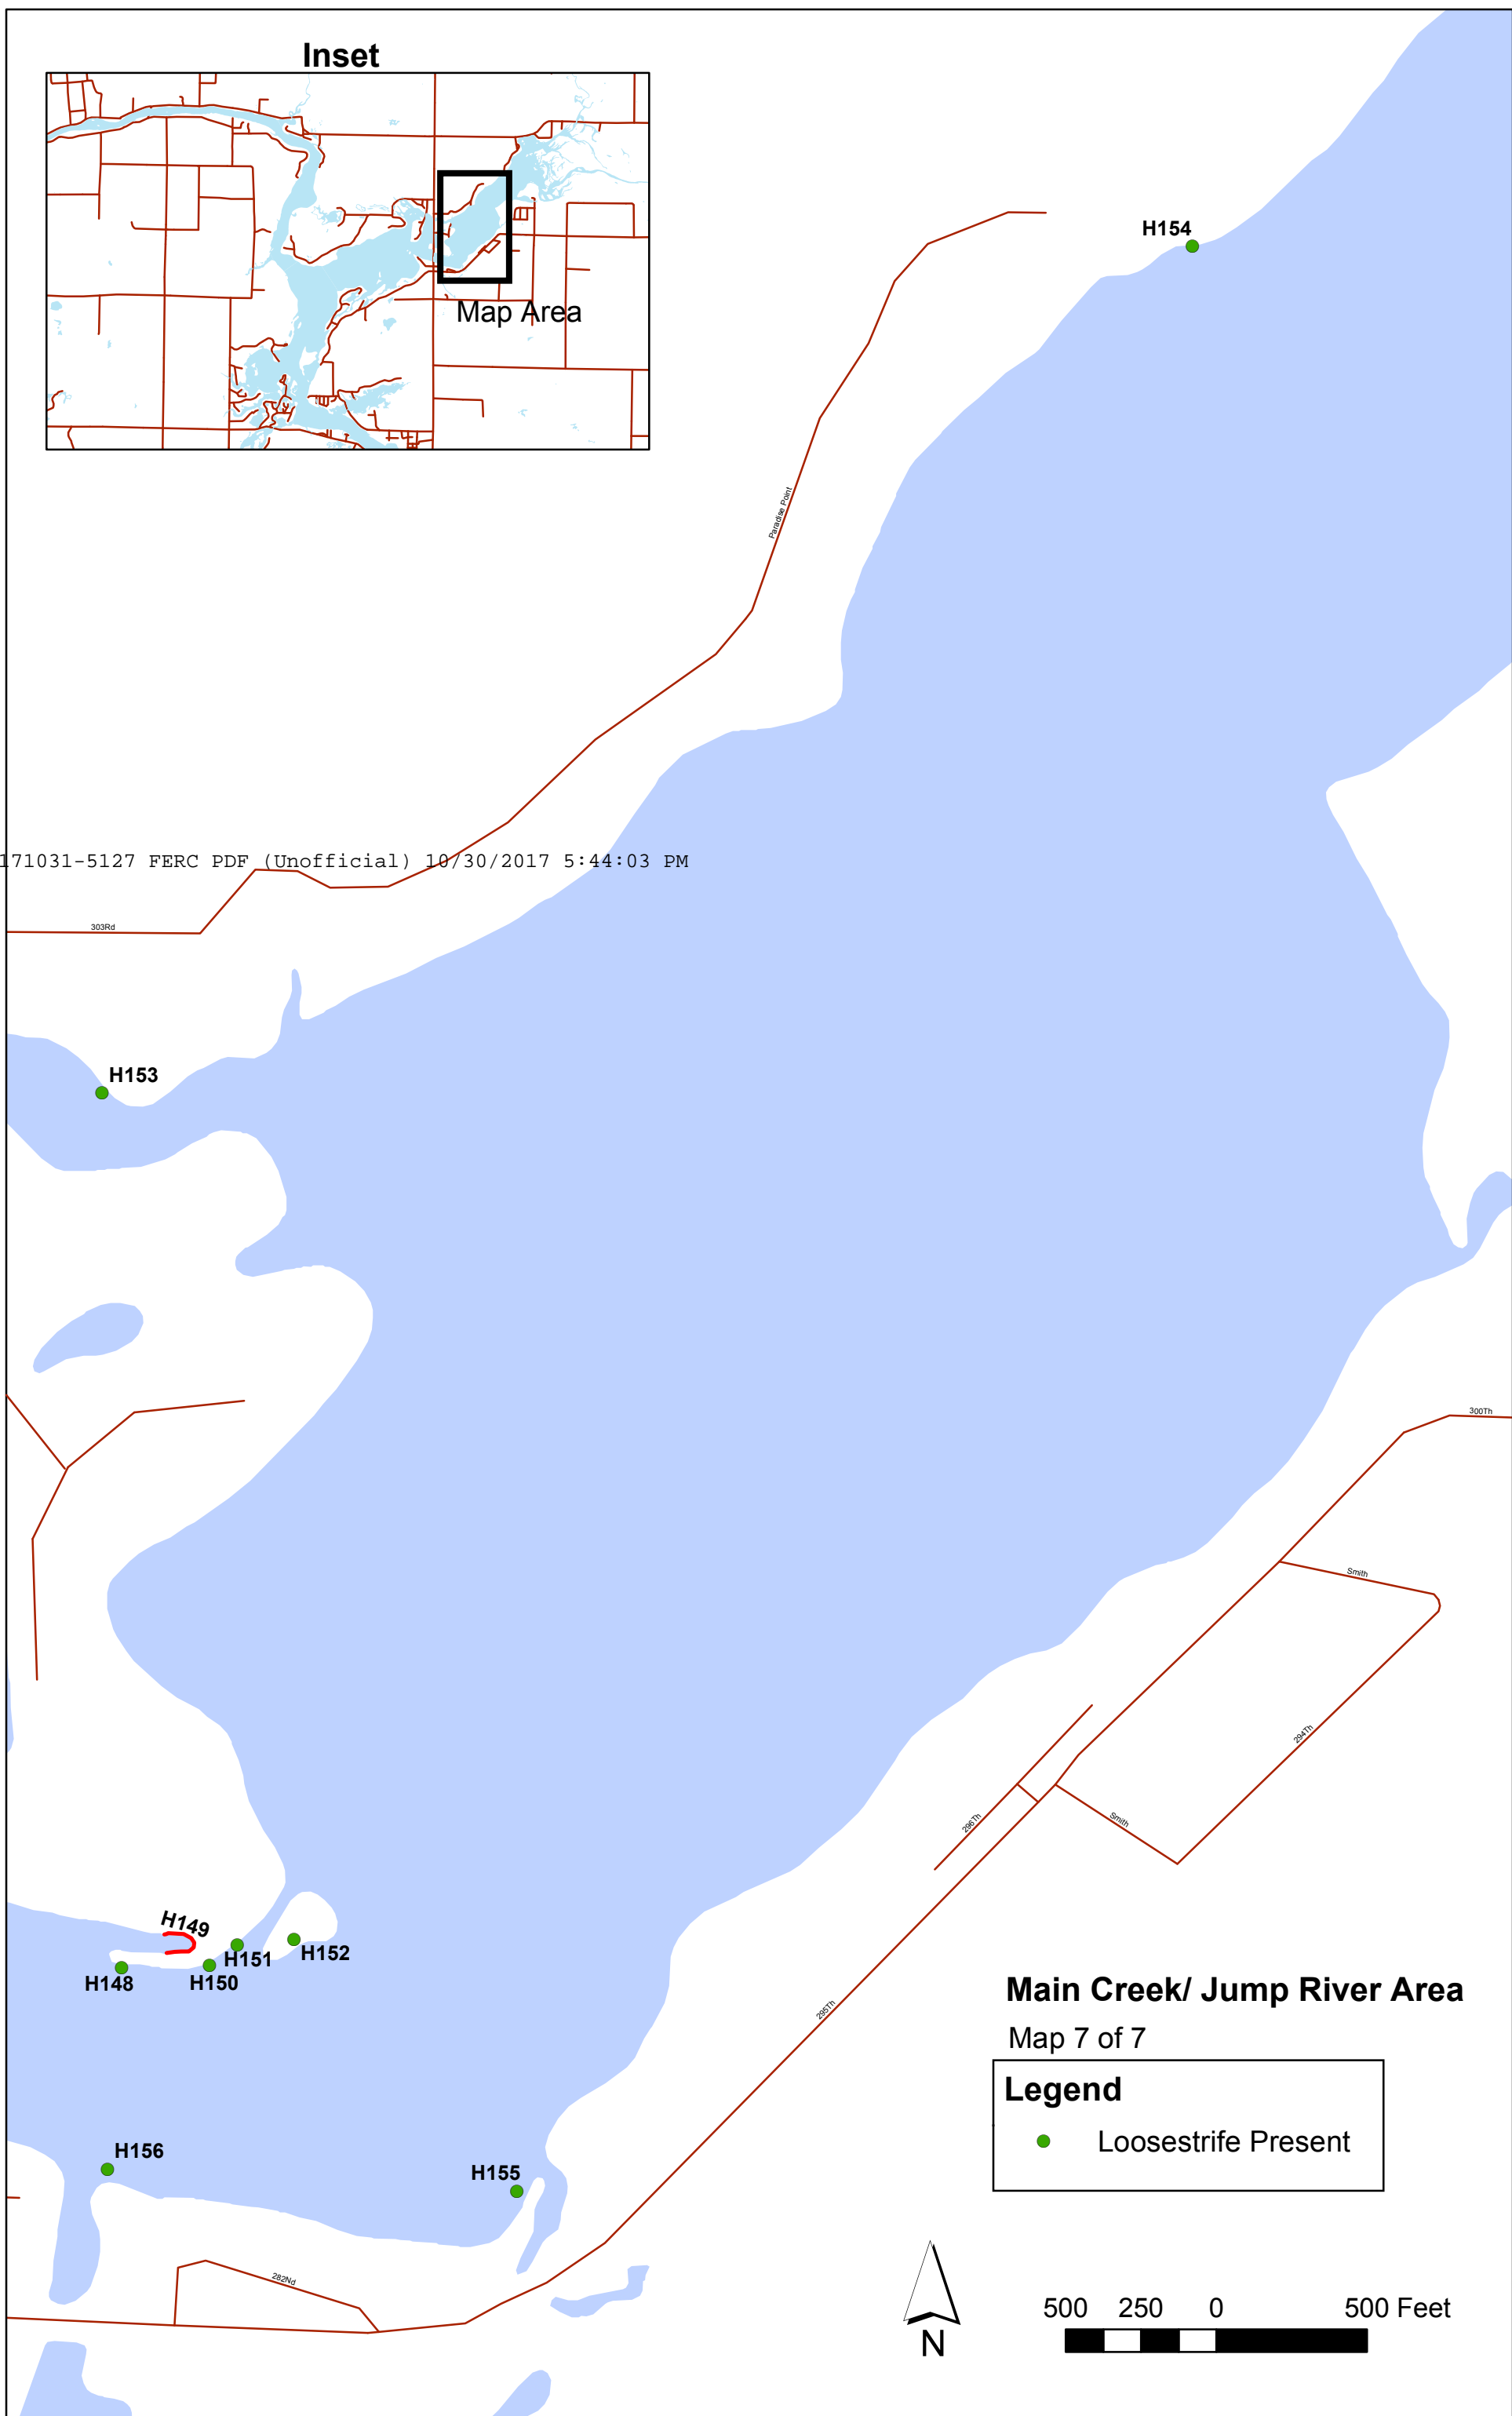
Map 7 of 7

The upstream reach of the flowage (see Holcombe Maps 5 and 6) also contains a number of purple loosestrife plants that have been noted in past surveys. The overall plant density in these areas was slightly more than what was documented in 2016. A few plants were noted in the eastern part of the flowage (see Holcombe Map 7), each of which have been seen in some of the previous years' surveys.

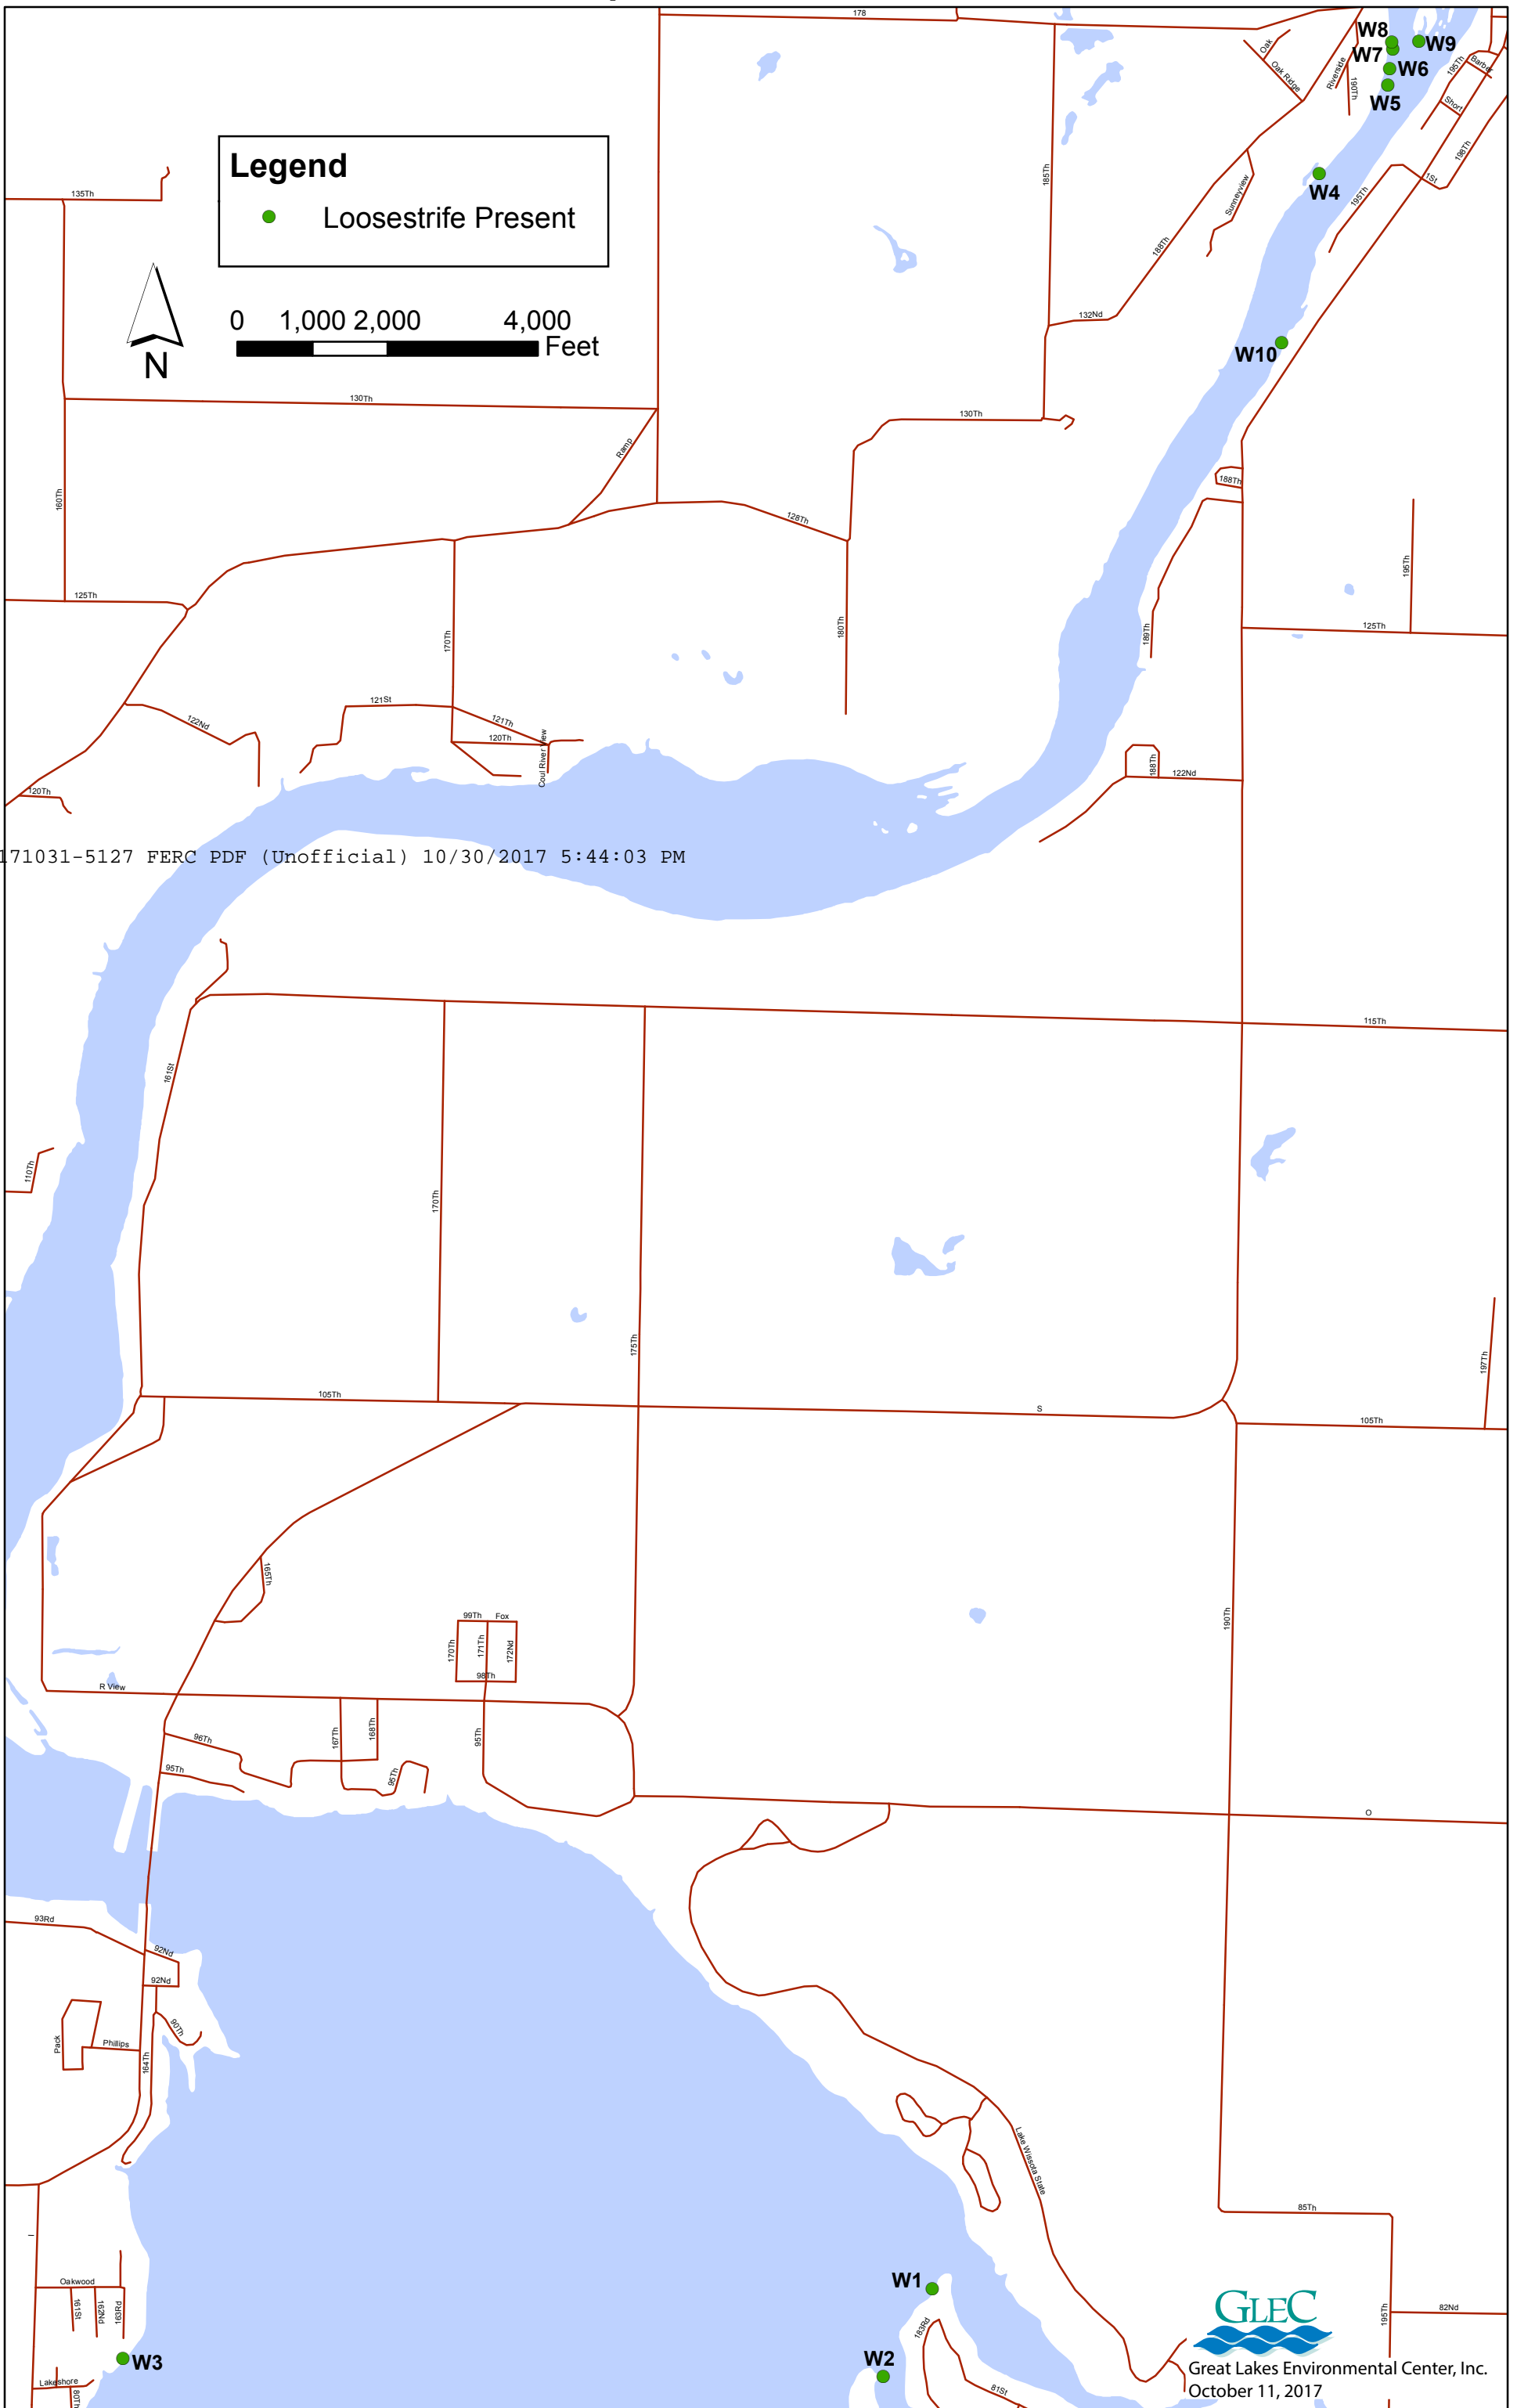
# Lake Wissota Purple Loosestrife Assessment - 2017

The number of purple loosestrife sites found on Lake Wissota increased from nine in 2016 to ten in 2017, matching the previous high number of plants documented in 2013. These locations are all minor infestations with small plant clumps at each location (see map of Lake Wissota). Total shoreline infested on Lake Wissota increased from 27 feet in 2016 to 30 feet in 2017. Very little variability has been documented over the last three years.

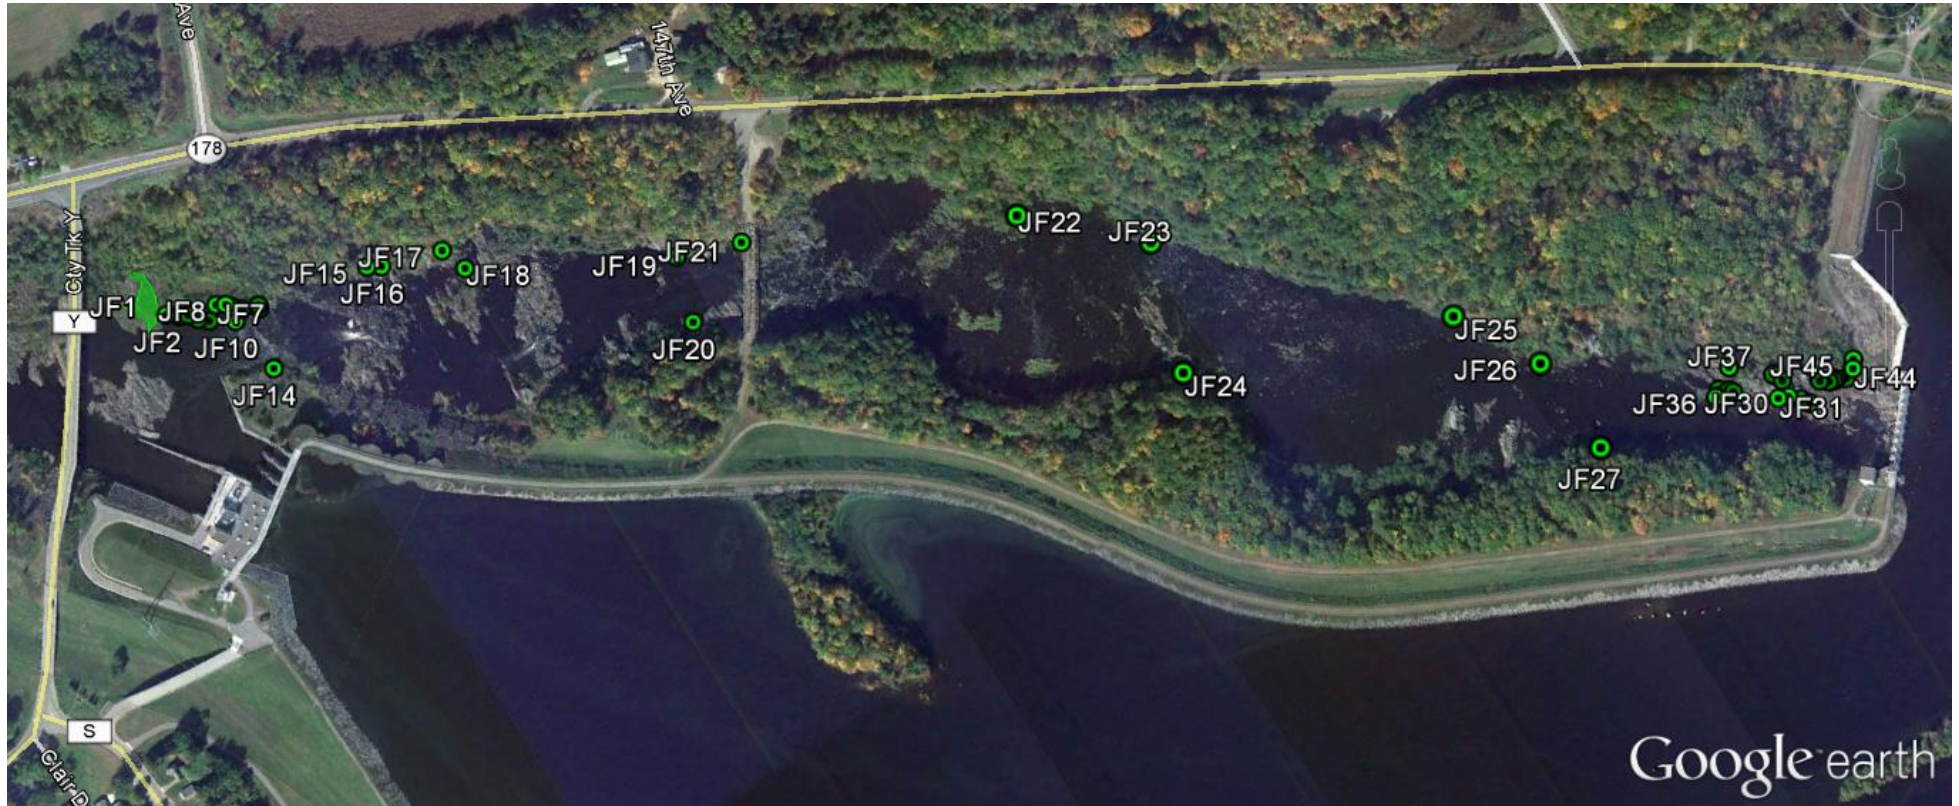
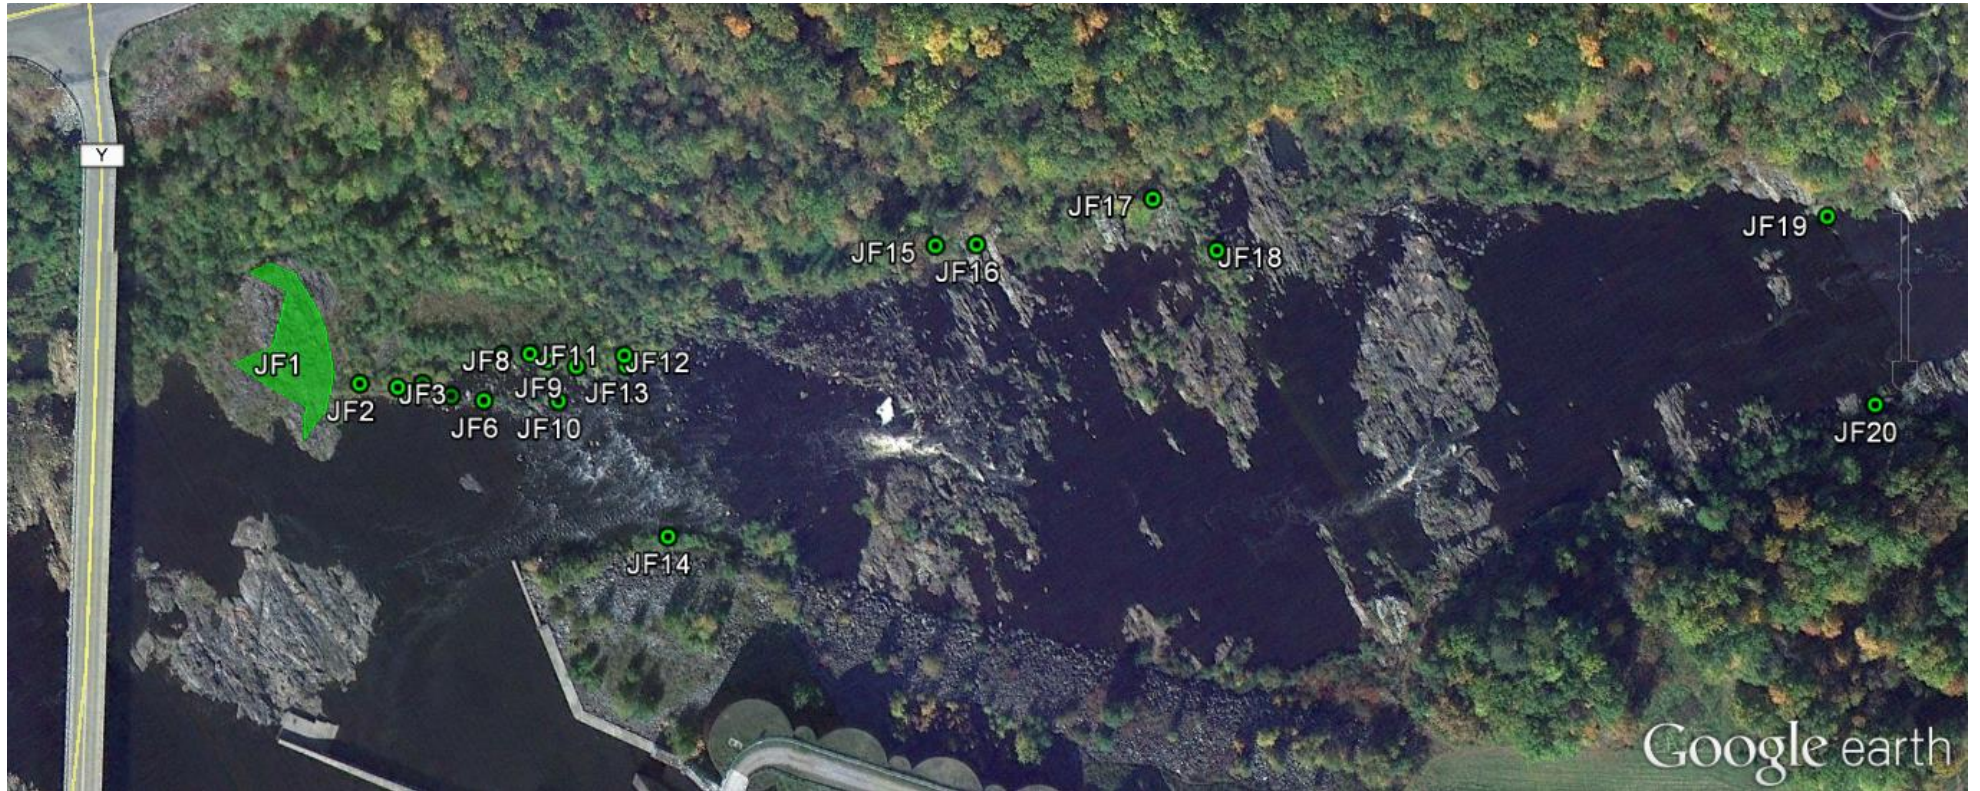
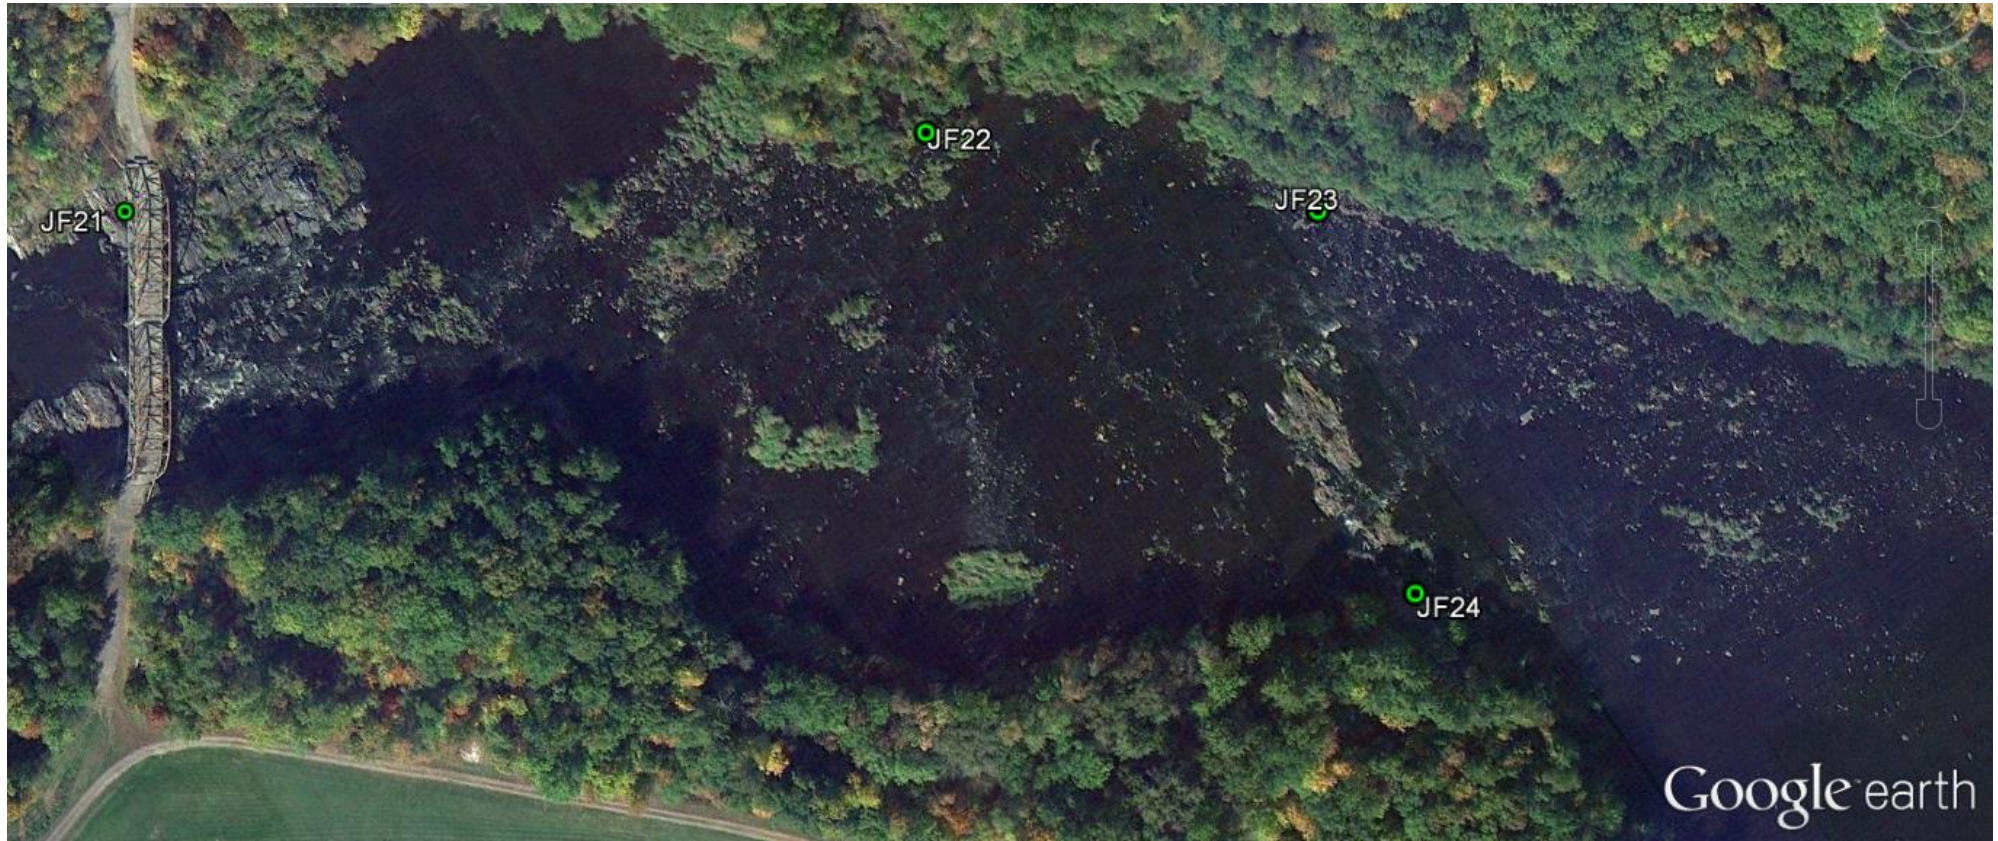
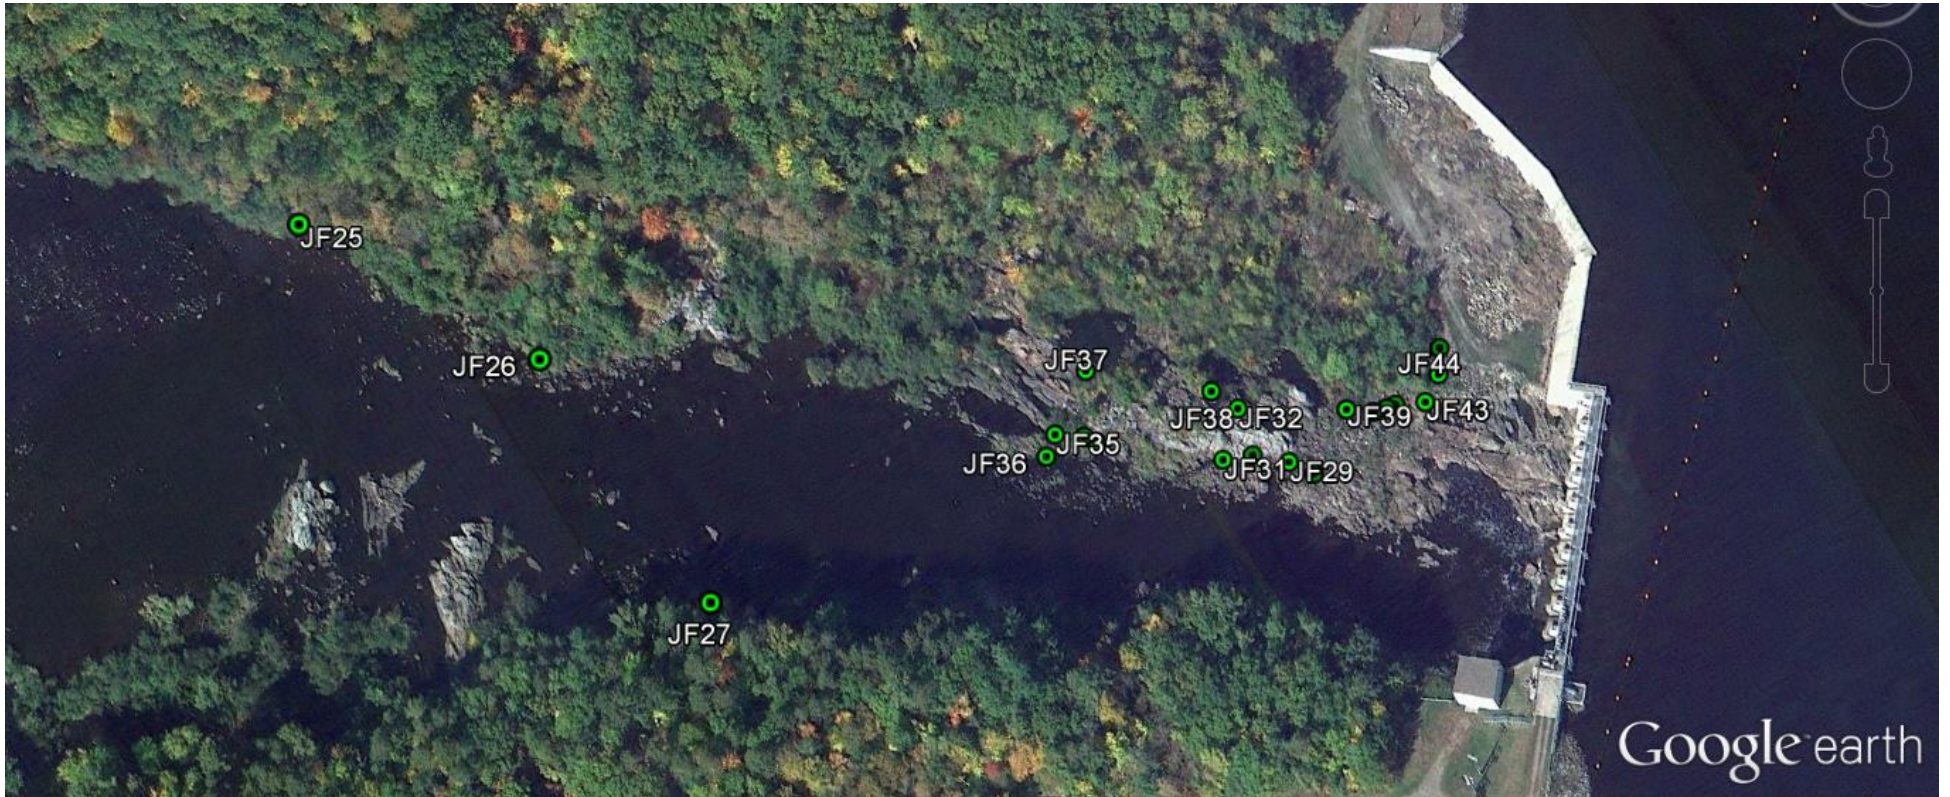
Jim Falls Spillway Channel Purple Loosestrife Assessment – 2017 (Map 1 of 4)

The minimum flow channel at Jim Falls Hydro remains infested with a relatively high concentration of purple loosestrife plants. A significant decrease in the number of plants was noted in 2012 followed by a rebound in 2013 and 2014 and another decline in 2015 and increase in 2016 (Table 3). In 2017, the amount of loosestrife decreased. Loosestrife was found scattered throughout the channel, with the lower third being moderately infested (see maps of Jim Falls Spillway Channel). The area of greatest concentration occurs just upstream from the County Highway Y Bridge (see Jim Falls Spillway map 2). The coverage of loosestrife in this area decreased from approximately 6,695 square feet in 2016 to 5,431

square feet in 2017 (Table 4). The loosestrife is scattered throughout the area and therefore is not classified as abundant. It also appears to be less dense overall than in previous years. Small areas of loosestrife in both the upper and lower portions of the spillway channel increased in both number and amount of shoreline affected. Collectively, these locations accounted for 222 feet of infested shoreline versus 313 feet in 2016. Most of these locations were comprised of small plant clumps infesting between one and ten feet of shoreline, with a few more significant areas of infestation.

Seven years have passed since the introduction of the bio-control beetles into the minimum flow channel. While it is difficult to make a determination as to their success, the fact that the density of loosestrife in the lower area of the spillway channel is continuing to decrease, and the fact that loosestrife infestation in the remaining portion of the channel appears to be stabilizing, is encouraging.
