**FAWN LAKE
LAKE CLASSIFICATION REPORT**

**Presented by Reesa Evans, CLM, Lake Specialist
P.O. Box 287, Friendship, WI 53934**

FEBRUARY 2008

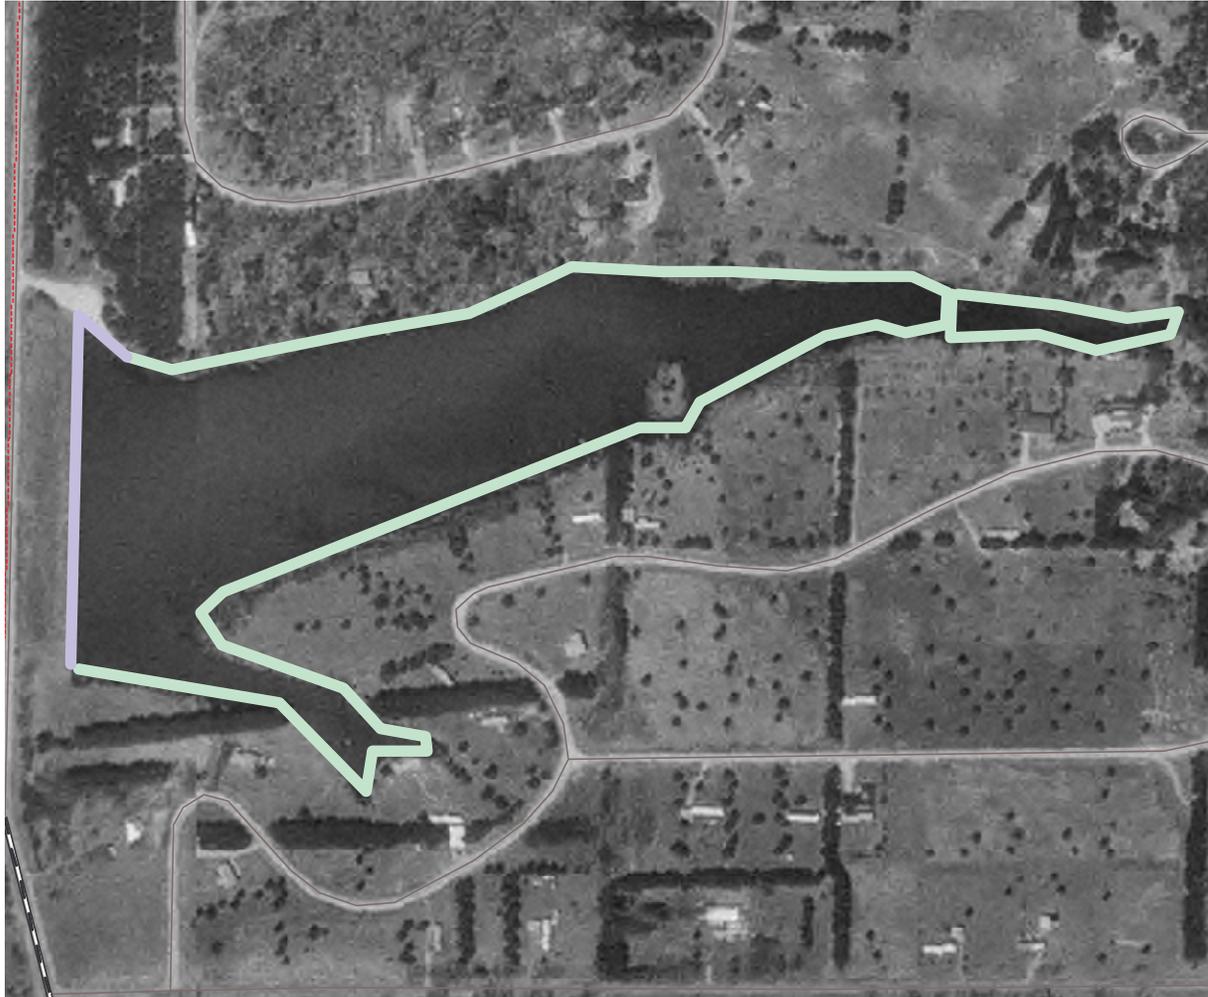
Figure 10: Fawn Lake Shoreline Map

Fawn Lake has a total shoreline of 2.08 miles (10976 feet). In 2004, a visual inventory of the lakeshore was done by Adams County Land & Water Conservation Department. One of the purposes of the inventory was to determine shoreline status around the lake. Most of Fawn Lake's shore is cattail marsh (a type of wetland). 90.53% of Fawn Lake's shoreline is vegetated; only 9.47% was armored or other shore cover. Most of the shore is in residential development, except for some WDNR-owned land on the northwest side of the lake and the dam/boat ramp area, owned by the county, on the east and northeast sides of the lake. The dam area is protected by rock riprap. Some emergent vegetation (mostly cattails) has grown in front of the rocks. As one enters the boat ramp, to the left is a willow thicket at the shore. No active erosion at the shore was noted in the 2004 survey. Most of the houses are set more than 70' back from the shore, even in those places where there is mowed lawn. Most of the shore is fairly flat.

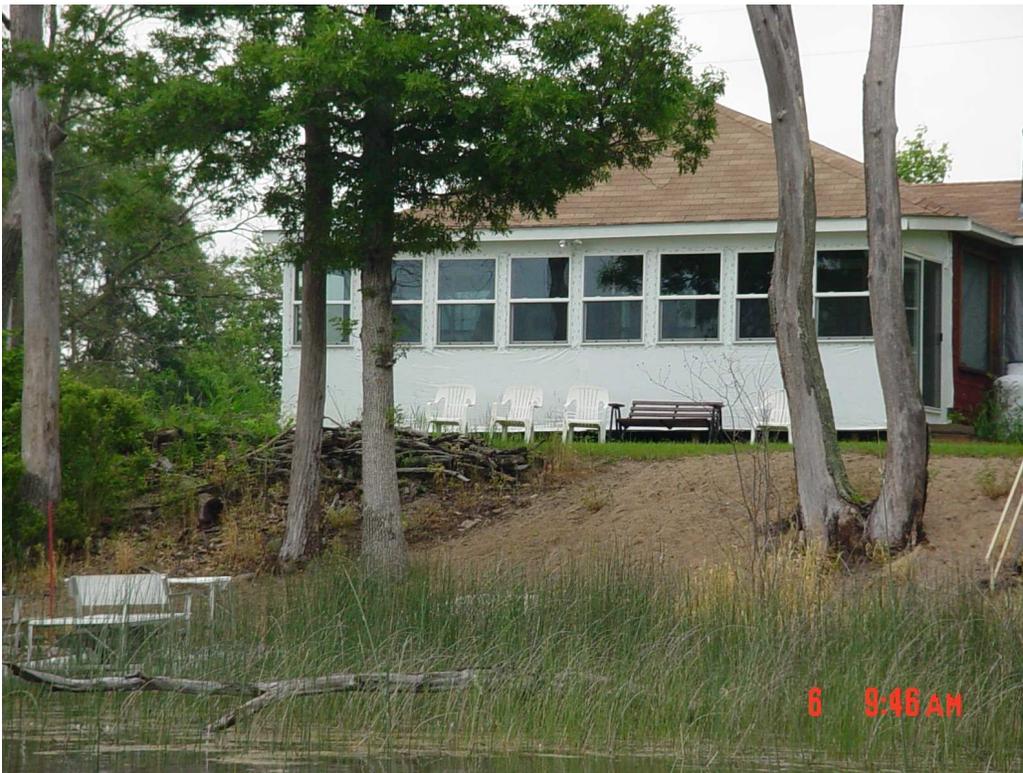
Figure 13: Example of Inadequate Vegetative Buffer

When the natural shoreline is replaced by traditional mowed turf-grass lawns, rock, wooden walls or similar installments, bird and animal life, land-based insects, and aquatic insects that hatch or winter on natural shore are negatively impacted. For example, on many Adams County lakes, the non-native aquatic plant, Eurasian Watermilfoil has invaded. There is a weevil native to Wisconsin that weakens Eurasian Watermilfoil by burrowing into and developing within its stems, but that weevil depends on a native-plant shore to overwinter. If the shore is instead covered by rock, seawall or traditional lawn, these weevils will be unavailable for the lake to use as Eurasian Watermilfoil control.

In the few spots where there are inadequate buffers on Fawn Lake, just letting that natural vegetation, including cattails, grow without more than necessary interruption would result in adequate buffers on the rest of the lake. If something more controlled or aesthetically pleasing was desired—by planting native seedlings sufficient to populate in the first 35 feet or using biologists to protect the shore that are vegetated.

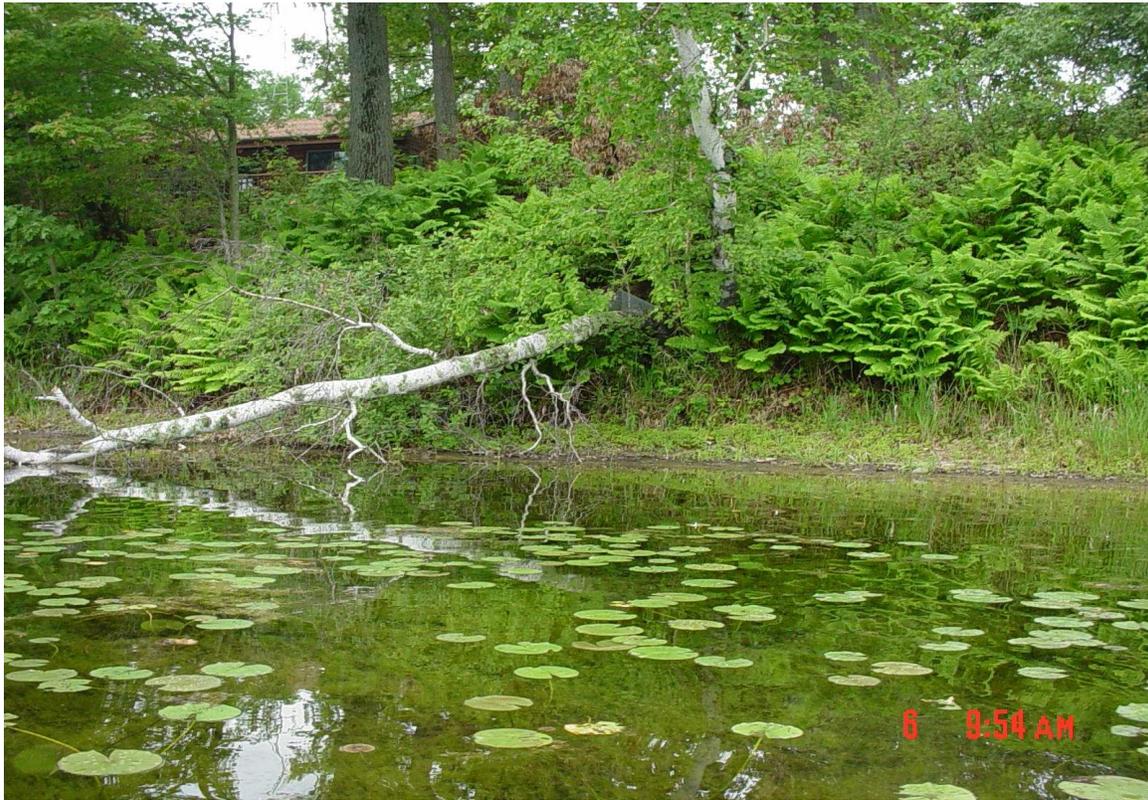
Figure 14: Example of Adequate Buffer

The filtering process and bank stabilization that buffers provide help improve a lake's water quality, including water clarity. Studies in Minnesota, Maine and Michigan have shown that waterfront property value increases for every foot the water clarity of a lake increases. (Krysel et al, 2003).

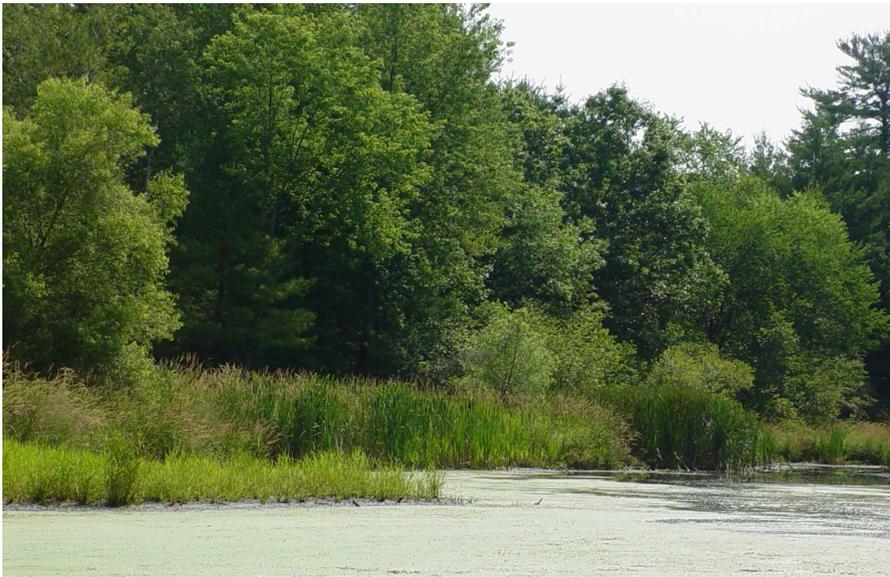
**Figure 17: Photo showing Tri-Level Vegetative Growth:
Trees; Shrubs; Emergents**

Phosphorus deposits such as that from flooded wetlands or from atmospheric deposition cannot be controlled by humans. However, some phosphorus (and other nutrient) input can be decreased or increased by changes in human land use patterns. Practices such as shoreland buffer restoration, especially with tri-levels of growth; infiltrating stormwater runoff from roof tops, driveways and other impervious surfaces; using no phosphorus lawn fertilizers; and reducing phosphorus input to and properly managing septic systems will minimize phosphorus inputs into the lake. Circumstances such as increased impervious surface, lawns mowed to water's edge, disturbance of shore areas, improperly-functioning septic systems and removal of native vegetation can greatly increase the volume and content of runoff—and thus increase the volume of phosphorus entering the lake. Many of these practices can also increase the concentration of phosphorus entering the lake, by runoff or other methods of entry.

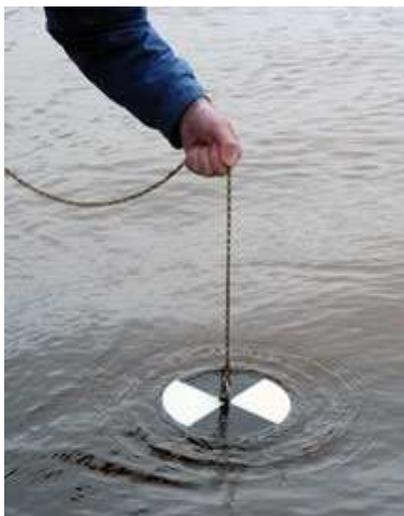
Figure 21: Photo of Testing Water Clarity with Secchi Disk

Water clarity is a critical factor for plants. If plants don't get more than 2% of the surface illumination, they won't survive. Water clarity can be reduced by turbidity (suspended materials such as algae and silt) and dissolved organic chemicals that color or cloud the water. Water clarity is measured with a Secchi disk. Average summer Secchi disk clarity in Fawn Lake in 2004-2006 was 5.05 feet. This is fair water clarity, putting Fawn Lake into the "mesotrophic" category for water clarity.

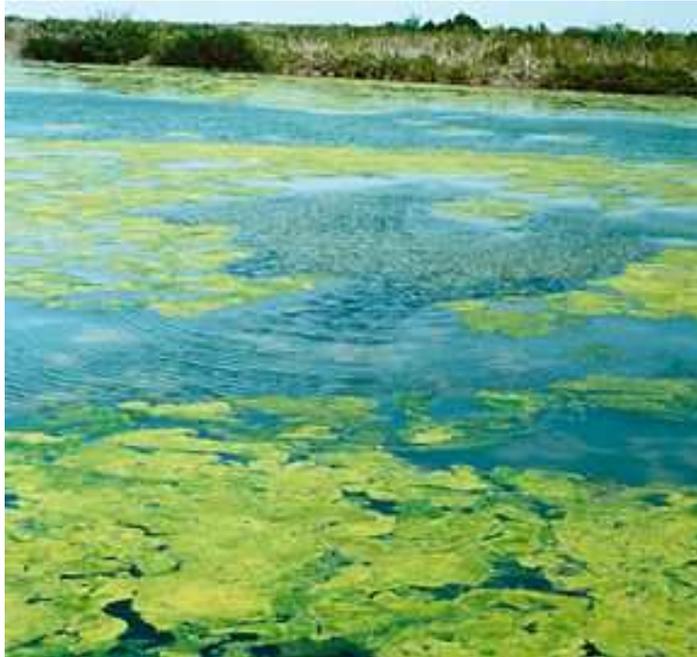
Figure 24:
Photo of a Lake
with Algal
Bloom

Measuring the phosphorus in a lake system provides an indication of the nutrient level in a lake. Increased phosphorus in a lake will feed algal blooms and also may cause excess plant growth. The 2004-2006 summer average phosphorus concentration in Fawn Lake was 31.9 micrograms/liter. This average is over the 30 micrograms/liter recommended to avoid algal blooms. This concentration suggests that Fawn Lake is likely to have nuisance algal blooms.

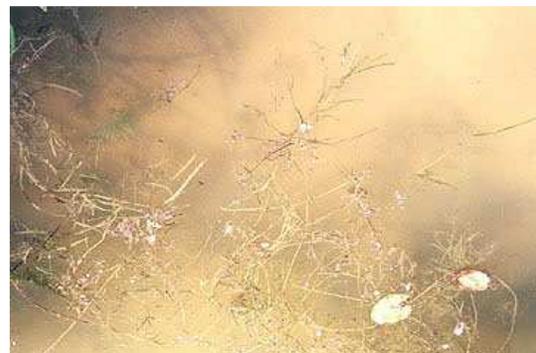
**Figure 31:
Examples of Very
Turbid Water**

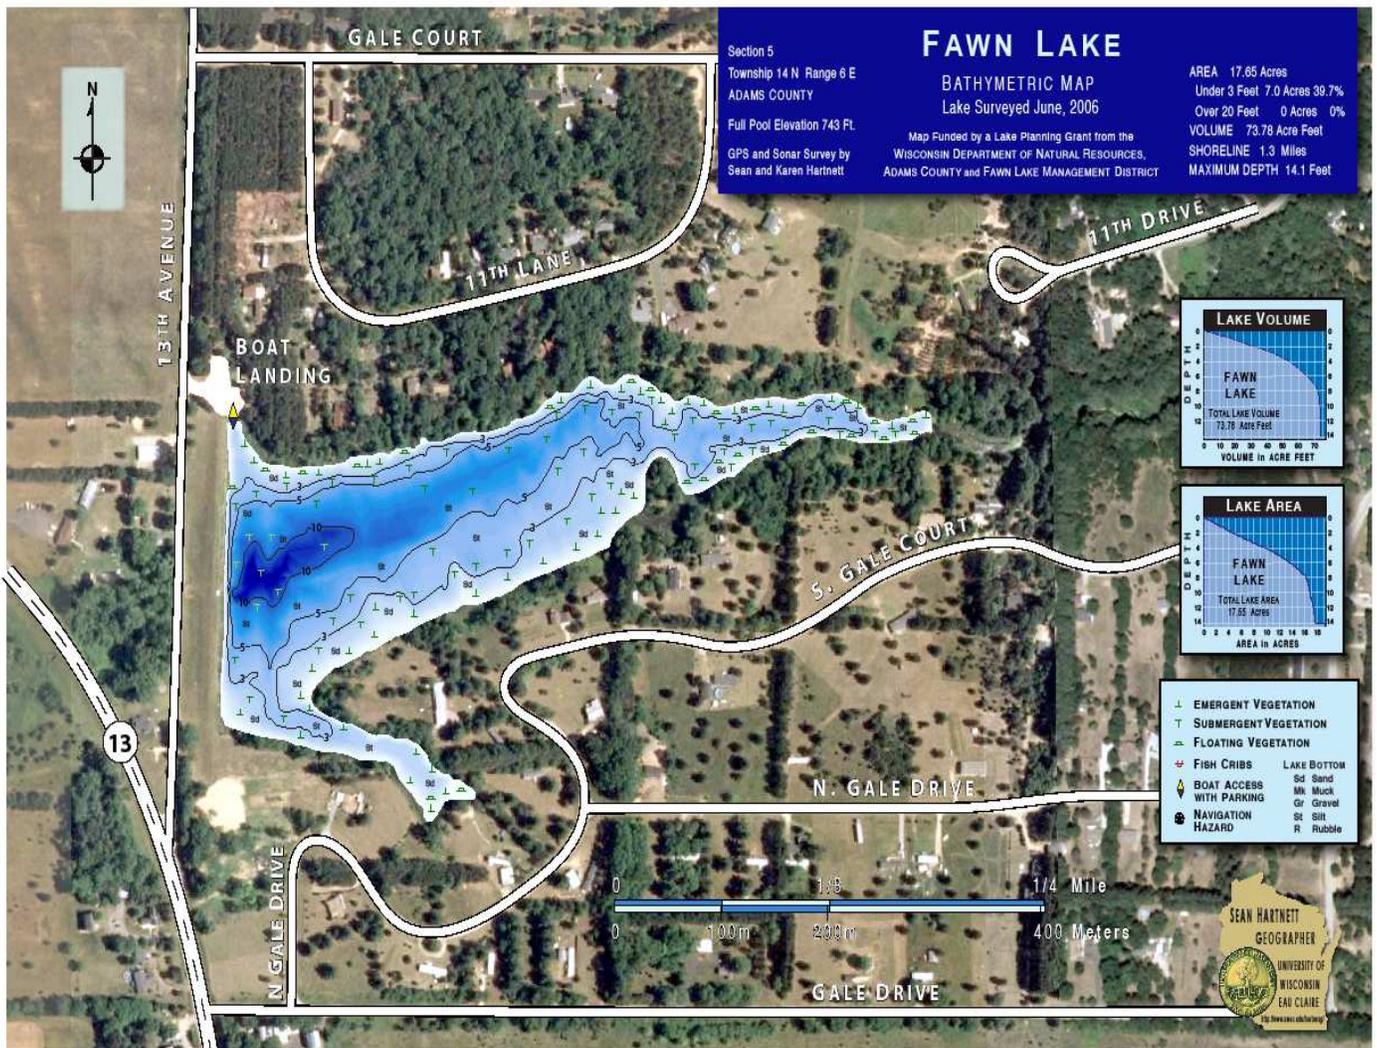
Figure 32: Bathymetric Map of Fawn Lake

According to data gathered for a recent bathymetric (depth) map, Fawn Lake is 17.65 surface acres, and the volume of the lake is 73.78 acre-feet. The mean depth is 6 feet. The maximum depth is 14.1 feet.

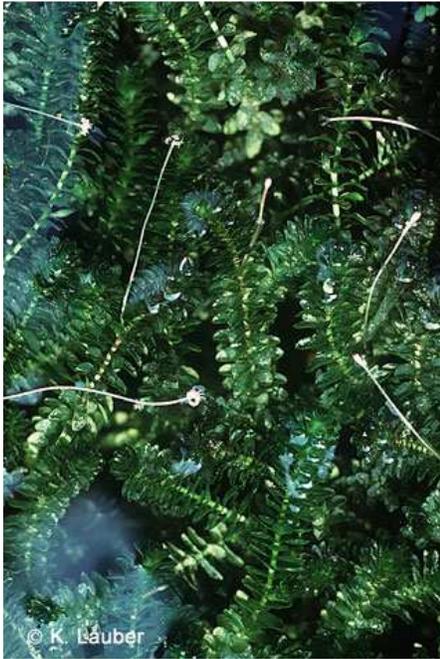
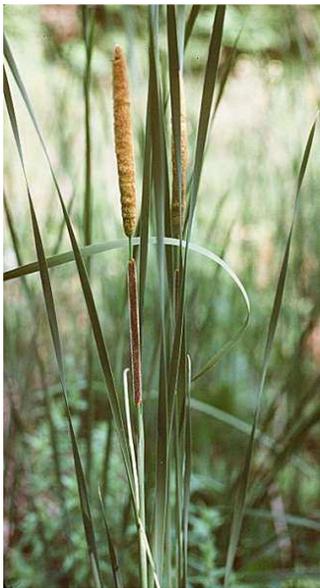
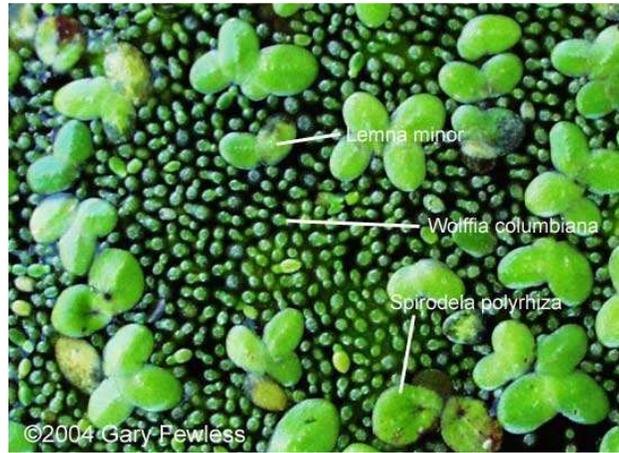
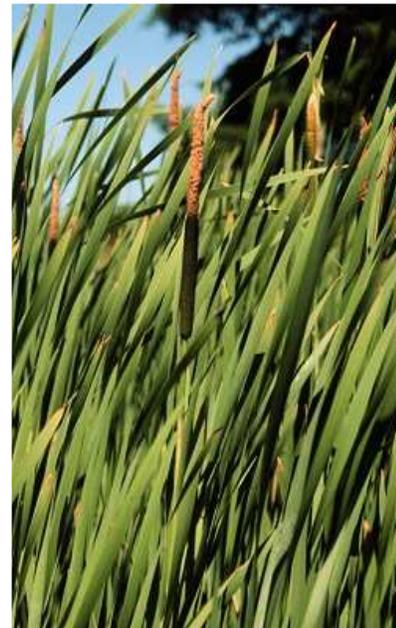
Elodea canadensis
(Common waterweed)

Typha angustifolia
(Wide-leaved Cattail)

**Figure 42: Most Common
Aquatic Species in Fawn Lake**

Lemna minor
(Small Duckweed)

Wolffia columbiana
(Common watermeal)

Typha latifolia
Narrow-
leaved
Cattail

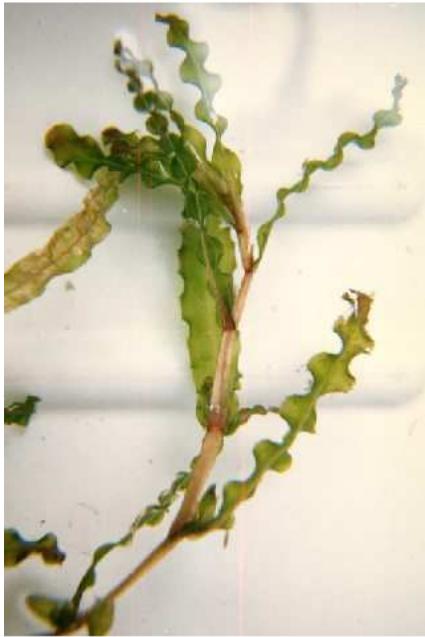
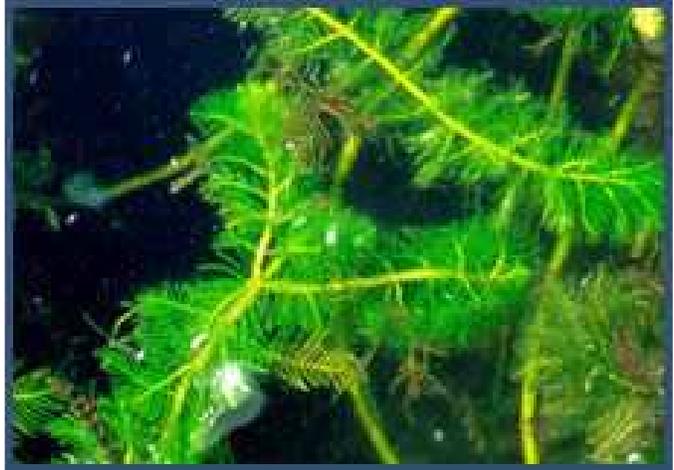
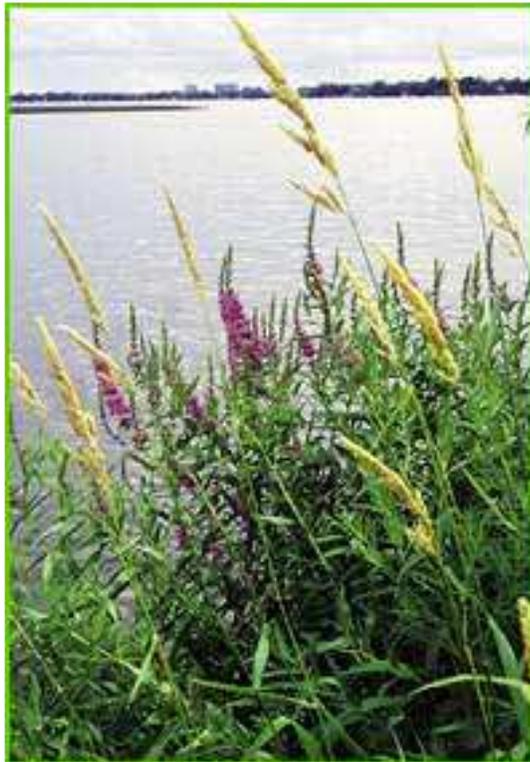
Potamogeton crispus
(Curly-Leaf Pondweed)

Myriophyllum spicatum
(Eurasian Watermilfoil)

Phalaris arundinacea
(Reed Canarygrass)
And
Lythrum salicaria
(Purple Loosestrife—
not found at Fawn
Lake)

**Figure 44: Invasive Aquatic
Plants in Fawn Lake**

- 3) All lake users should protect the aquatic plant community in Fawn Lake.
- 4) The Fawn Lake Association should maintain exotic species signs at the boat landings and contact DNR if the signs are missing or damaged.

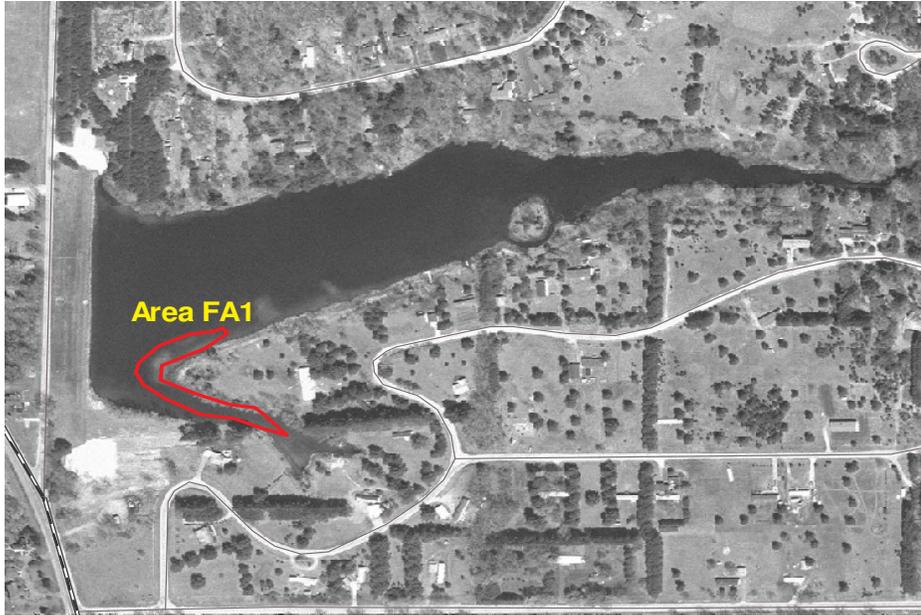
Figure 45: Critical Habitat Area on Fawn Lake

This area, FL1 extends along approximately 500 feet of the shoreline and has an average water depth of 3 feet. Maximum rooting depth of aquatic vegetation in FL1 was 6 feet. Sediment includes marl, muck, peat, sand, silt and mixtures thereof. 75% of the shore is native herbaceous cover and 25% is wooded. Some woody cover is available for habitat. Human disturbance impact on this area is currently limited. Aquatic vegetation found at FL1 includes emergent plants such as bulrush, cattails, rushes and sedges. Emergents provide important fish habitat and spawning areas, as

well as food and cover for wildlife. One floating-leaf rooted plant was also found in FL1. Floating-leaf vegetation provides cover and dampens waves, protecting the shore. Seven species of submergent aquatic plants were also found here, including two invasives. Most of these plants are used by a variety of fish and wildlife. Filamentous algae were found at this site as well.

- (1) Maintain current habitat for fish and wildlife.
- (2) Do not remove any fallen trees along the shoreline or in the water.
- (3) No alteration of littoral zone unless to improve spawning habitat.

- (19) Placement of swimming rafts or other recreational floating devices only by permit.
- (20) Maintain aquatic vegetation buffer in undisturbed condition for wildlife habitat, fish use and water quality protection.

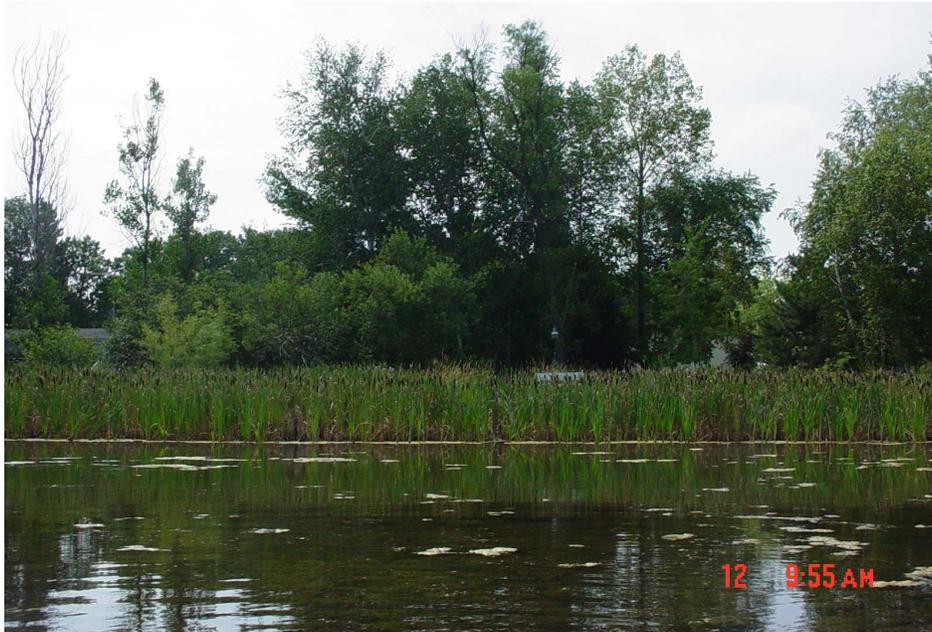
Figure 46: North Side of FL1

Fishery in this area includes largemouth bass and several types of panfish, including bluegills, pumpkinseed and crappie. Geese and songbirds are known at this site, as are amphibians and reptiles.
