# **PEPPERMILL LAKE LAKE CLASSIFICATION REPORT**

**Submitted by Reesa Evans, CLM, Lake Specialist  
Adams County Land & Water Conservation Department  
P.O. Box 287, Friendship, WI 53934**

**MAY 2008**

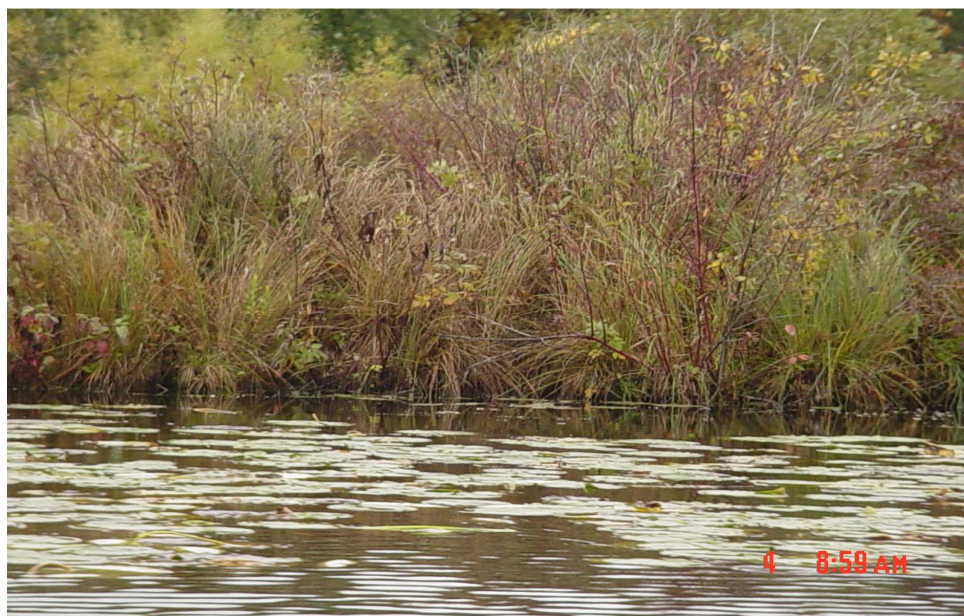
**Figure 8:  
Wetland at  
Shore of  
Peppermill  
Lake**

The wetlands in the Peppermill Lake serve as filters and traps that help keep the lake as clean as it is. It is essential to preserve these wetlands for the health of Peppermill Lake.

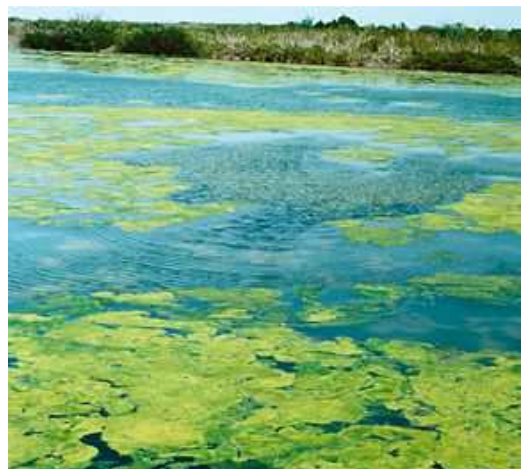
**Figure 23: Photo of a Lake in Algal Bloom**

Chlorophyll-a averages remained fairly low (under 5 micrograms/liter) until 2007, when summer figures were very elevated. These readings might have been a factor of the very hot summer of 2007, as plants slowed down photosynthesis due to the much hotter water and algal blooms were frequent.

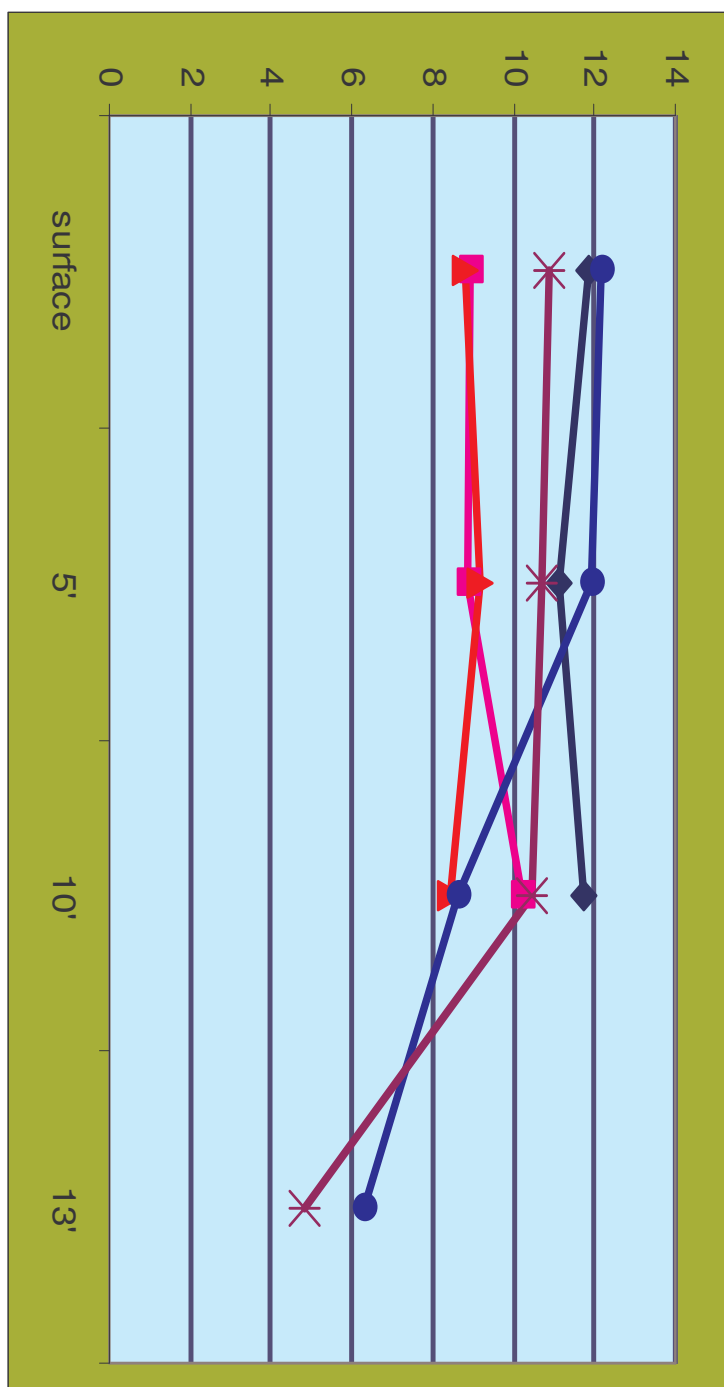
**Figure 26a: Dissolved Oxygen Levels 2002-2003 in milligrams/liter**

The charts (Figures 26a, 26b, 26c & 26d) below show the annual variations in dissolved oxygen levels in milligrams/liter, depth in feet and months of the year for 2002-2003, 2004, 2005 and 2006.

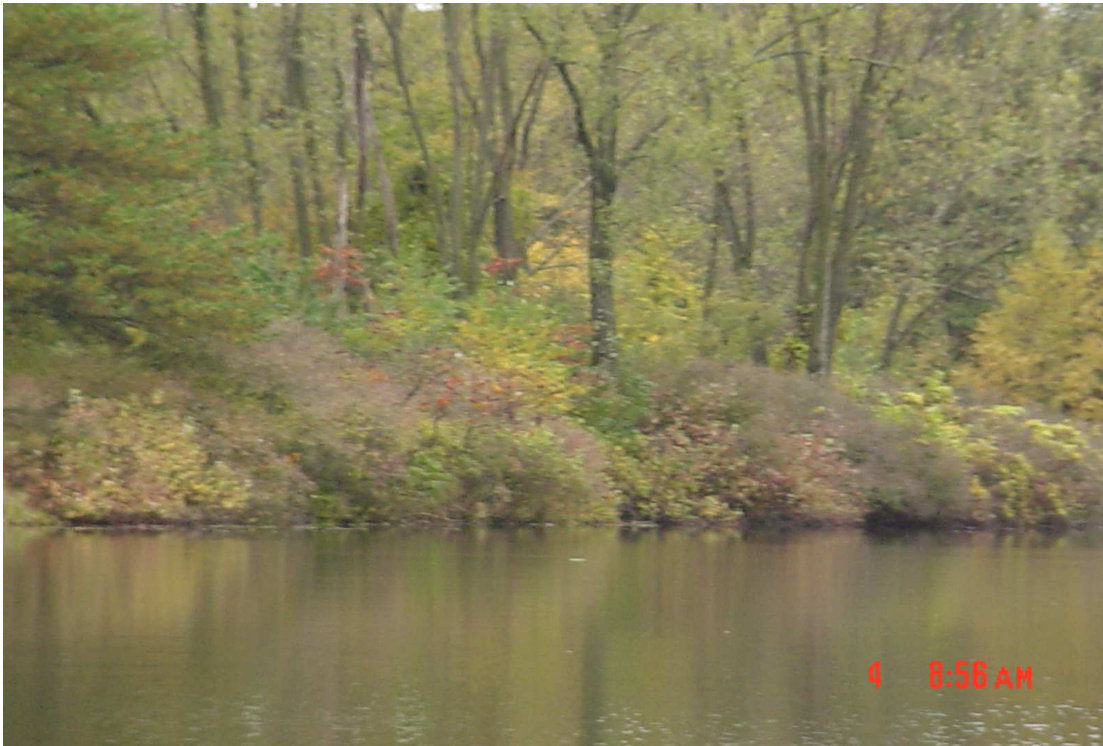
**Figure 50: Sections of PE1**

Maximum rooting depth of aquatic vegetation in PE1 was 7.5 feet. Eight species of emergent aquatic plants were found in this area. Emergents provide important fish habitat and spawning areas, as well as food and cover for wildlife. Two species of free-floating plants and three species of floating-leaf rooted plants were also present. These provide cover for fish and invertebrates and are eaten by fish and waterfowl. Floating-leaf rooted vegetation also provides cover and dampens waves, protecting the shore. Filamentous algae were common in this area. Eleven species of submergent aquatics were found in PE1.

The only exotic invasive plant found in this area was Eurasian Watermilfoil. Most of the aquatic vegetation in this area has multiple uses for fish and wildlife. Because this site provides all three structural types of vegetation, the community has a diversity of structure and species that supports even more diversity of fish and wildlife.

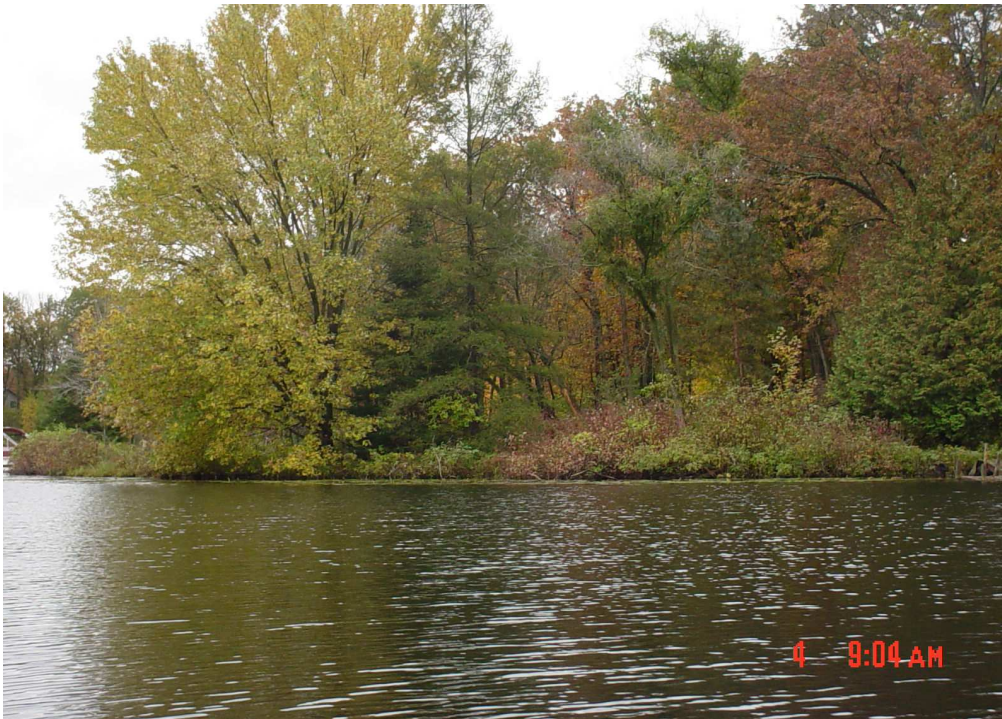
**Figure 51: Area of PE2**

Maximum rooting depth in PE2 was 8 feet. No threatened or endangered species were found in this area. One exotic invasive, *Myriophyllum spicatum* (Eurasian watermilfoil), was found in this area. Filamentous algae were present, especially near the shores. Only two types of emergents were found here. Two species of floating-leaf rooted plants were present. Two free-floating plants were also at this site. The remaining five aquatics in this area were submergents. A diverse submergent community can provide many benefits. All of these plants have multiple fish and wildlife uses.

PE2 extends along approximately 800 feet of the shoreline along the middle south part of the lake. 35% of the shore is wooded; 10% is native herbaceous cover; the remaining shore is cultivated lawn and a little hard structure. Shallow marsh covers part of the shore. Large woody cover is common for habitat. No threatened or endangered species were found in this area. One exotic invasive, *Myriophyllum spicatum* (Eurasian watermilfoil), was found in this area. Filamentous algae were present, especially near the shores. Only two types of emergents were found here. Two species of floating-leaf rooted plants were present. Two free-floating plants were also at this site. The remaining five aquatics in this area were submergents. A diverse
