# **LAKE CLASSIFICATION REPORT FOR LOWER CAMELOT LAKE, UPPER CAMELOT LAKE AND CAMELOT CHANNEL**

**Presented by Reesa Evans, CLM, Lake Specialist  
Adams County Land & Water Conservation Department  
P.O. Box 287, Friendship, WI 53934**

**NOVEMBER 2008**

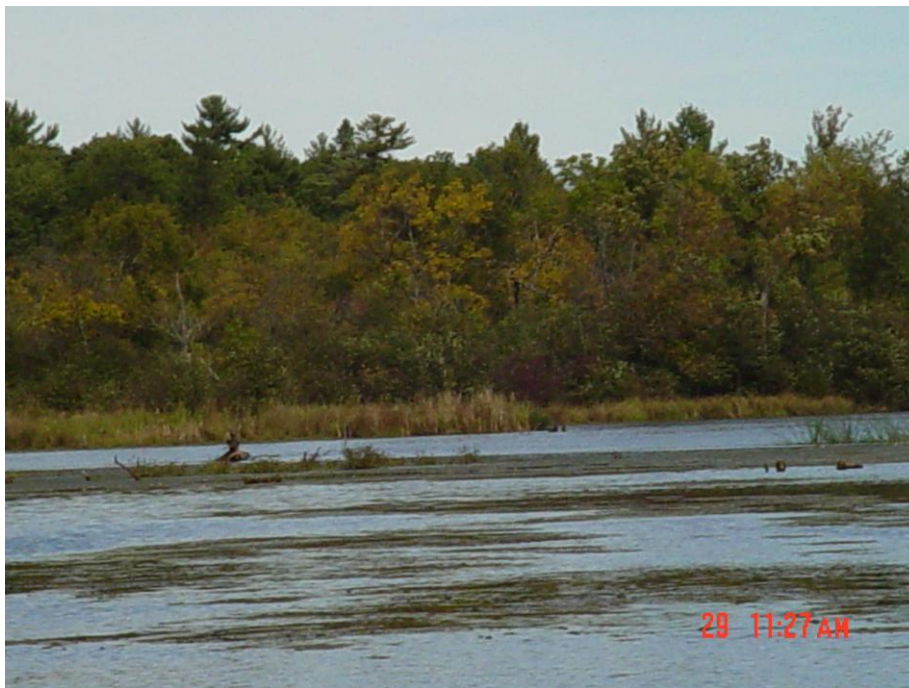
**Figure 8:  
Example of  
lake end  
wetland (not  
at Tri-  
Lakes)**

The large areas of wetlands east of the Camelot Lakes serve as filters and traps that help reduce nutrient loading from the upper watersheds into the lakes. It is essential to preserve these wetlands for the health of all the Tri-Lakes.

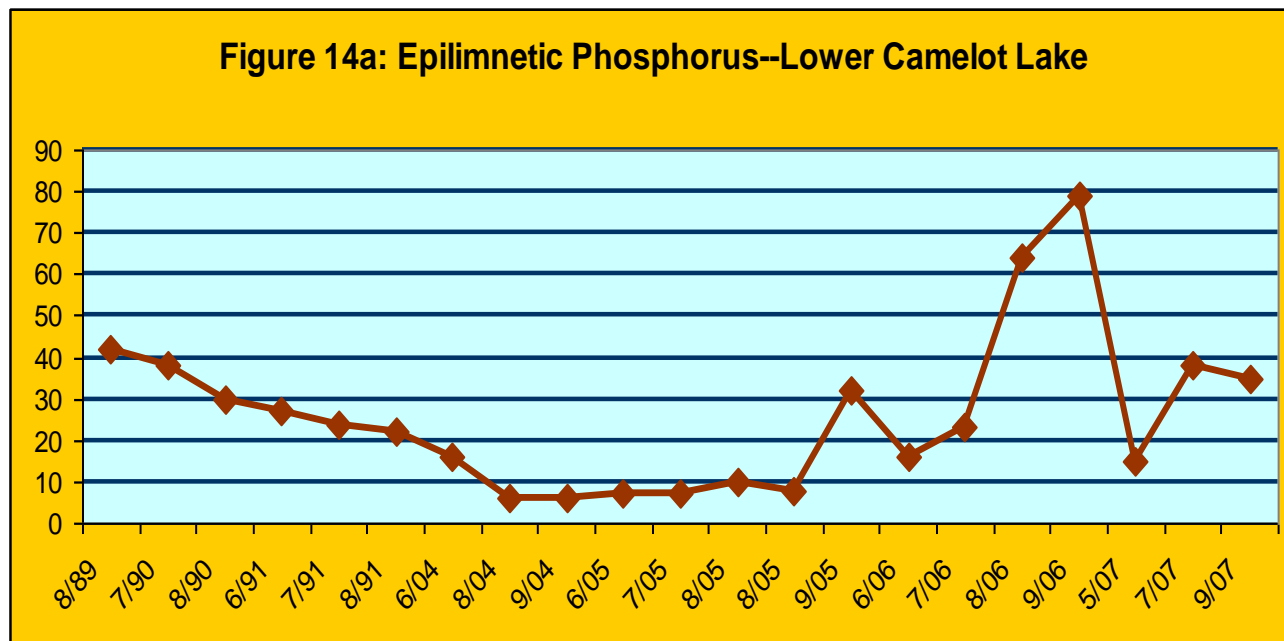
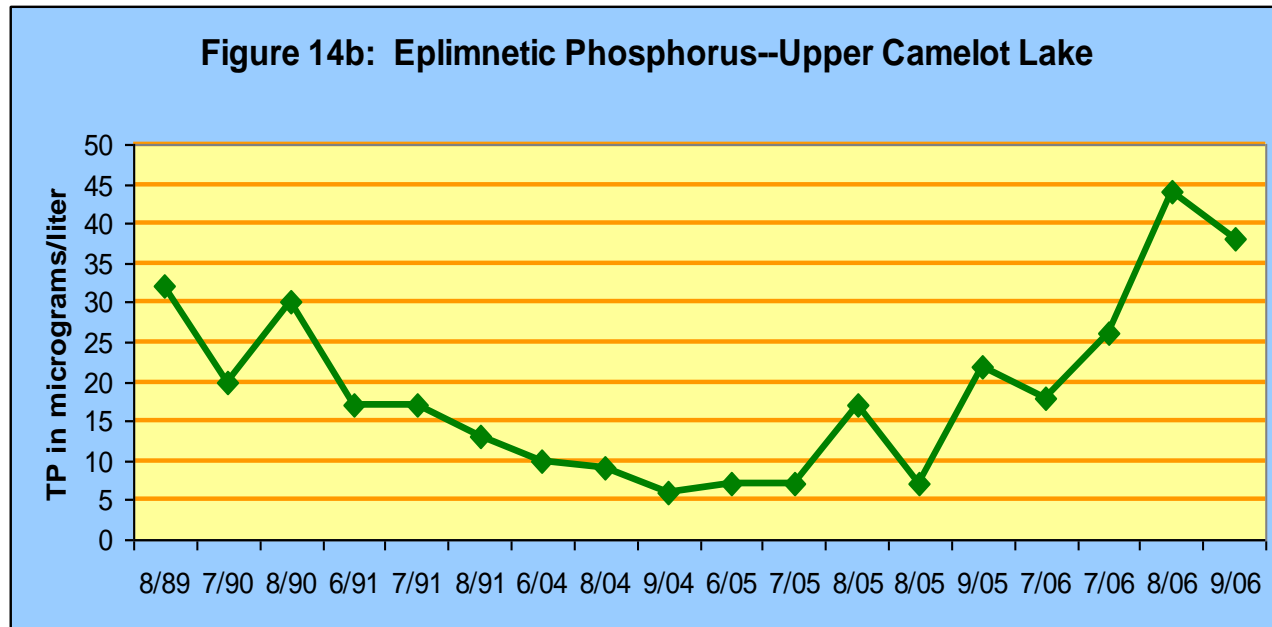
Figures 14a and 14b show the epilimnetic growing season total phosphorus readings for the Camelot Lakes since 1989.

Although the growing season epilimnetic total phosphorus levels have stayed below the state impoundment average of 65 micrograms/liter, the prior studies on the Tri-Lakes showing increasing phosphorus accumulation below septic fields around the lake and the continued heavy growth of aquatic plants in the lakes suggest that lake surface

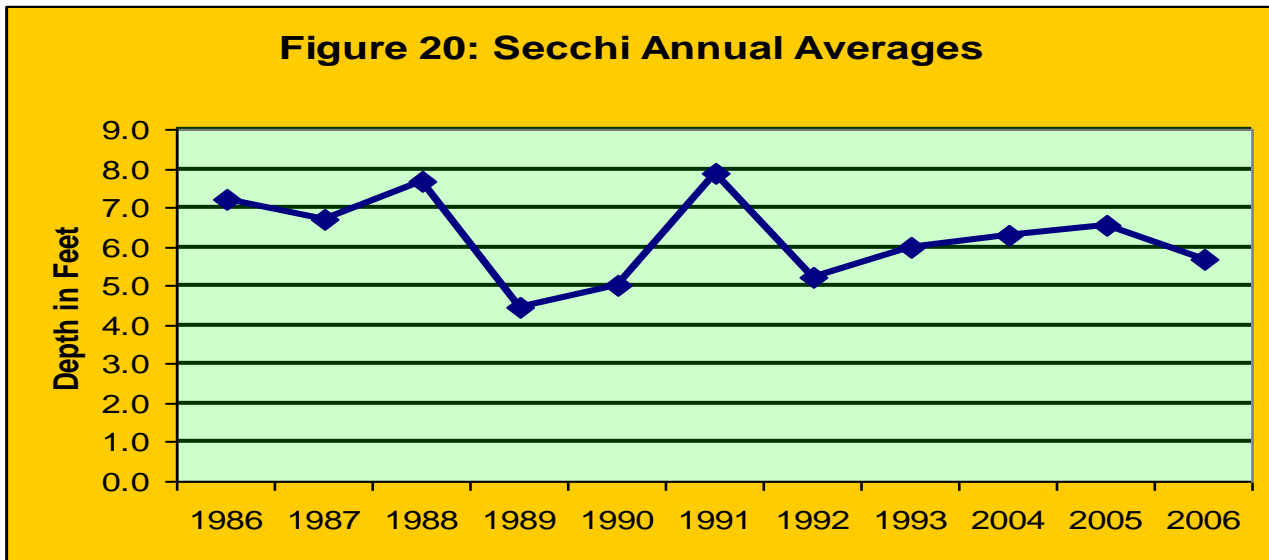
Upper Camelot Lake has a considerable history of Secchi disk readings in a number of years. A look at the average Secchi depth for the growing season in each year since 1986, Secchi disk depth readings on Upper Camelot Lake show a slight downward trend over the years (see figure 20). However, the overall average depth for the twenty years is 6.24 feet, only slightly above the growing season average of 6.19 feet for 2004-2006.

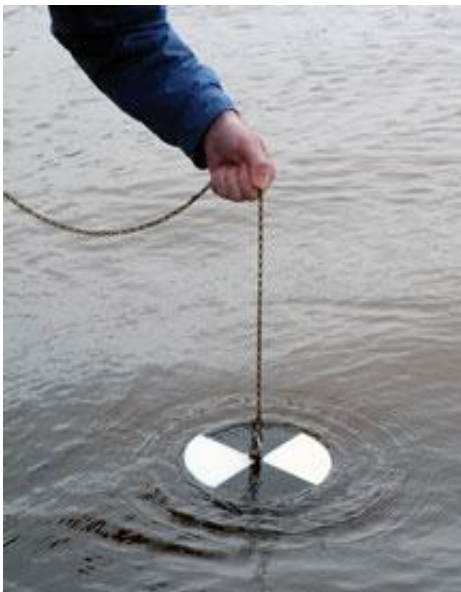
**Figure 21: Photo of  
Testing Water  
Clarity with Secchi  
Disk**

Water clarity is a critical factor for plants. If plants don't get more than 2% of the surface illumination, they won't survive. Water clarity can be reduced by turbidity (suspended materials such as algae and silt) and dissolved organic chemicals that color or cloud the water. Water clarity is measured with a Secchi disk. Average summer Secchi disk clarity in Lower Camelot Lake in 2004-2006 was 5.54 feet, in the "fair" category for water clarity. The Secchi disk average for the growing season in the 1990s was 5.9 feet. These figures suggest that Lower Camelot Lake's water clarity has stayed fairly steady for the last twenty years, i.e., it didn't substantially decrease or substantially increase. Water clarity can be reduced by turbidity (suspended materials such as algae and silt) and dissolved organic chemicals that color or cloud the water. Water clarity often gets worse during the growing season due to increase in algae & other pollutants in the water, then clears up again by fall turnover.

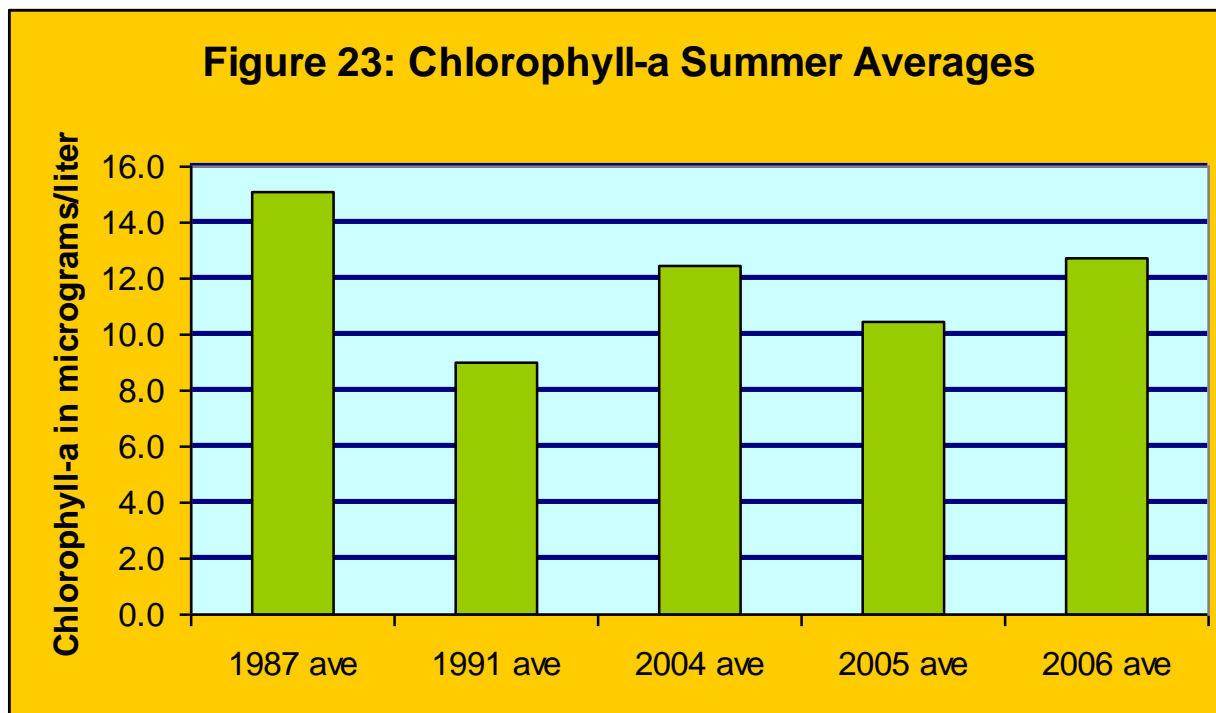
Records for Upper Camelot Lake are more extensive than those for Lower Camelot Lake. A view of the chlorophyll-a averages since 1987 don't suggest that there is a substantial change in the level since then.

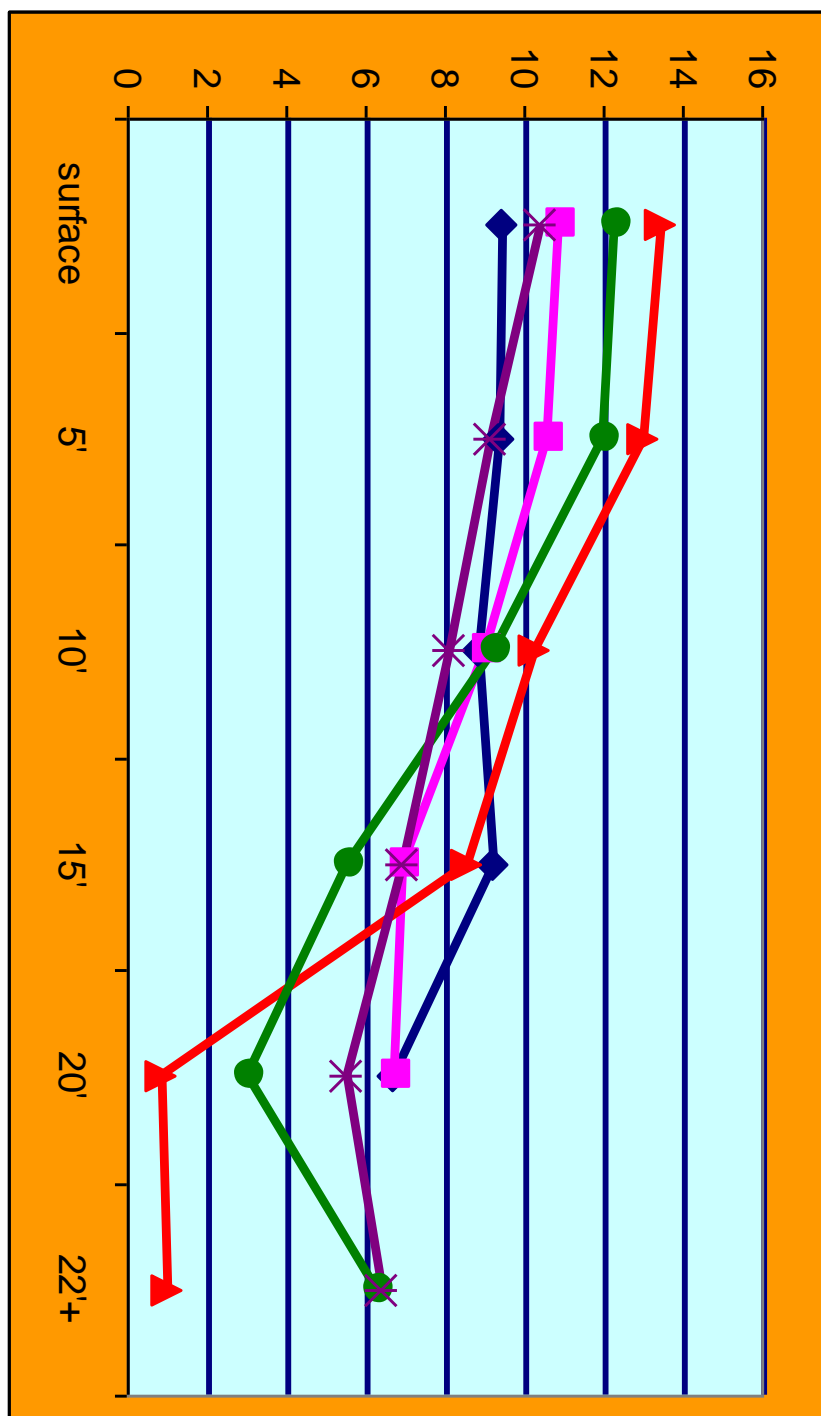
**Figure 24a: Dissolved Oxygen Levels 2004 in milligrams/liter—Upper Camelot Lake**

Prior studies of the Camelot Lakes have found anoxic (no oxygen) or hypoxic (low oxygen) in the lakes. During the 2004-2006 study, hypoxia was found on Upper Camelot Lake in August 2004 and June 2006 and on Lower Camelot Lake in August 2005. Otherwise, dissolved oxygen levels didn't usually go below levels 5 milligrams/liter, the appropriate level for good fish survival. The charts (Figures 24 and 25) show the annual variations in dissolved oxygen levels in milligrams/liter, depth in feet and months of the years.

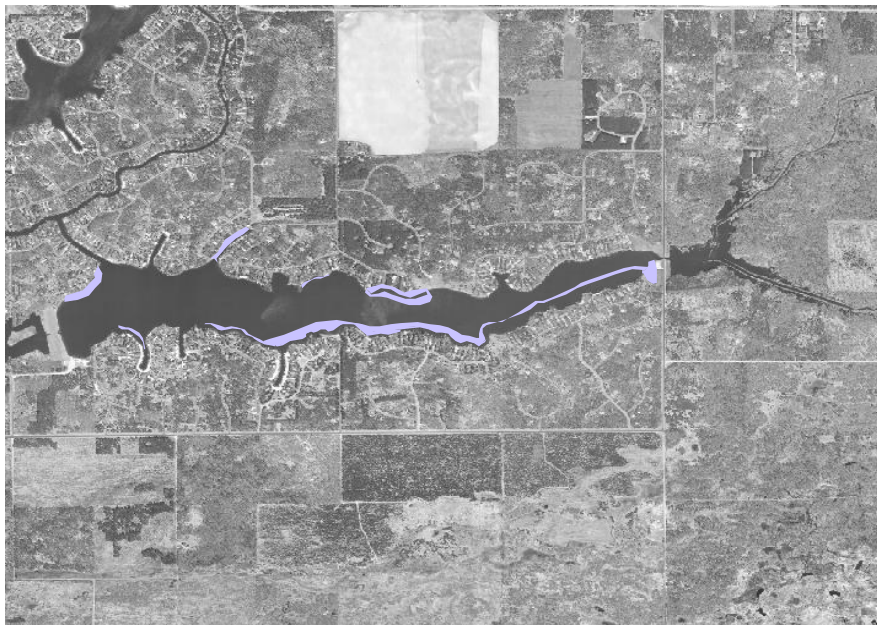
**Figure 60: Distribution of Exotic Aquatic Plants in Lower Camelot Lake 2006**

### Exotic Aquatic Vegetation Found in Lower Camelot Lake 2006
