# Curly-leaf pondweed (*Potamogeton crispus*)

## Pre/Post Herbicide and June Bed Mapping Surveys

### Long Lake - WBIC: 2478200

### Polk County, Wisconsin

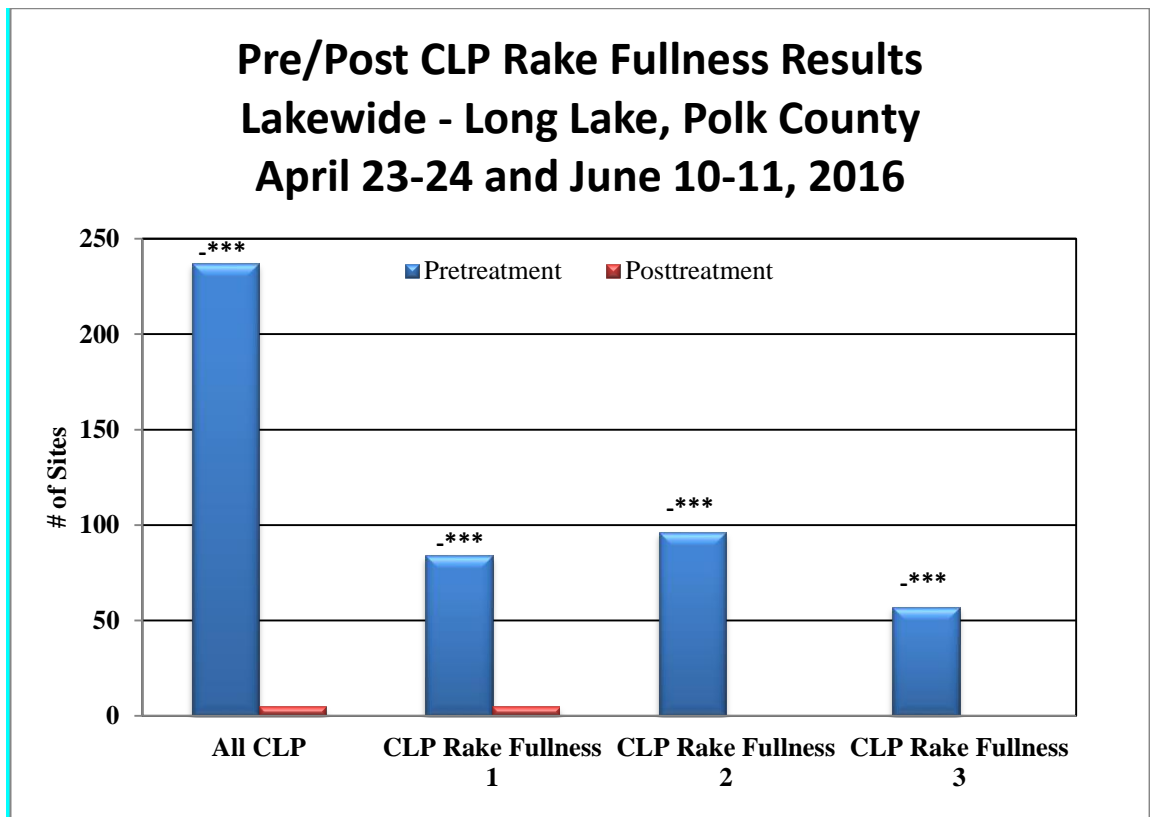
**Figure 11: Whole Lake Changes in CLP Rake Fullness Ratings**

During the posttreatment survey, we found CLP at just five points (1.0% coverage) all of which rated a 1. Three of these occurred in the the HDAs (0.9%), and just two were in the LDAs (1.0%). **Our findings suggest the treatment produced a highly significant reduction in CLP lakewide** (Figure 11), in the HDAs (Figure 12), AND in the LDAs (Figure 13). This was surprising as only the HDAs were treated, and, even here, only 70% of the acreage was treated. **That CLP was knocked back even in areas that weren't treated suggests that this dosage of Endothall over this acreage effectively resulted in a lakewide treatment.**

Significant differences = \*  $p < .05$ , \*\*  $p < .01$ , \*\*\*  $p < .005$
