**Final Report**

Grant Type		
Select Grant Type Large Scale Total Maximum Daily Load (TMDL)		
Project Name & Location		
Project Name Little Willow Creek Large Scale TMDL		
Grant Number TMD-L/LW12-52000	TMD-L/LW12-52000-14	Governmental Unit Name Richland County Land Conservation Department
County Richland	Watershed Name Middle Willow Creek	12-Digit HUC 070700051002
Project Contact Name Kenneth Anderson	Phone Number (608) 647-2100	E-mail Address kenneth.anderson@wi.nacdnet.net
<input checked="" type="checkbox"/> For a project with multiple site locations, an aerial photo map is attached with each site location labeled.

# Rip Rap Sites

# Stream Improvement

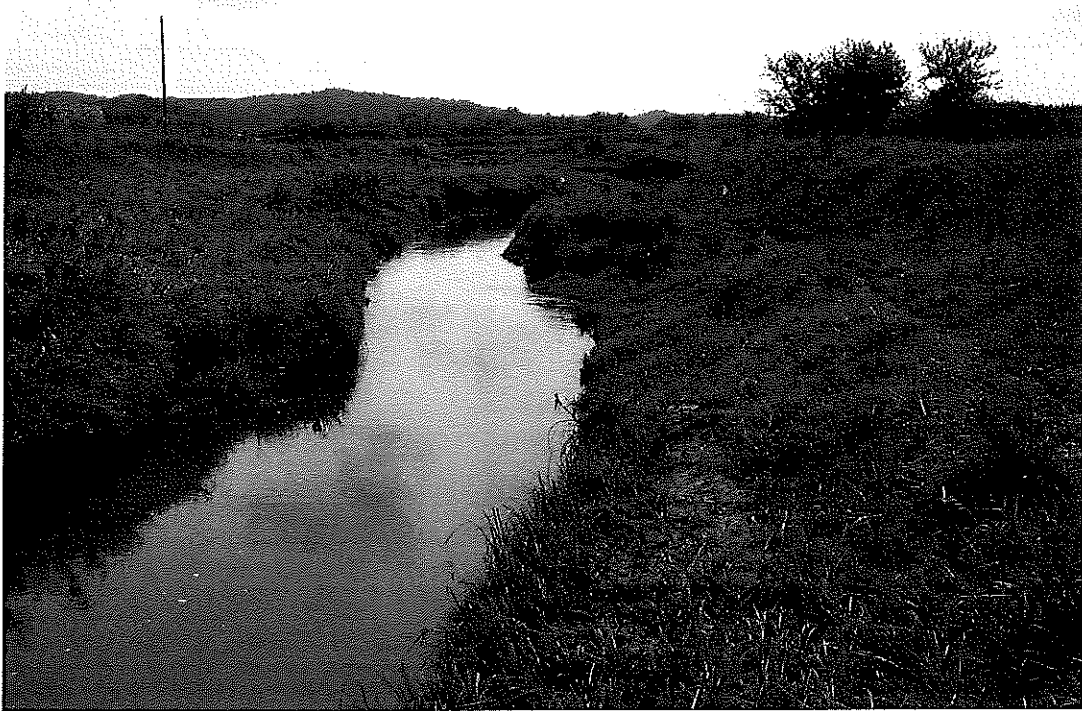
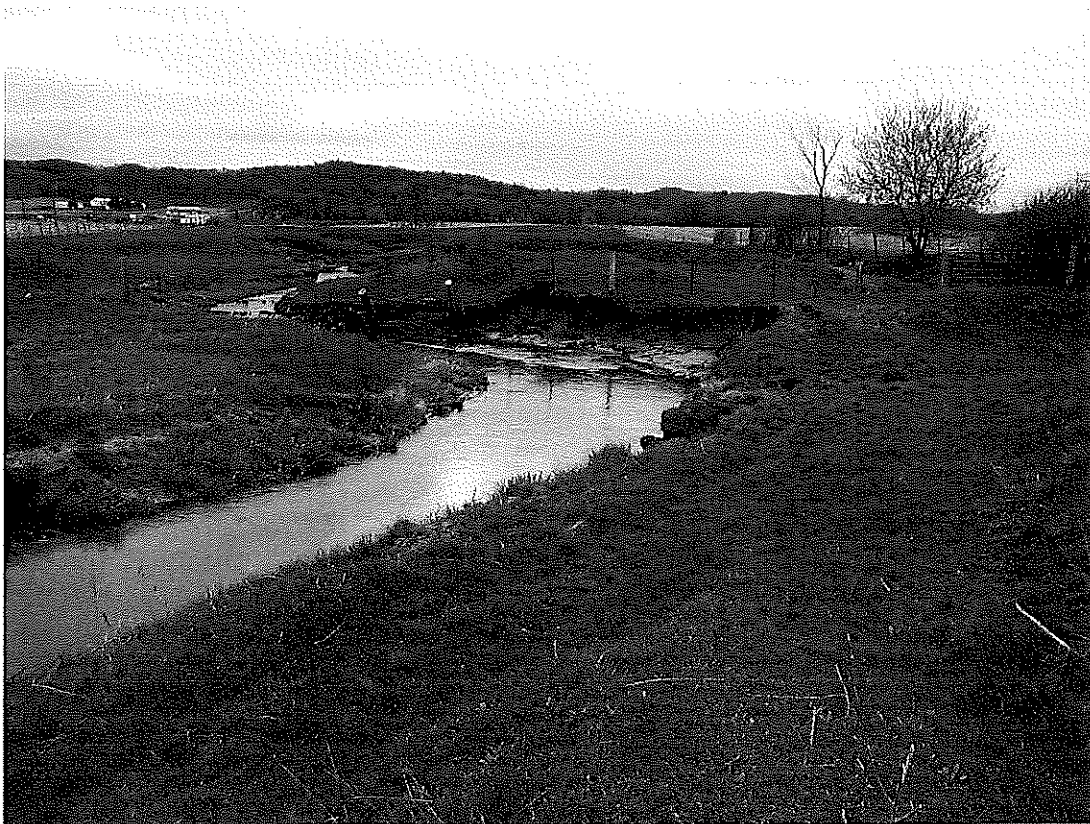
Scott Gald  
Rip Rap sites Before

Erosion on the streambank was adding sediment to Little Willow and degrading habitat. Habitat degradation by sediment is one of the impairments of Little Willow. The sites that were rip rapped were the sites contributing the most sediment.

$$\frac{225 \text{ lin. ft.} \times 4 \text{ ft.} \times 0.4 \text{ ft./yr} \times 100 \text{ pcf}}{2000 \text{ lbs/ton}} = 18 \text{ ton/yr.}$$

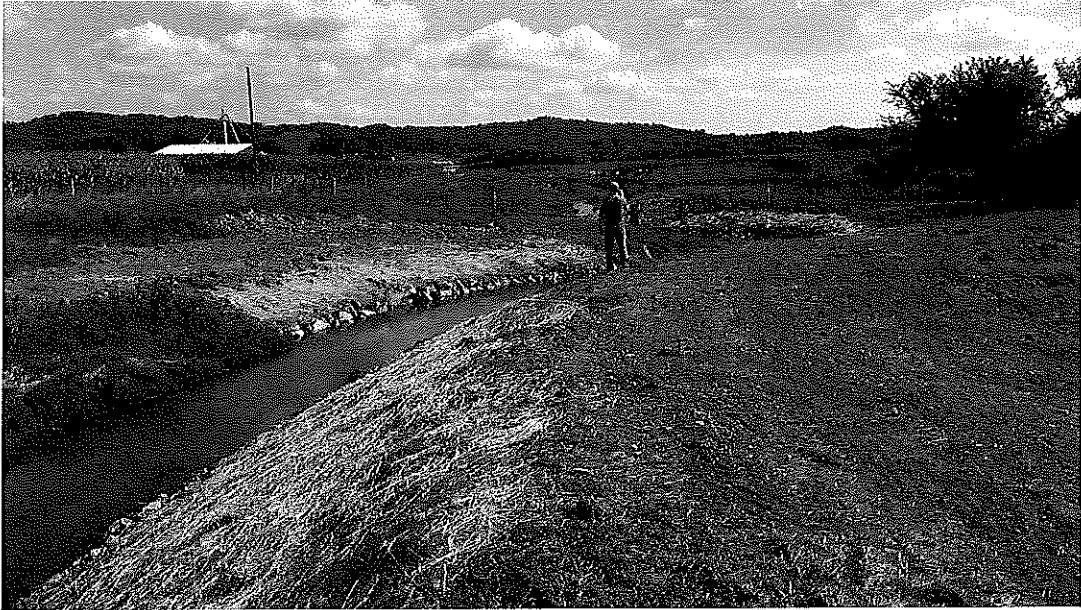
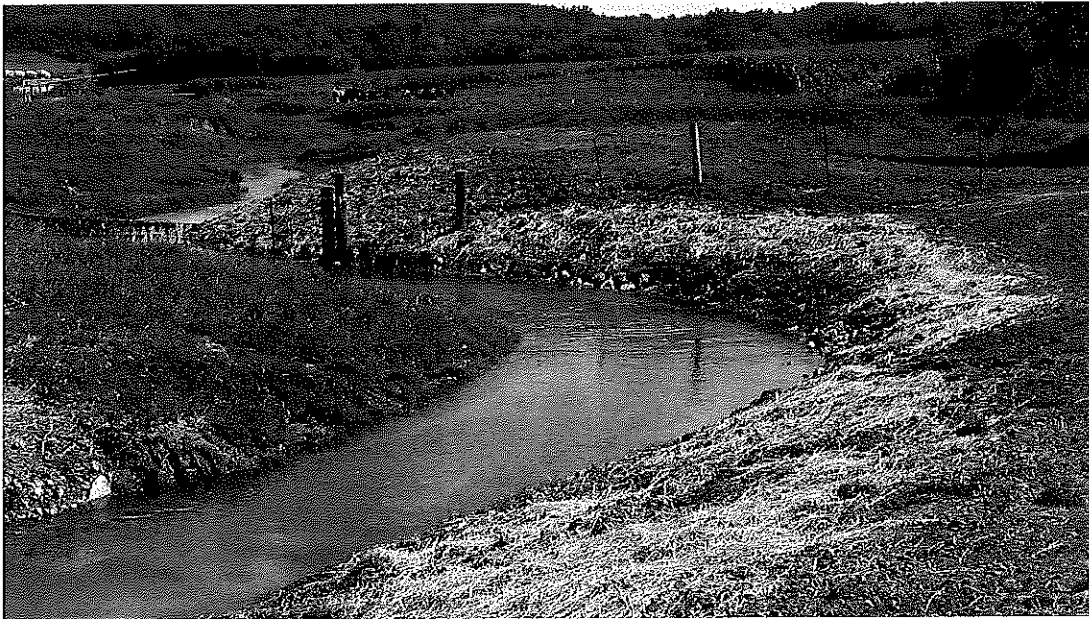
Scott Gald  
Rip Rap sites After

Summary of Results - 3							
Best Management Practice Installed	Quantity	Unit of Measure	Performance Standard/Prohibition Addressed	Total Installation Cost	Load Reduction		
					Phosphorus lbs/yr	Nitrogen lbs/yr	Sediment Tons/yr
Streambank/Shoreline Rip-Rapping	225	Feet	Code(s) 13	\$5,484.00			18

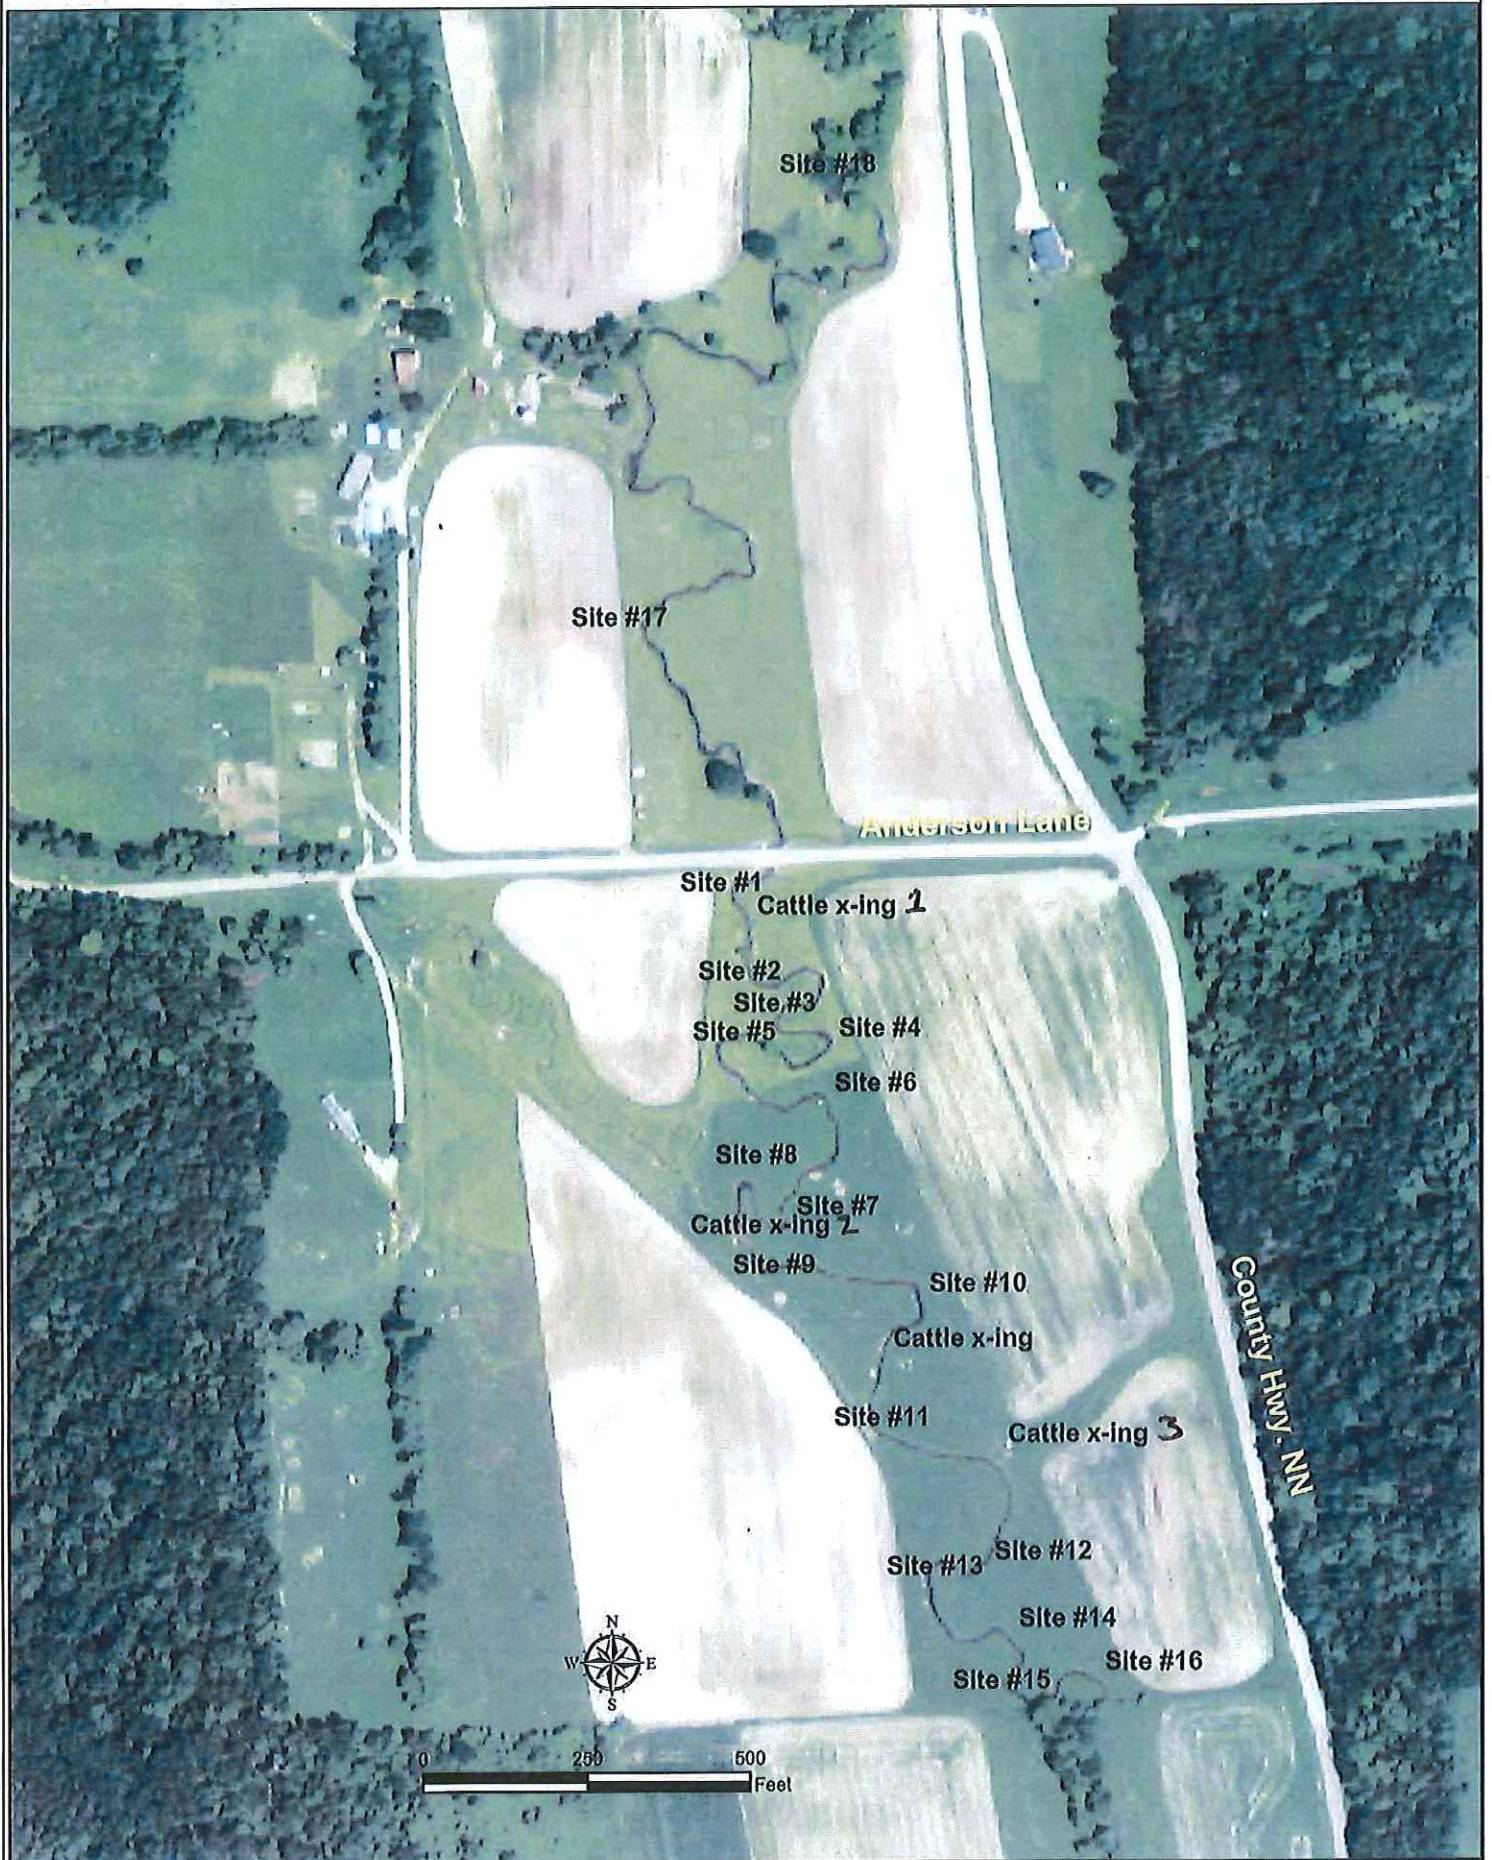
Location:  
Richland County, WI  
Willow (T11N R2E) Section: 31

Owner  
Dale Servais

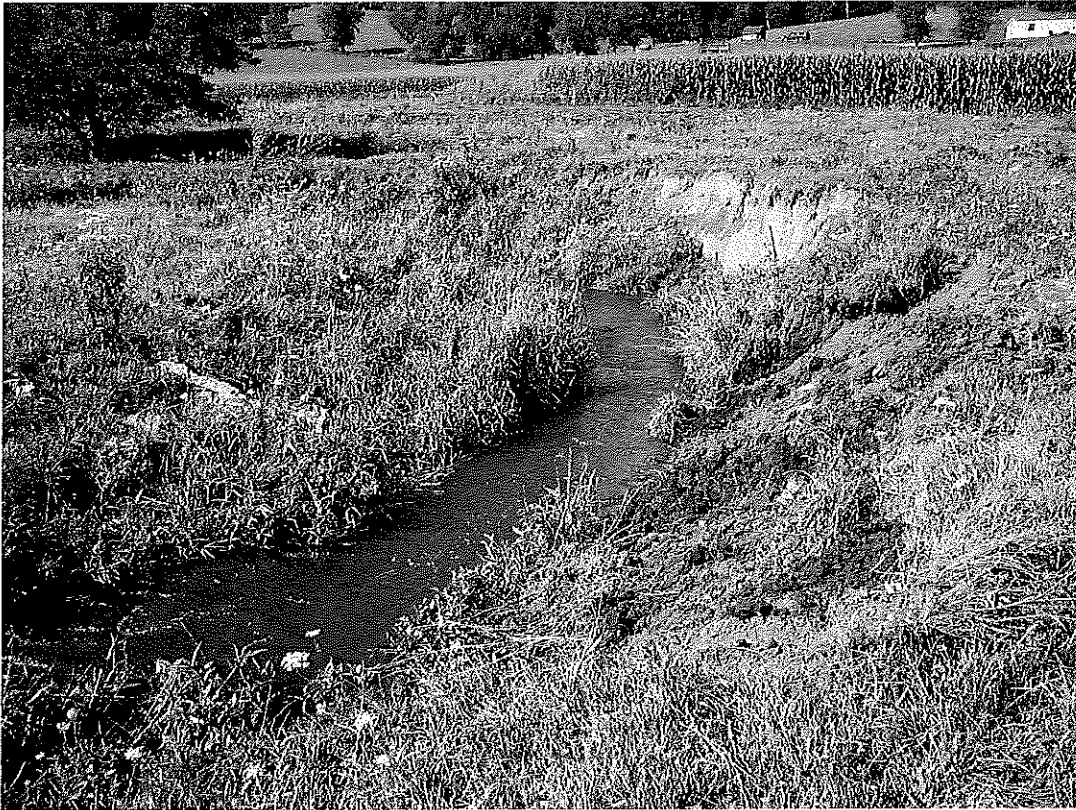
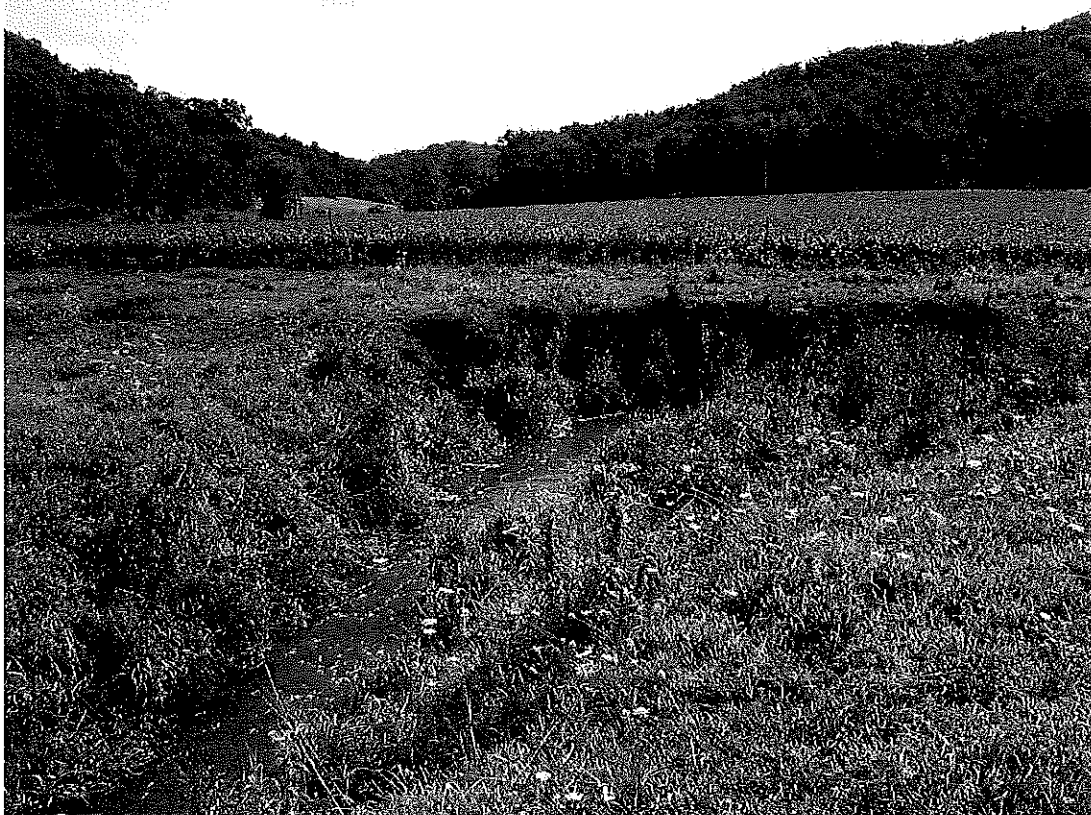
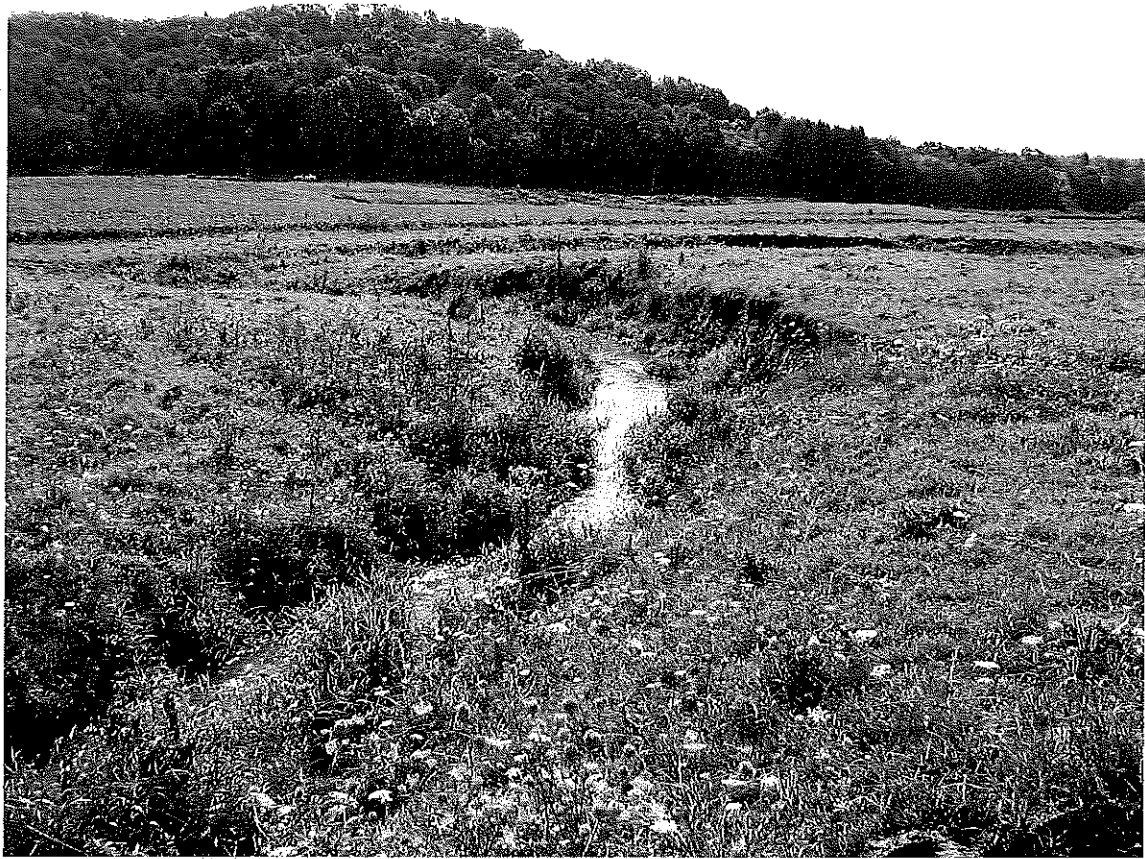
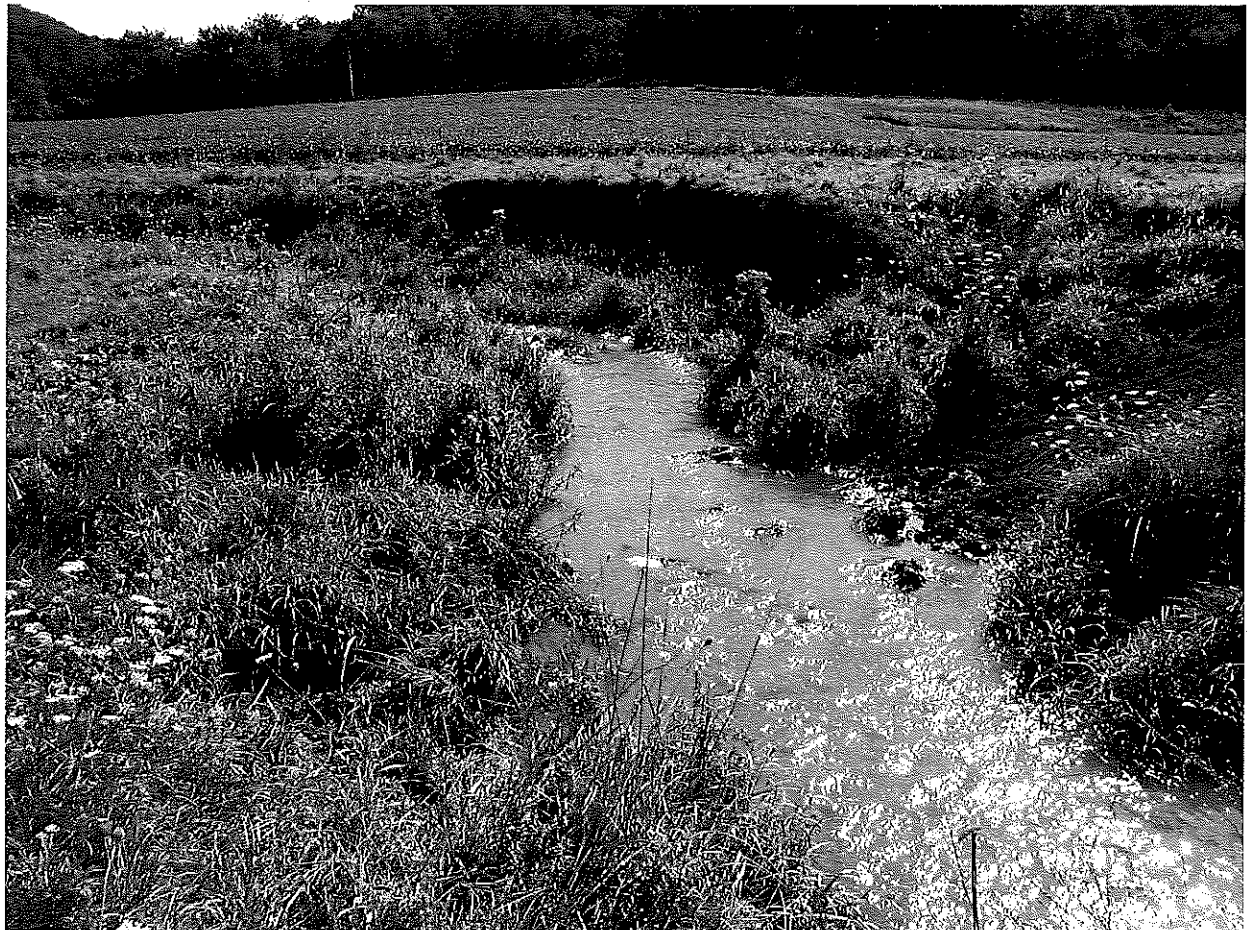
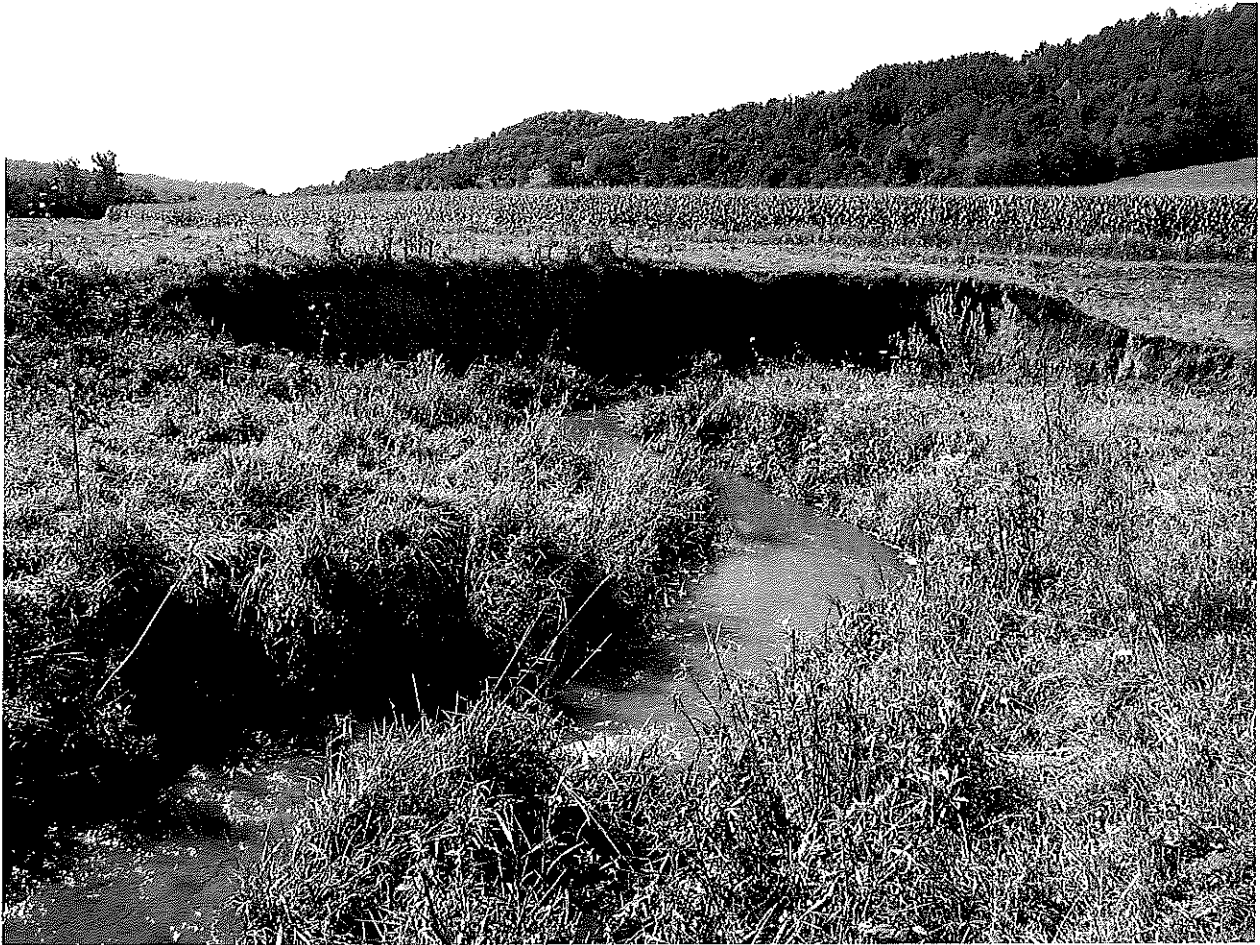
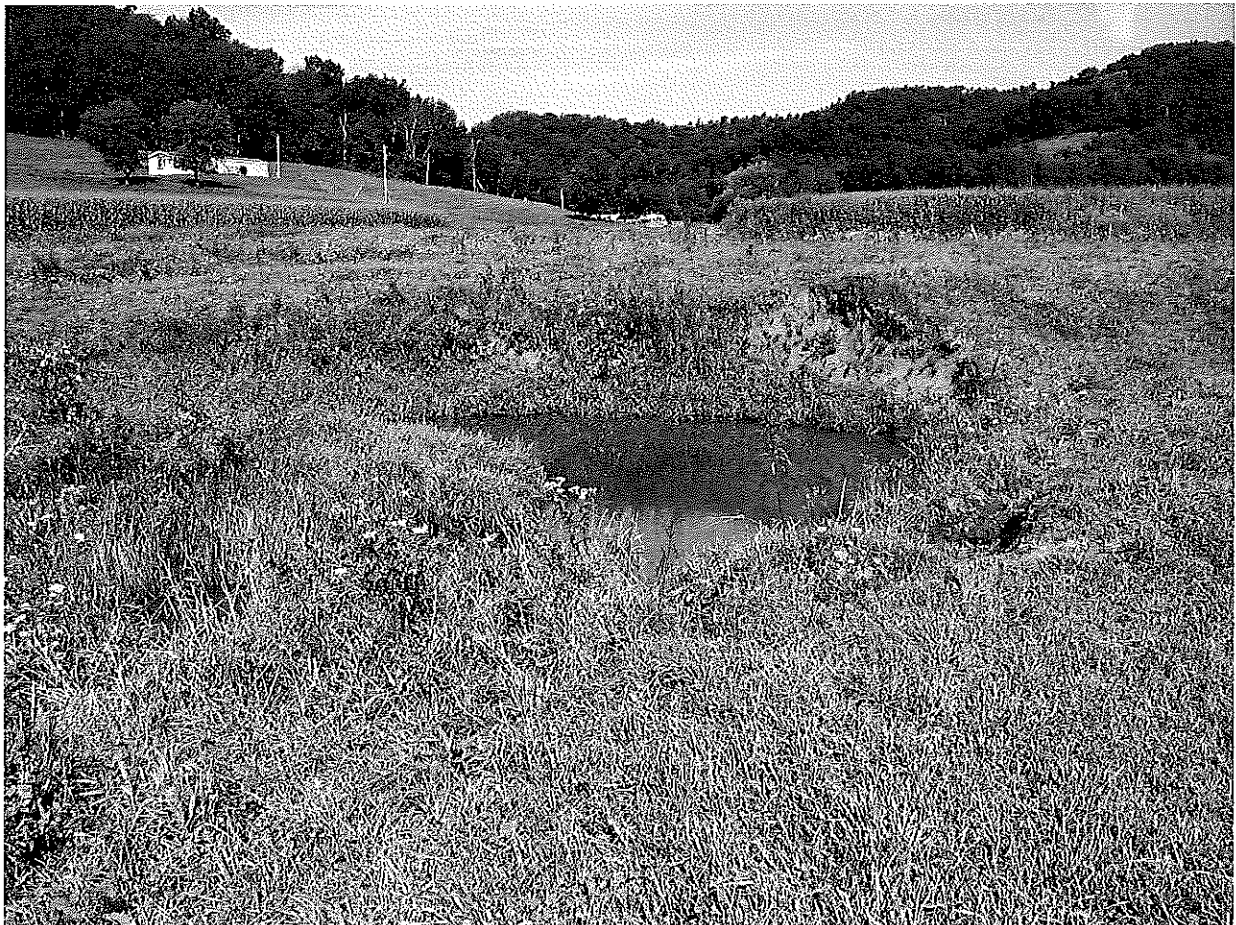
Dale Servais  
Some of Rip Rap sites Before

Summary of Results - 2							
Best Management Practice Installed		Quantity	Unit of Measure	Performance Standard/Prohibition Addressed	Total Installation Cost	Load Reduction Phosphorus lbs/yr    Nitrogen lbs/yr    Sediment Tons/yr	
Streambank/Shoreline Rip-Rapping		2,400	Feet	Code(s) 13			144
Site Location Attachment - 2							
Check the box if the required information for the site is attached:							
<input checked="" type="checkbox"/> Photos of pre-and post-implementation of BMP(s)				<input checked="" type="checkbox"/> Load reduction modeling documents			
<input checked="" type="checkbox"/> Aerial photo map of site with BMPs labeled				<input type="checkbox"/> Water quality monitoring results/summary, if applicable			
Site Information - 2							
<i>Narrative space will expand to fit</i>							
Erosion on the streambank was adding sediment to Little Willow and degrading habitat. Habitat degradation by sediment is one of the impairments of Little Willow. The sites that were rip rapped were the sites contributing the most sediment. Habitat work was also added to the site such as rock weirs and half logs.

$$\frac{2400 \text{ lin. ft.} \times 3 \text{ ft.} \times 0.4 \text{ ft./yr} \times 100 \text{ pcf}}{2000 \text{ lbs/ton}} = 144 \text{ ton/yr}$$

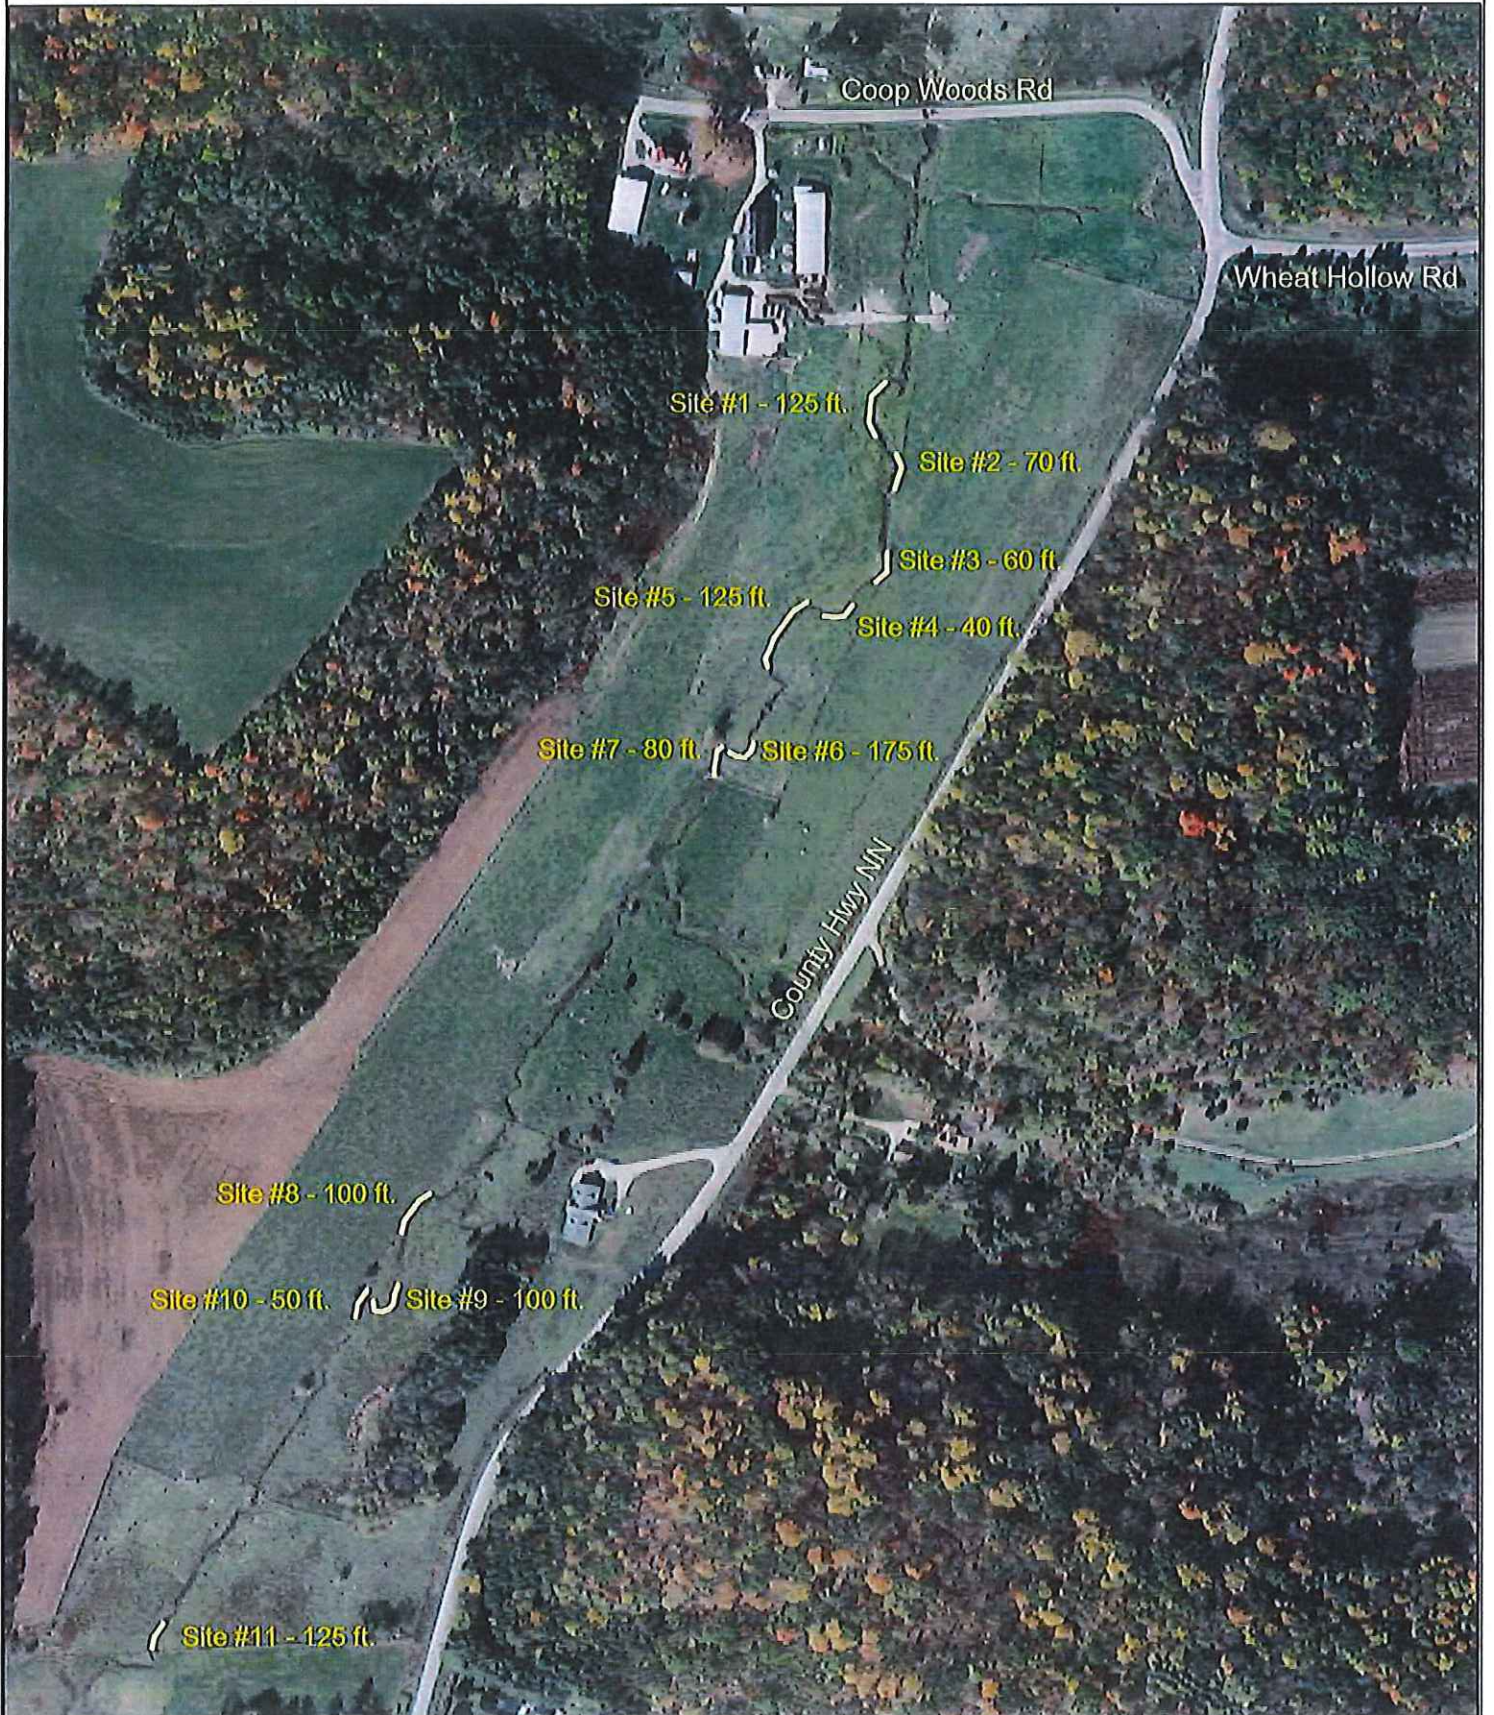
# Rip Rap Sites

Location:  
Richland County, WI  
Willow (T10N-R2E) Section 19

Owners  
Ed & Colleen Uhlenhake

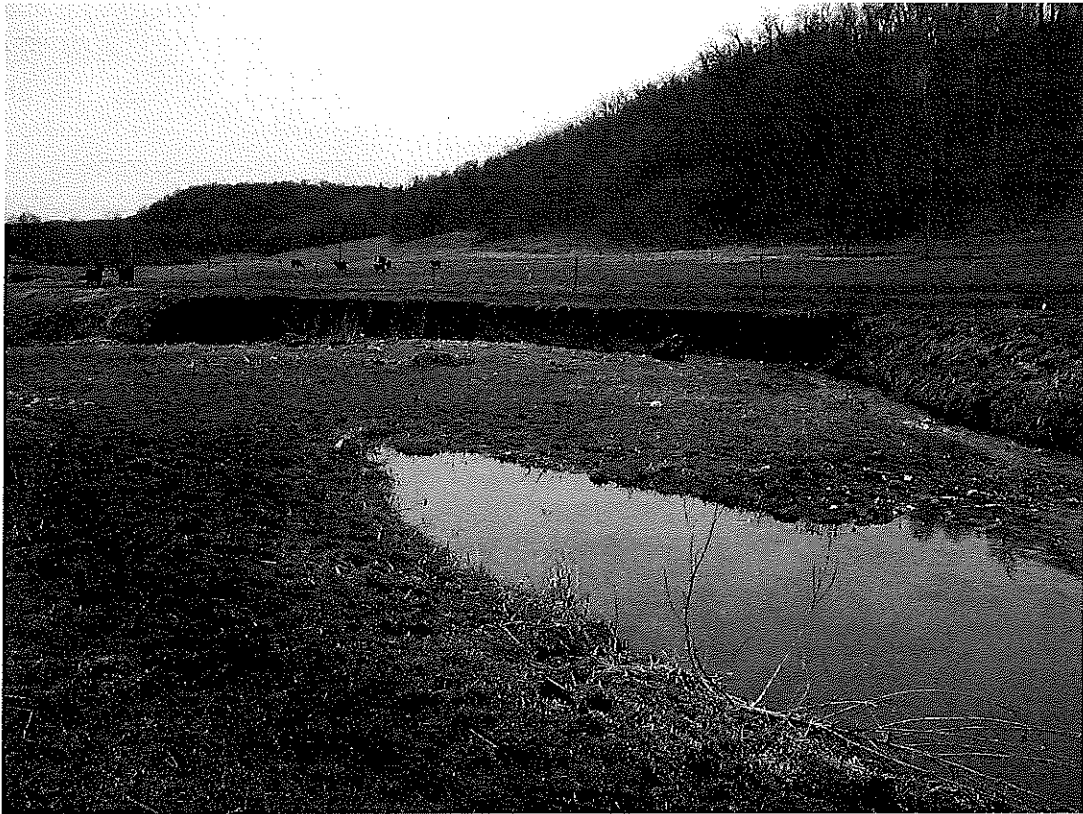
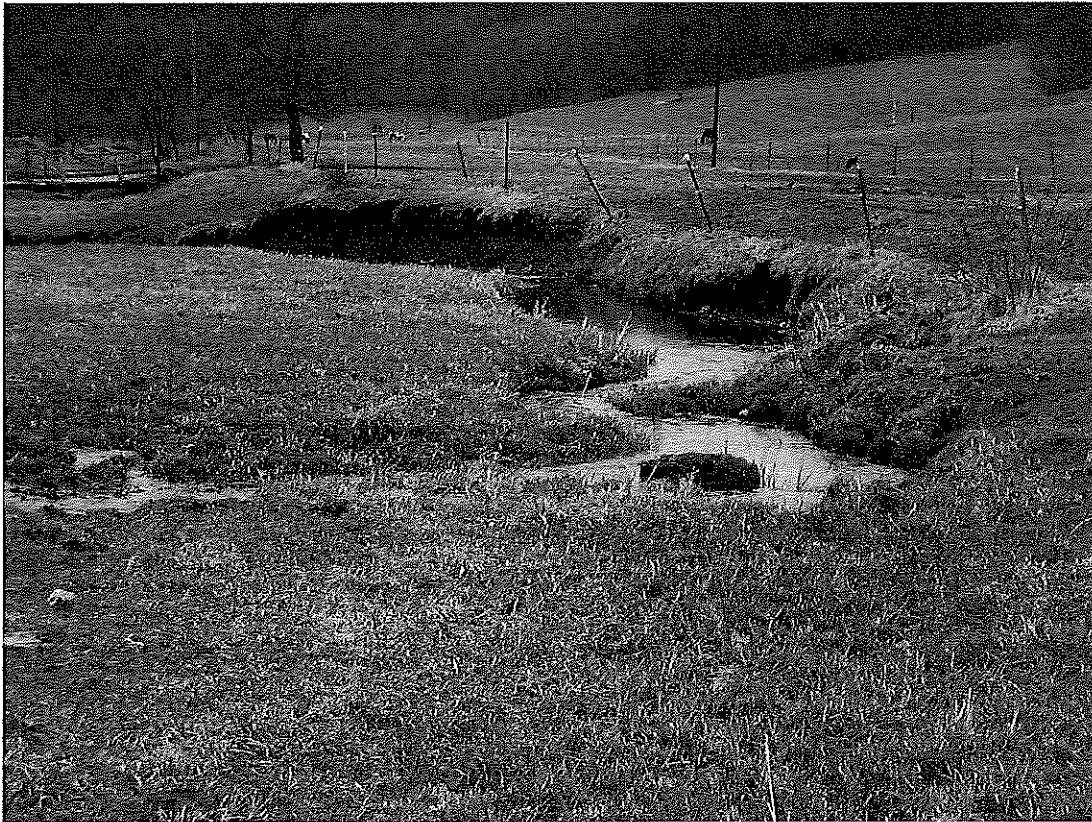
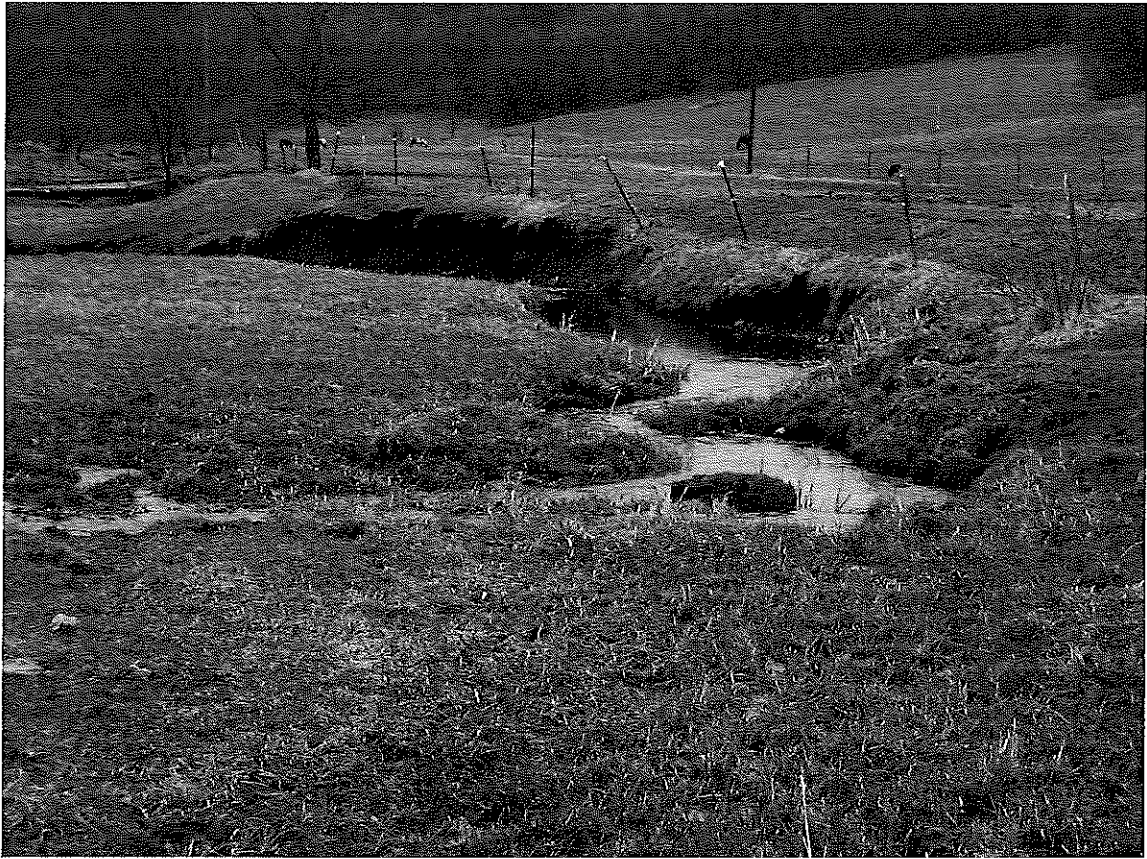
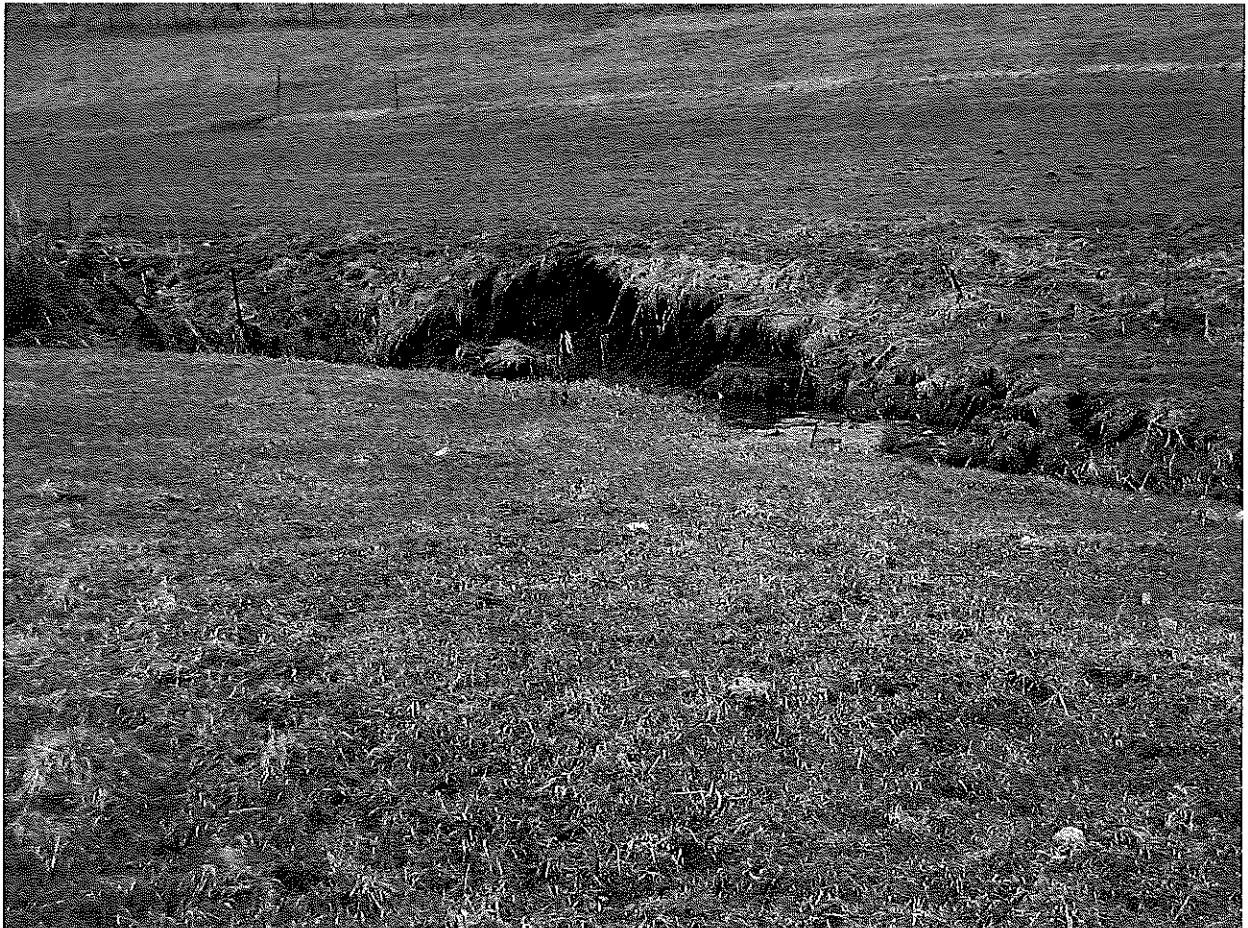
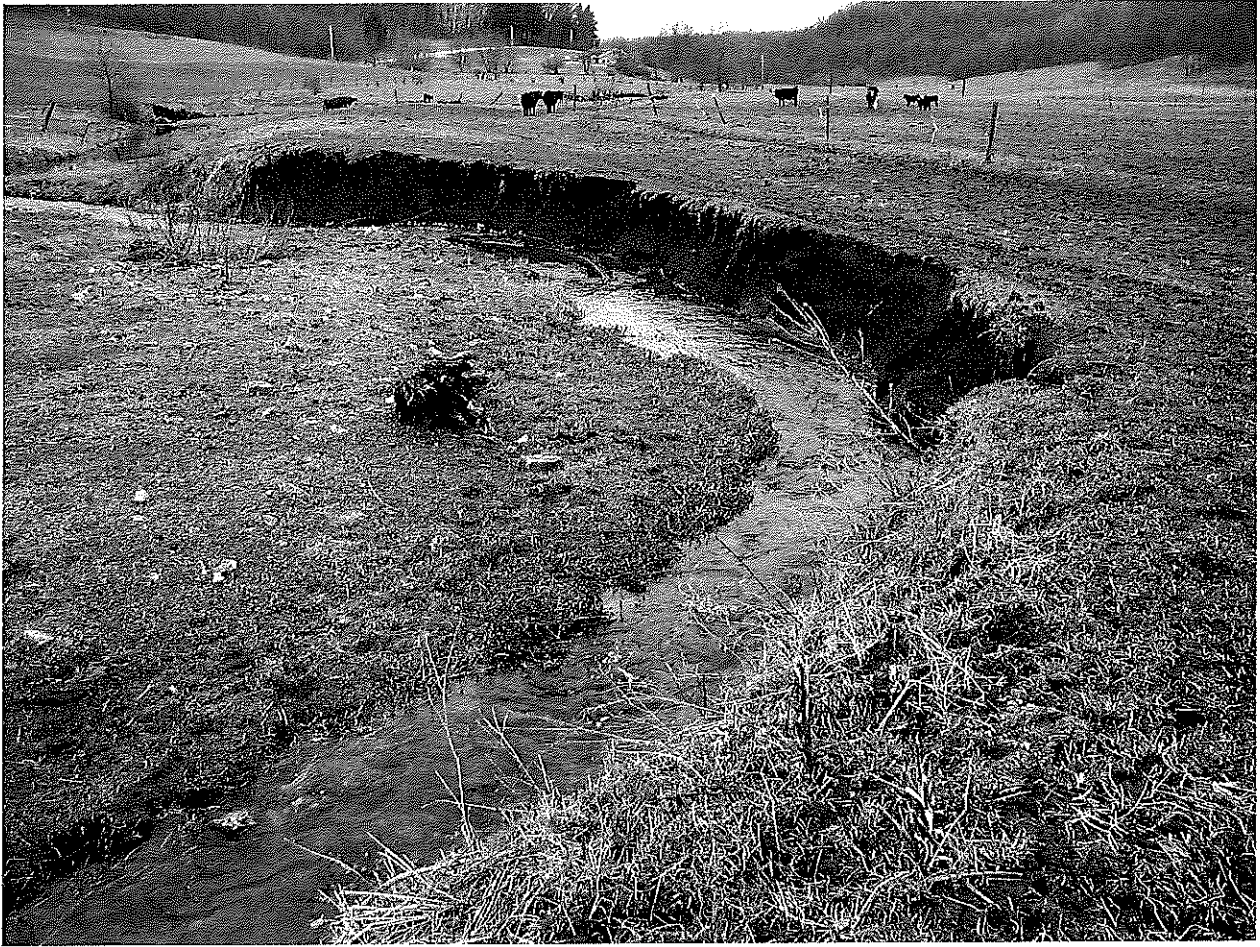
Ed Uhlenhake  
Some of Rip Rap sites Before

Site Information - 1
<i>Narrative space will expand to fit</i> Erosion on the streambank was adding sediment to Little Willow and degrading habitat. Habitat degradation by sediment is one of the impairments of Little Willow. The sites that were rip rapped were the sites contributing the most sediment. Habitat work was completed on the site including rock weirs and half logs. The Southeast Chapter of Trout Unlimited paid for part of the costs as Uhlenhakes signed a public fishing easement with the county.
<input checked="" type="checkbox"/> DNR may use this site as a success story to meet state and federal reporting needs.

$$\frac{1050 \text{ lin. ft.} \times 3 \text{ ft.} \times 0.4 \text{ ft./yr} \times 100 \text{ pcf}}{2000 \text{ lbs/ton}} = 63 \text{ ton/yr}$$
