**Final Report**

Grant Type		
Select Grant Type Large Scale Total Maximum Daily Load (TMDL)		
Project Name & Location		
Project Name Little Willow Creek Large Scale TMDL		
Grant Number TMD-L/LW12-52000	TMD-L/LW12-52000-14	Governmental Unit Name Richland County Land Conservation Department
County Richland	Watershed Name Middle Willow Creek	12-Digit HUC 070700051002
Project Contact Name Kenneth Anderson	Phone Number (608) 647-2100	E-mail Address kenneth.anderson@wi.nacdnet.net
<input checked="" type="checkbox"/> For a project with multiple site locations, an aerial photo map is attached with each site location labeled.

# Rip Rap Sites

# Stream Improvement

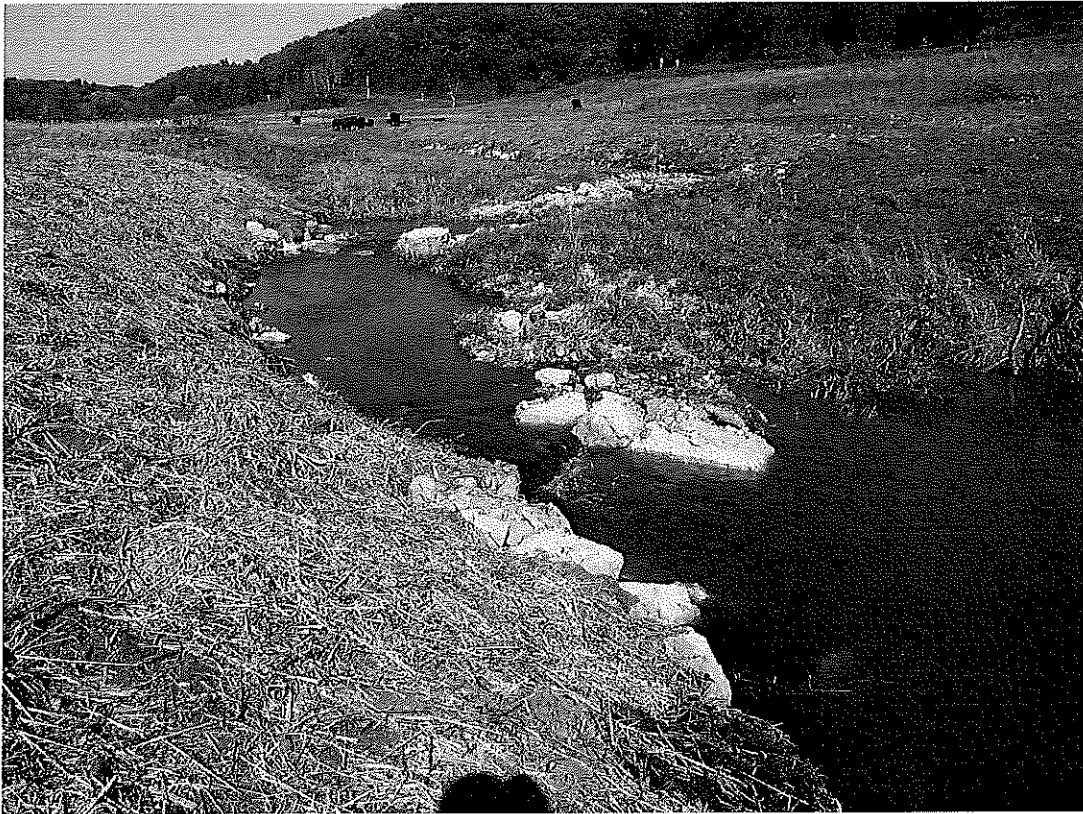
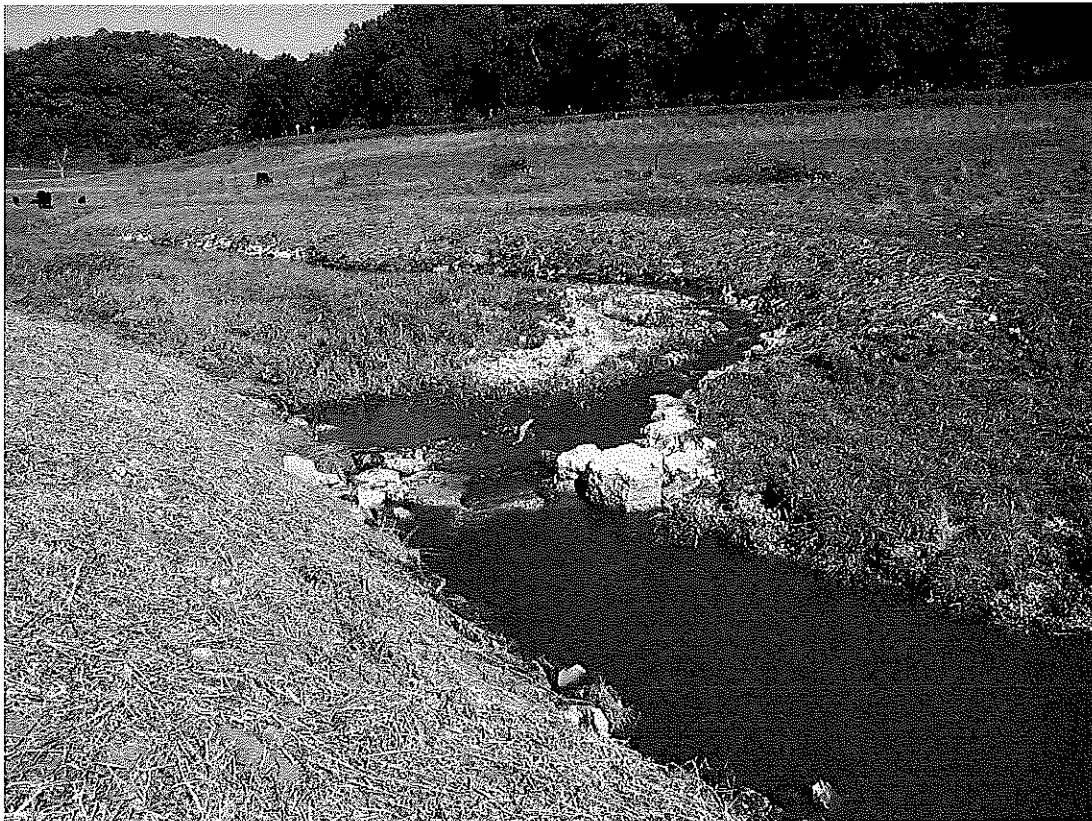
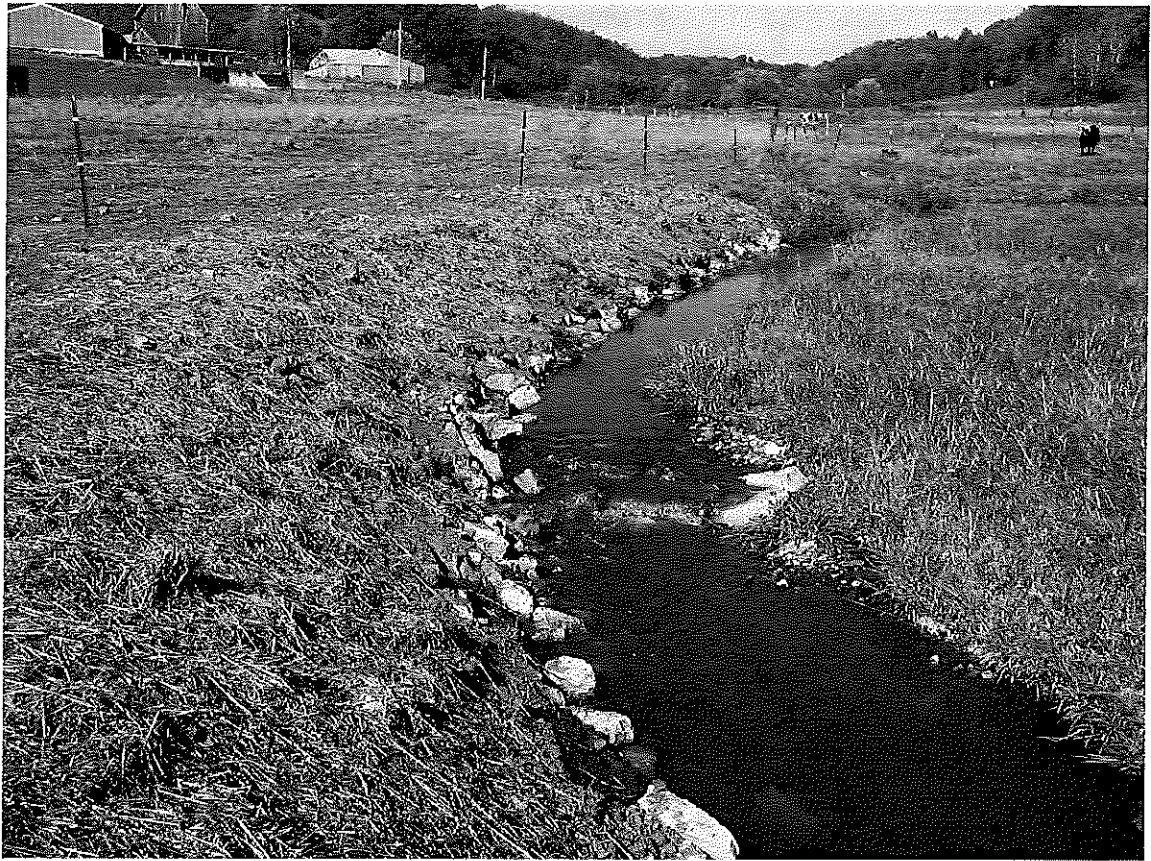
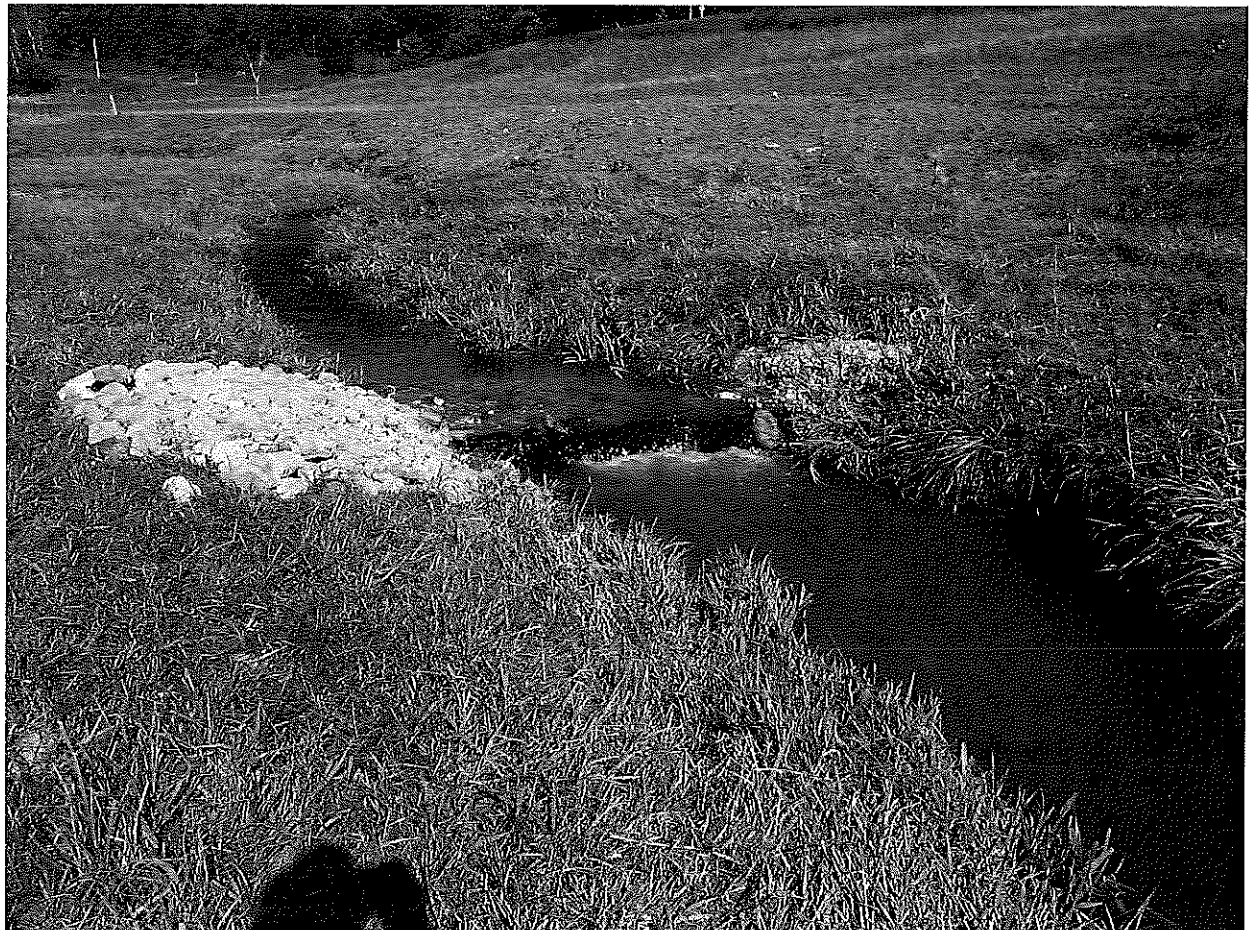
Ed Uhlenhake  
Some of Rip Rap sites After

Summary of Results - 1							
Best Management Practice Installed	Quantity	Unit of Measure	Performance Standard/Prohibition Addressed	Total Installation Cost	Load Reduction		
					Phosphorus lbs/yr	Nitrogen lbs/yr	Sediment Tons/yr
Streambank/Shoreline Rip-Rapping	1,050	Feet	Code(s) 13	\$25,500.00			63
