Lake Management Plans for Crooked Lake, Bass Lake, and Gilkey Lake, Oconto County, Wisconsin

June 1995

Prepared by:
Steve McComas
Jo Stuckert
Blue Water Science
St. Paul, Minnesota
612.690.9602

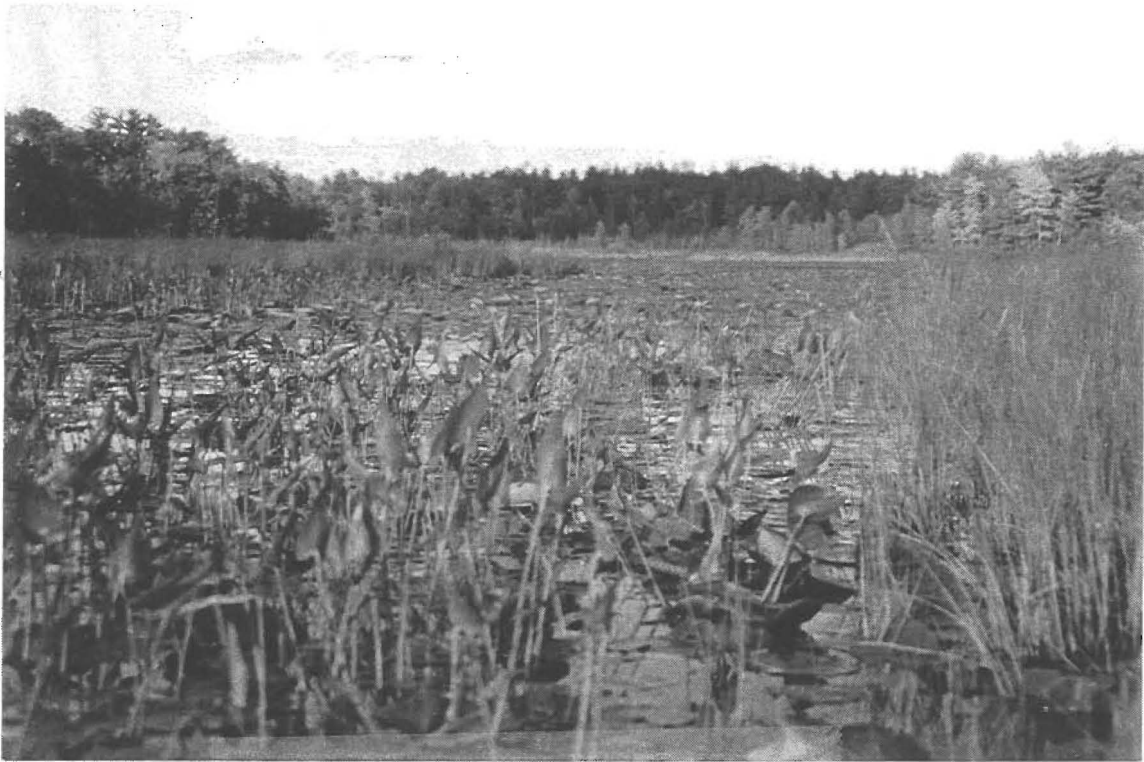
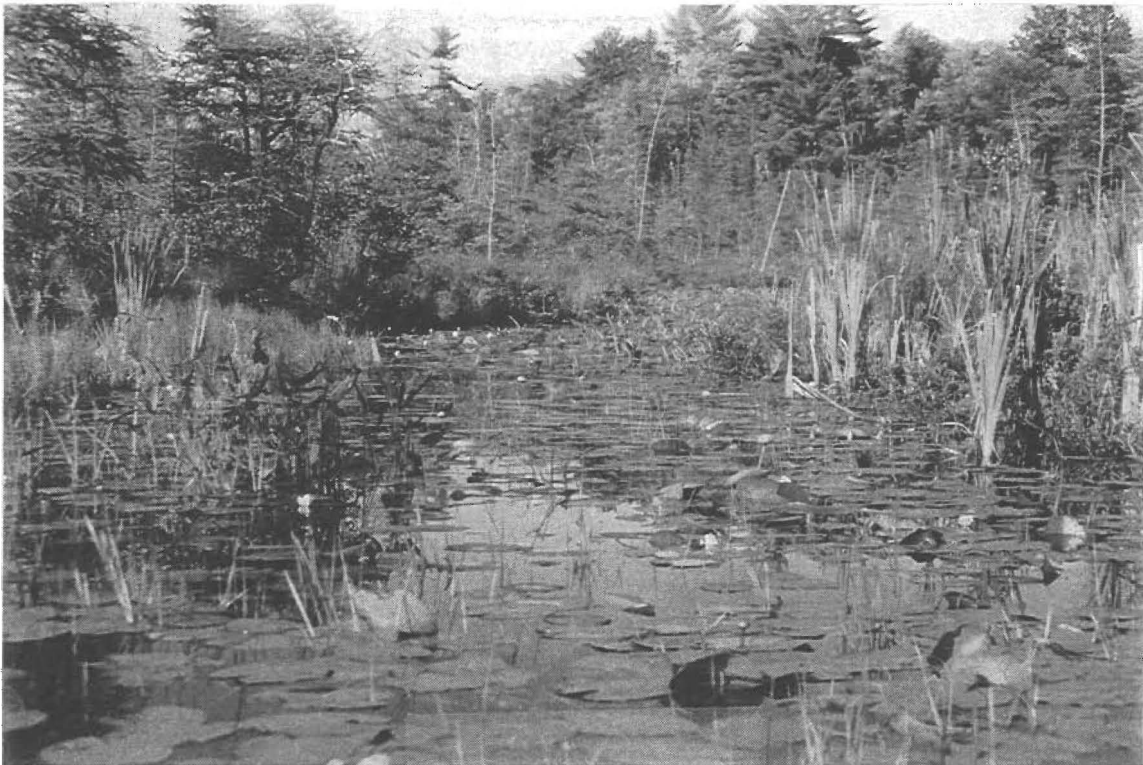
Figure 5. Both pictures show the outlet area of North Crooked Lake, before the dam. We tried to find the incoming stream for subwatershed 1, and the bottom picture shows it. This water input does not seem to impact Crooked Lake, it heads right to the dam.

The watershed for Crooked Lake was delineated using U.S.G.S. 7.5 minute quadrangle maps (Figure 4). Subwatershed acres are shown below in Table 1. Drainage to Crooked Lake is complicated. For example, in subwatershed 1 (Figure 4) the drainage is at the extreme end of Crooked Lake near the outlet. A field evaluation hinted that this water inflow would have little impact on the water quality of Crooked Lake, because it probably did not circulate into the main body of the lake. We did not include drainage from this subwatershed as part of the Crooked Lake watershed (Figure 5 shows this inlet area).

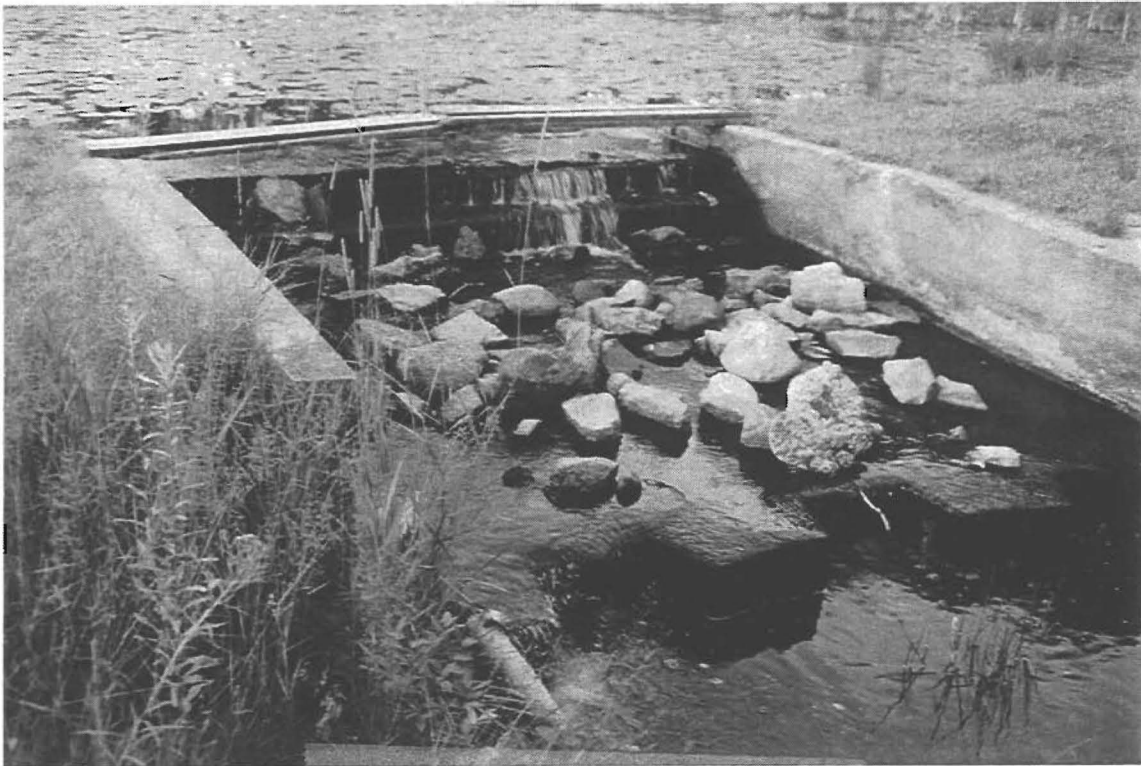
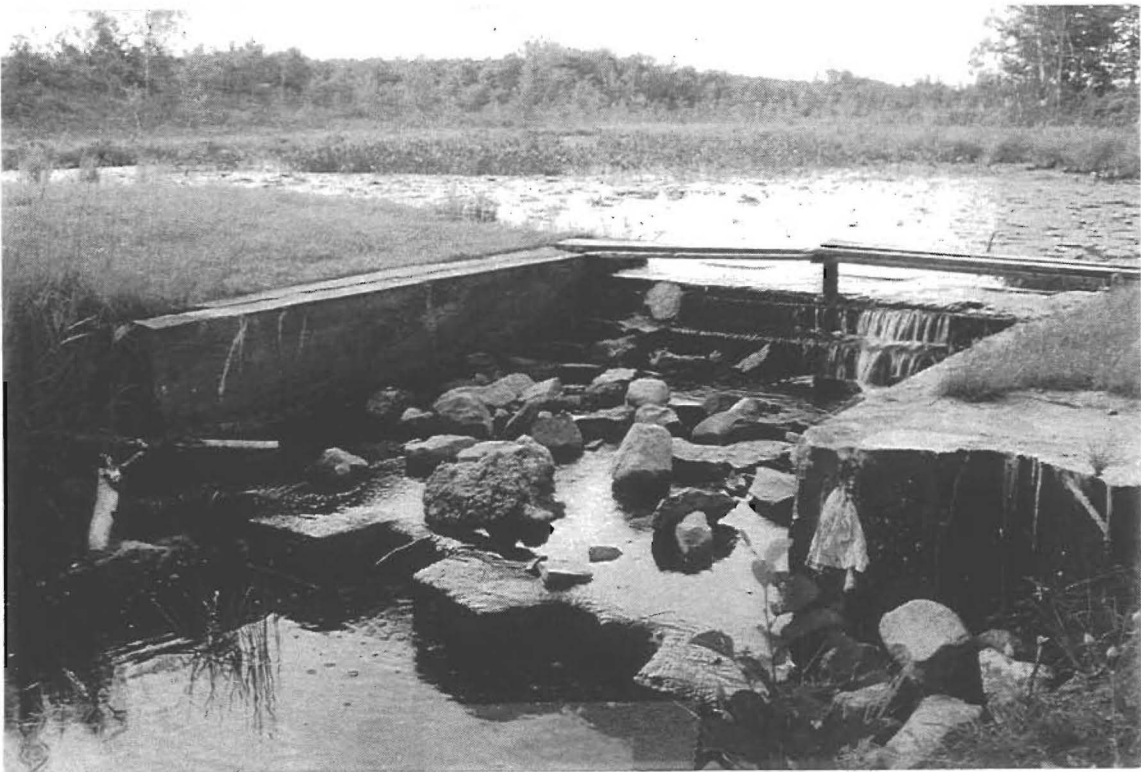
Figure 6. The Crooked Lake Dam. Accessible from Tar Dam Road.

The outlet for Crooked Lake is controlled by a low head, fixed crest dam (Figure 6).

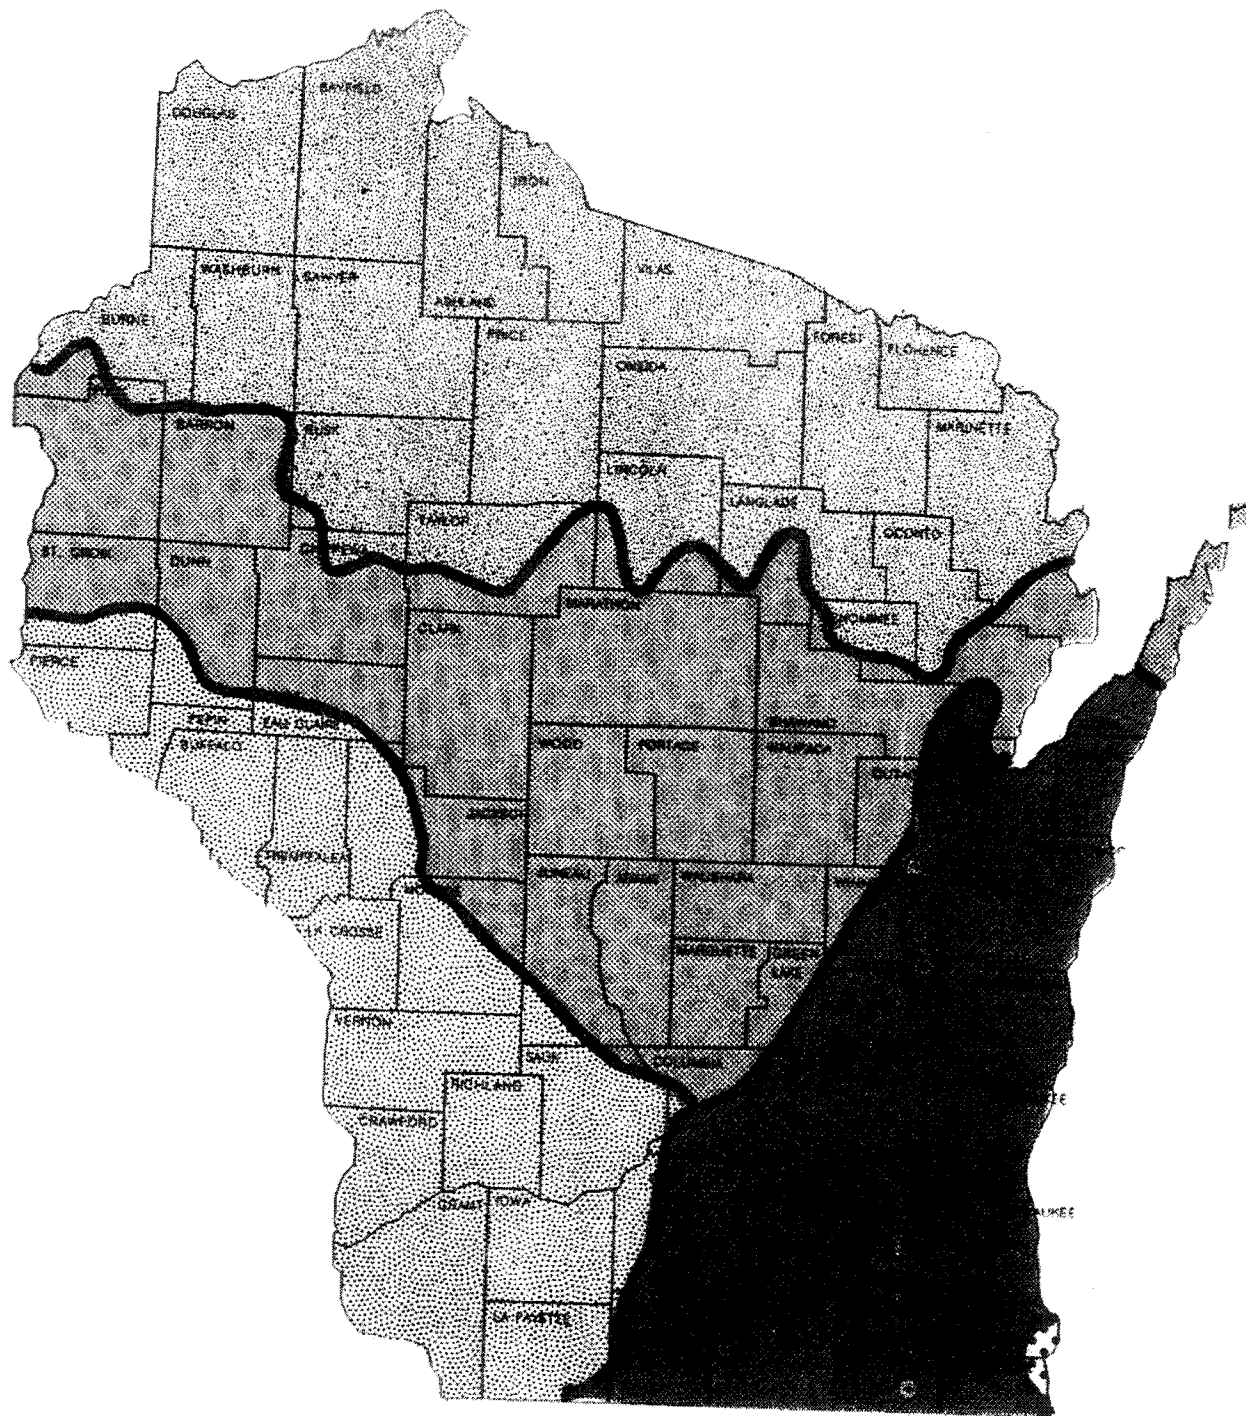
Figure 20. Wisconsin ecoregions.

A map showing the ecoregion area and the Crooked Lakes location is displayed in Figure 20. Phosphorus concentrations were generally less than 20 ppb for Crooked, Bass and Gilkey Lakes.

These comparisons indicate that the Crooked Lakes are in a protection status in terms of water chemistry, meaning no drastic lake or watershed restoration projects are needed. At this point in time the challenge is to keep the lakes in good shape.
