Phase III Lake Study Report

Archibald Lake, Oconto County

Archibald Lake Association Phase III Report

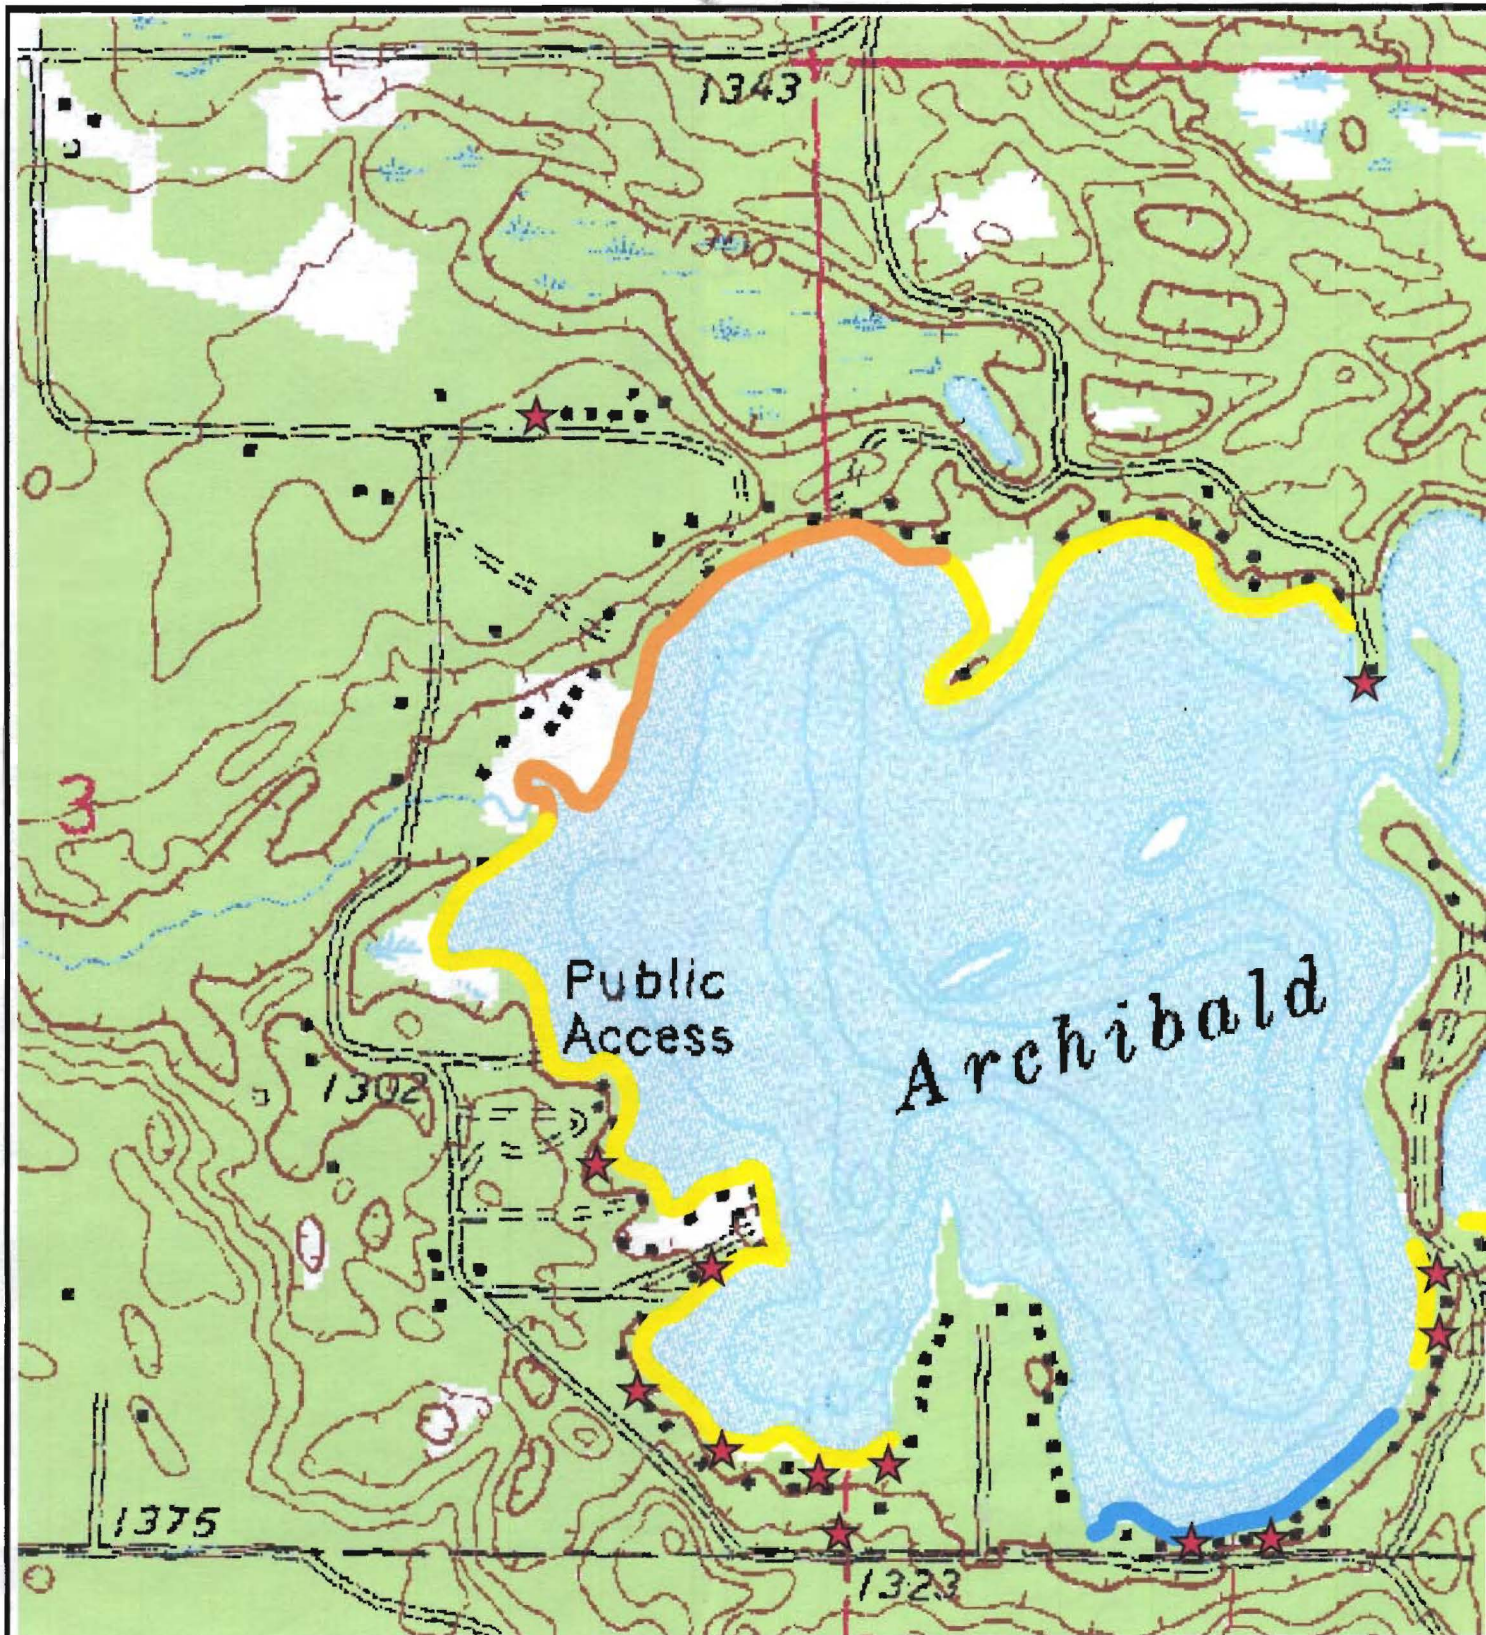
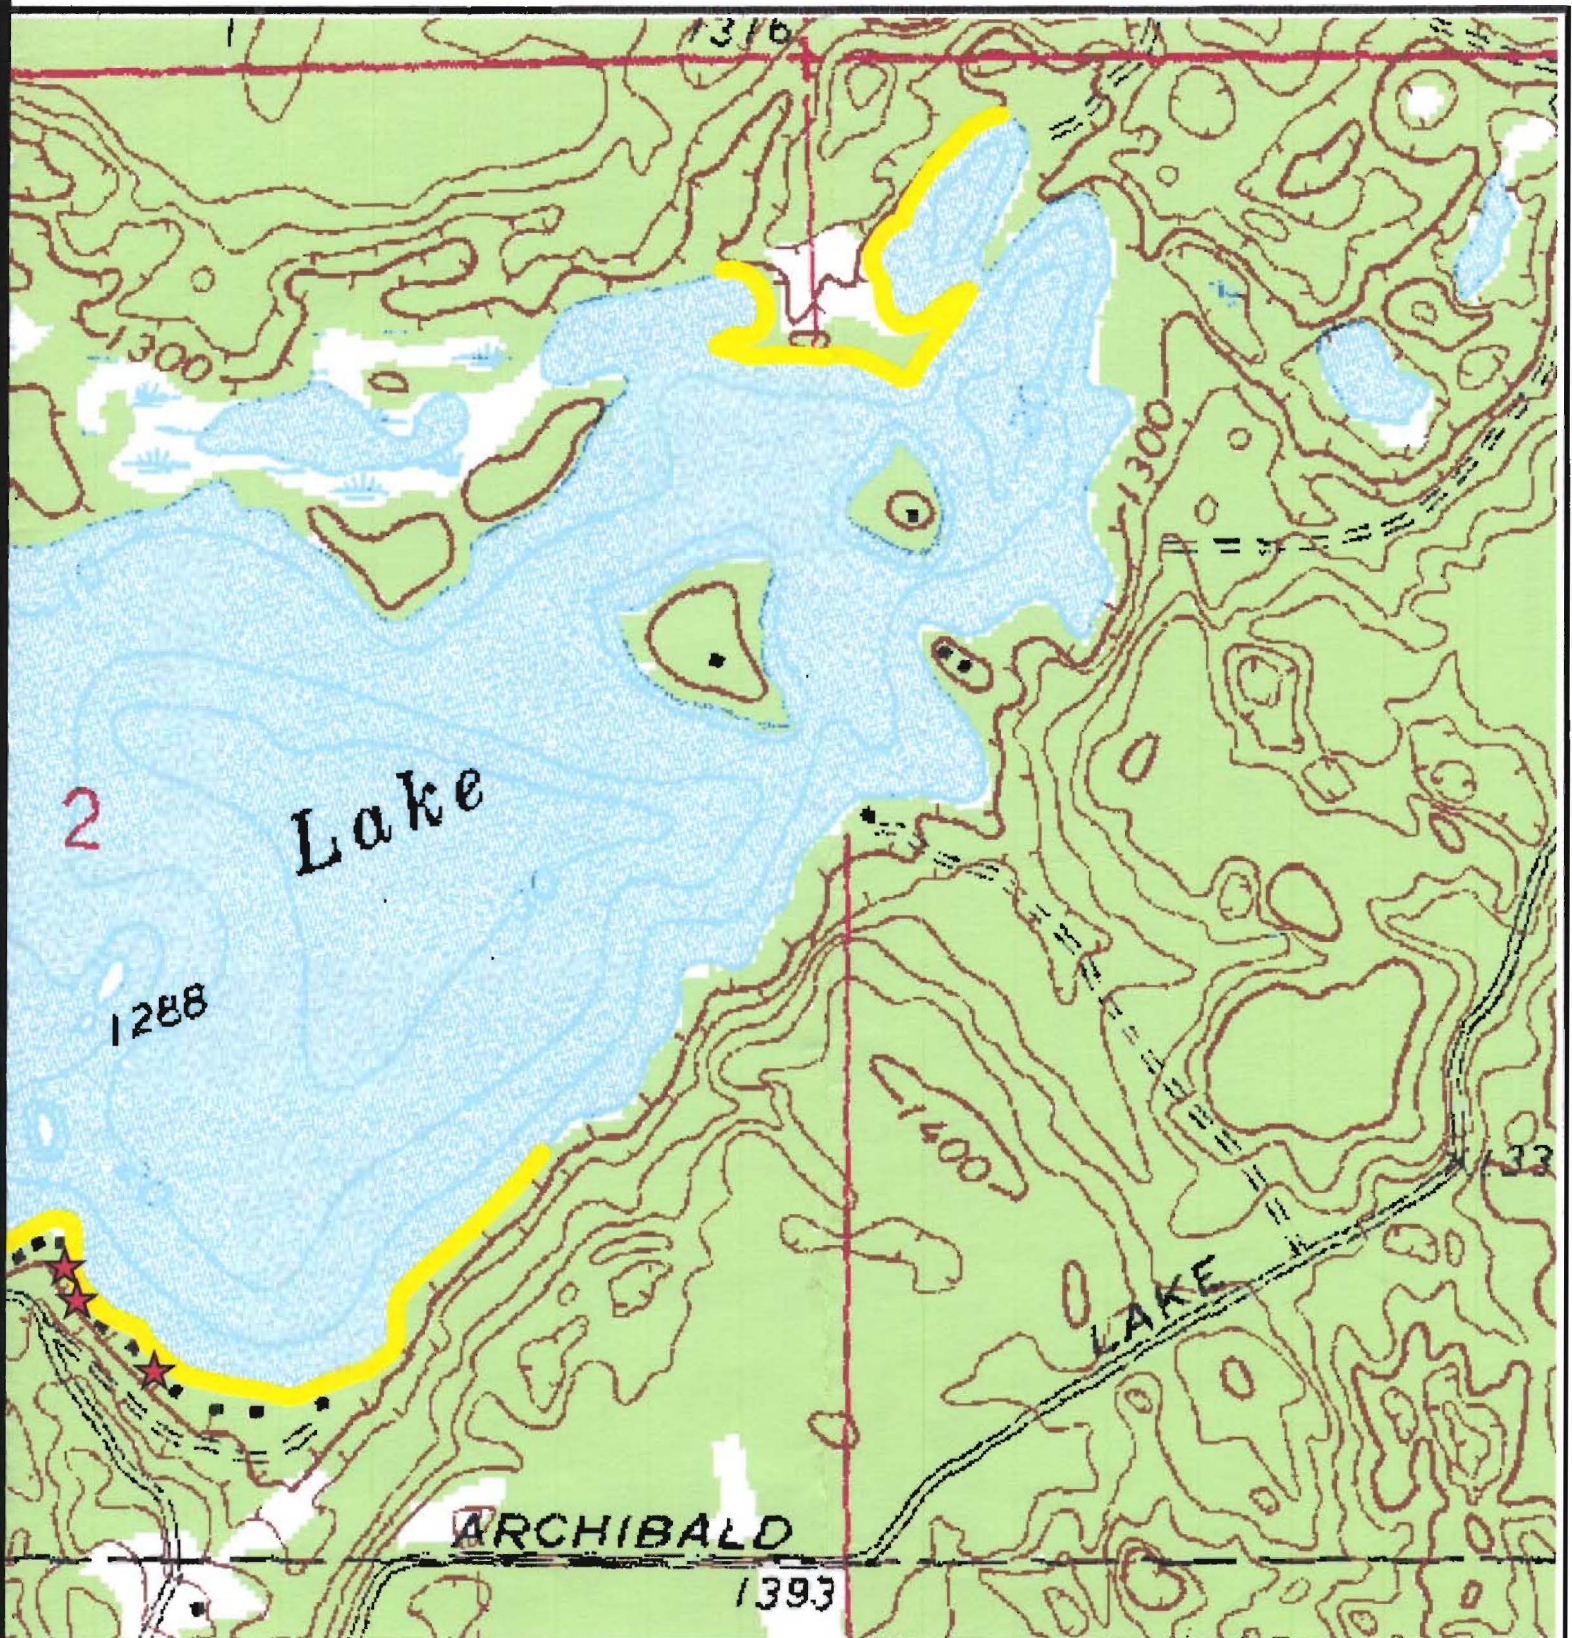
FIGURE 2-1
SEPTIC SYSTEMS EVALUATION

Figure 2-1 shows the location of septic systems with an impact score of nine or less.

★ Septic Systems with an impact score of 9 or less.

— 0% groundwater flow to lake

— Less than 50% groundwater flow to lake

— Greater than 50% groundwater flow to lake

- ◆ Approximately 20 % of the homes around the lake have septic systems that may be contributing nutrients into the lake. These systems typically are 15 years old or more, are within 100 feet of the lake, and are less than 12 feet above the lake level. These systems are predominantly on the south side of the lake.
