2004 Clear Lake Aquatic Plant Survey Technical Report and Management Plan

September 2006

By J. E. Britton¹ and N. D. Strasser²

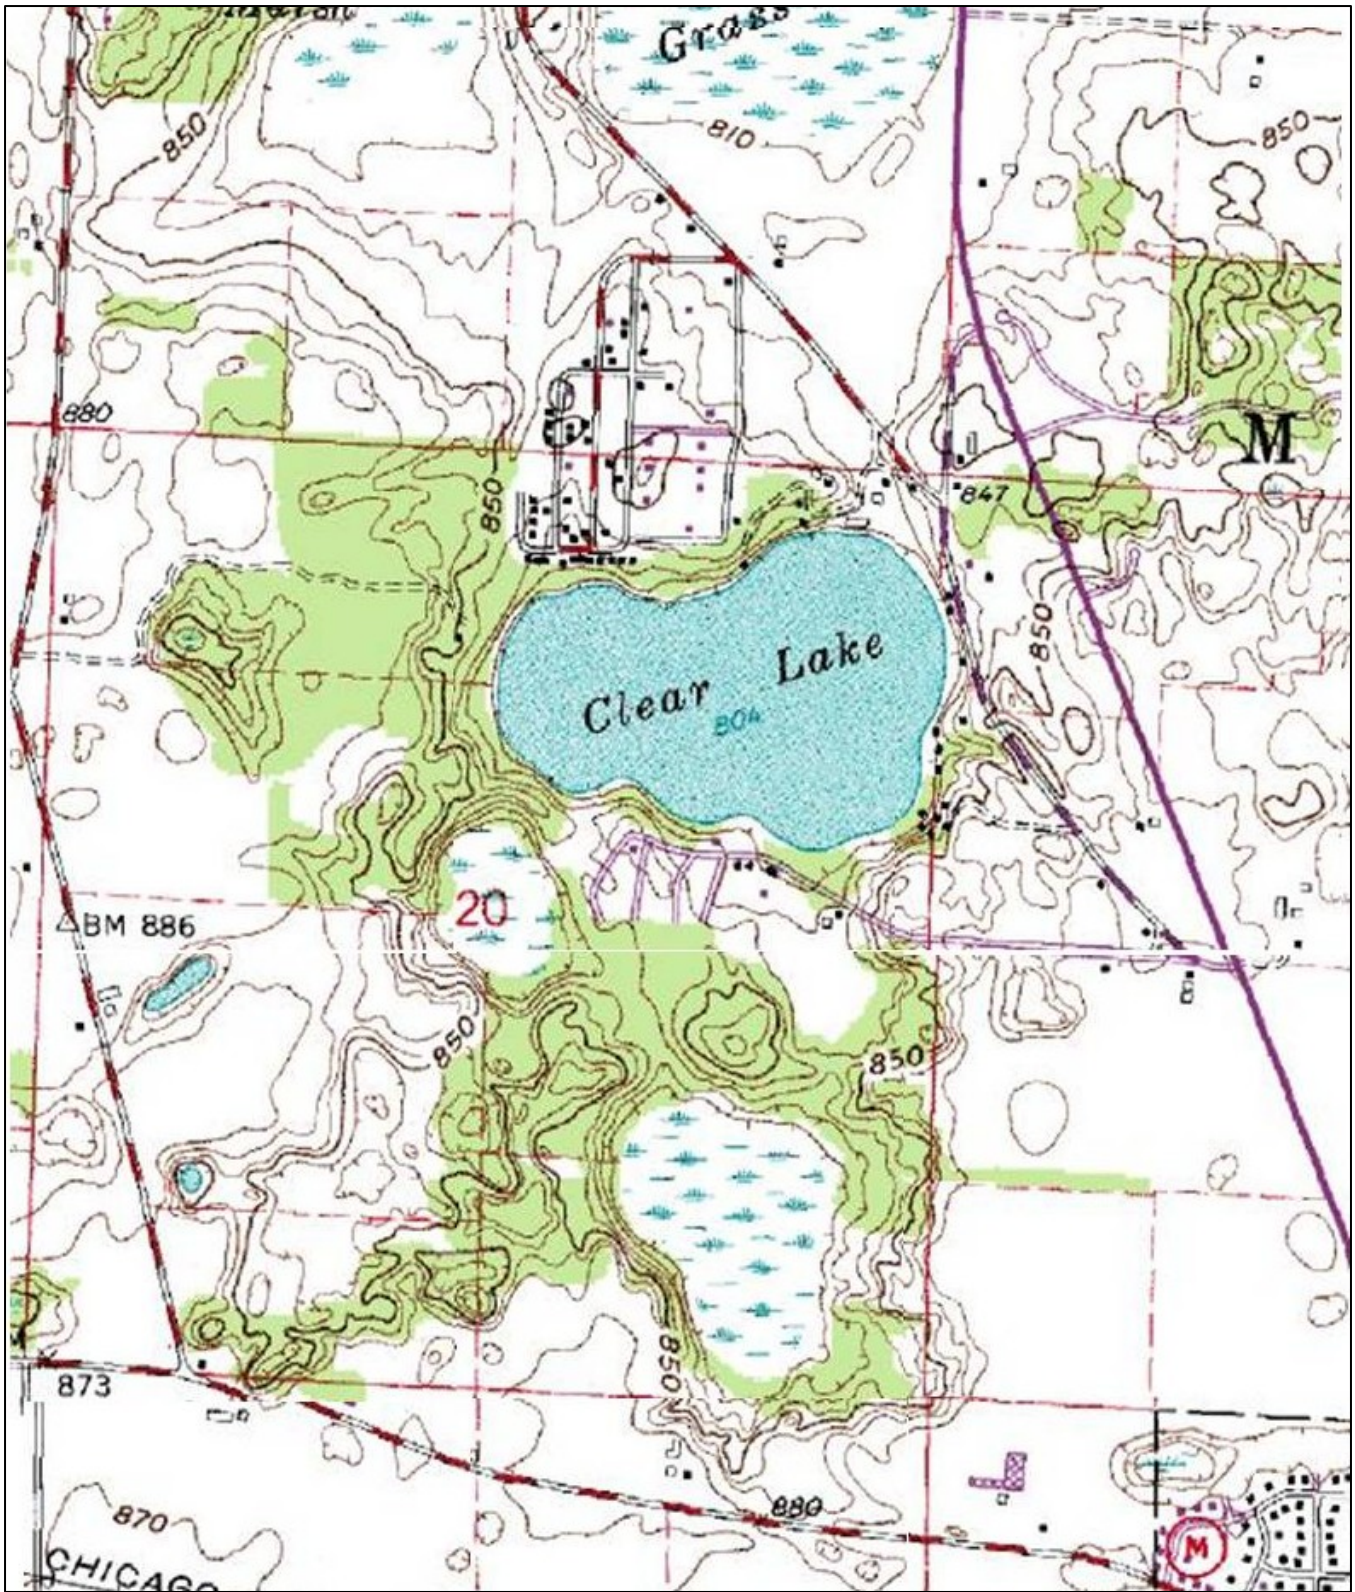
Figure 5. Topography of region surrounding Clear Lake (Rock County, WI.)

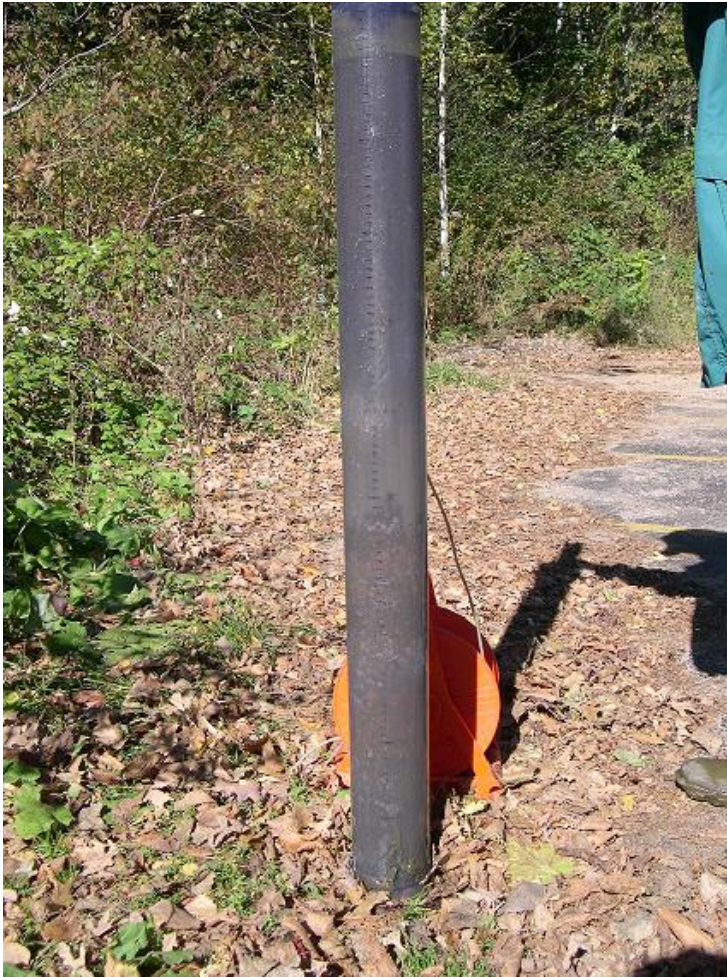
Figure 10. Sediment core sample from Clear Lake (Rock County, Wisconsin) October 4, 2004.

The cleaning methods used by Paul Garrison were: 1) hydrogen peroxide/potassium dichromate, 2) boiling with 10% potassium hydroxide, and 3) nitric acid. It was anticipated that the top sample would represent recent deposition while the deepest sample would have been deposited over 150 years ago.
