***1991 Water Quality Study of  
Nugget Lake  
(Pierce County, Wisconsin)  
Wisconsin Lake Management Project***

***Prepared for  
Nugget Lake County Park  
RR 1 Box 213B  
Plum City, WI***

***March 1993***

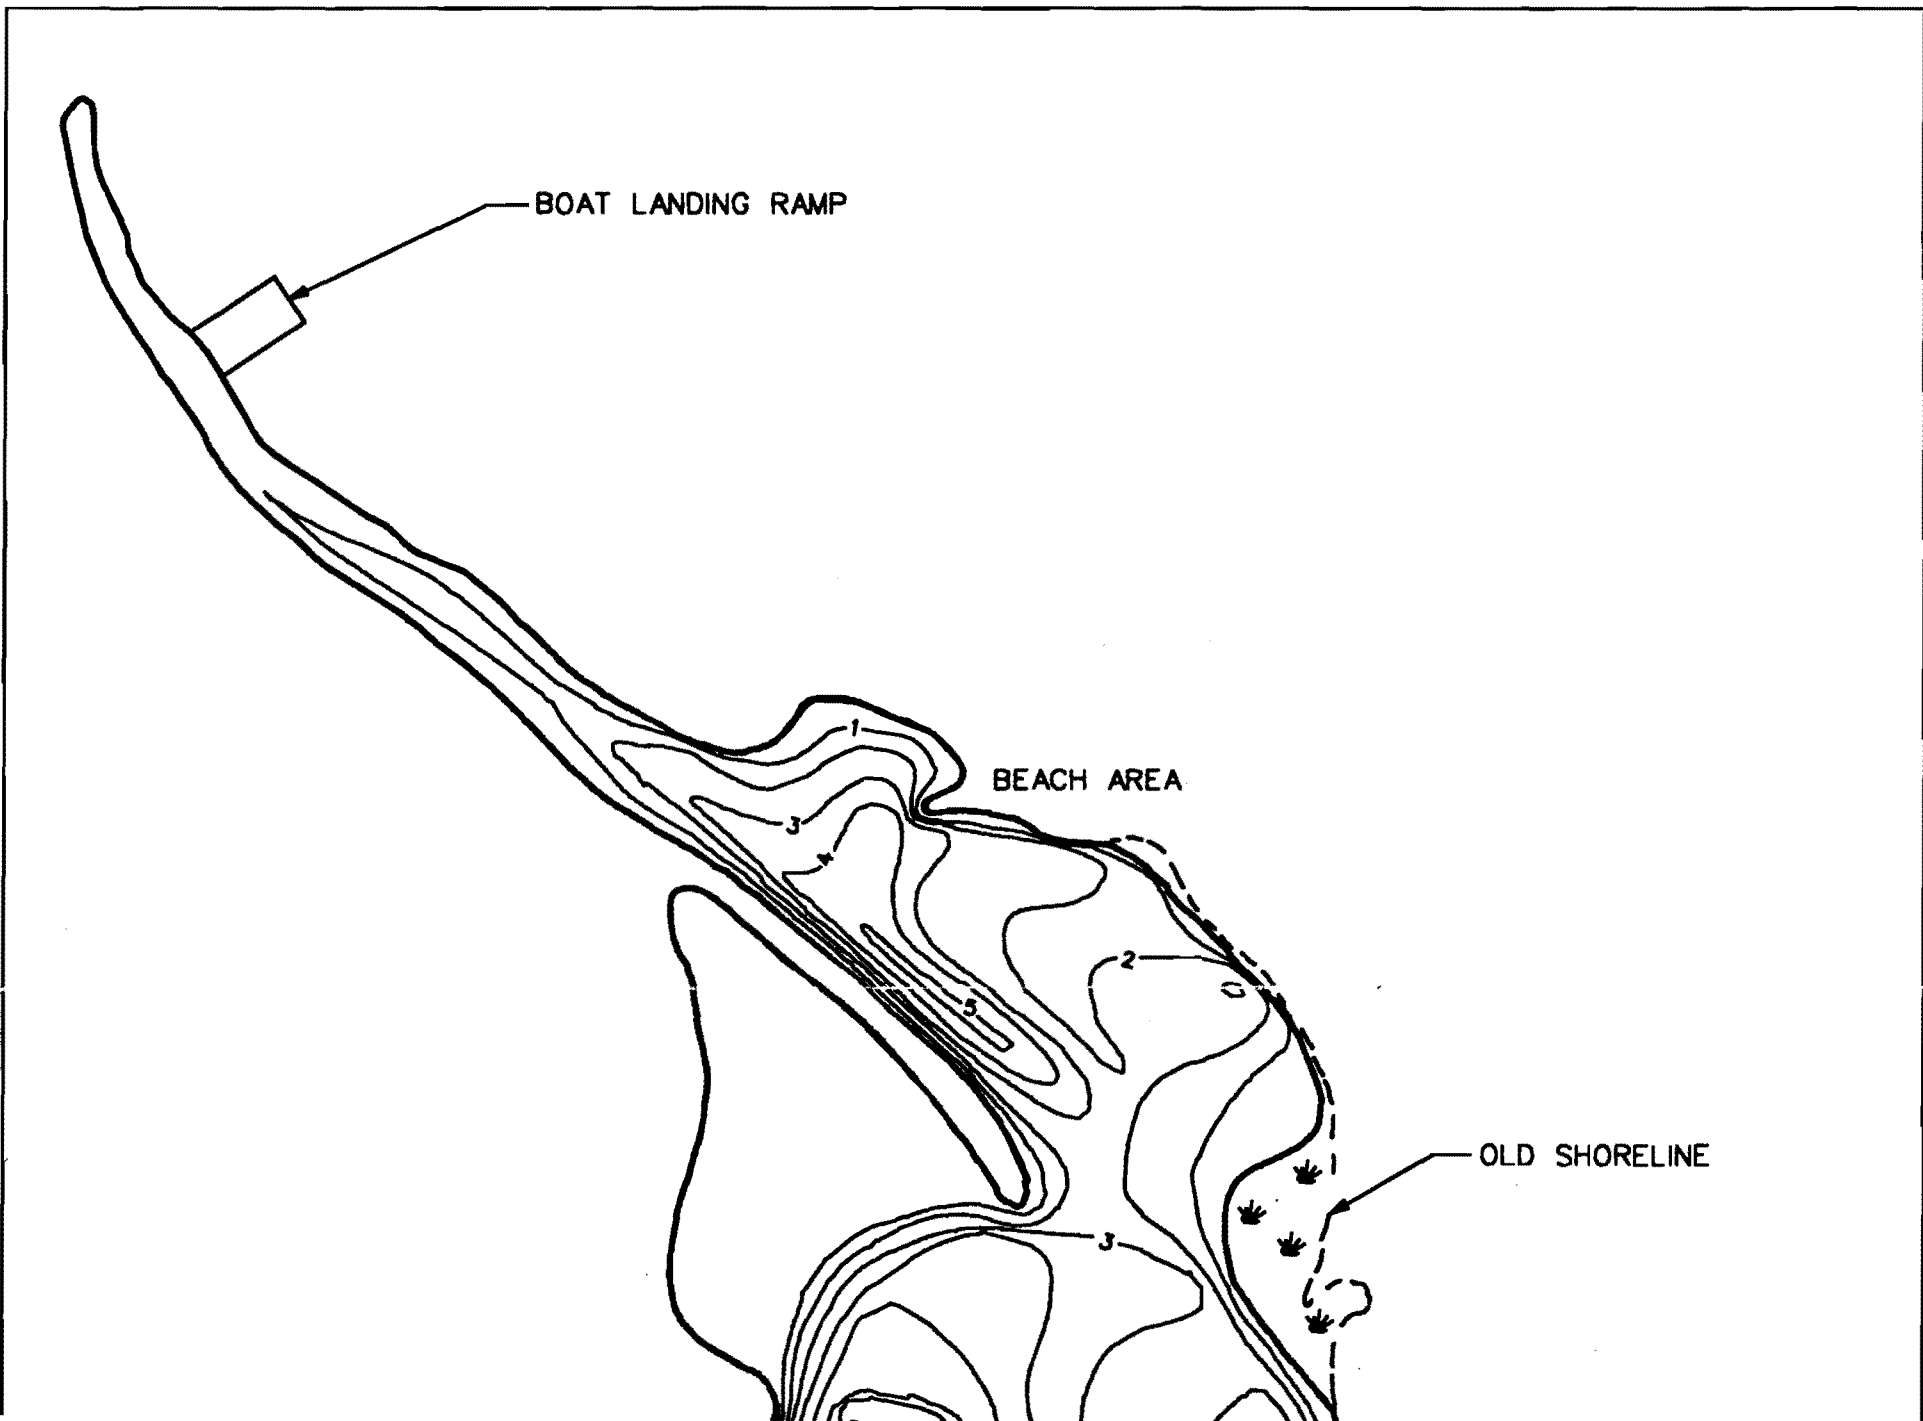
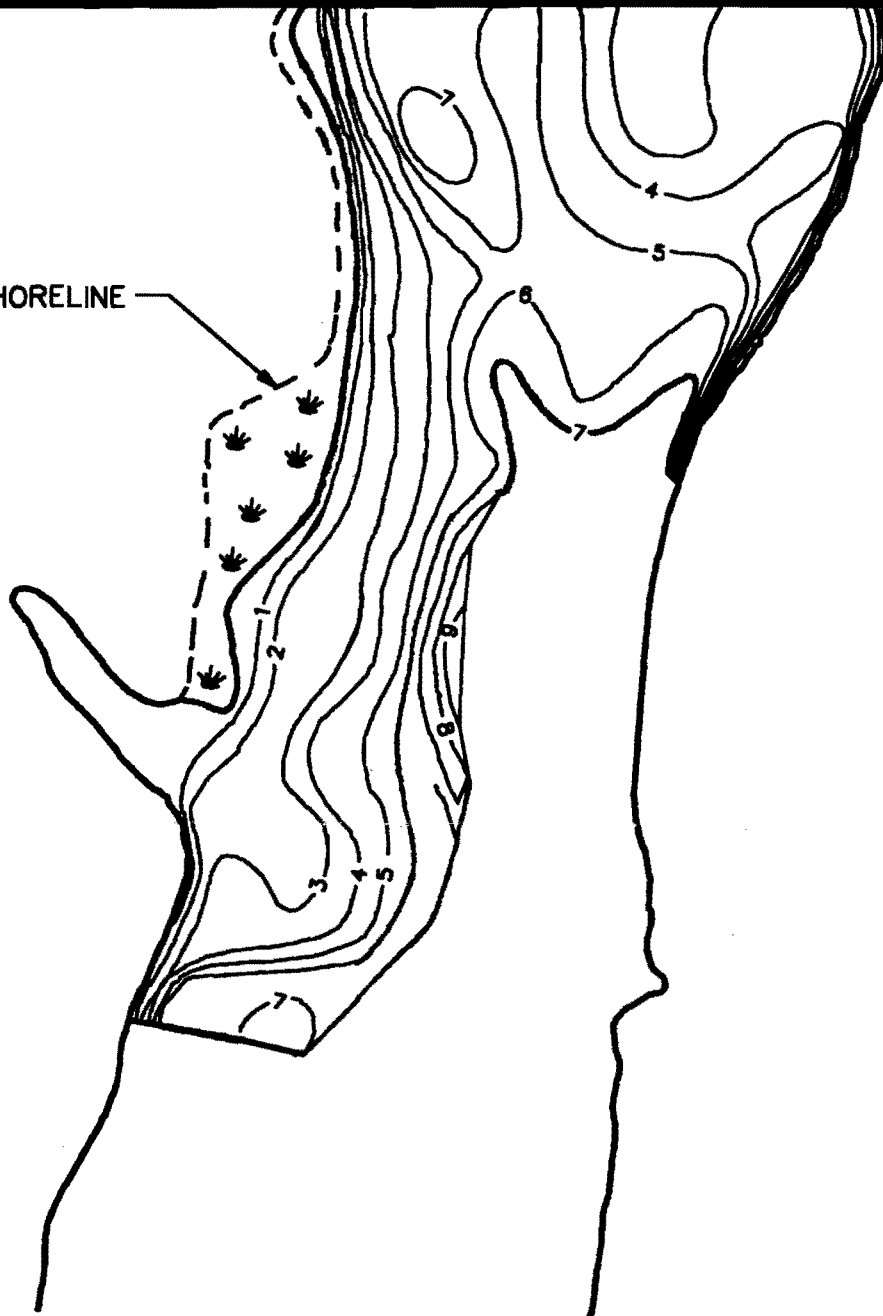
**FIGURE 5**  
1991 NUGGET LAKE BATHYMETRIC MAP  
OF SURVEYED AREA

OLD SHORELINE

SURFACE AREA: 18.88 Acres  
LAKE VOLUME: 57 ACRE - FEET

A change in water volume over time was used to determine the average annual sedimentation rate of Nugget Lake. The water volumes of the northern portion of the lake during 1972 and 1991 were determined from bathymetric maps. The difference in volumes was caused by the addition of sediments to this portion of the lake. Therefore, the water volume difference was also a measurement of the volume of sediment deposited in the lake. The volume of sediment was divided by the 19 years over which deposition occurred to obtain the average annual sedimentation rate of Nugget Lake.

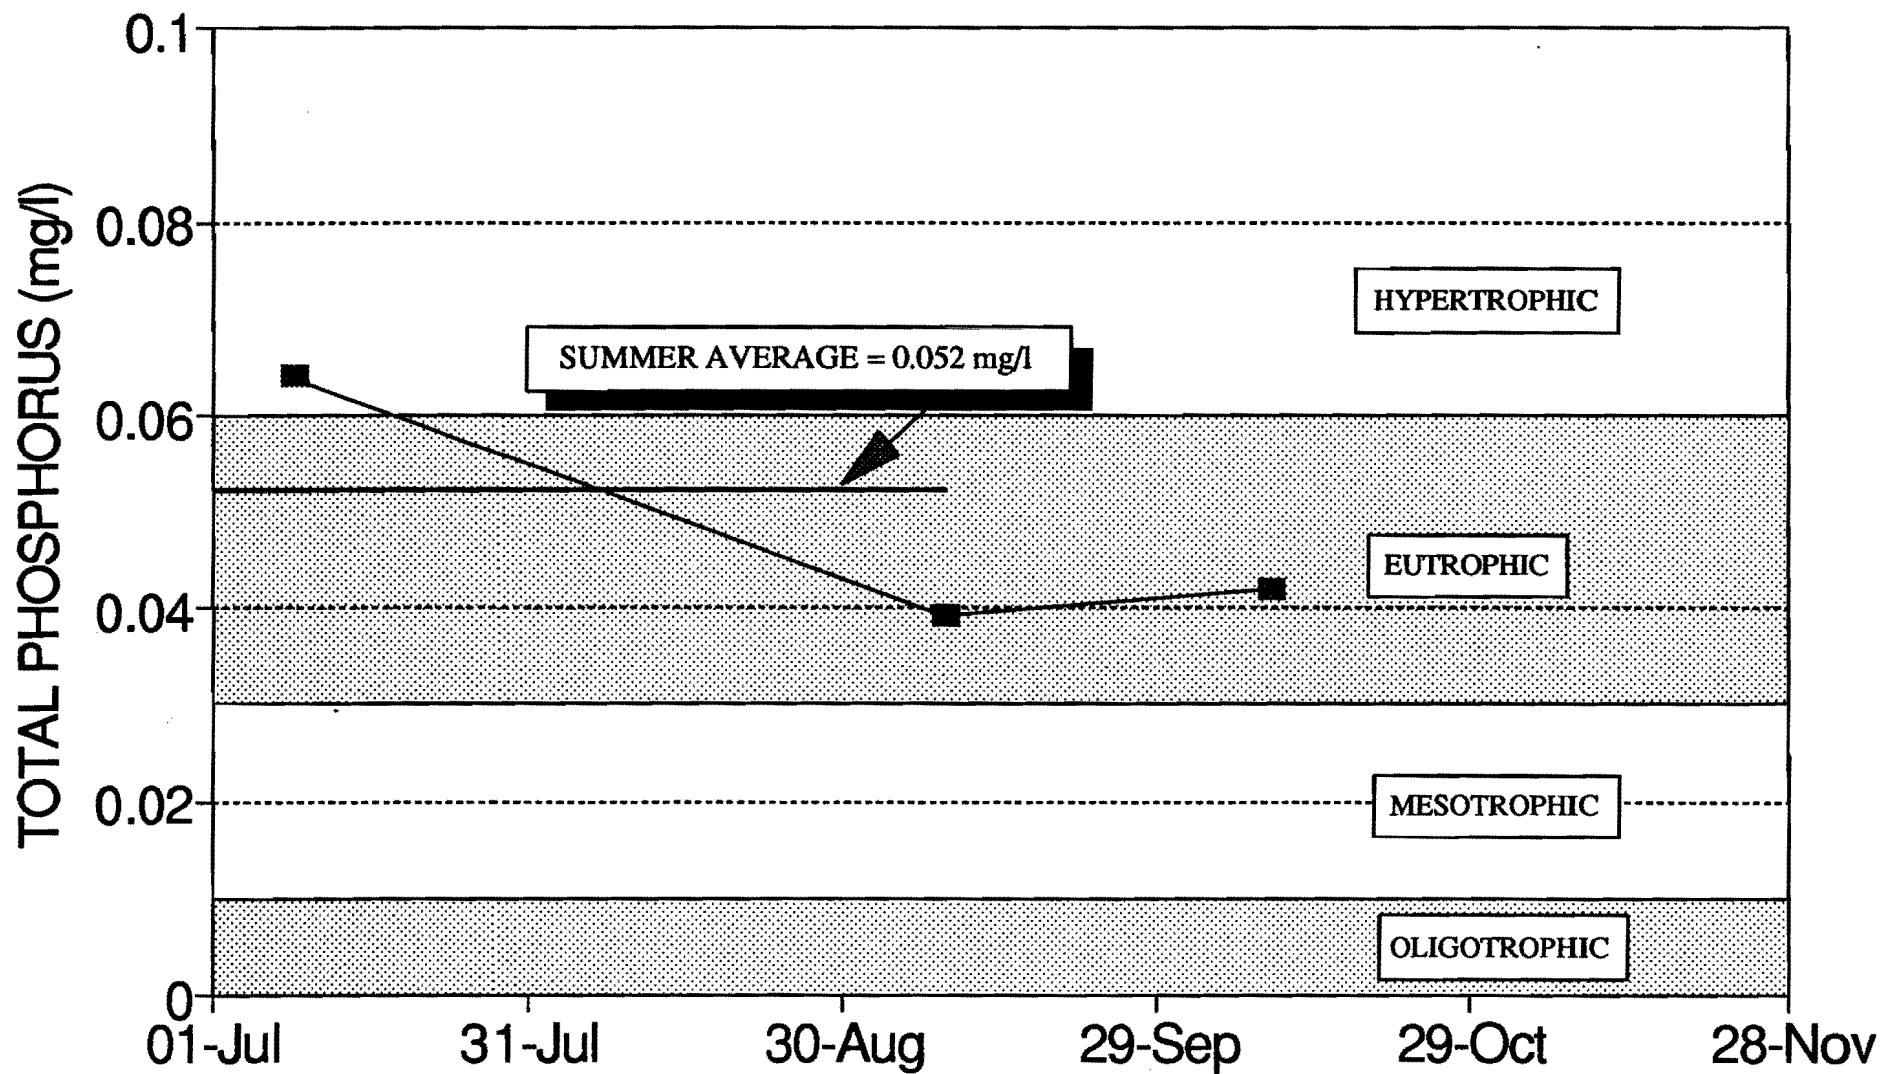
Figure 8

# NUGGET LAKE--STATION 3 1991 EPILIMNETIC TOTAL PHOSPHORUS

Phosphorus, chlorophyll *a*, and Secchi disc data from Nugget Lake indicate it is a eutrophic lake. Figures 8 to 16 compare the 1990 and 1991 total phosphorus, chlorophyll *a*, and Secchi disc data from the lake to levels characteristic of each of the trophic status categories. The summer average values were generally within the bounds of the eutrophic category. Based on this comparison, it would be assigned a nutrient status of eutrophic. As discussed earlier, this classification describes a water body that is rich in nutrients and has summer algal blooms. Nugget Lake experiences frequent algal blooms throughout the summer months. Pictures of algal blooms occurring in the northern portion of Nugget Lake during August of 1991 are shown in Figure 17. A eutrophic classification means the lake has undergone significant degradation, and is aging quickly.

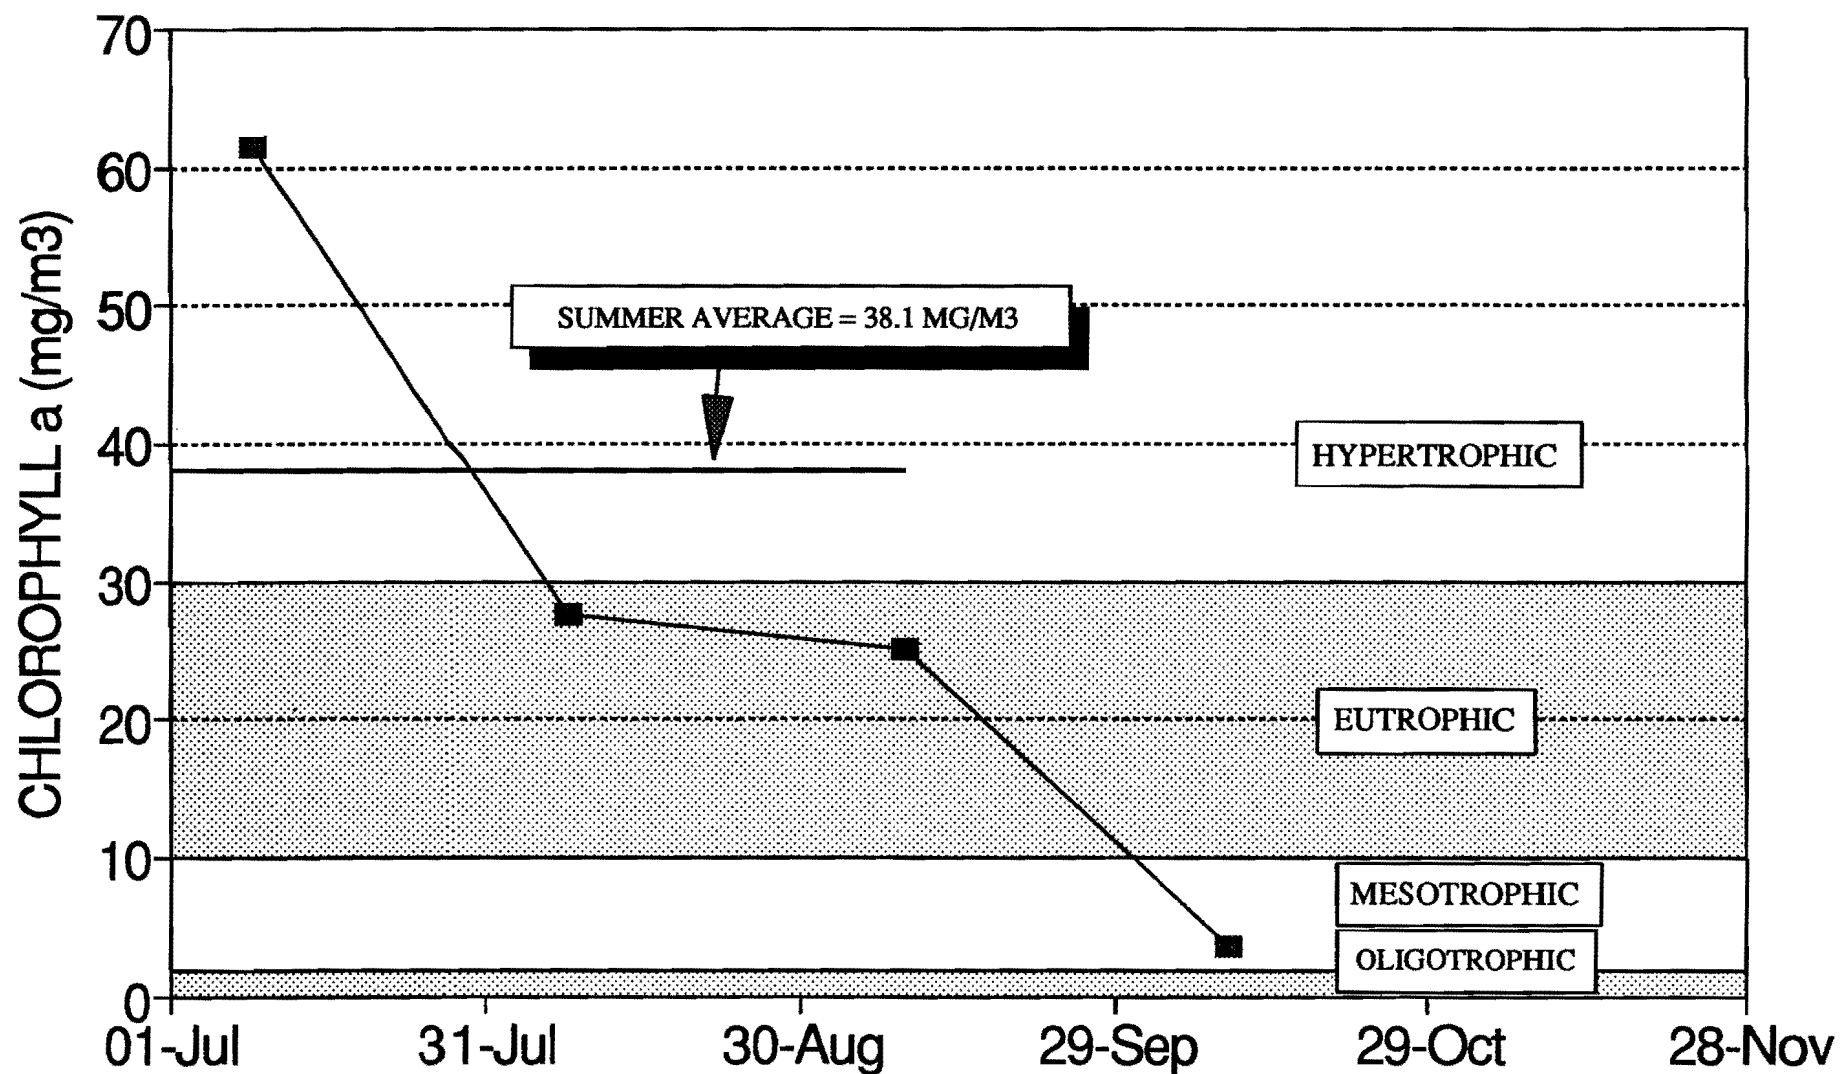
Figure 9

# NUGGET LAKE--STATION 3 1991 EPILIMNETIC CHLOROPHYLL a

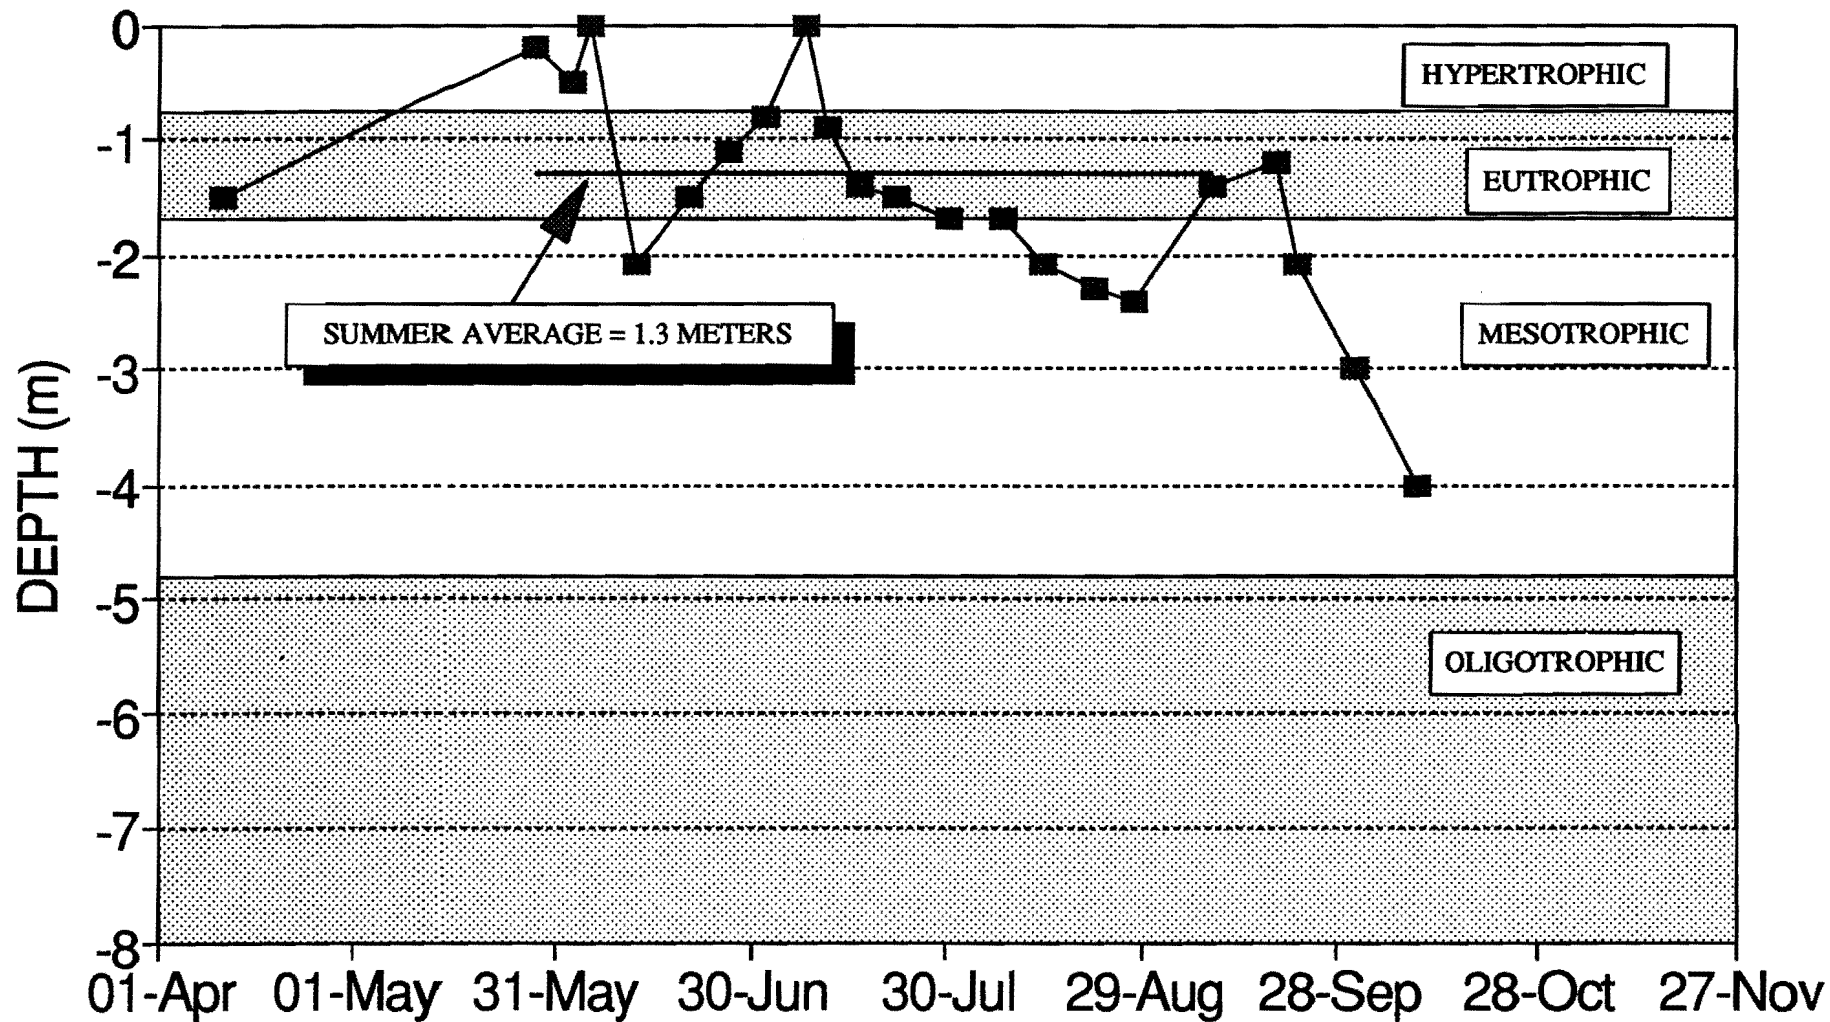
Figure 10

# NUGGET LAKE--STATION 3

## 1991 SECCHI DISC TRANSPARENCIES

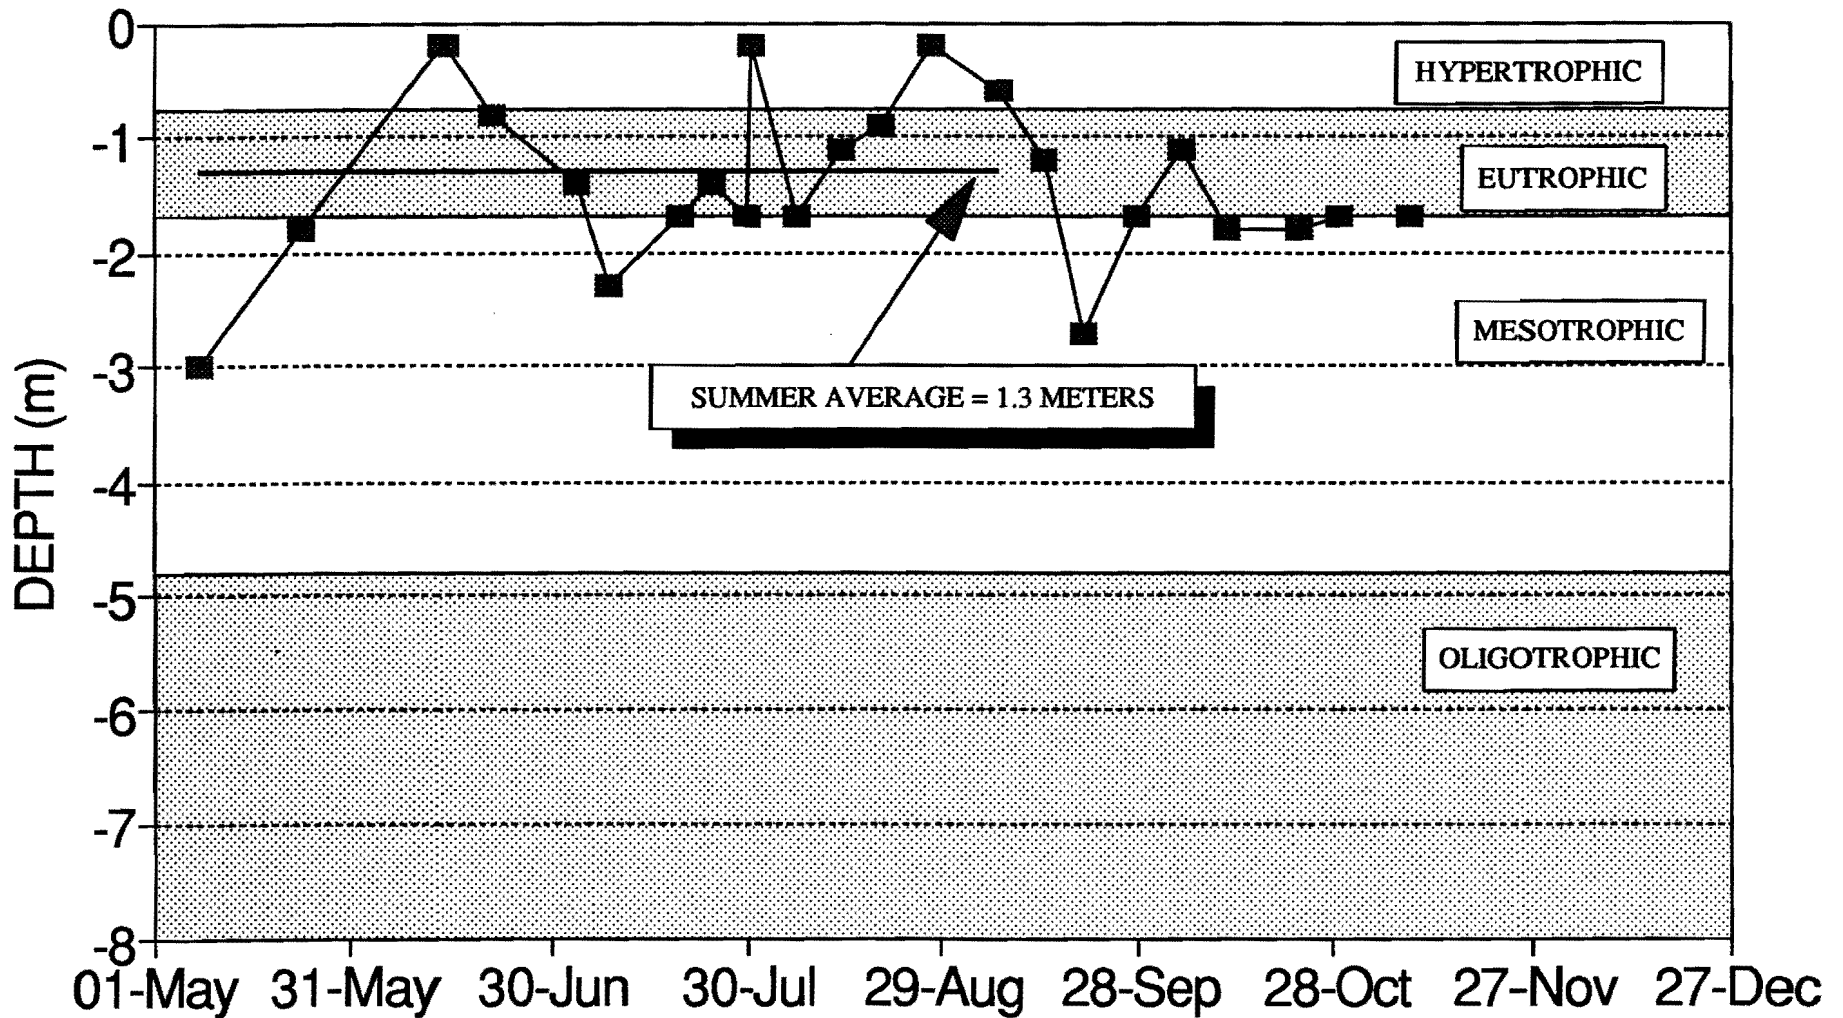
Figure 11

# NUGGET LAKE--STATION 3

## 1990 SECCHI DISC TRANSPARENCIES

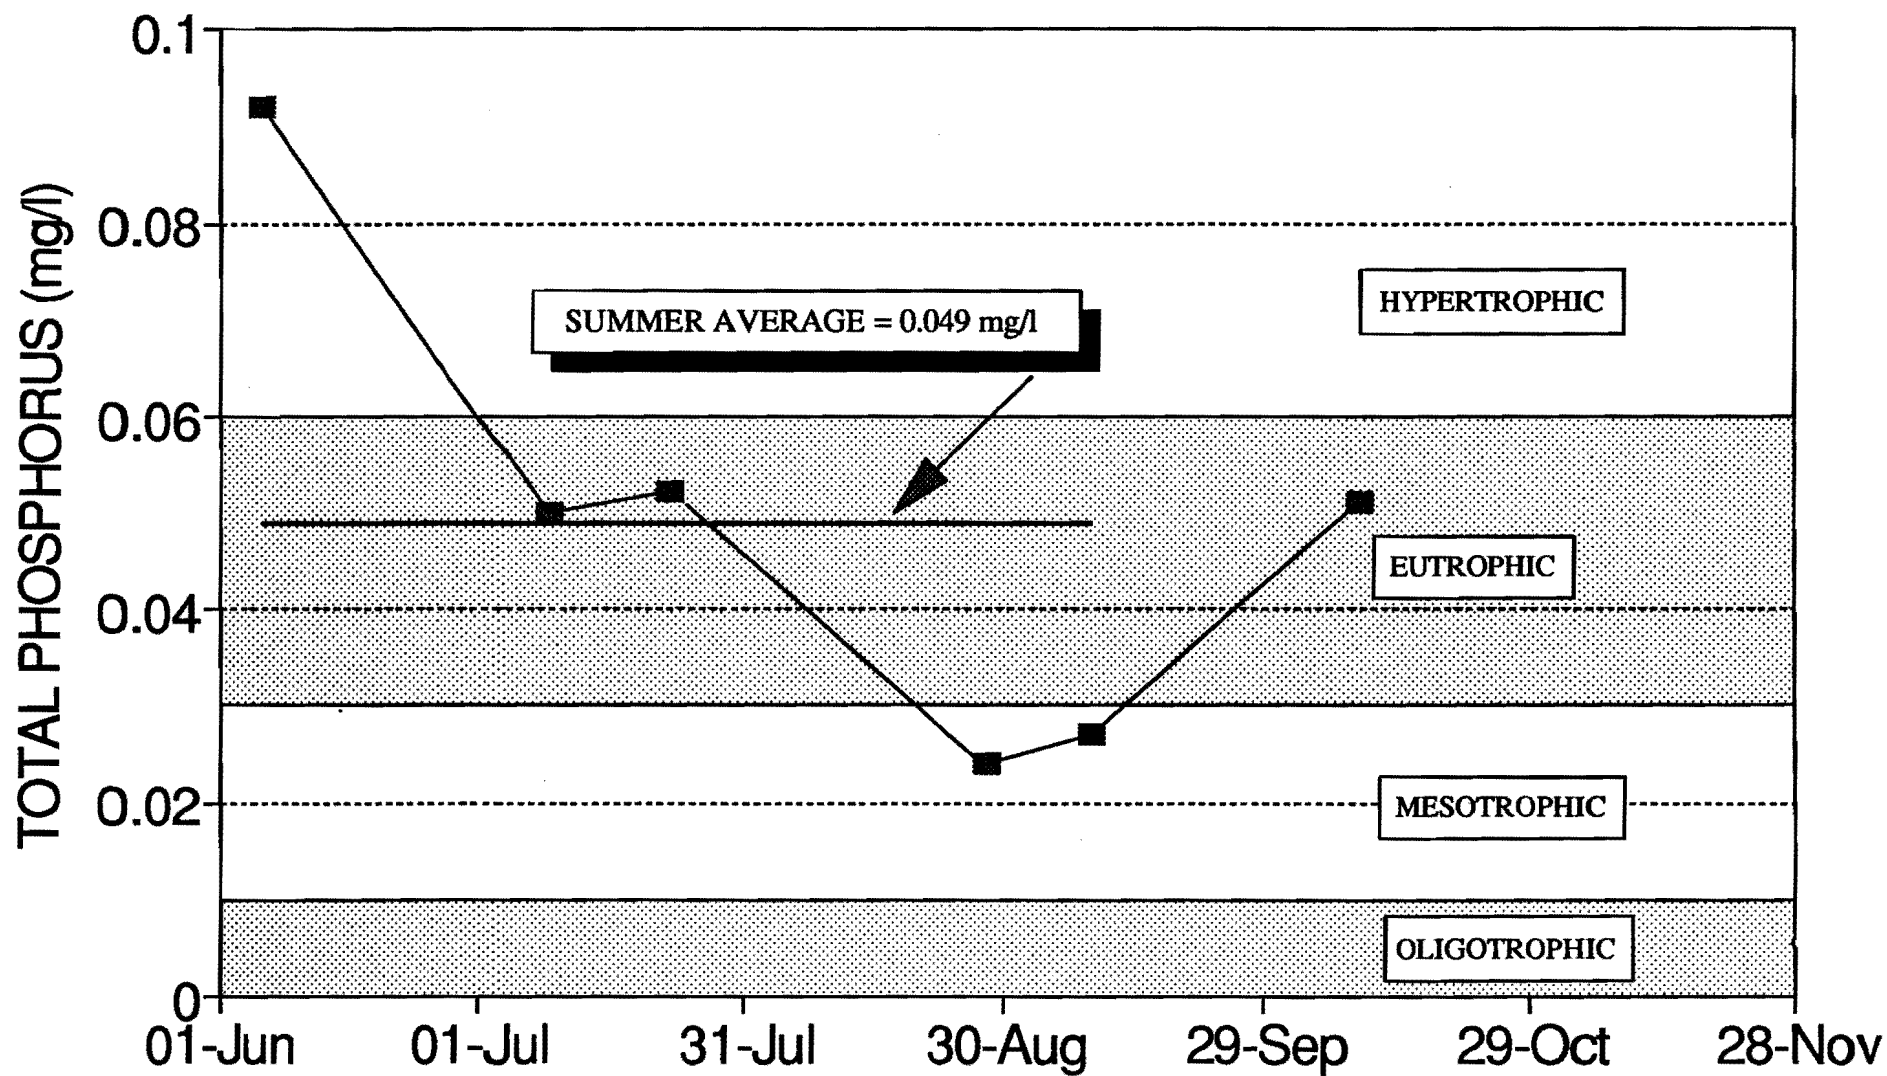
Figure 12

# NUGGET LAKE--STATION 4 1991 EPILIMNETIC TOTAL PHOSPHORUS

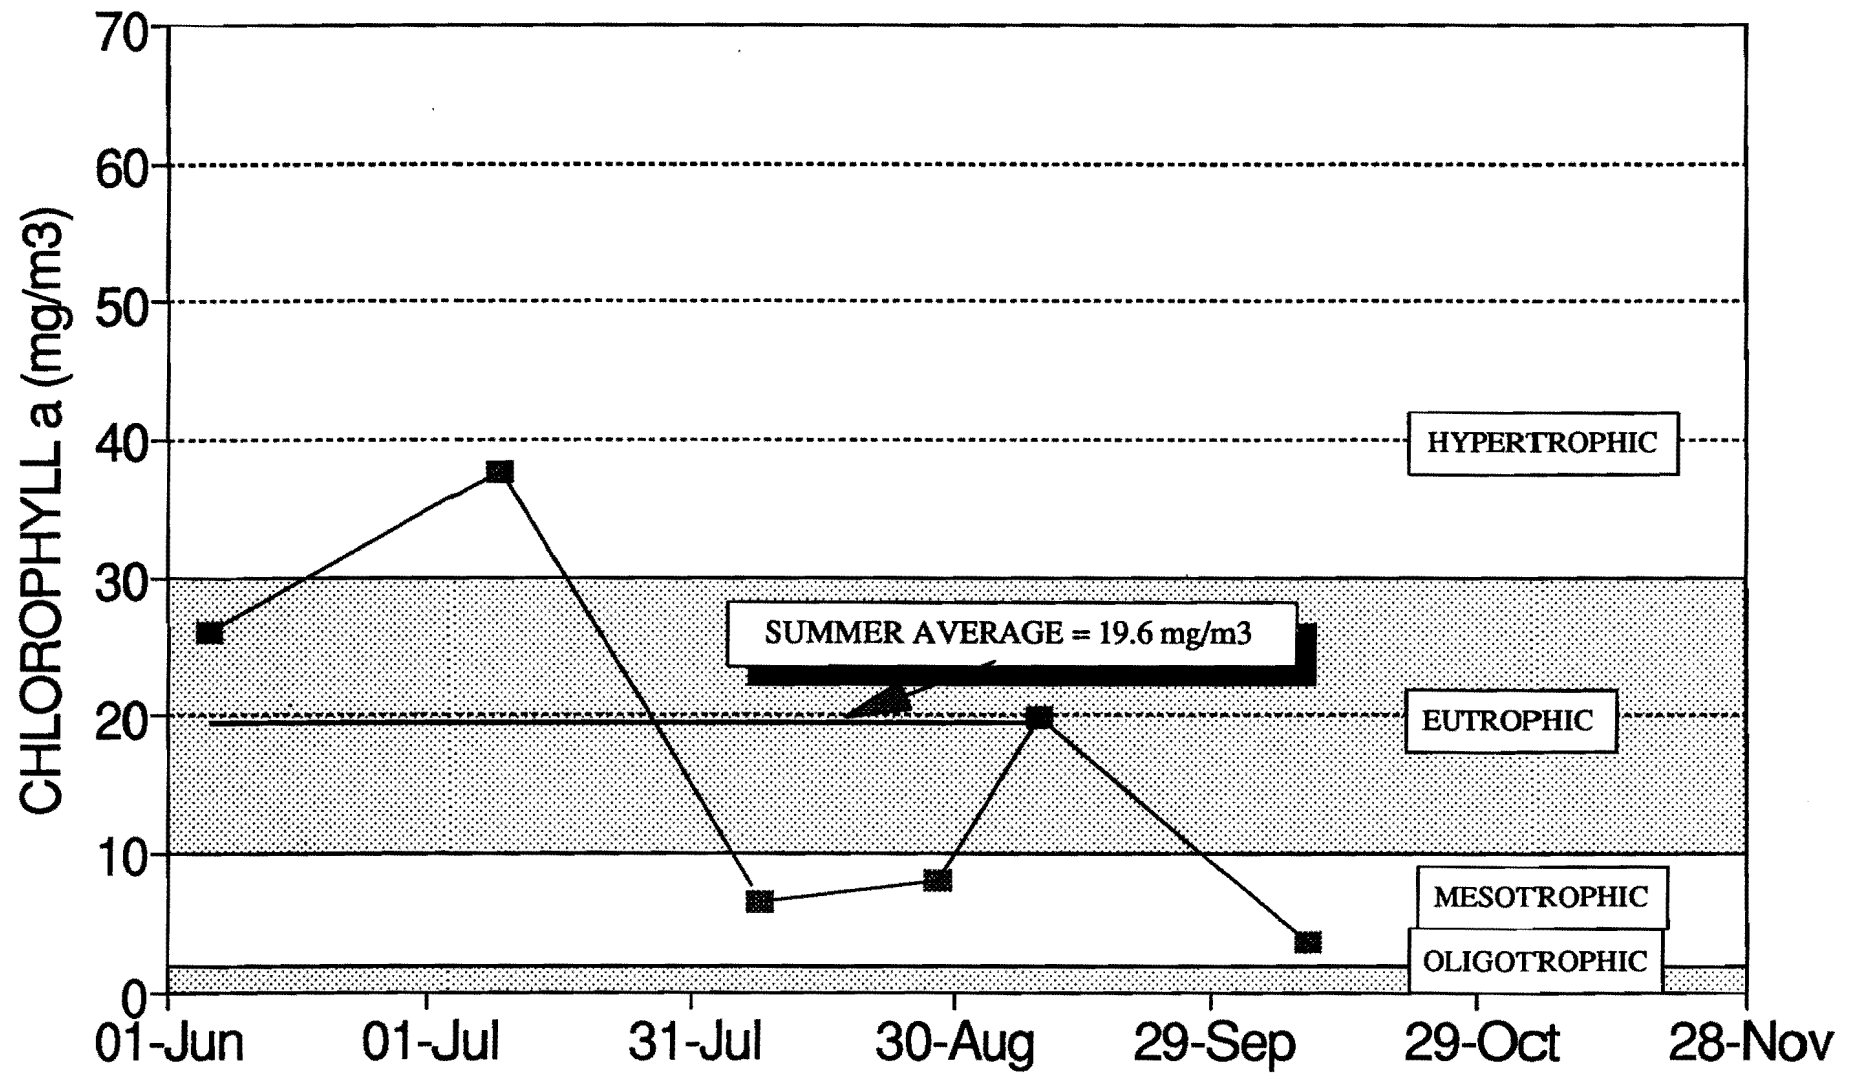
Figure 13

# NUGGET LAKE--STATION 4 1991 EPILIMNETIC CHLOROPHYLL a

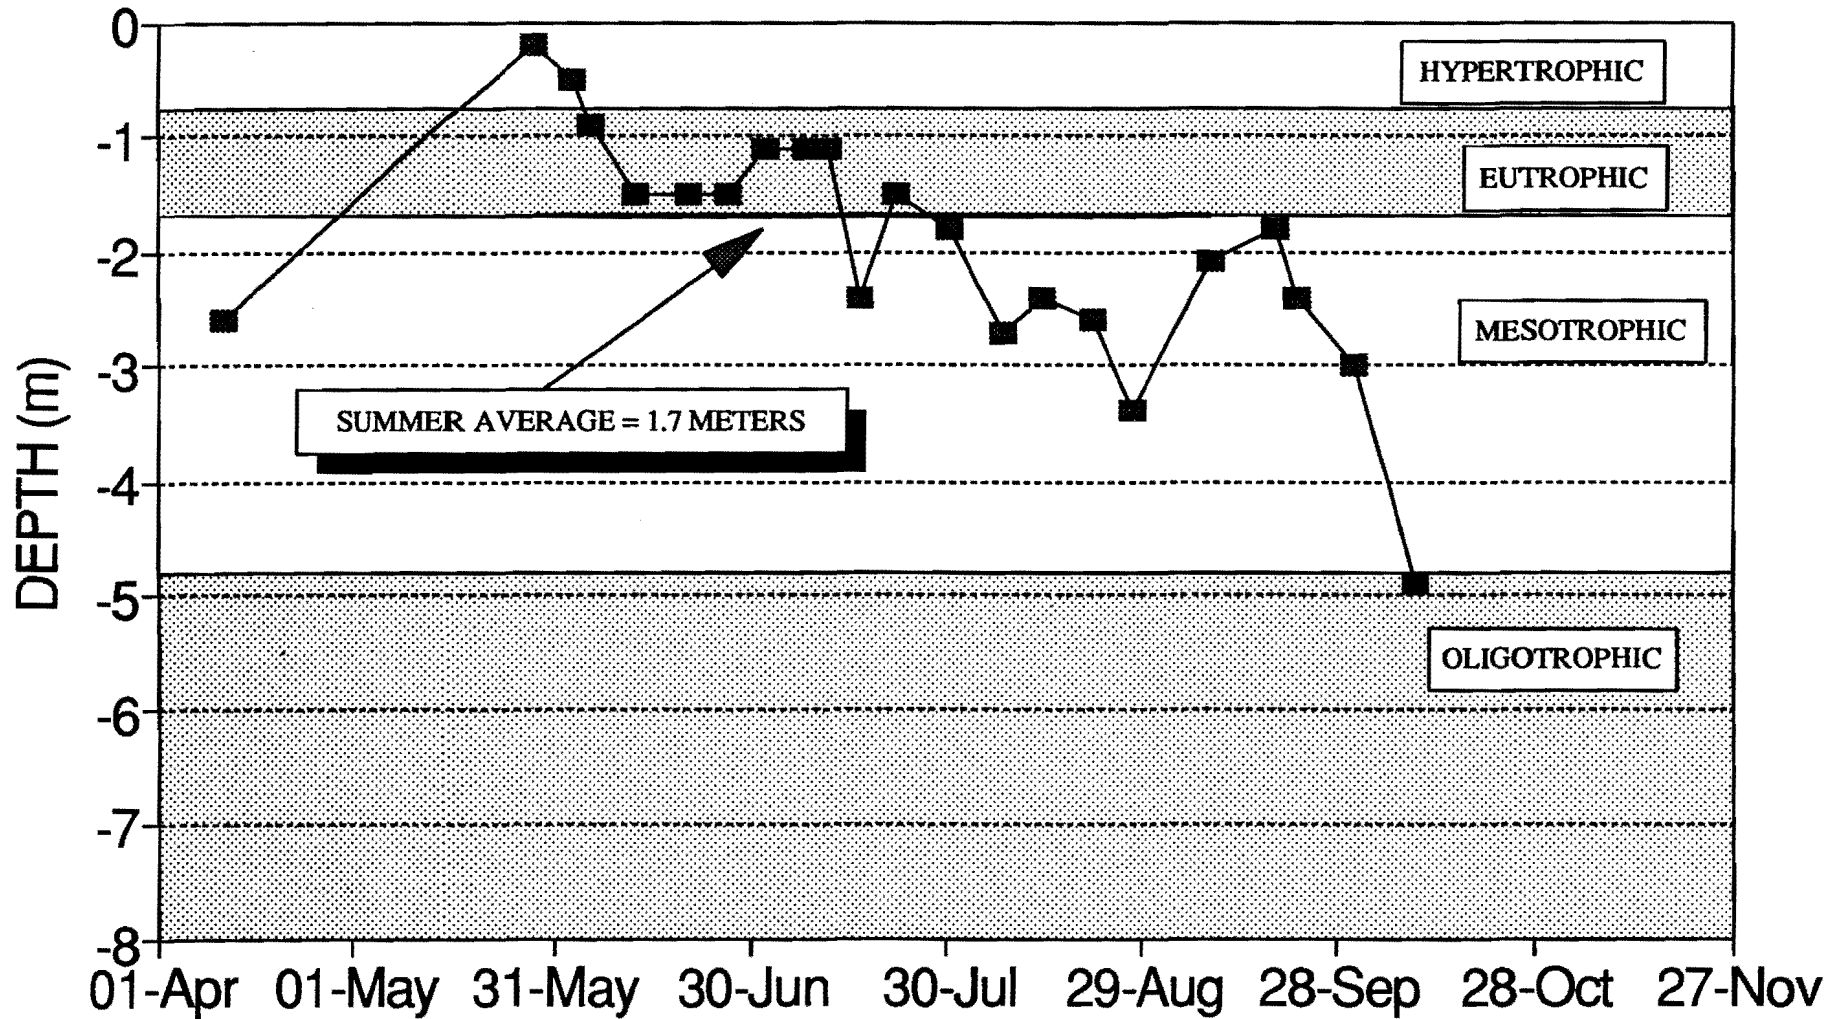
Figure 14

# NUGGET LAKE--STATION 4

## 1991 SECCHI DISC TRANSPARENCIES

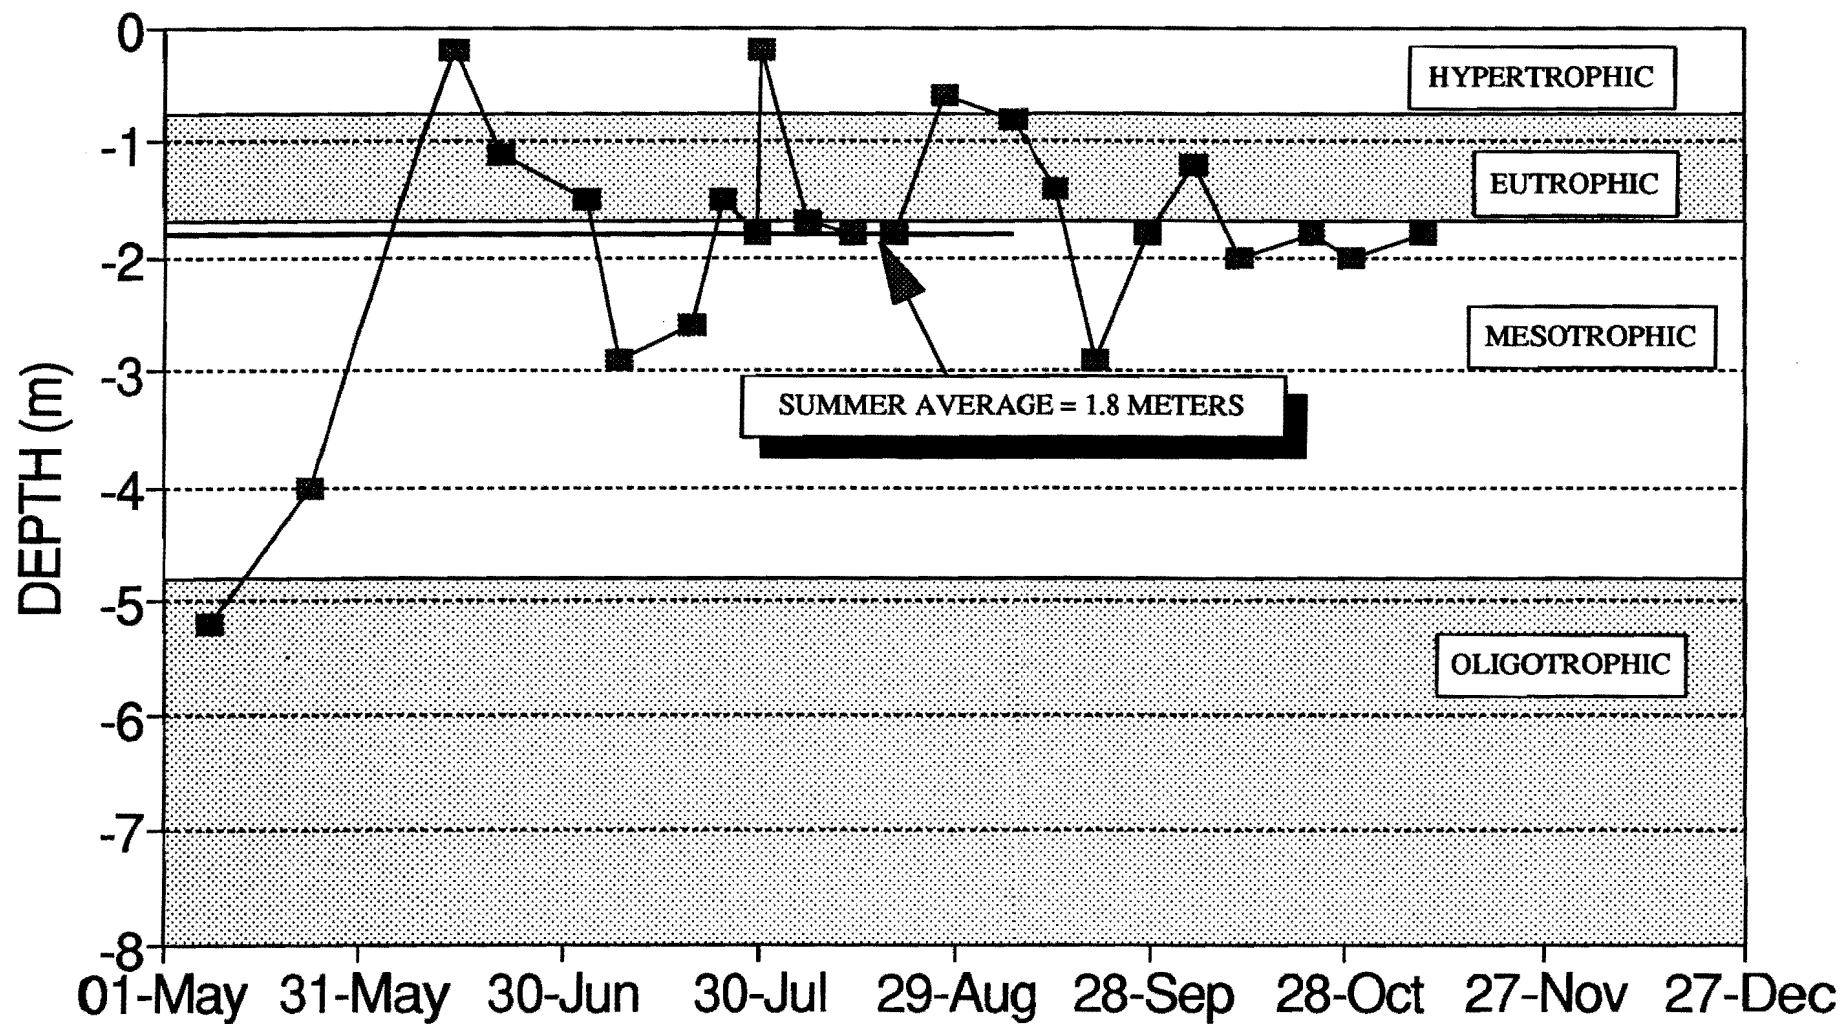
Figure 16

# NUGGET LAKE--STATION 4

## 1990 SECCHI DISC TRANSPARENCIES

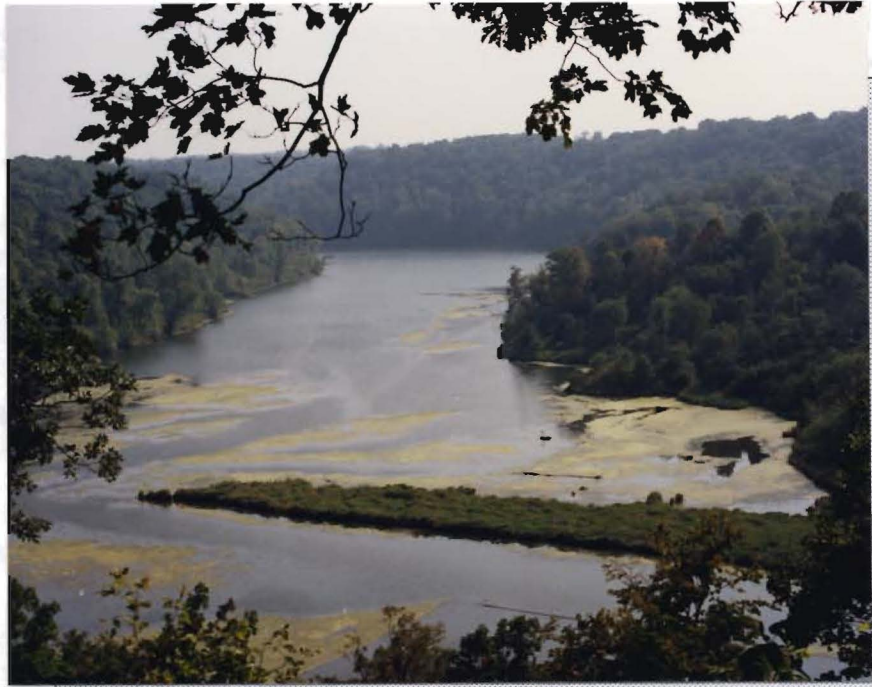
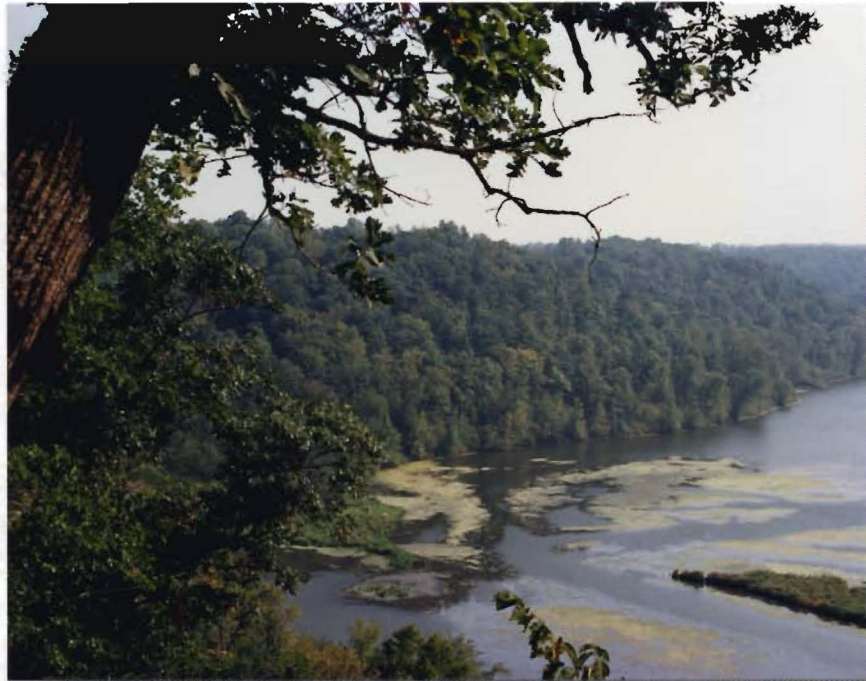
Figure 17

NORTHERN PORTION OF NUGGET LAKE -- ALGAL BLOOMS  
ON AUGUST 27, 1991
