***1991 Water Quality Study of  
Nugget Lake  
(Pierce County, Wisconsin)  
Wisconsin Lake Management Project***

***Prepared for  
Nugget Lake County Park  
RR 1 Box 213B  
Plum City, WI***

***March 1993***

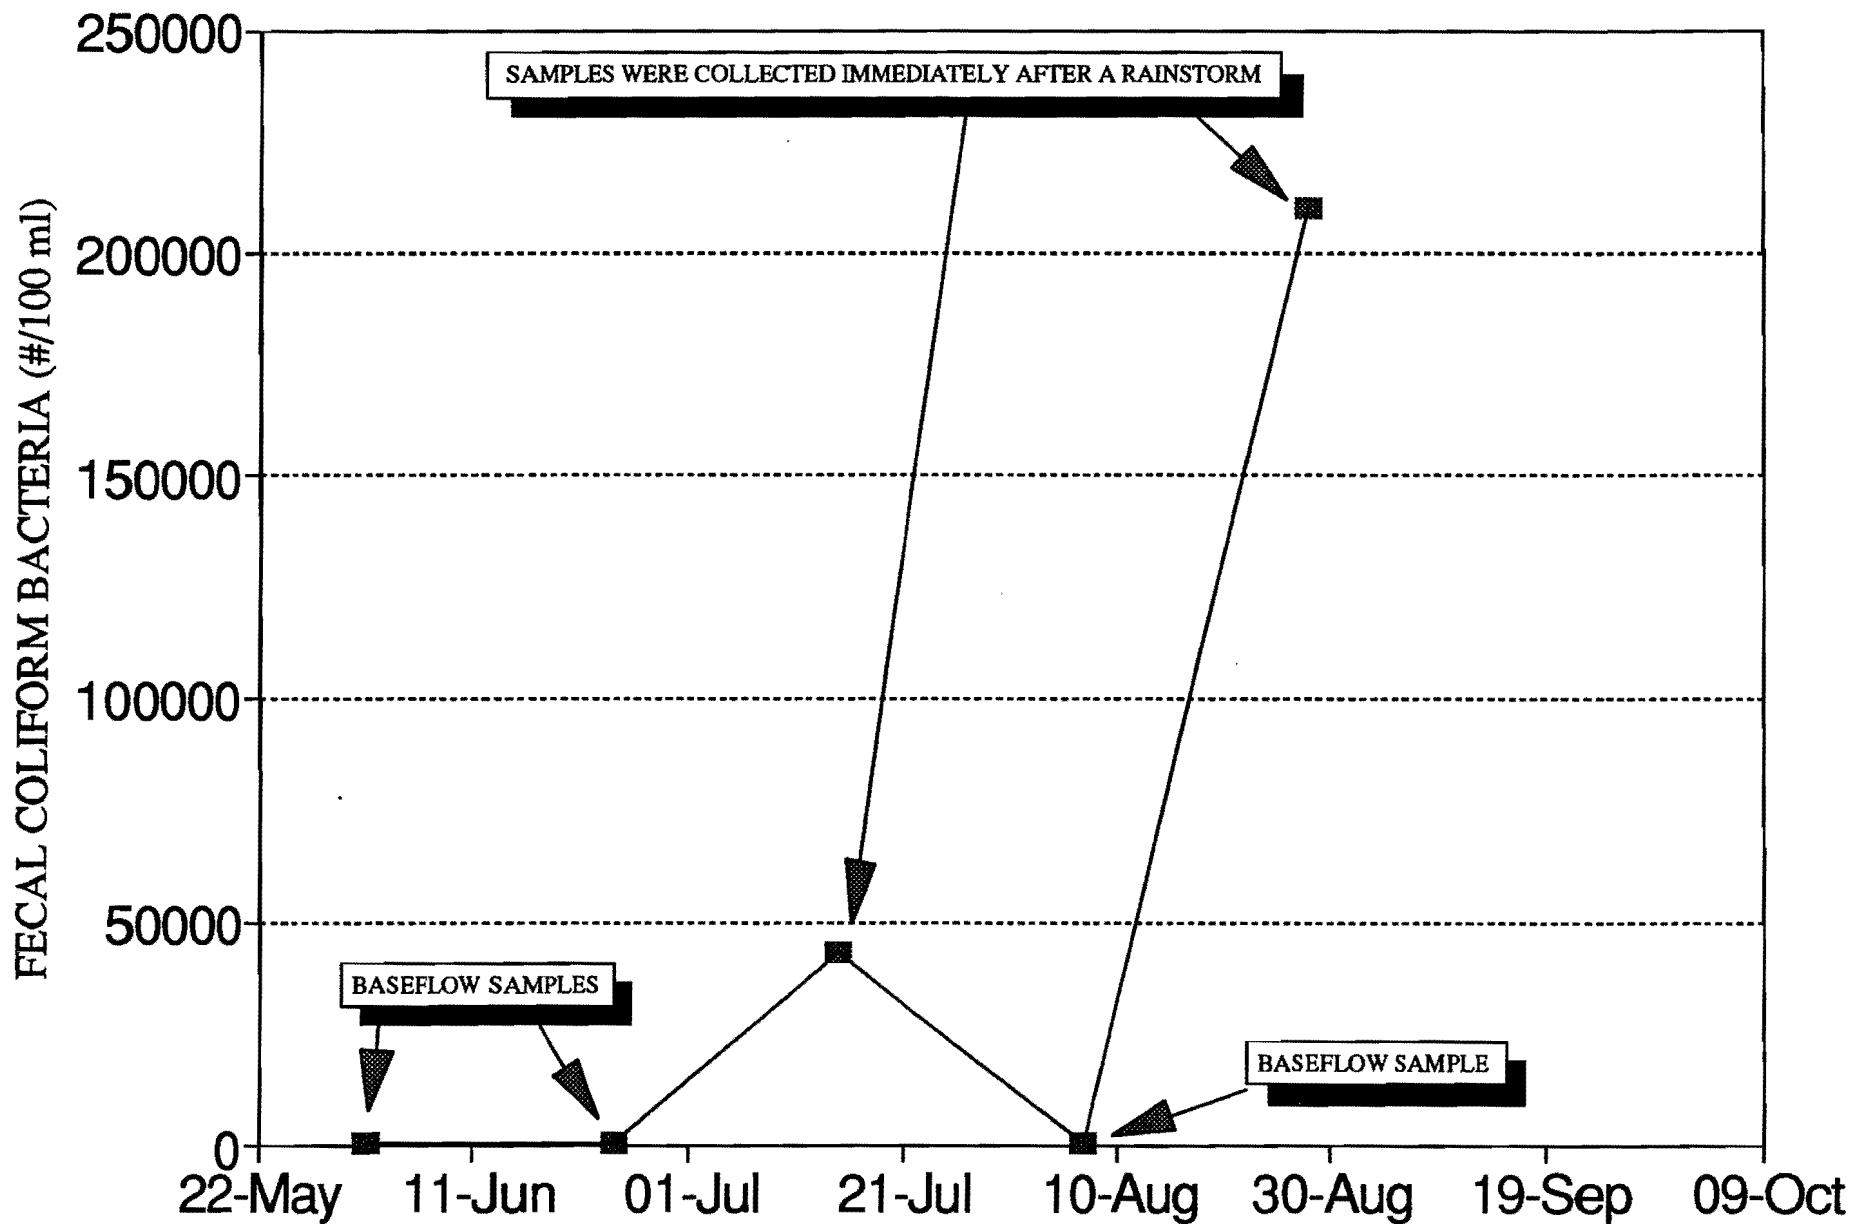
Figure 21

# 1991 FECAL COLIFORM BACTERIA CONCENTRATIONS -- ROCK ELM CREEK

Assessment results indicate feedlots are adding animal wastes to Plum Creek and Rock Elm Creek via stormwater runoff. The results, presented in Figures 20 (Plum Creek) and 21 (Rock Elm Creek), show the occurrence of significant increases in bacteria levels in both streams following rainstorms. The data, however, indicate larger quantities of animal waste are added to Rock Elm Creek than Plum Creek.

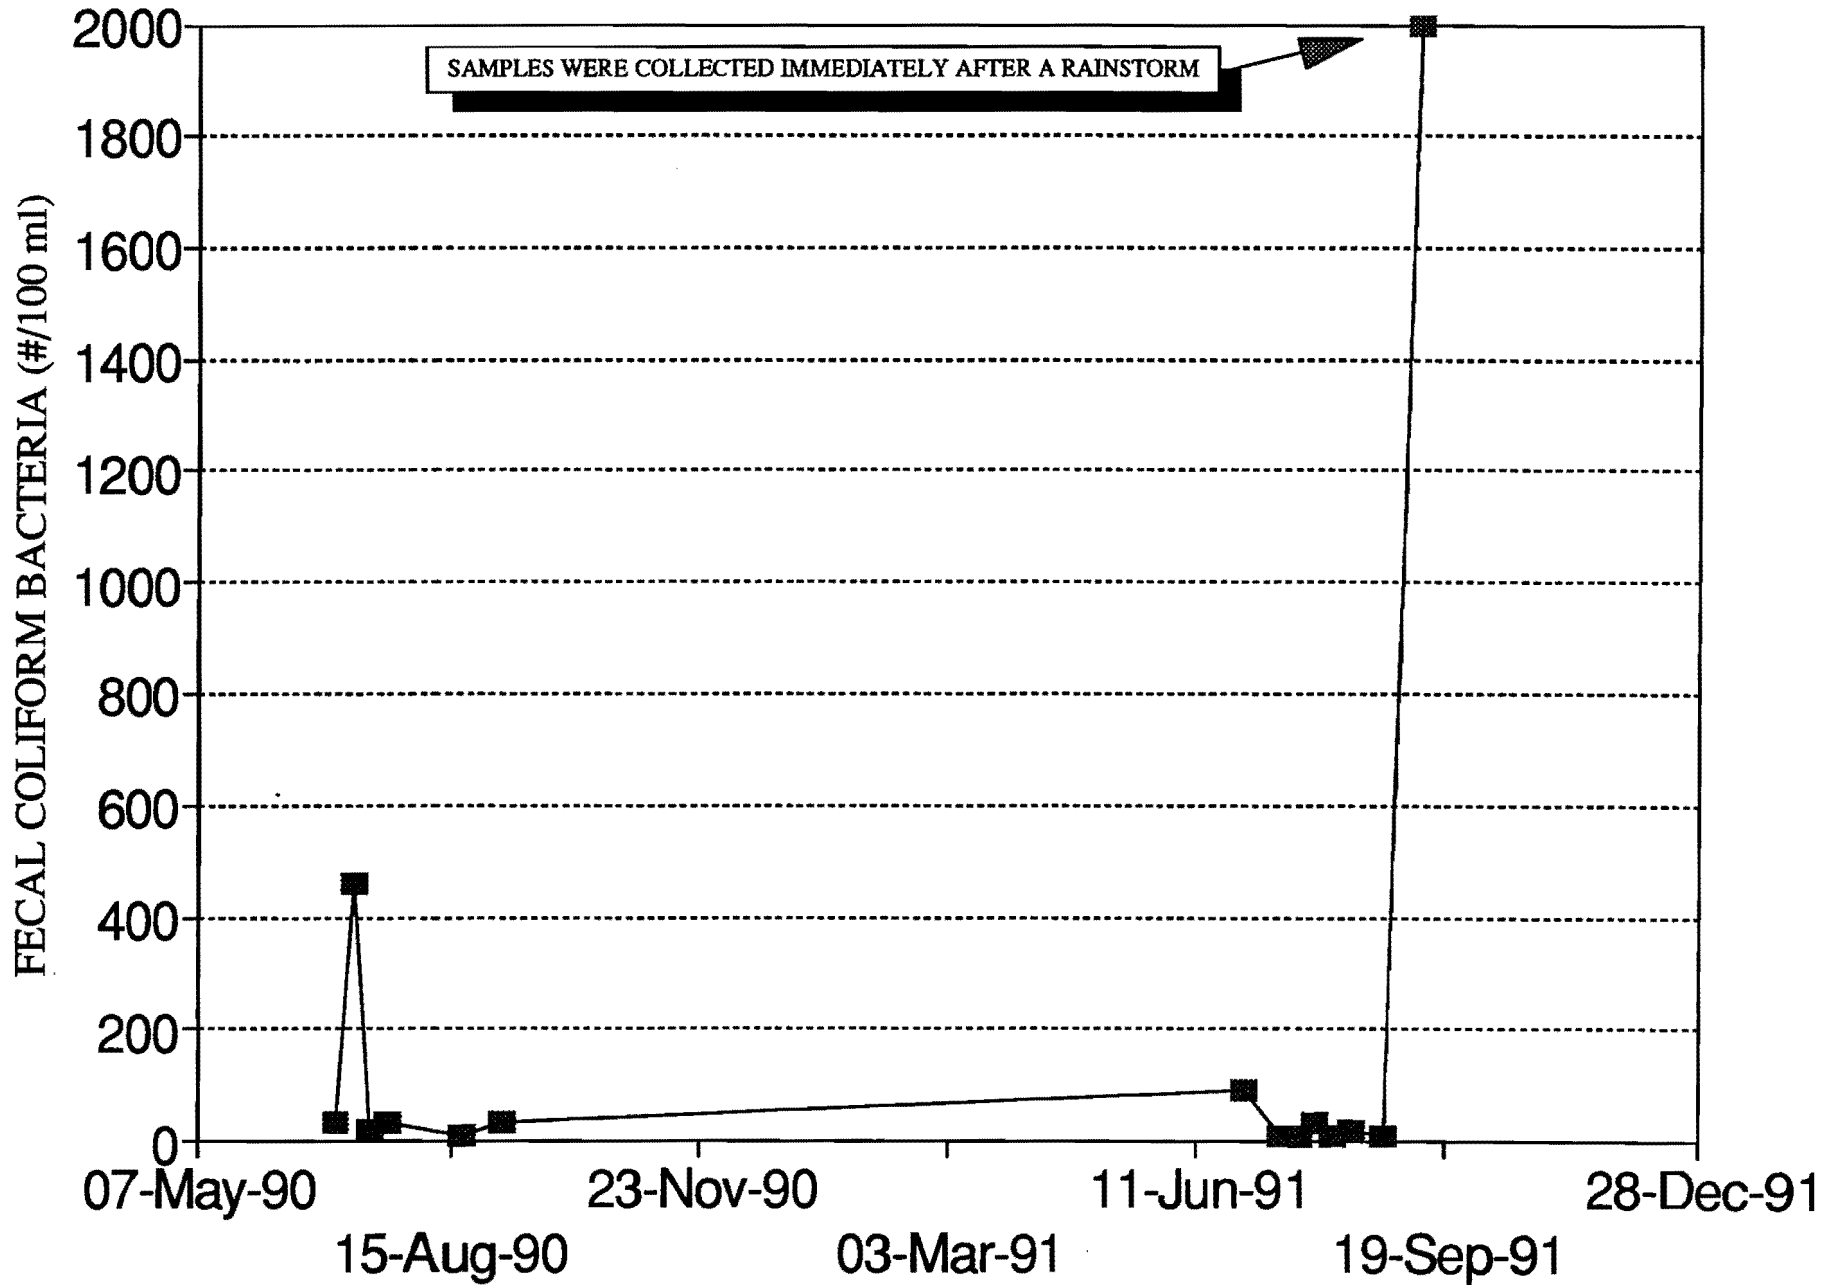
Figure 22

# 1990-1991 FECAL COLIFORM BACTERIA CONCENTRATIONS -- NUGGET LAKE

Data were also collected from Nugget Lake, near the swimming beach, to evaluate the effect of stream bacteria additions to the lake. Although fecal coliform bacteria themselves typically do not present a health hazard, they have been used to indicate the potential presence of disease-carrying bacteria. Therefore, the presence of large quantities of fecal coliform bacteria in the lake is an indication of a possible health threat to swimmers. The data are presented in Table D-5, Appendix D, and in Figure 22. High concentrations of fecal coliform bacteria were found in Nugget Lake following a rainstorm on September 9, 1991. The data indicate animal wastes entering Plum Creek and Rock Elm Creek via runoff increase the bacteria levels of Nugget Lake.
