# St. Louis River Estuary Wild Rice Restoration Monitoring (2015-2017)

Technical Report 17-09  
December 2017

1854 Treaty Authority  
Resource Management Division  
4428 Haines Road  
Duluth, MN 55811-1524  
(218) 722-8907  
[www.1854treatyauthority.org](http://www.1854treatyauthority.org)

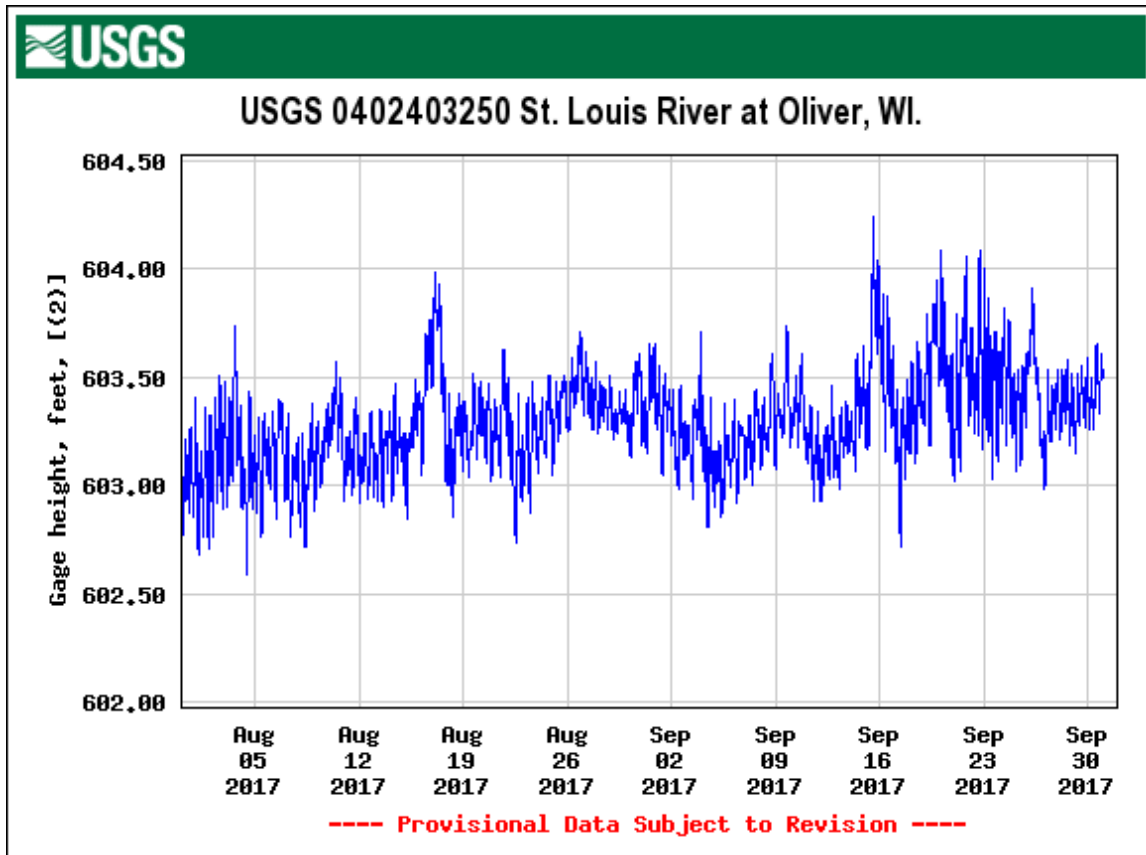
**Figure 4: Water Elevation in St. Louis River Estuary 2017 (Oliver Bridge), USGS**

Water depth is an important factor in wild rice growth, with 12-36 inches typically considered as ideal conditions. Average water depths at the time of sampling in late August to early September 2017 were greater than the upper end of this range (Table 5). However, it must be noted that these reported depths were on a single date, and not representative of the entire 2017 season. Monitored areas may also be larger than the current restoration footprint, resulting in some sampling points (and water depths) on the edge or outside of expected wild rice growth. Water levels in the St. Louis River estuary were high in 2017, and likely affected wild rice growth and restoration success. Water elevation at the Oliver bridge courtesy of data from the U.S. Geological Survey (Figure 4)

is available for July 31 – October 1, 2017. This location is near the restoration areas and provides a suitable summary of water levels in the upper estuary.

A comparison of water levels across years is helpful to understand potential impacts to wild rice growth and restoration success. Water depth is collected (every 15 minutes by data logger) by the Lake Superior National Estuarine Research Reserve at the Oliver bridge, and depths from 2015 to 2017 (May 1 – October 1 each year) are displayed in Appendix C. Pairing this information with the USGS data can allow for a calculation of water elevations over this time, also shown in Appendix C. However, some differences in data logger readings and the two datasets make this calculation a close estimate of water elevations but perhaps not completely accurate.

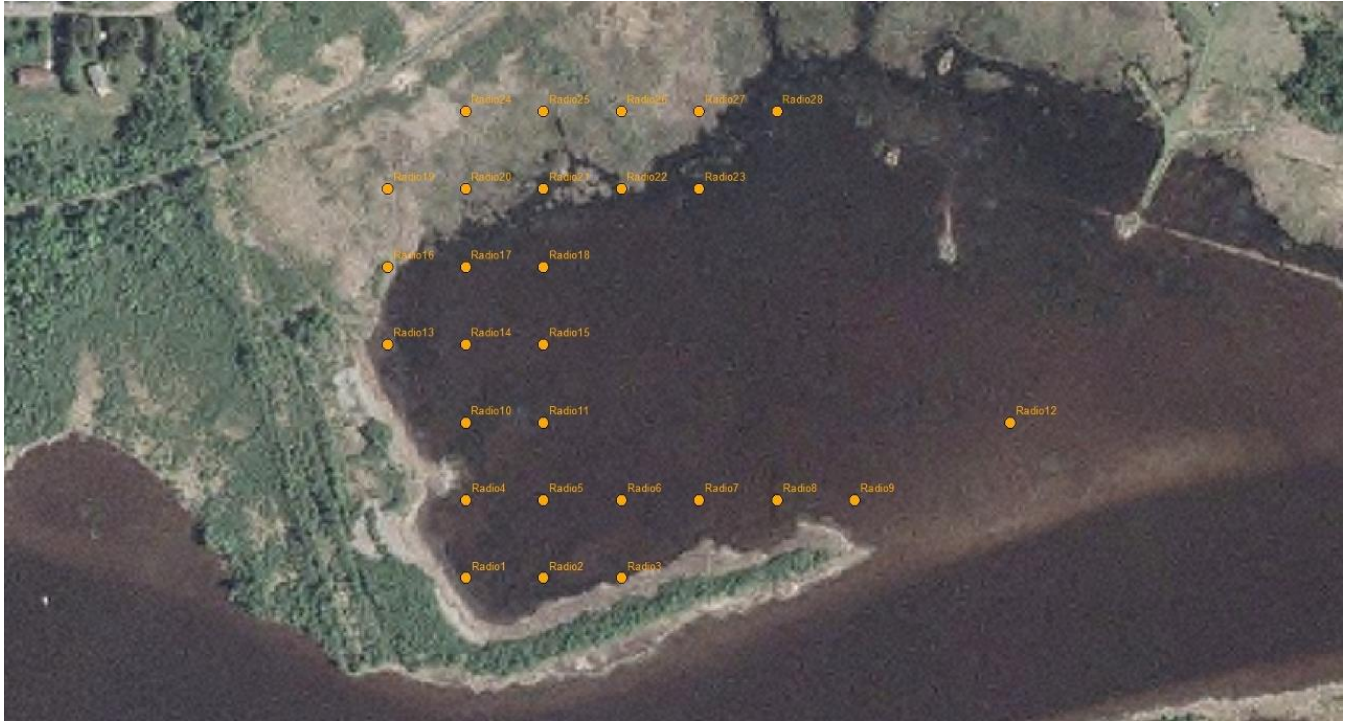
**Figure A-5: Monitoring Points in Radio Tower Bay (28 points, 50 m grid)**  
(aerial photograph taken before open water habitat created in north portion of bay)

Wild rice surveys were completed on 8/24/15 (after wood removal work that year), 8/29/16, and 8/30/17. In 2017, sparse wild rice was found along the south shore, west end, and into the north side. Wild rice biomass increased from 2016, and at least one stalk of wild rice was present in 41% of the sampling points. Moderate to severe impacts from grazing were observed during the August 2017 survey, with many leaves and some stems nipped off. Many areas contained sparse wild rice, but much was short, laying in water, or nipped off. Some rice was still in floating-leaf stage. During the 7/19/17 site visit, sparse floating-leaf wild rice was found in the restoration area. Photo points have been established at five locations.
