# Curly-leaf pondweed (*Potamogeton crispus*)

## Pre/Post Herbicide Treatment Surveys

### Long Lake - WBIC: 2478200

### Polk County, Wisconsin

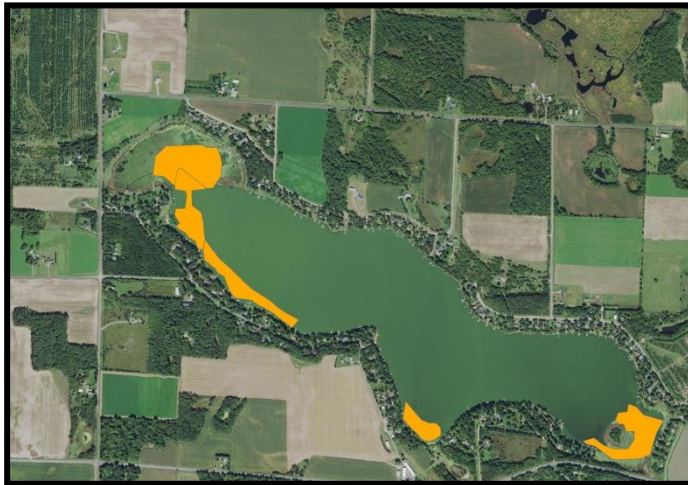
Long Lake Aerial Photo with Final 2017 Treatment Areas

Of the seven areas identified by Barr Engineering as having CLP in 2009, we have consistently found high density CLP in only six of them in an area covering 49.88 acres (Table 1). Following analysis of the pretreatment survey, it was decided to eliminate Area 3 and trim the rest of the areas to encompass the 33.65 acres (12.4% of the lake's surface area) that had the highest CLP densities in 2017 (Figure 3) (Appendix I).

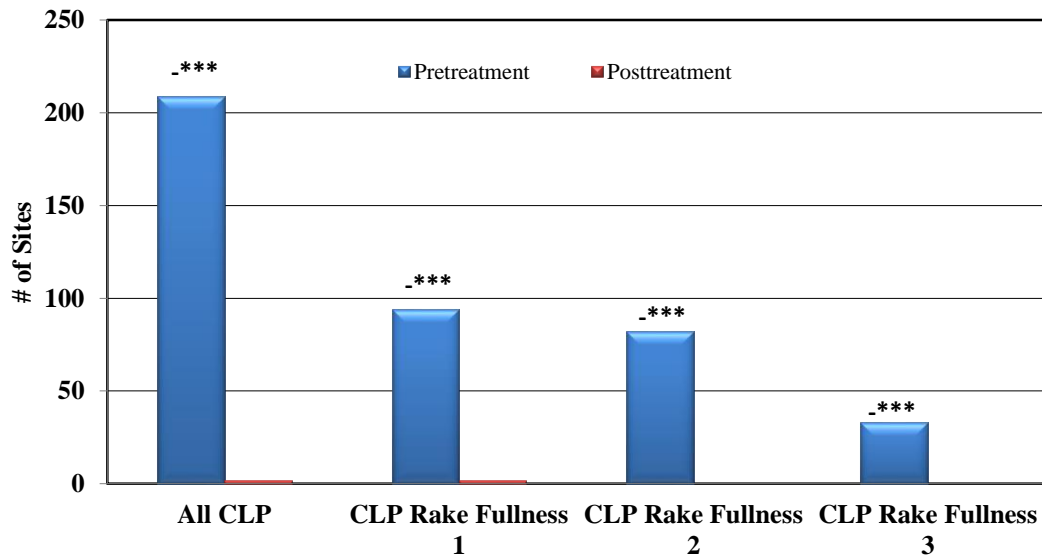
**Figure 9: Whole Lake – Changes in CLP Rake Fullness Ratings**

### Pre/Post CLP Rake Fullness Results Lakewide - Long Lake, Polk County April 29 and June 5-6, 2017

Significant differences = \*  $p < .05$ , \*\*  $p < .01$ , \*\*\*  $p < .001$

During the posttreatment survey, we found CLP at just two points (0.4% coverage) with each rating a 1, and both occurring in the the high density areas (0.6% coverage). In the low density areas, we saw no evidence of CLP at or between any survey points. **Our findings suggest the treatment produced a highly significant reduction in CLP lakewide** (Figure 9), in the HDAs (Figure 10), **AND** in the LDAs (Figure 11). This was surprising as only the HDAs were treated, and, even here, only 67.5% of the acreage was treated. **That CLP was knocked back even in areas that weren't treated suggests that this dosage of Endothall over this acreage effectively resulted in a lakewide treatment.**

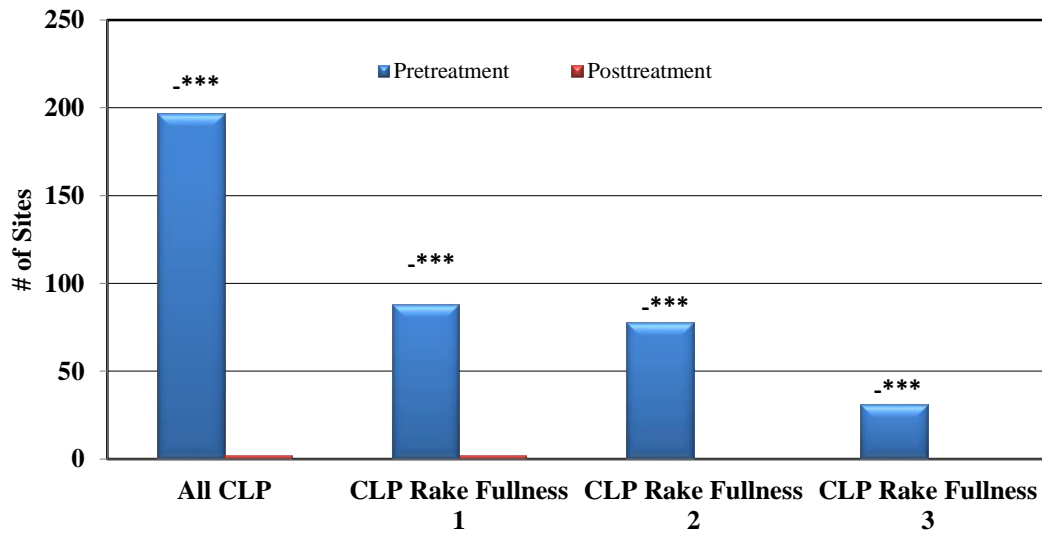
**Figure 10: High Density Areas - Changes in CLP Rake Fullness Ratings**

### Pre/Post CLP Rake Fullness Results High Density Areas - Long Lake, Polk County April 29 and June 5-6, 2017

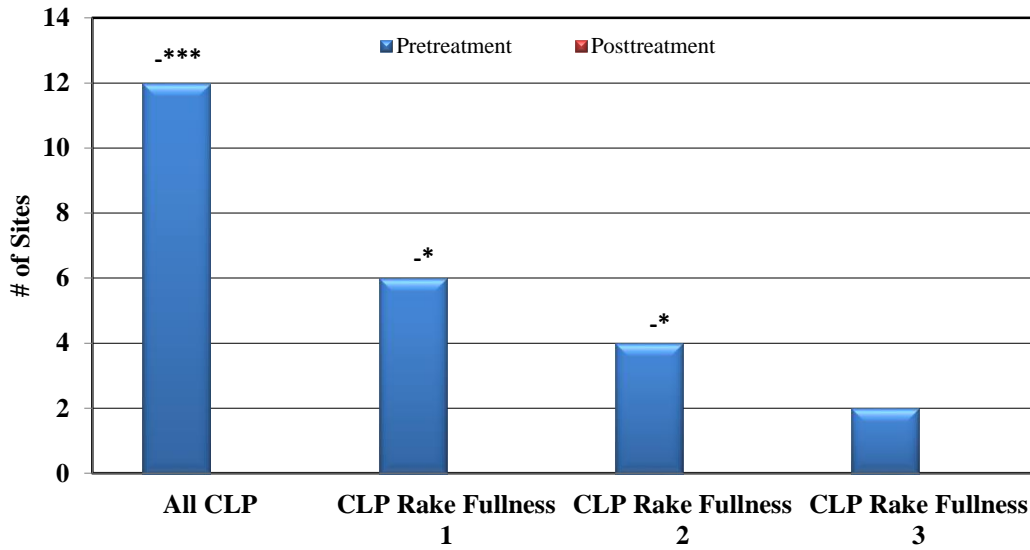
**Figure 11: Low Density Areas - Changes in CLP Rake Fullness Ratings**

## Pre/Post CLP Rake Fullness Results Low Density Areas - Long Lake, Polk County April 29 and June 5-6, 2017

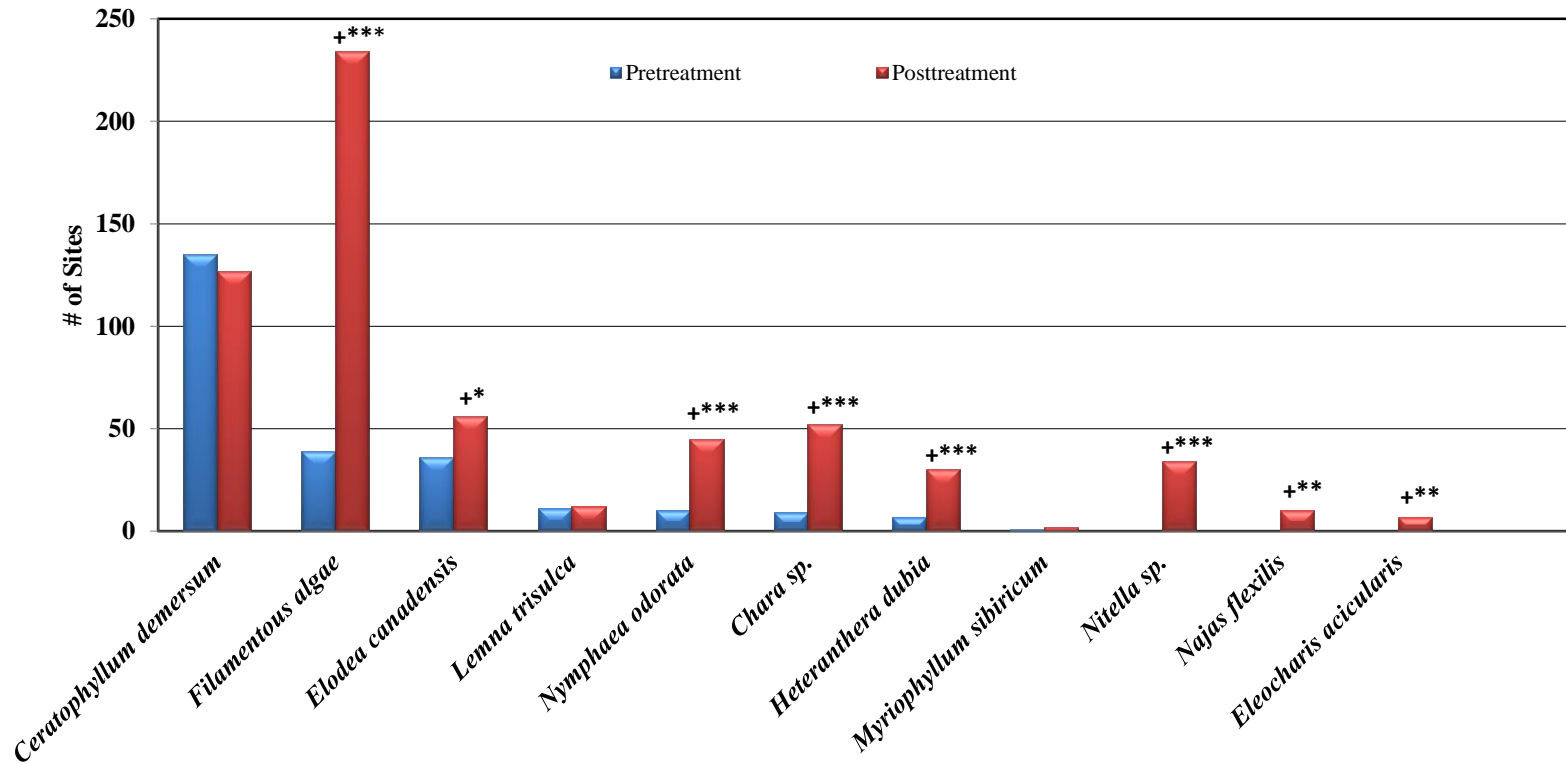
**Figure 14: Whole Lake Pre/Post Native Species Changes**

Lakewide, we found Coontail (*Ceratophyllum demersum*) and Common waterweed (*Elodea canadensis*) were the most common and second most common native species during both the pre and posttreatment surveys (Figures 12 and 13) (Tables 3-6). Neither these, nor any other native species showed a significant decline posttreatment; however, filamentous algae and many later growing species that were largely dormant during the pretreatment survey showed significant lakewide increases (Figure 14). Specifically, filamentous algae, White water lily (*Nymphaea odorata*), Muskgrass (*Chara* sp.), Water star-grass (*Heteranthera dubia*), and Nitella (*Nitella* sp.) demonstrated highly significant increases; Slender naiad (*Najas flexilis*) and Needle spikerush (*Eleocharis acicularis*) showed moderately significant increases; and Common waterweed experienced a significant increase (Maps of all native species from the pre and posttreatment surveys can be found in Appendixes VI and VII).

**Pre/Post Differences for All Native Species  
Lakewide - Long Lake, Polk County  
April 29 and June 5-6, 2017**

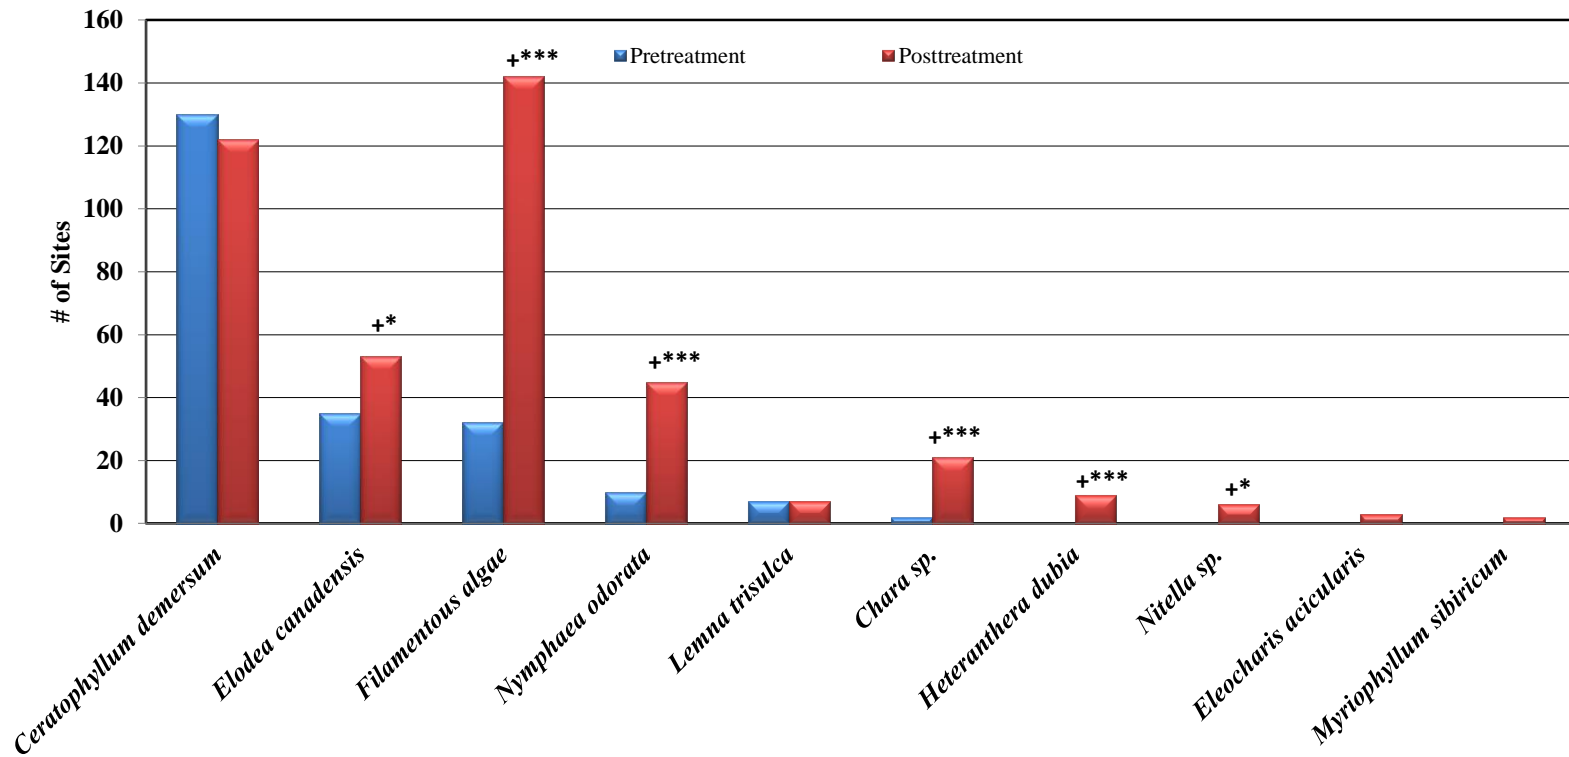
**Figure 15: High Density Areas - Pre/Post Native Species Changes**

Breaking the data out between high density areas (Figure 15) and low density areas (Figure 16) provided little additional information. Based on all these data that showed the overall effectiveness of the treatment at controlling CLP while simultaneously having minimal impact on native species, 2017 appears to have been highly successful at meeting the LLPRD’s stated goals for managing CLP.

**Pre/Post Differences for All Native Species  
High Density Areas - Long Lake, Polk County  
April 29 and June 5-6, 2017**

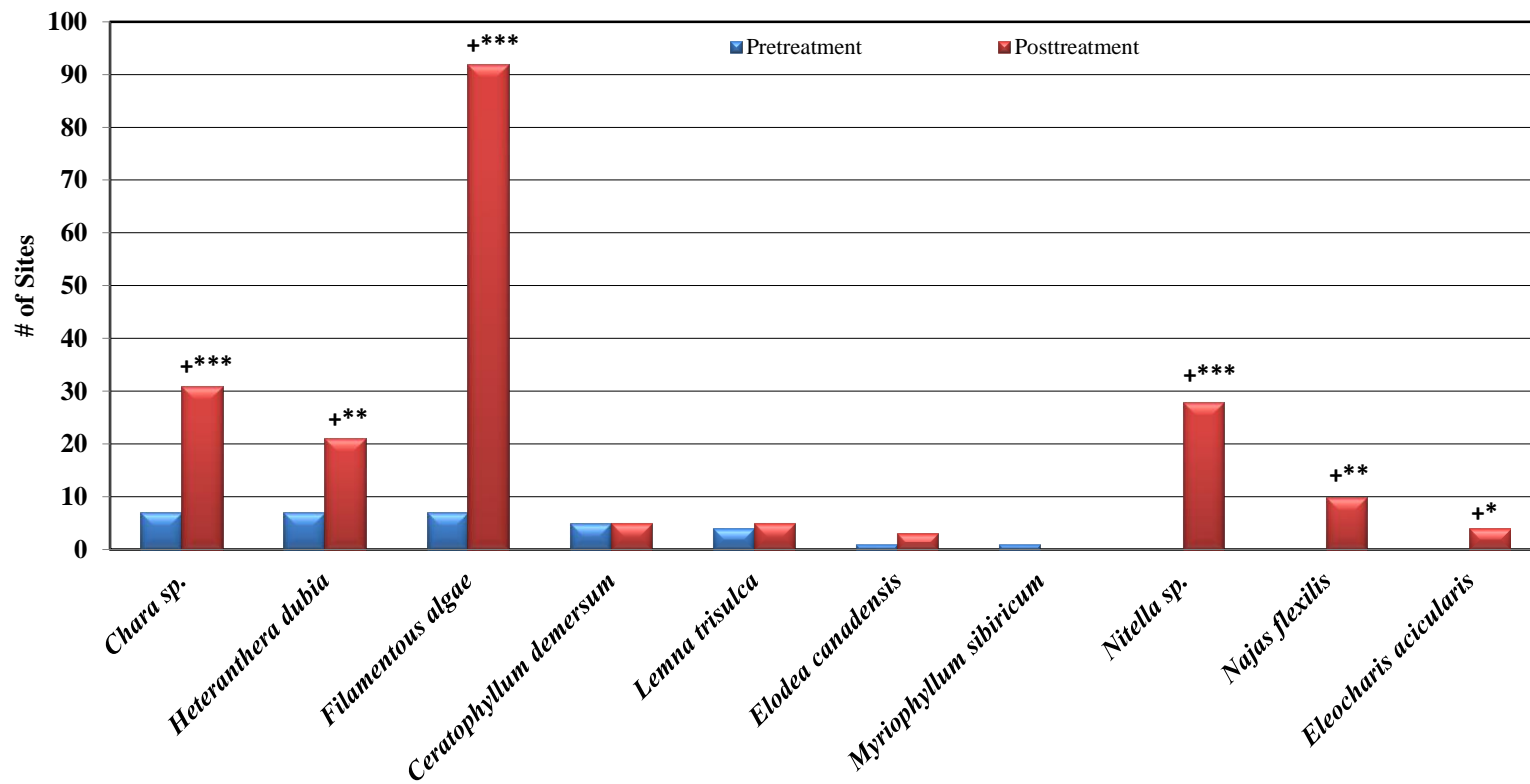
**Figure 16: Low Density Areas - Pre/Post Native Species Change**

**Pre/Post Differences for All Native Species  
Low Density Areas - Long Lake, Polk County  
April 29 and June 5-6, 2017**
