Church Pine, Round and Big Lakes Protection and Rehabilitation District

Aquatic Invasive Species Control Grant Project # ACEI-145-14

Final Report

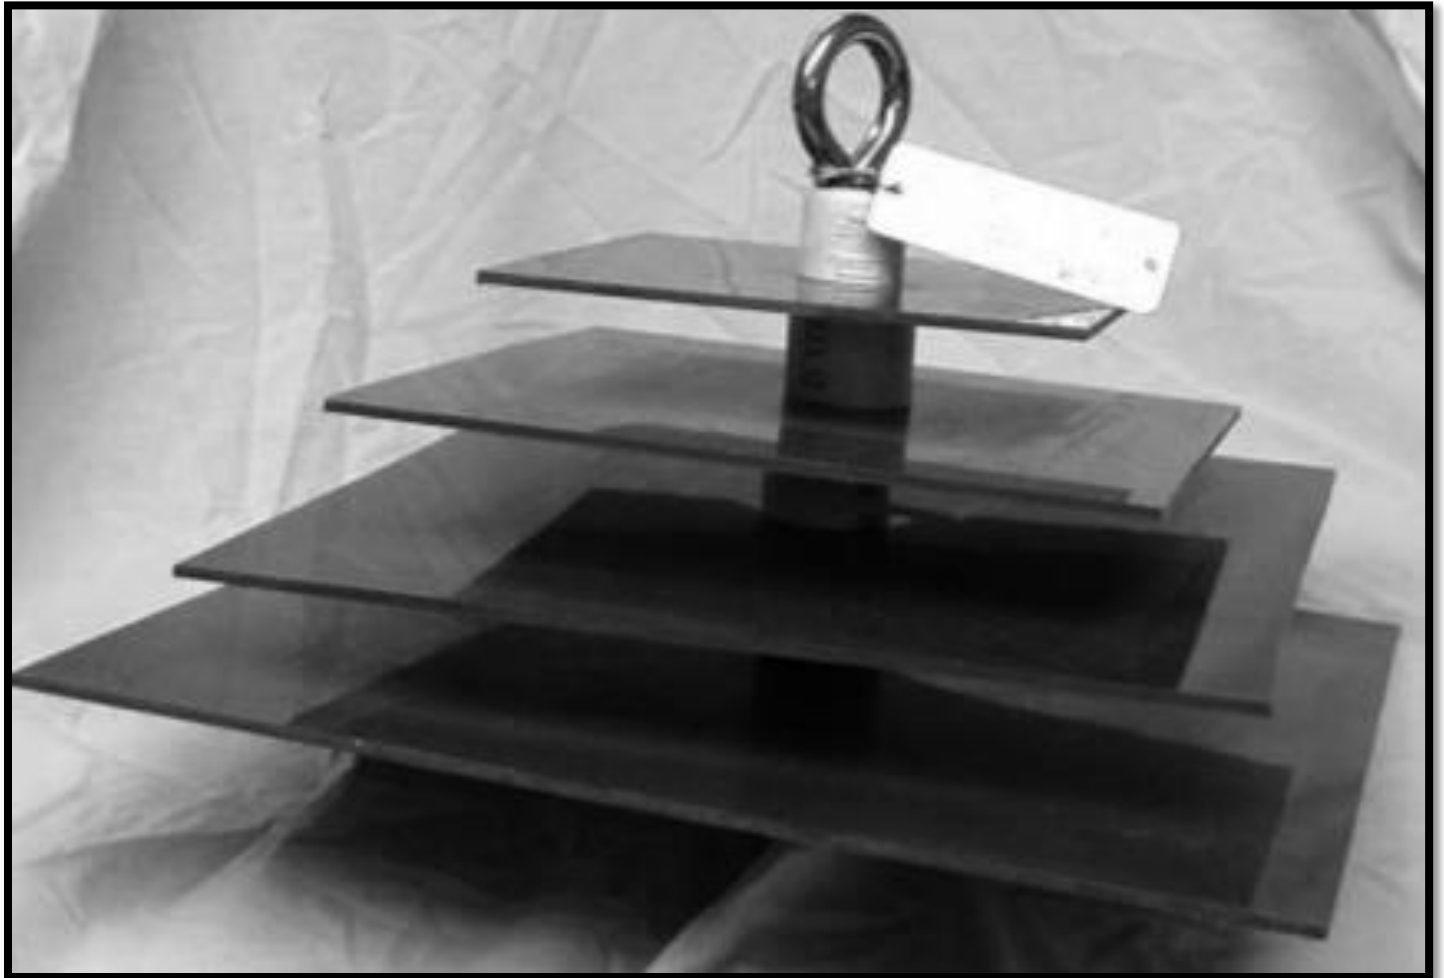
- Constructed and deployed 6 Zebra Mussel Substrate Samplers near high usage areas on all three lakes.

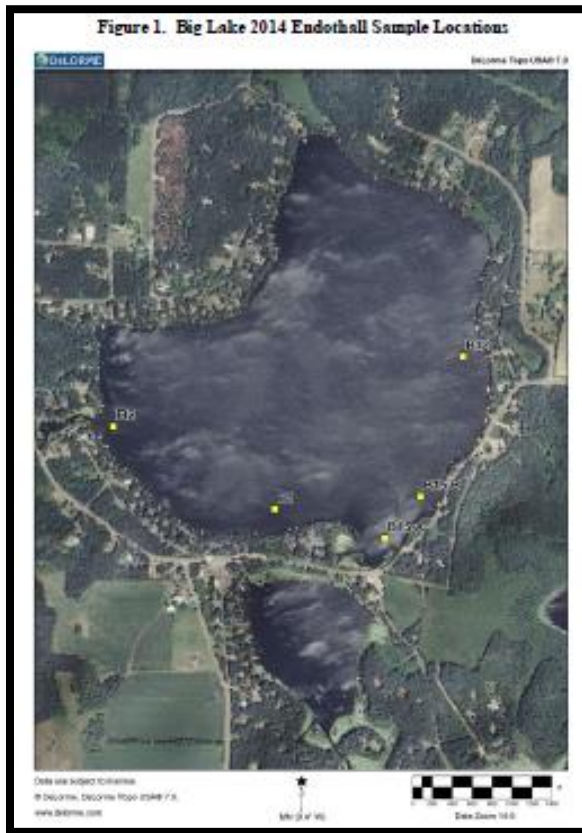
Figure 1. Big Lake 2014 Endothall Sample Locations:

- The Lake District participated in an herbicide concentration study led by John Skogerboe of the Army Corps of Engineers. Volunteers collected water samples as directed by the study design in order to fine-tune herbicide application rates for Big Lake. These studies were continued during the grant period. Results also provided guidance for lakes across the state.

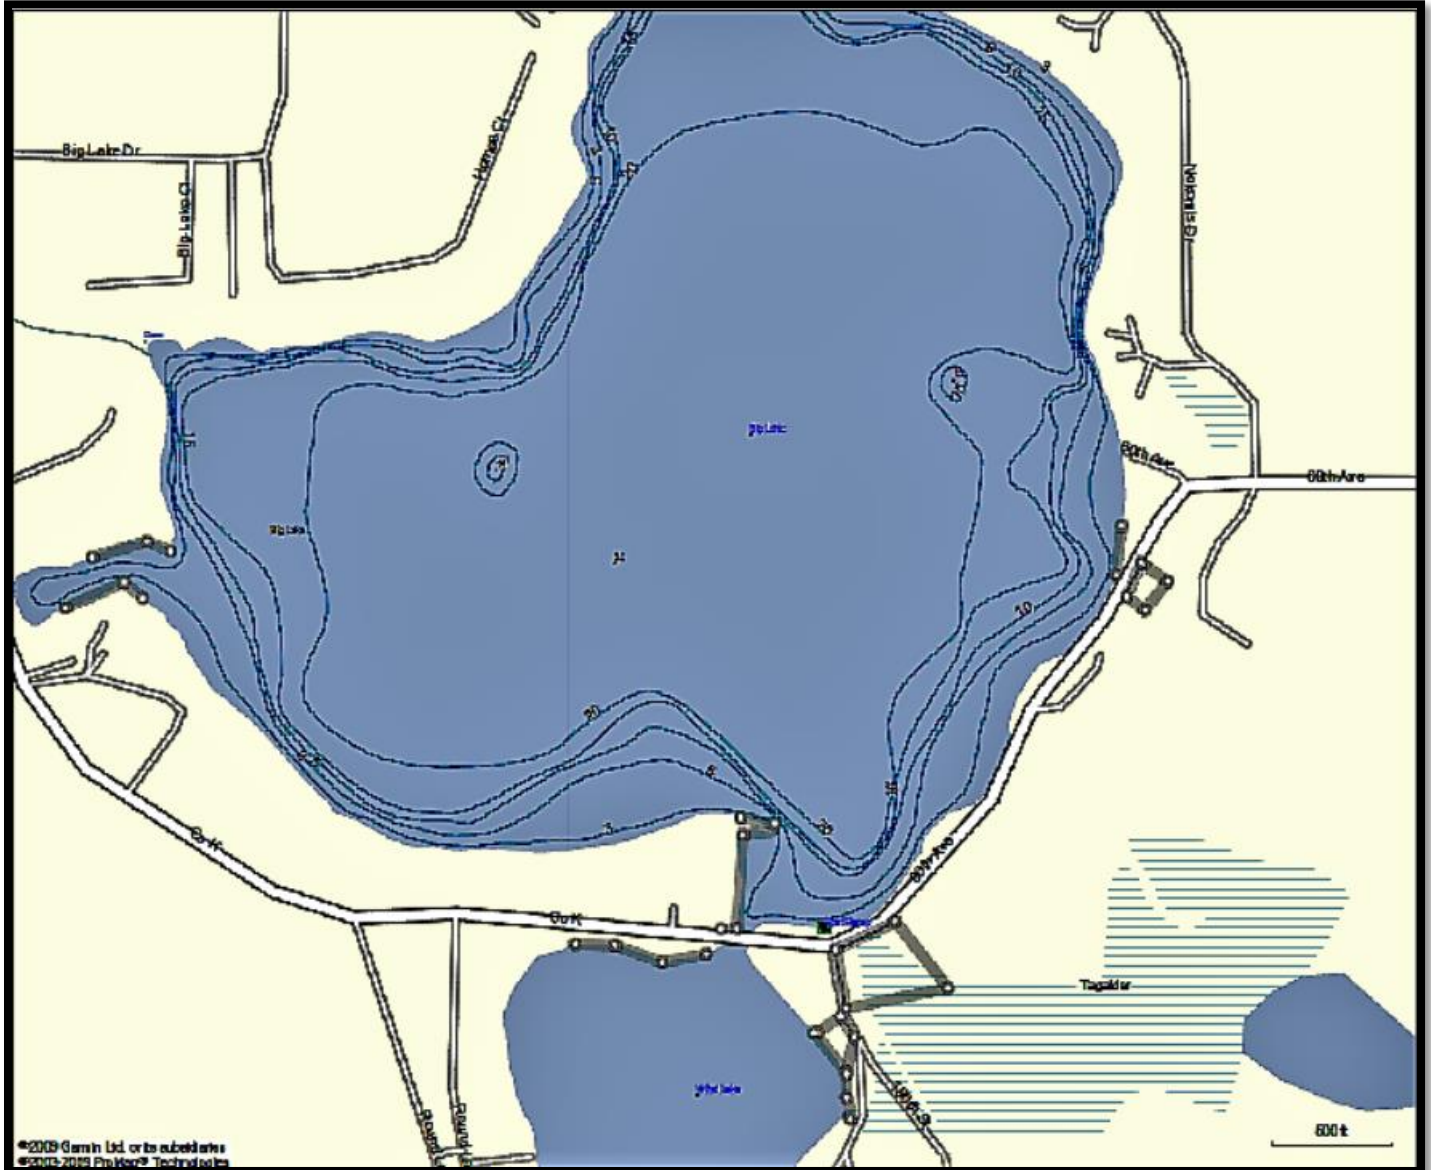
Map of 2016 Purple Loosestrife

- Northern Aquatic Service has been hired each project year to map and treat Purple Loosestrife.

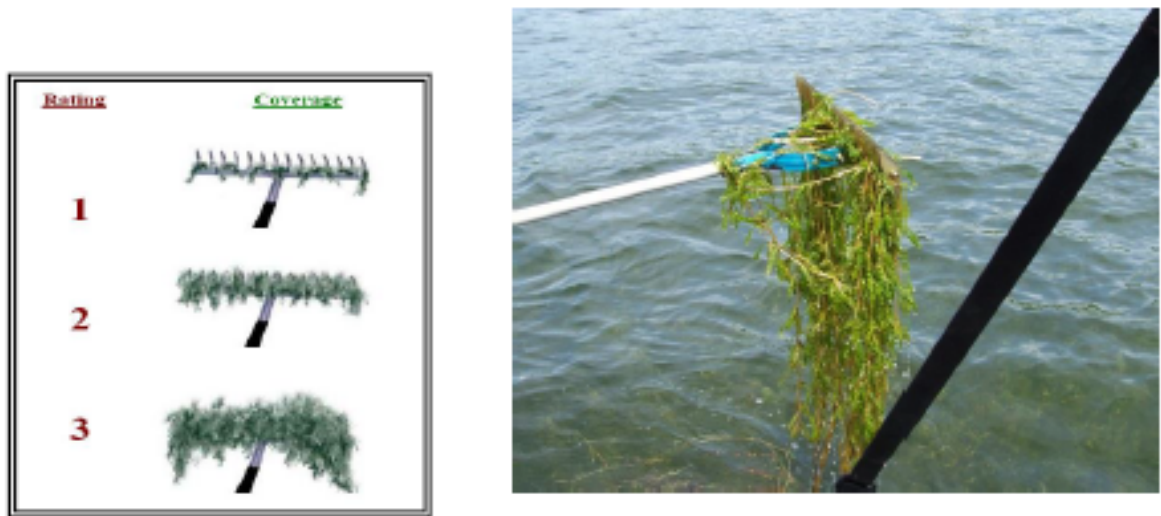
Figure 2: Density rating system and example CLP rake sample.

The second survey is referred to as the post treatment survey. This survey involves going to the same GPS coordinates as the pre-treatment survey and doing a rake sample at the point. If any CLP is on the rake, the density of the CLP is recorded (see fig 2 for reference). All other species are also recorded from the rake sample in order to verify no damage to the native plants.

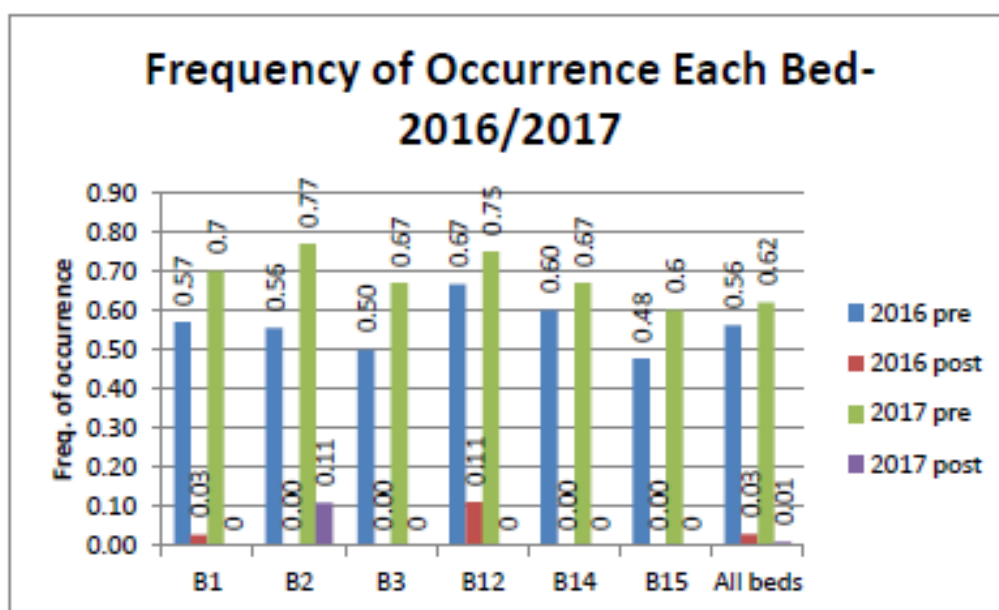
Figure 4: Graph showing the CLP frequency from pre/post treatment surveys for each bed 2016-2017.

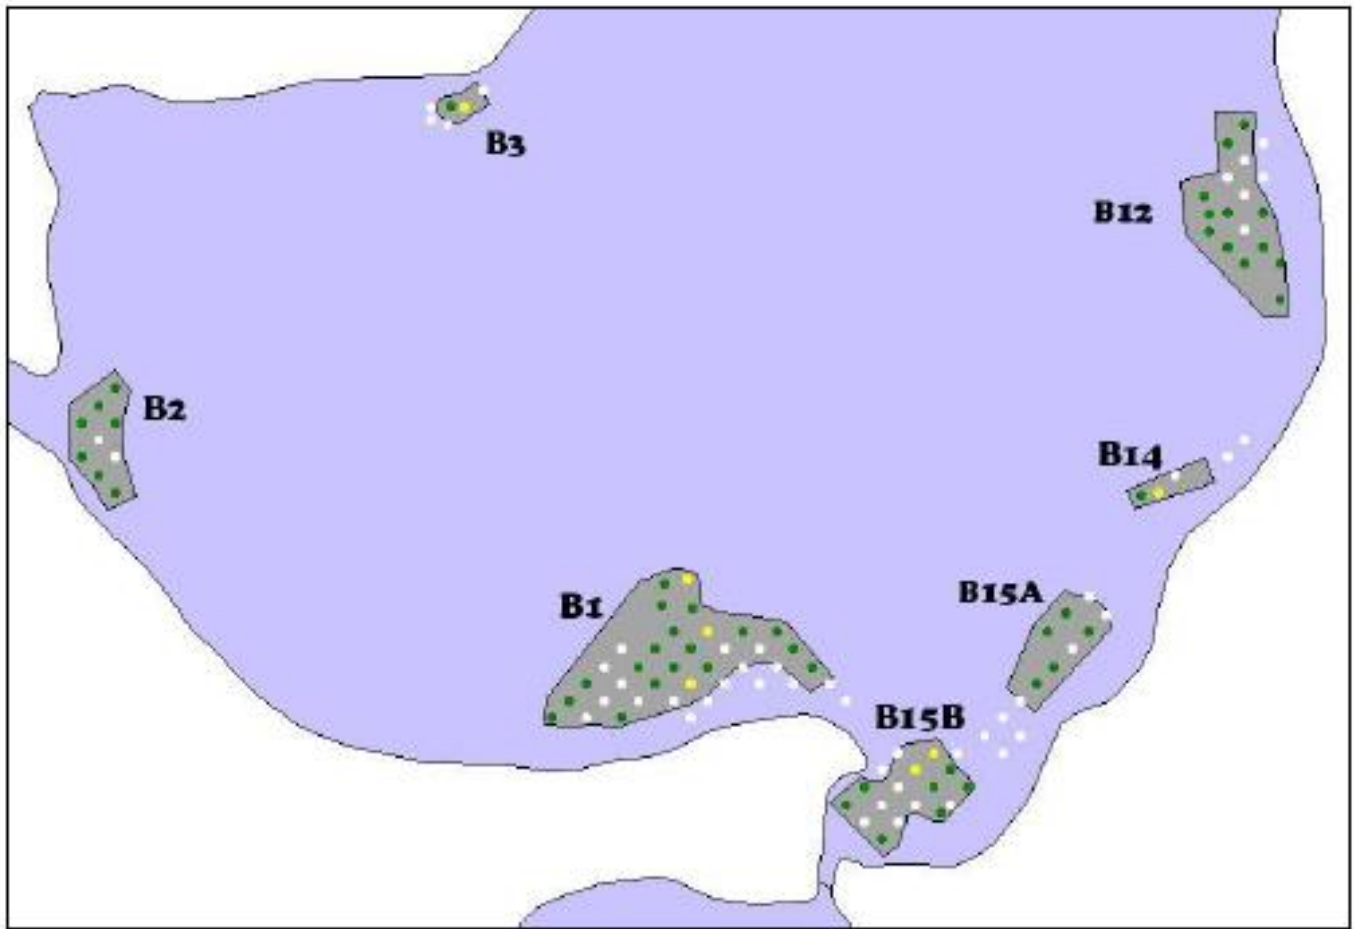
Figure 5: Map of CLP frequency from 2017 pretreatment survey.

A pretreatment survey was conducted on April 21, 2017. This survey found CLP growing in 61.6% of the sample points within the proposed treatment beds. A few changes were made in the bed borders, with the most dramatic separating Bed 15 into two beds. These beds (15A and 15B) are combined in the frequency summary chart in order to more easily compare from previous years. Table 2 shows the frequency summary from 2016 and 2017.

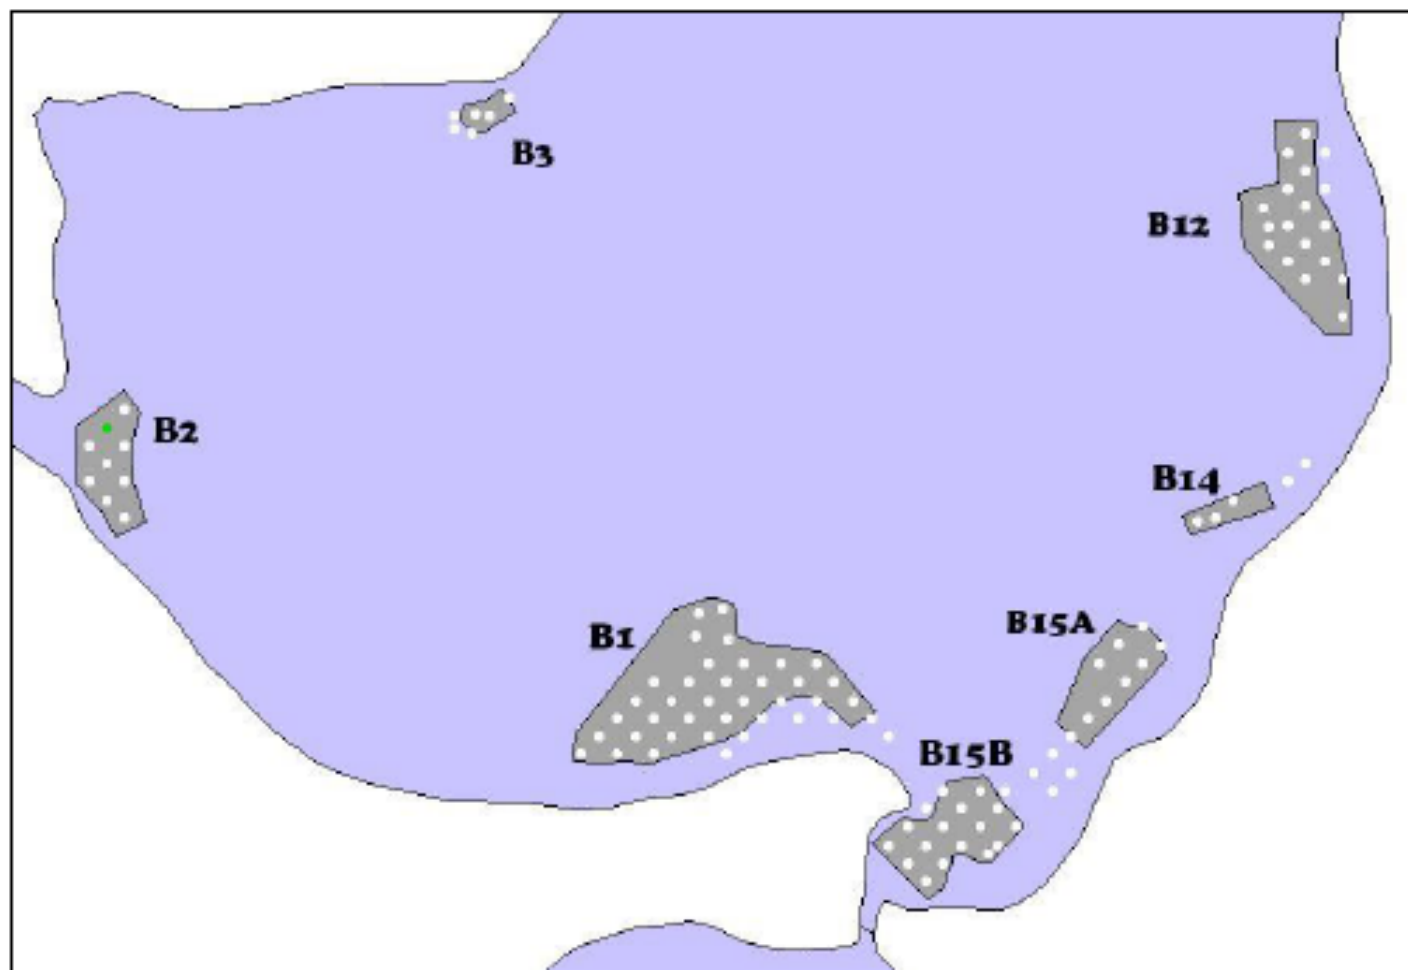
Figure 6: Map of CLP frequency from 2017 post treatment survey.

Following treatment, a post treatment survey was conducted on June 6, 2017. This time corresponds with dense growth of CLP on other area lakes (can't compare untreated areas in Big Lake as no CLP growth was occurring). CLP was present in only 1.2% of the sample points. Figures 5 and 6 show the distribution of CLP within the treatment beds.

The data shows a significant reduction in CLP growth from before treatment occurred (pretreatment survey) and after treatment occurred (post treatment). The CLP frequency before treatment was 56.25 and was reduced to 1.2% after treatment. A chi-square analysis showed this was statistically significant. Comparing the 2016 frequency results to 2017 can show if an overall reduction occurred between those years. The post treatment frequency change was a very small reduction from 2016 to 2017, but is not statistically significant. It is difficult to reduce such small frequency results. Statistics are calculated on all beds combined, but figure 4 graphically reflects frequencies in various surveys for each treatment bed.

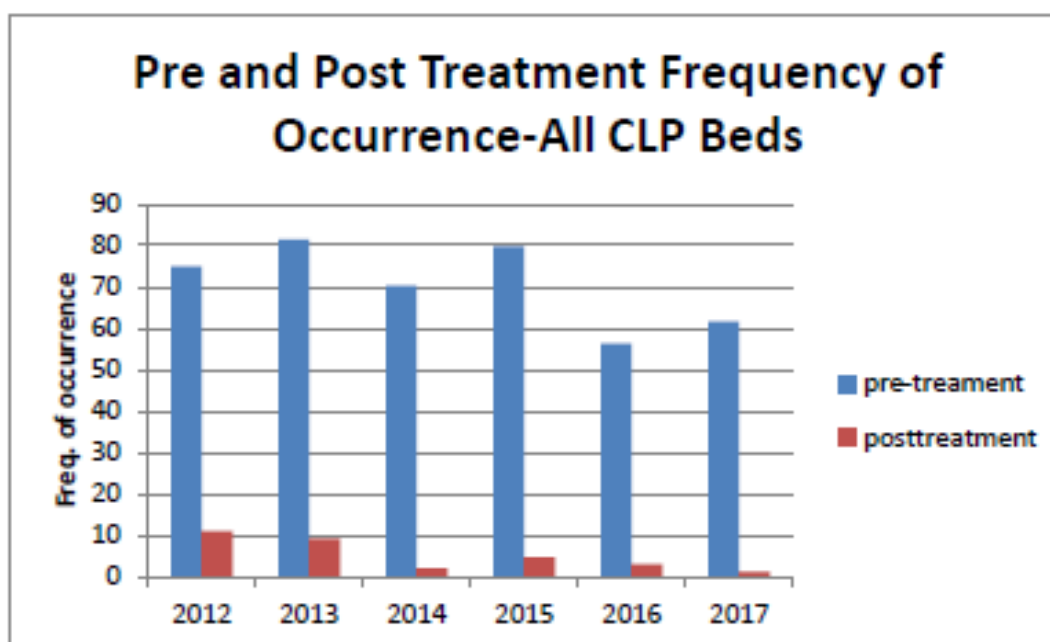
Figure 7: Graph showing CLP frequency changes from 2012 to 2017.

Comparing pretreatment surveys show long-term changes as these surveys are conducted after CLP growth has resulted from turion germination in the winter/spring. There was a small increase from 2016 to 2017 (56.25% to 61.2%), but this increase could be from reducing size of bed 15 making more sample points only in areas with CLP. Figure 7 graphically demonstrates the changes in overall frequency from 2012 to 2017.

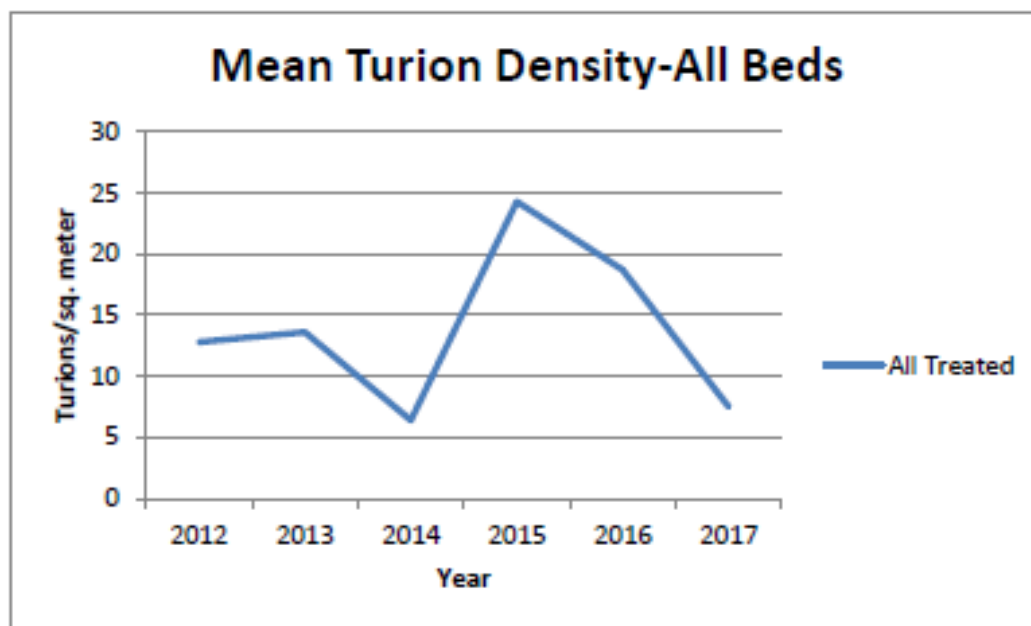
Figure 8: Graph showing turion density changes from 2012 to 2016.

The overall turion density decreased from 2016 to 2017, 18.7 turions/m² to 7.5 turions/m² respectively. Figure 8 shows the mean turion density is back down near the lowest point. This suggests less CLP will be growing in the spring. Since some turions remain, some growth can be expect in spring, 2018.

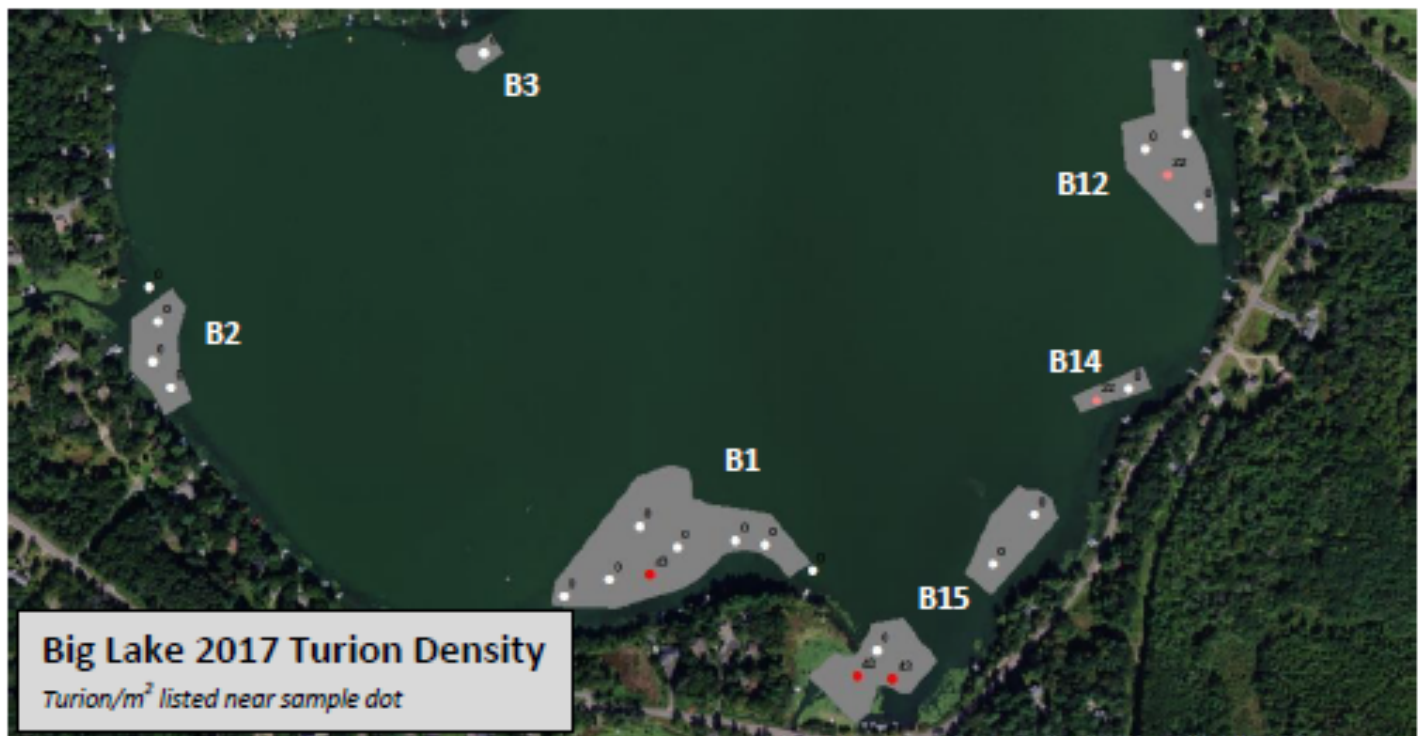
Figure 9: Map of turion density from turion analysis October, 2017.

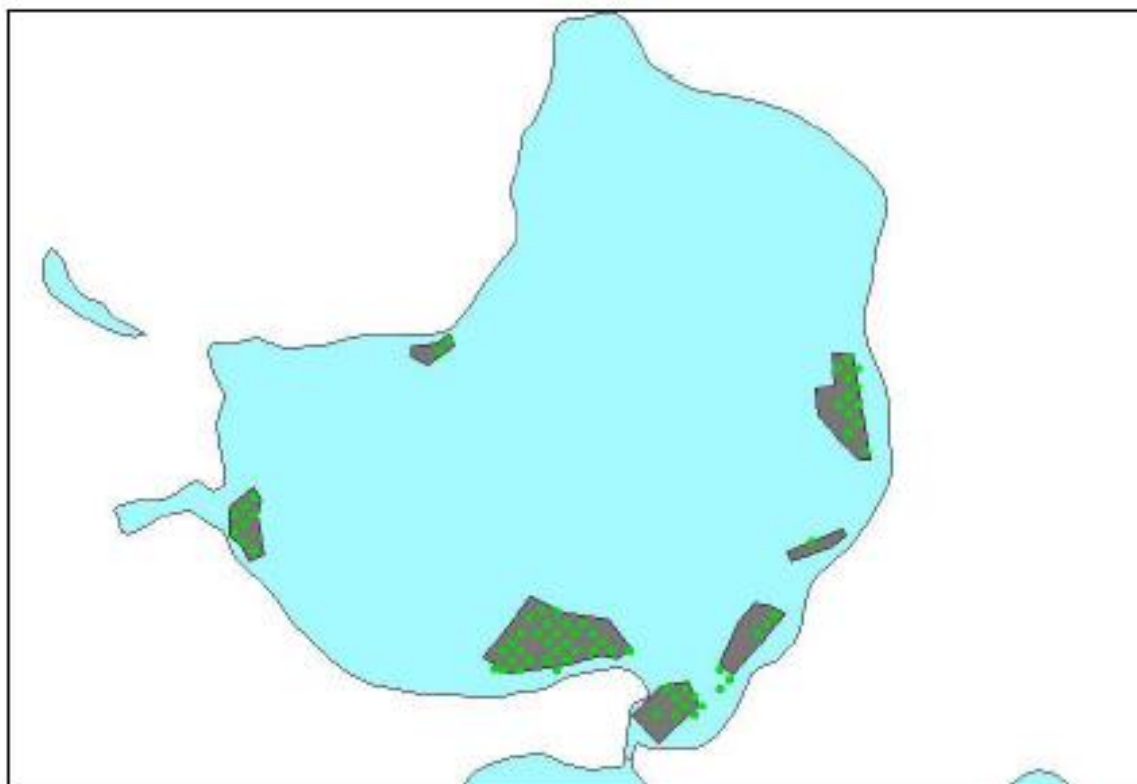
Waterweed or elodea-*Elodea Canadensis*-2016

The 2017 chi-square analysis indicates there were two statistically significant reductions in native plant species (*Elodea canadensis* and *Lemna trisulca*). There was one significant increase in native species (*Ceratophyllum demersum*). The cause of the reductions could be due to herbicide use. It is also possible that natural variation and/or sampling variation could be a factor. Plants that are not dormant at the time of treatment are susceptible. Table 4 shows a summary of the native plant frequencies for 2016 and 2017, along with the significance of any changes.

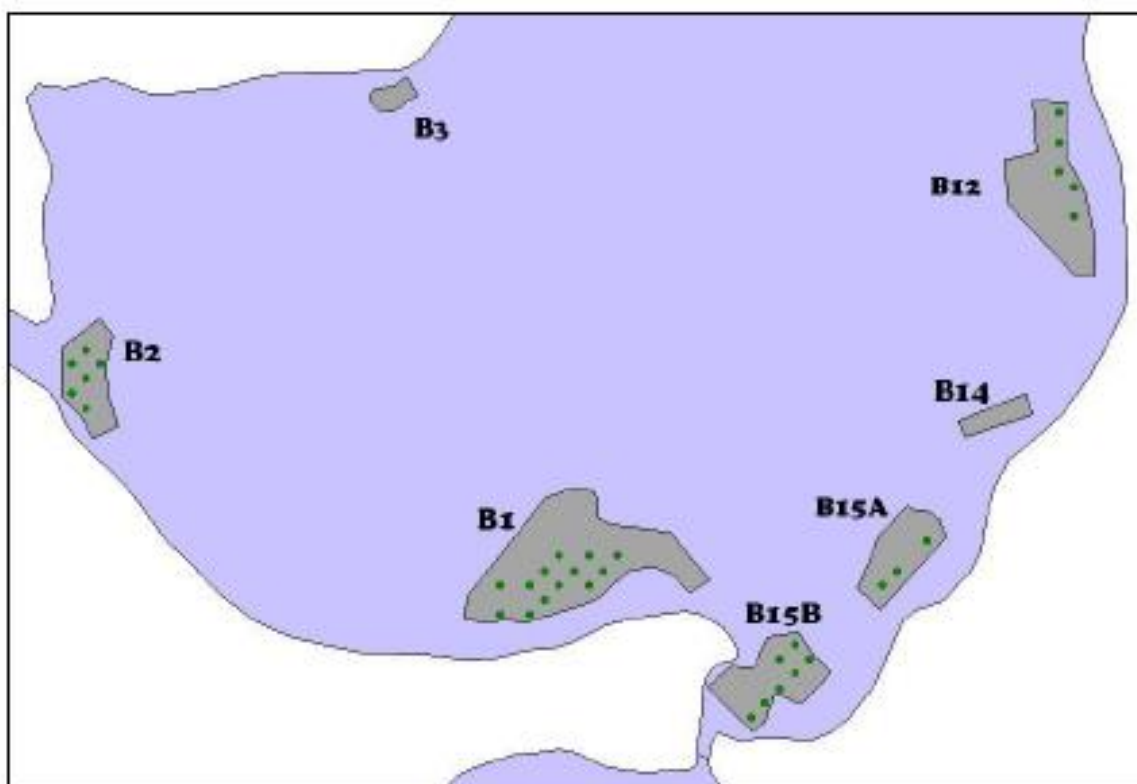
Waterweed or elodea-*Elodea Canadensis*-2017

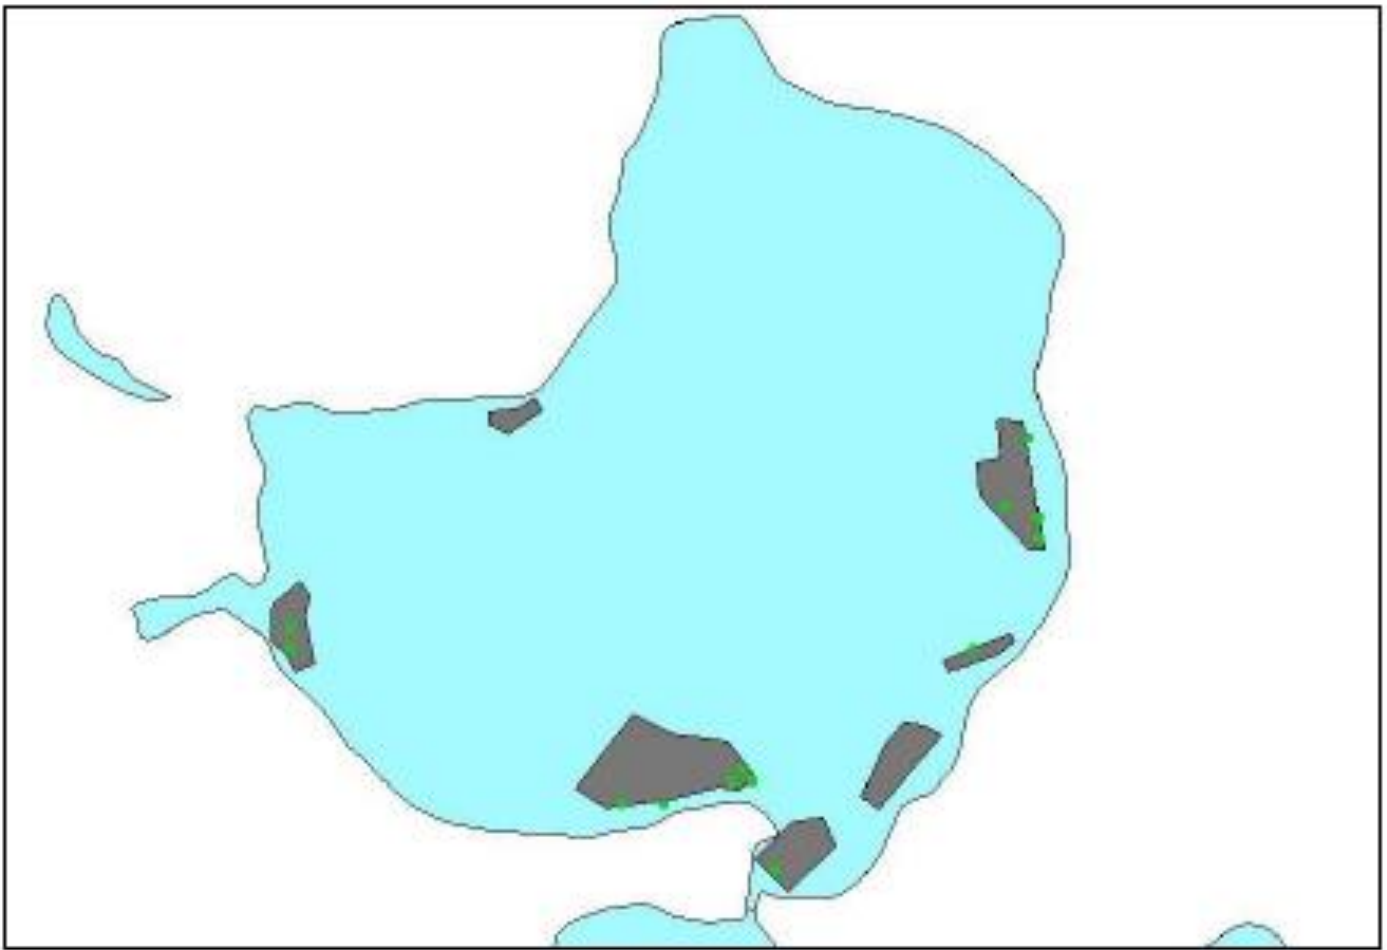
Forked duckweed-*Lemna trisulca*-2016
