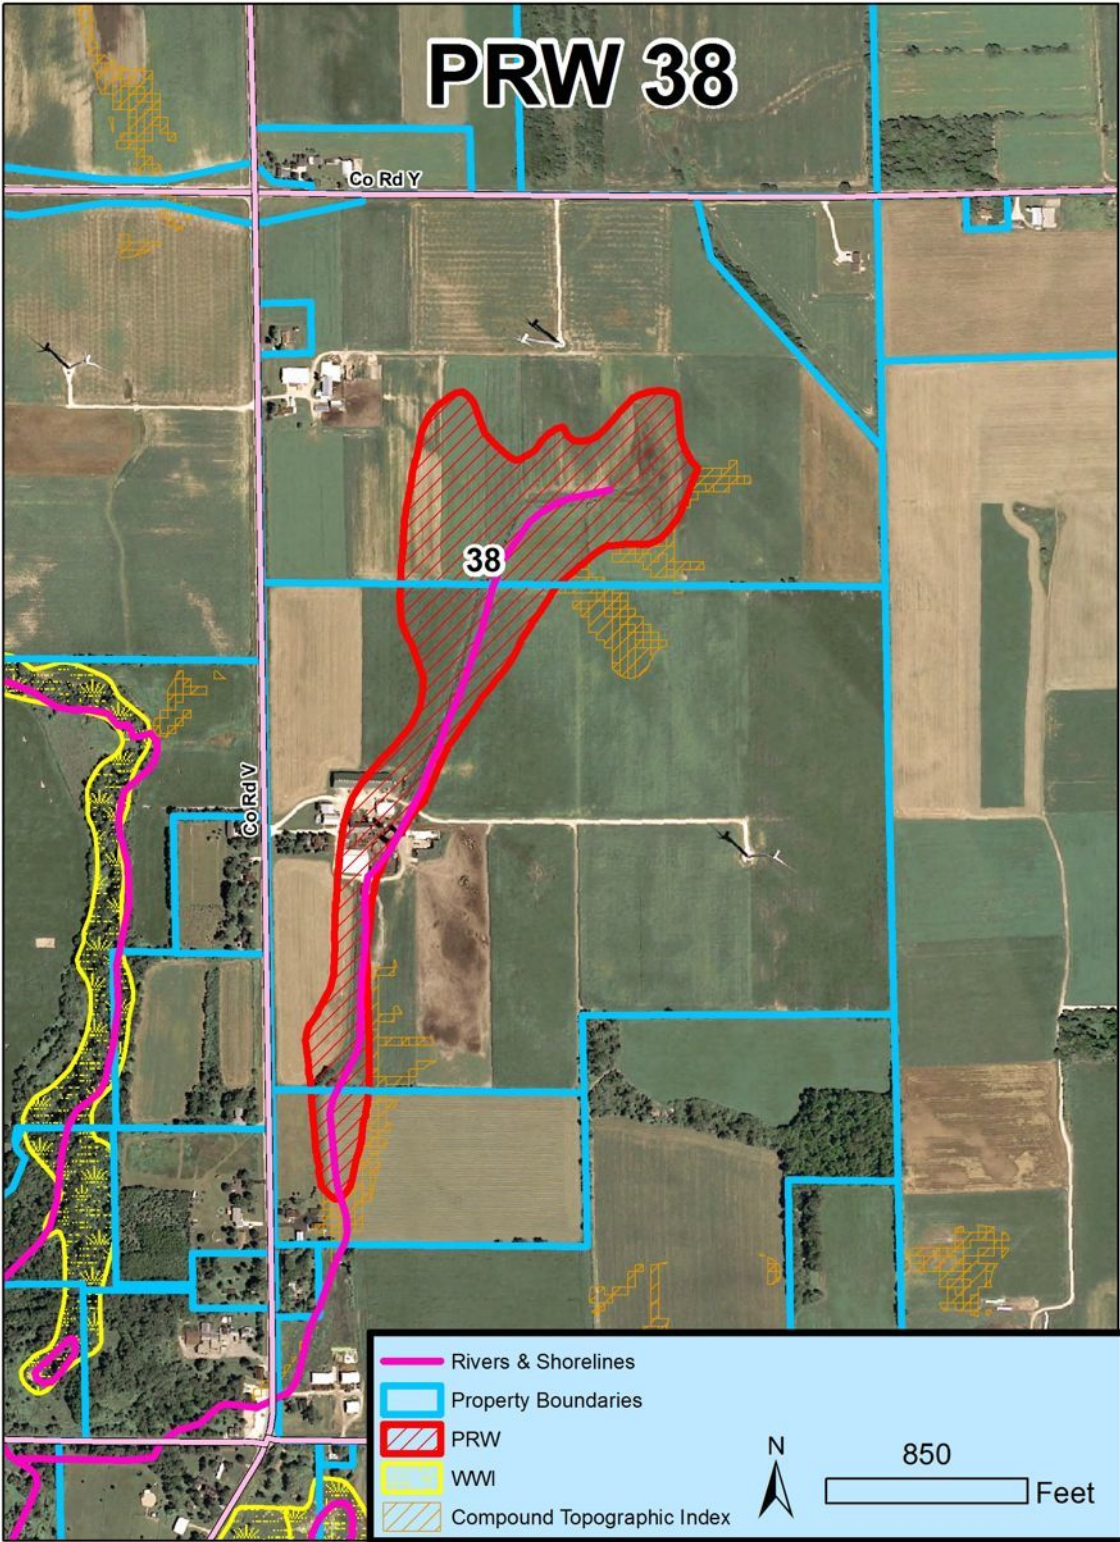
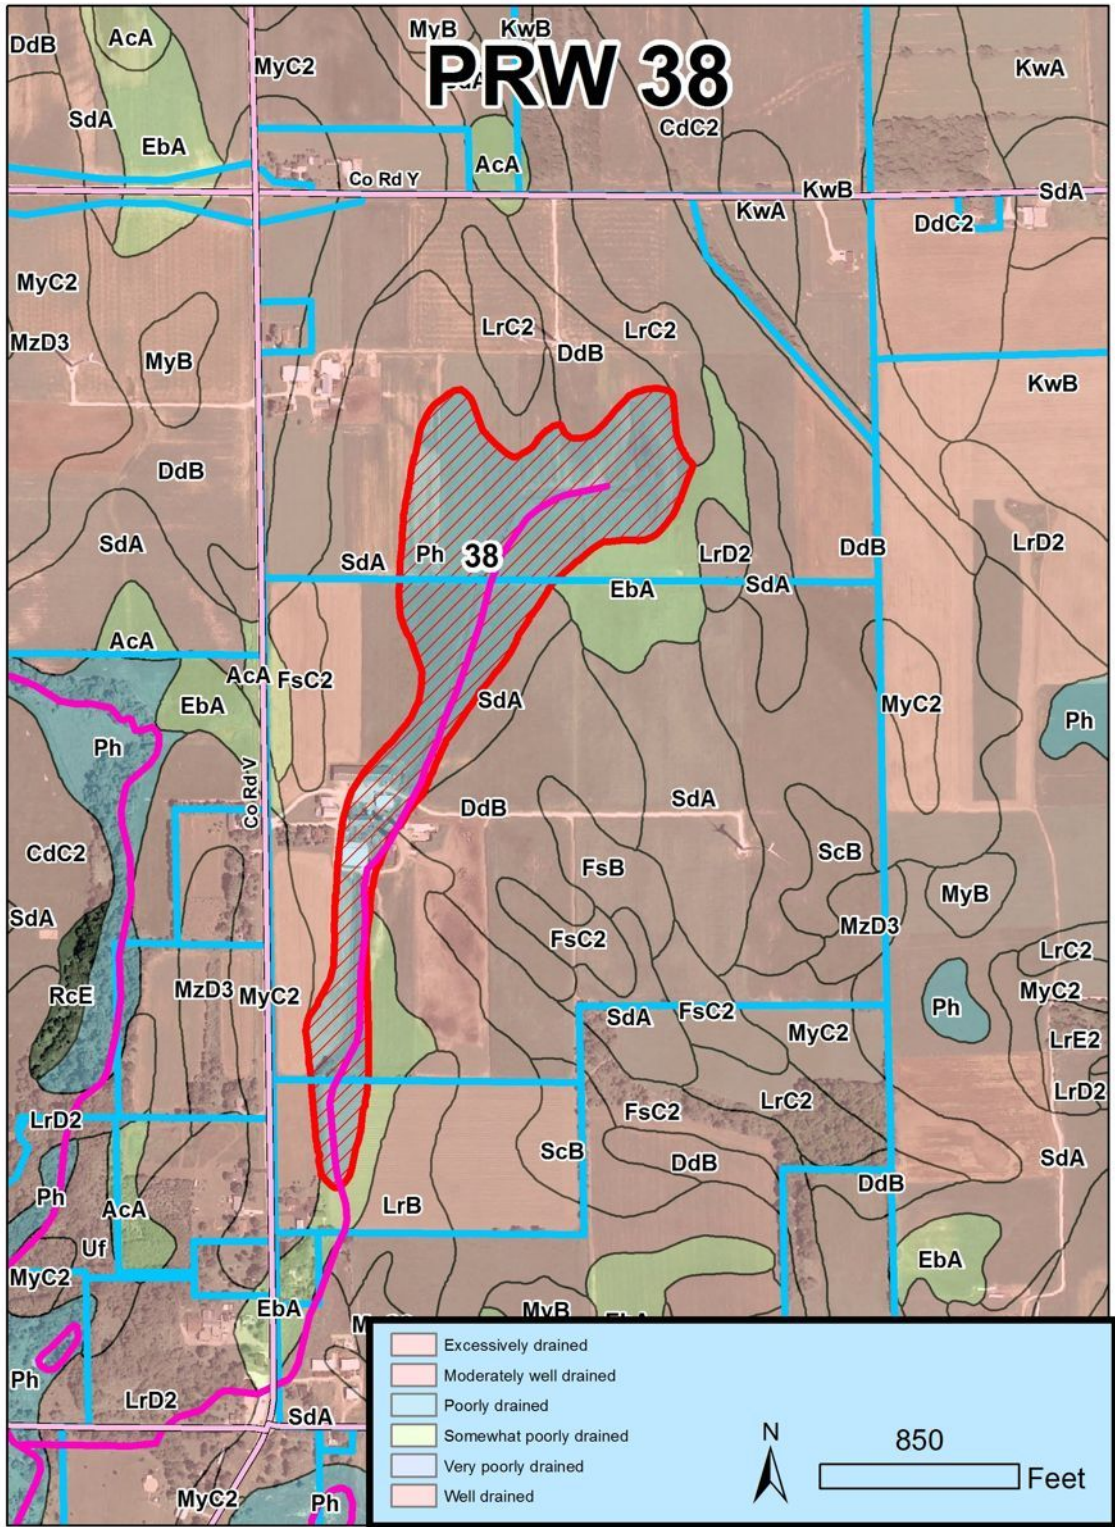
# PRW 38

One large ditch present. North end near windmill has unplanted areas. Ditch fill could pond water over large, flat area. North end of PRW restorable.

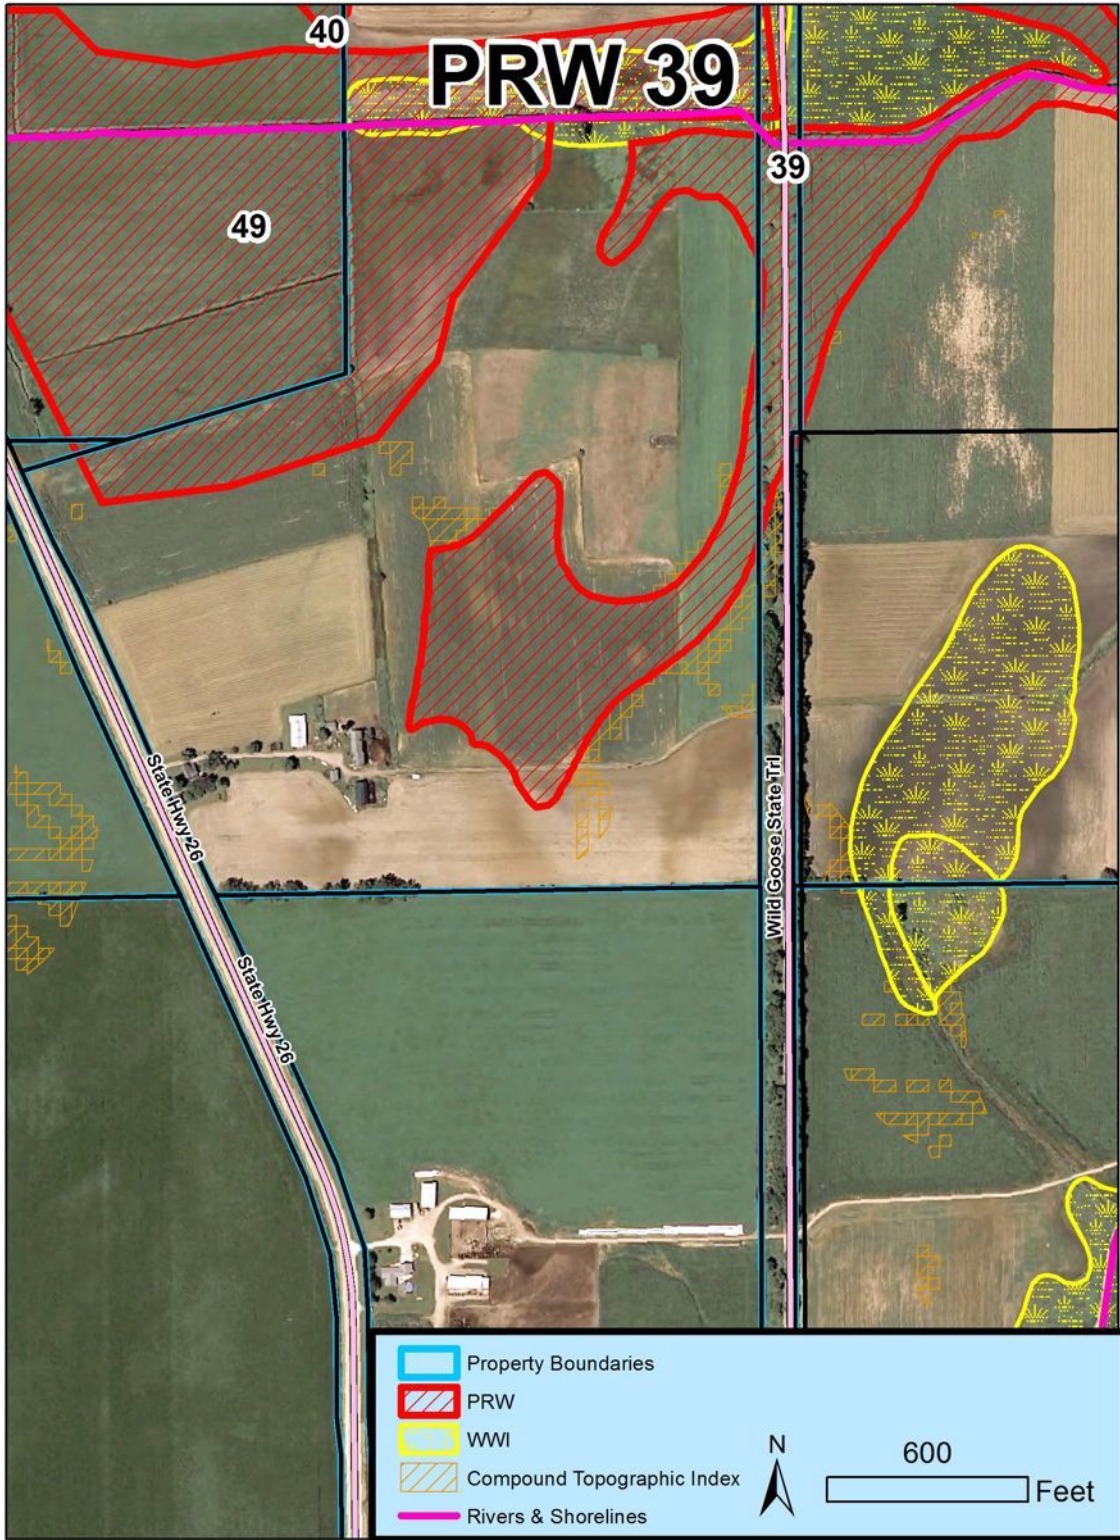
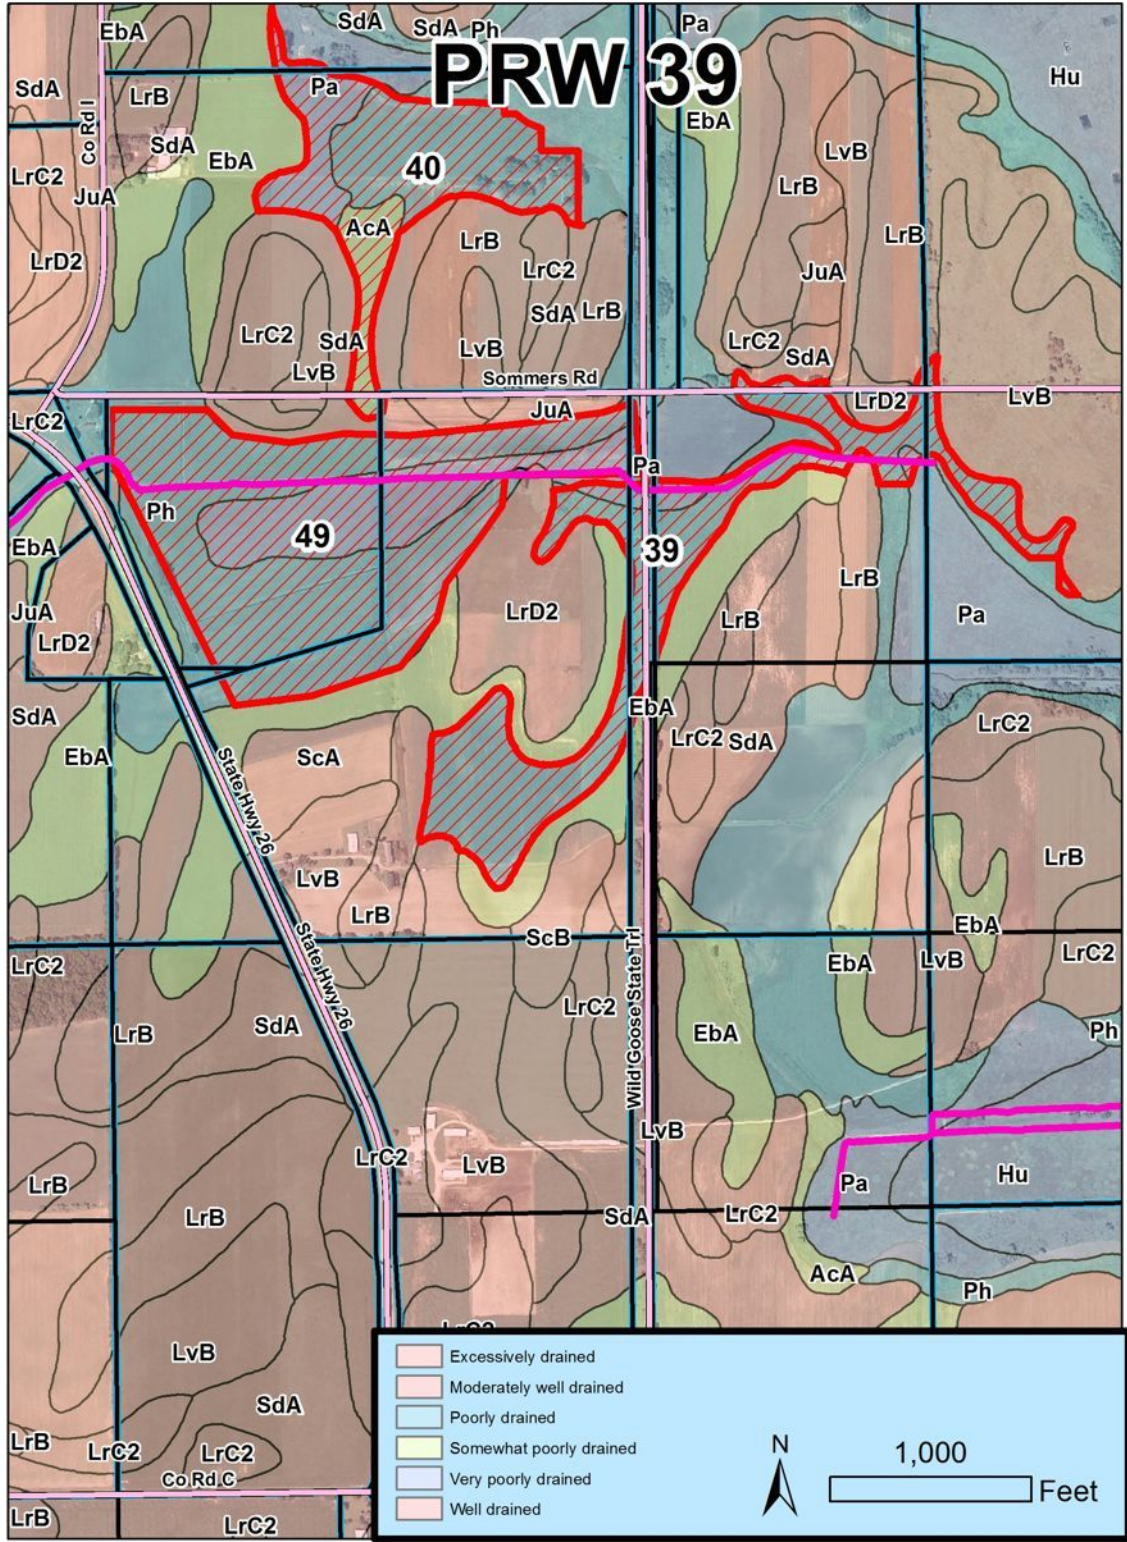
# PRW 39

No surface drainage, may be tiled. Does not look restorable unless tiled.

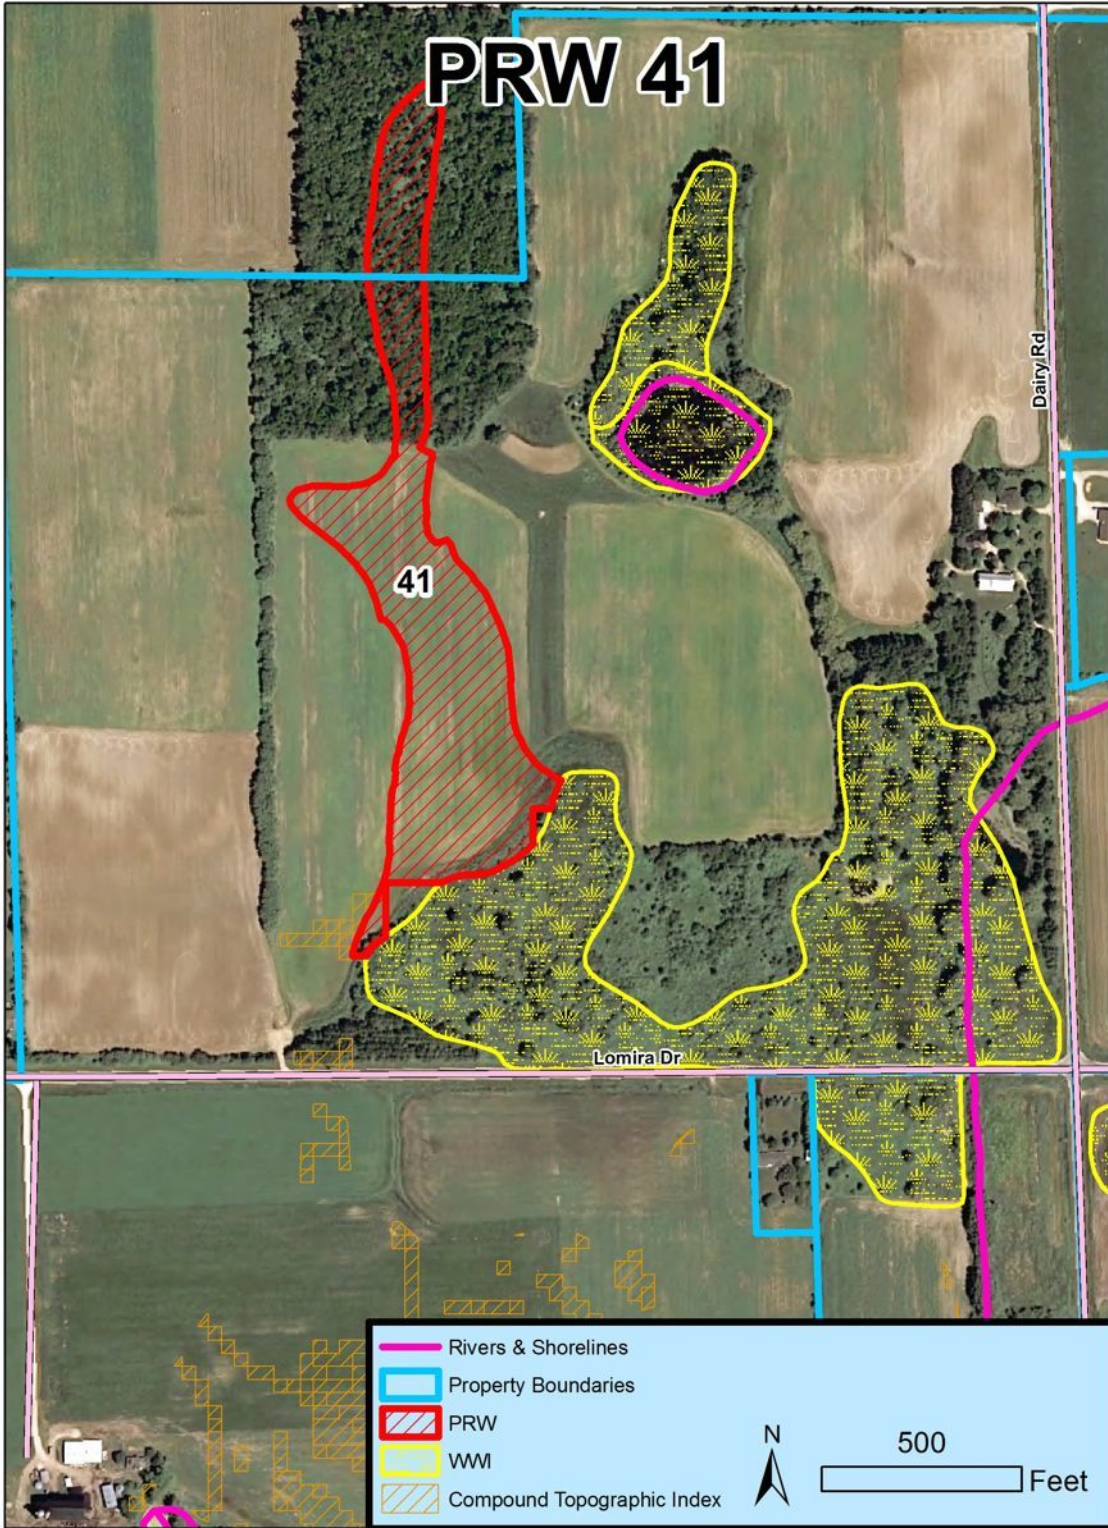
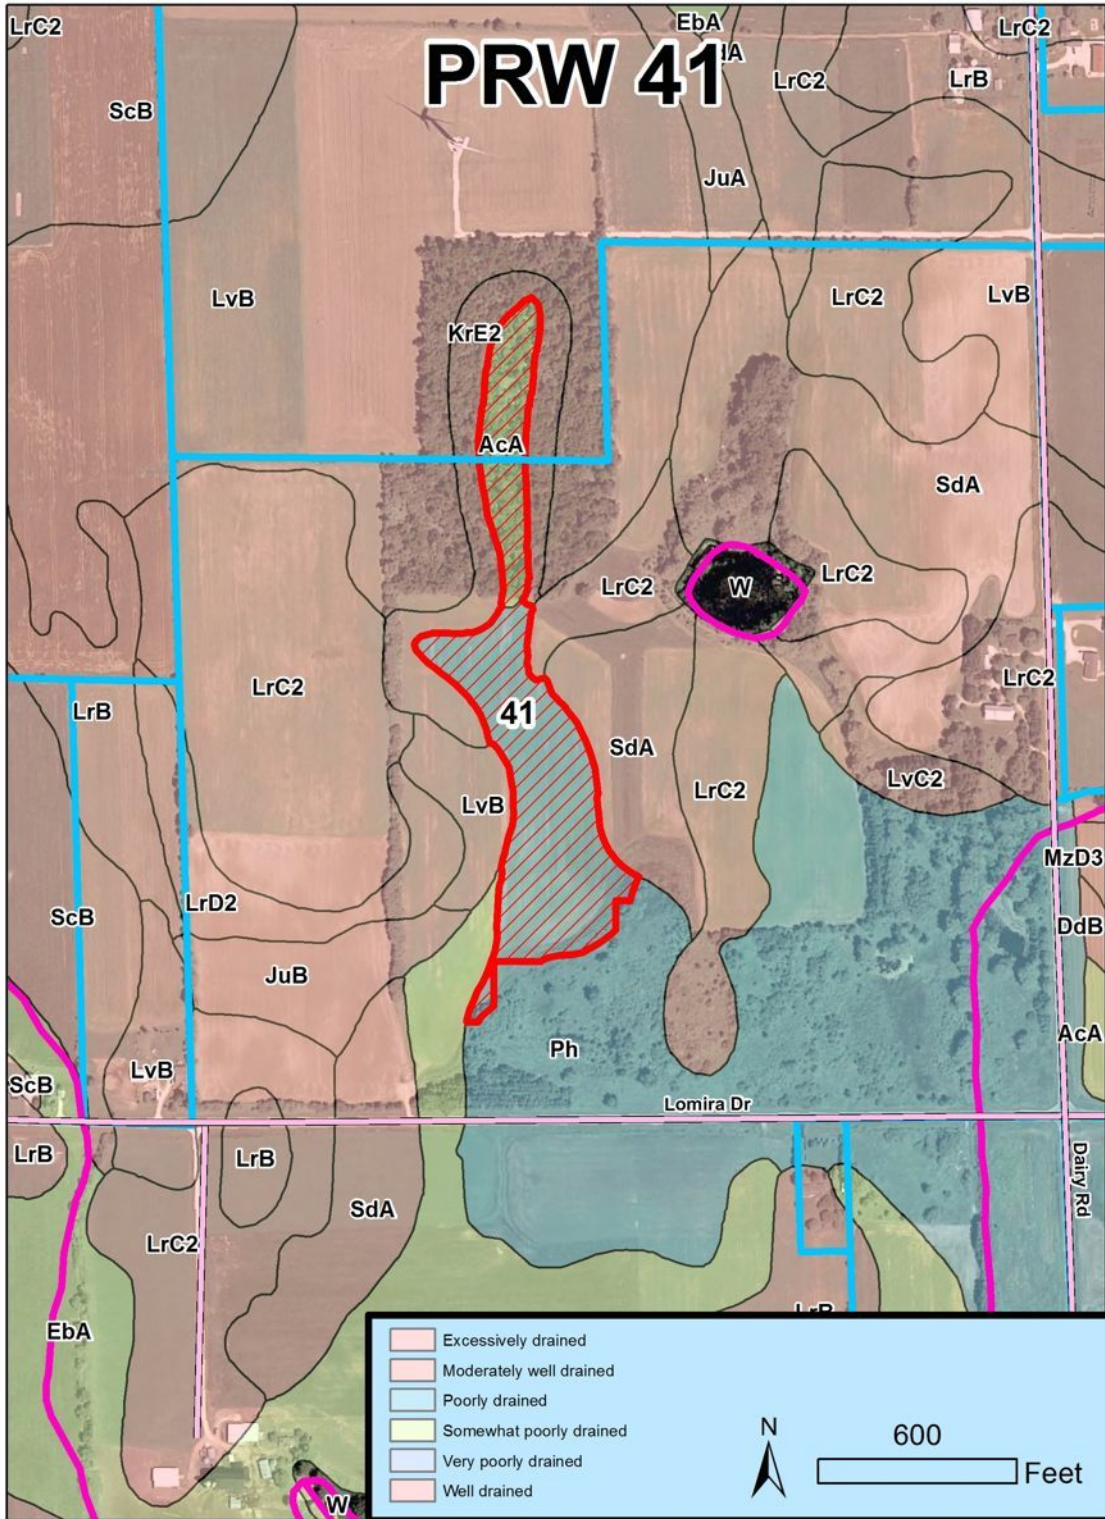
# PRW 41

Could not see PRW. Two ditches run south out of wetland that sits south of PRW. But PRW is probably higher on landscape and without strong restoration potential.

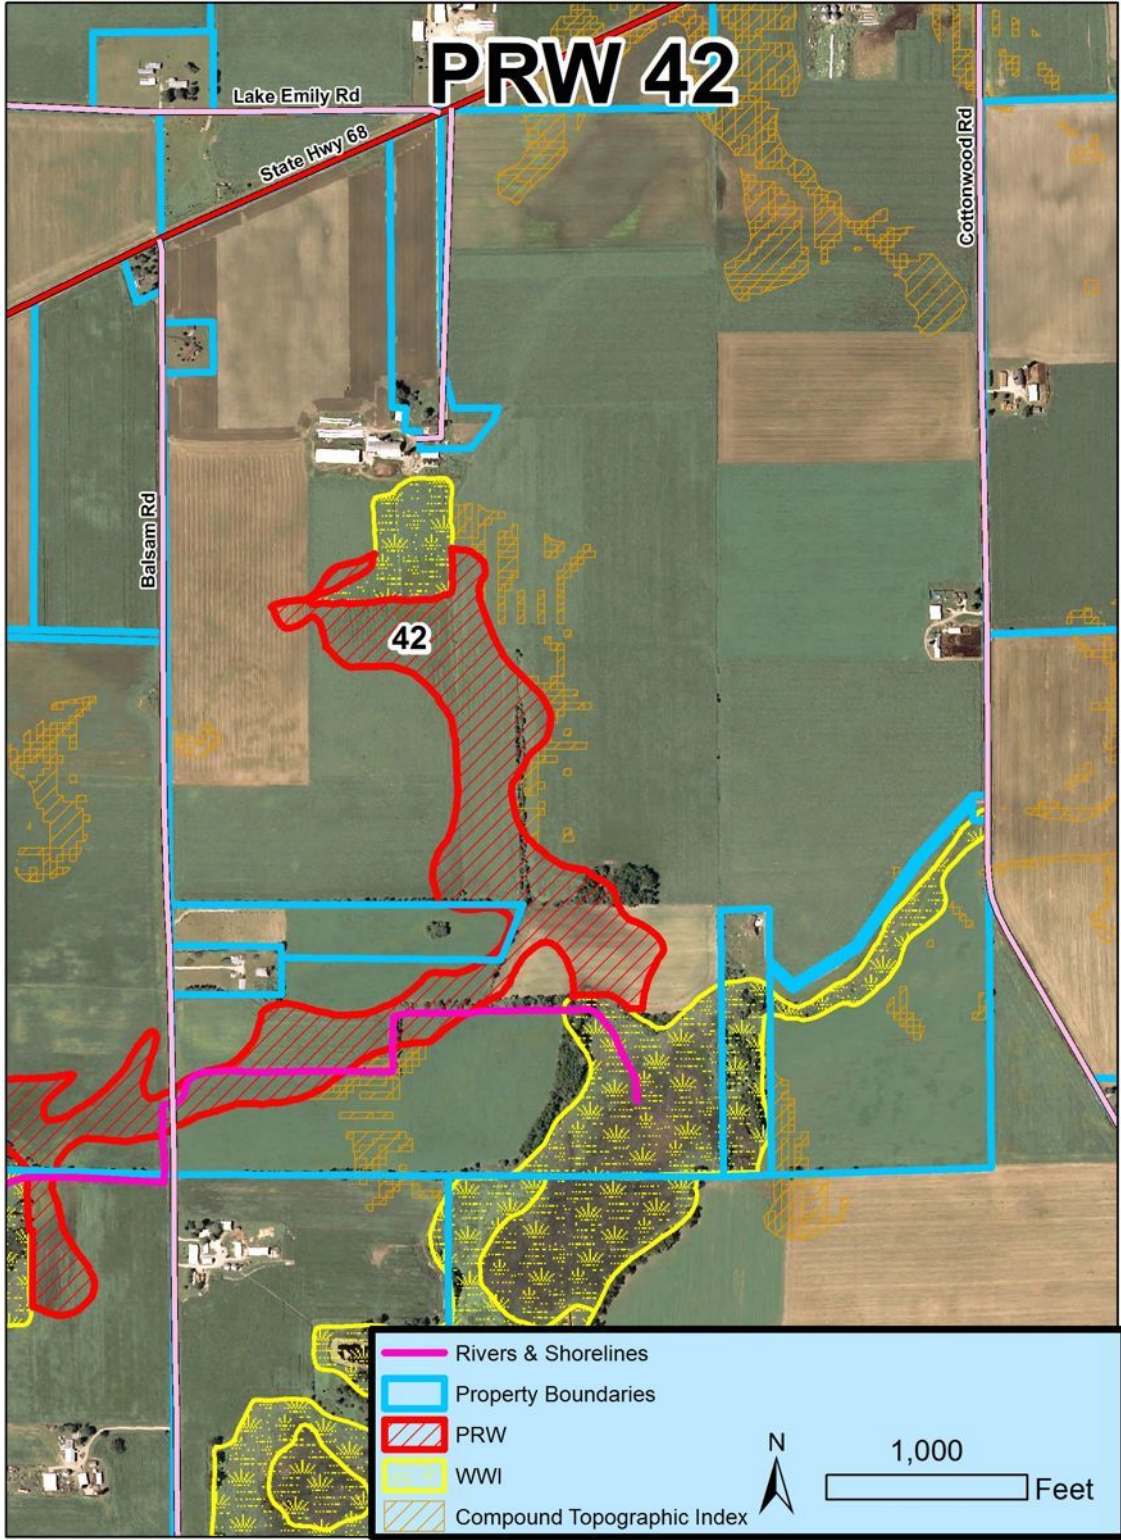
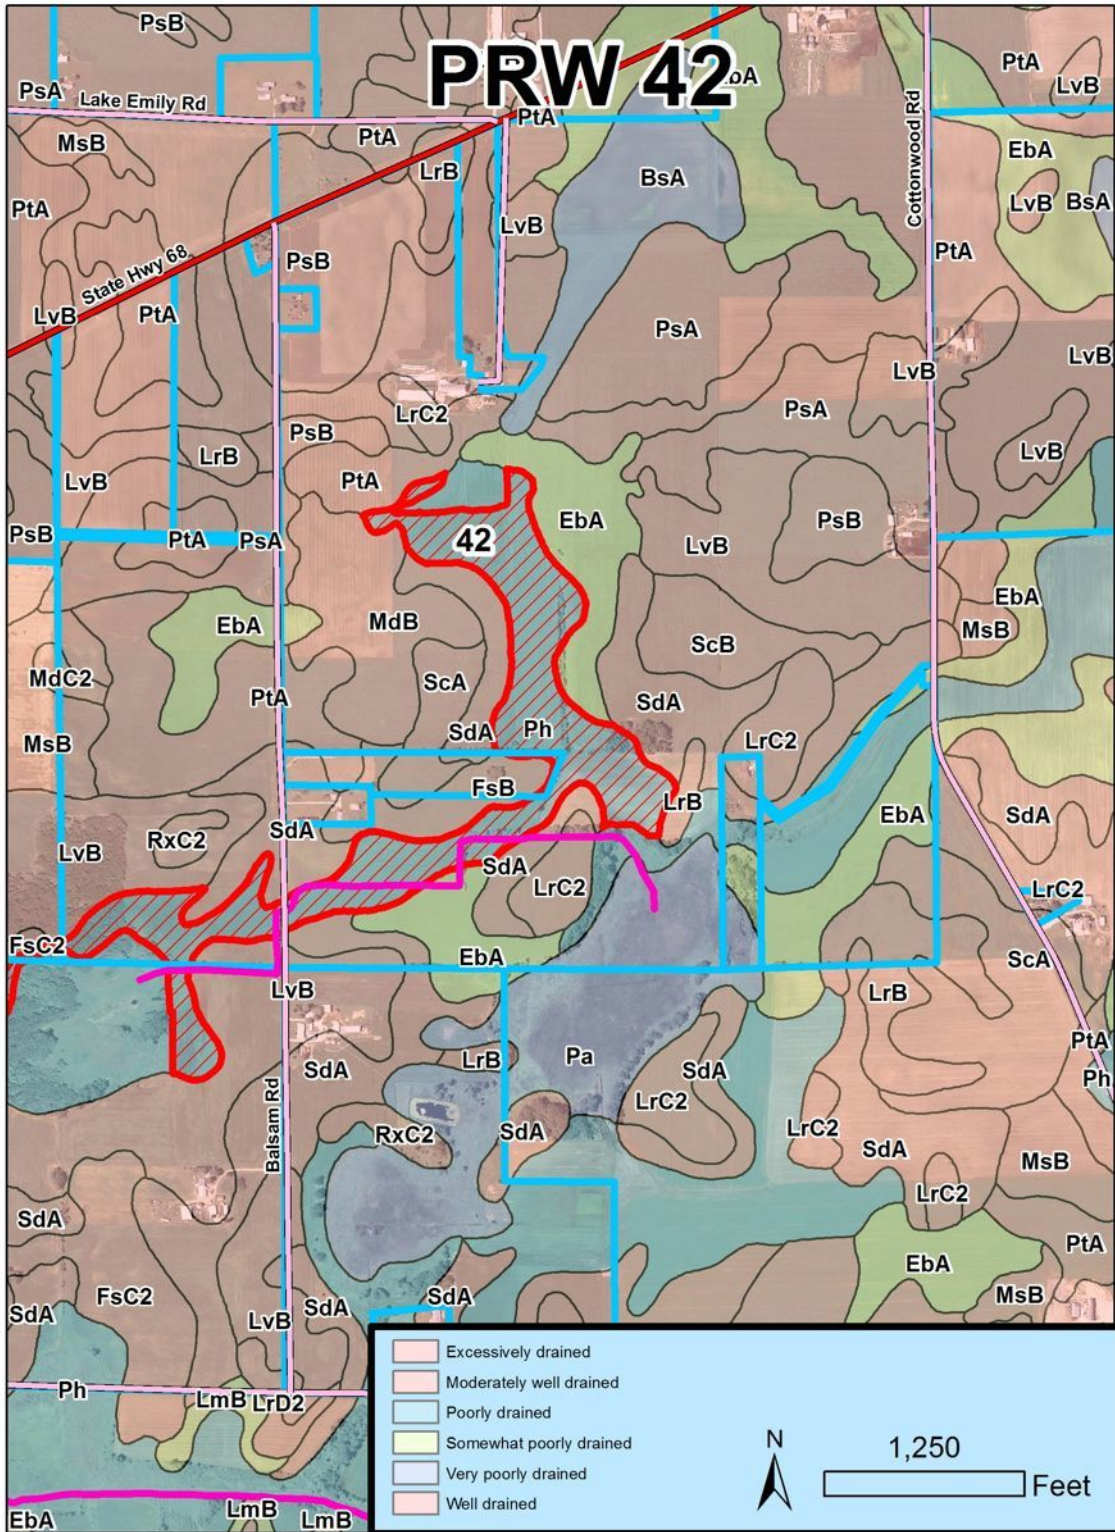
# PRW 42

Shallow ditch, recently cleaned of trees, restorable. Need to keep adjacent P/L ditch open for neighbor on west. Could be tile system running south to outlet.

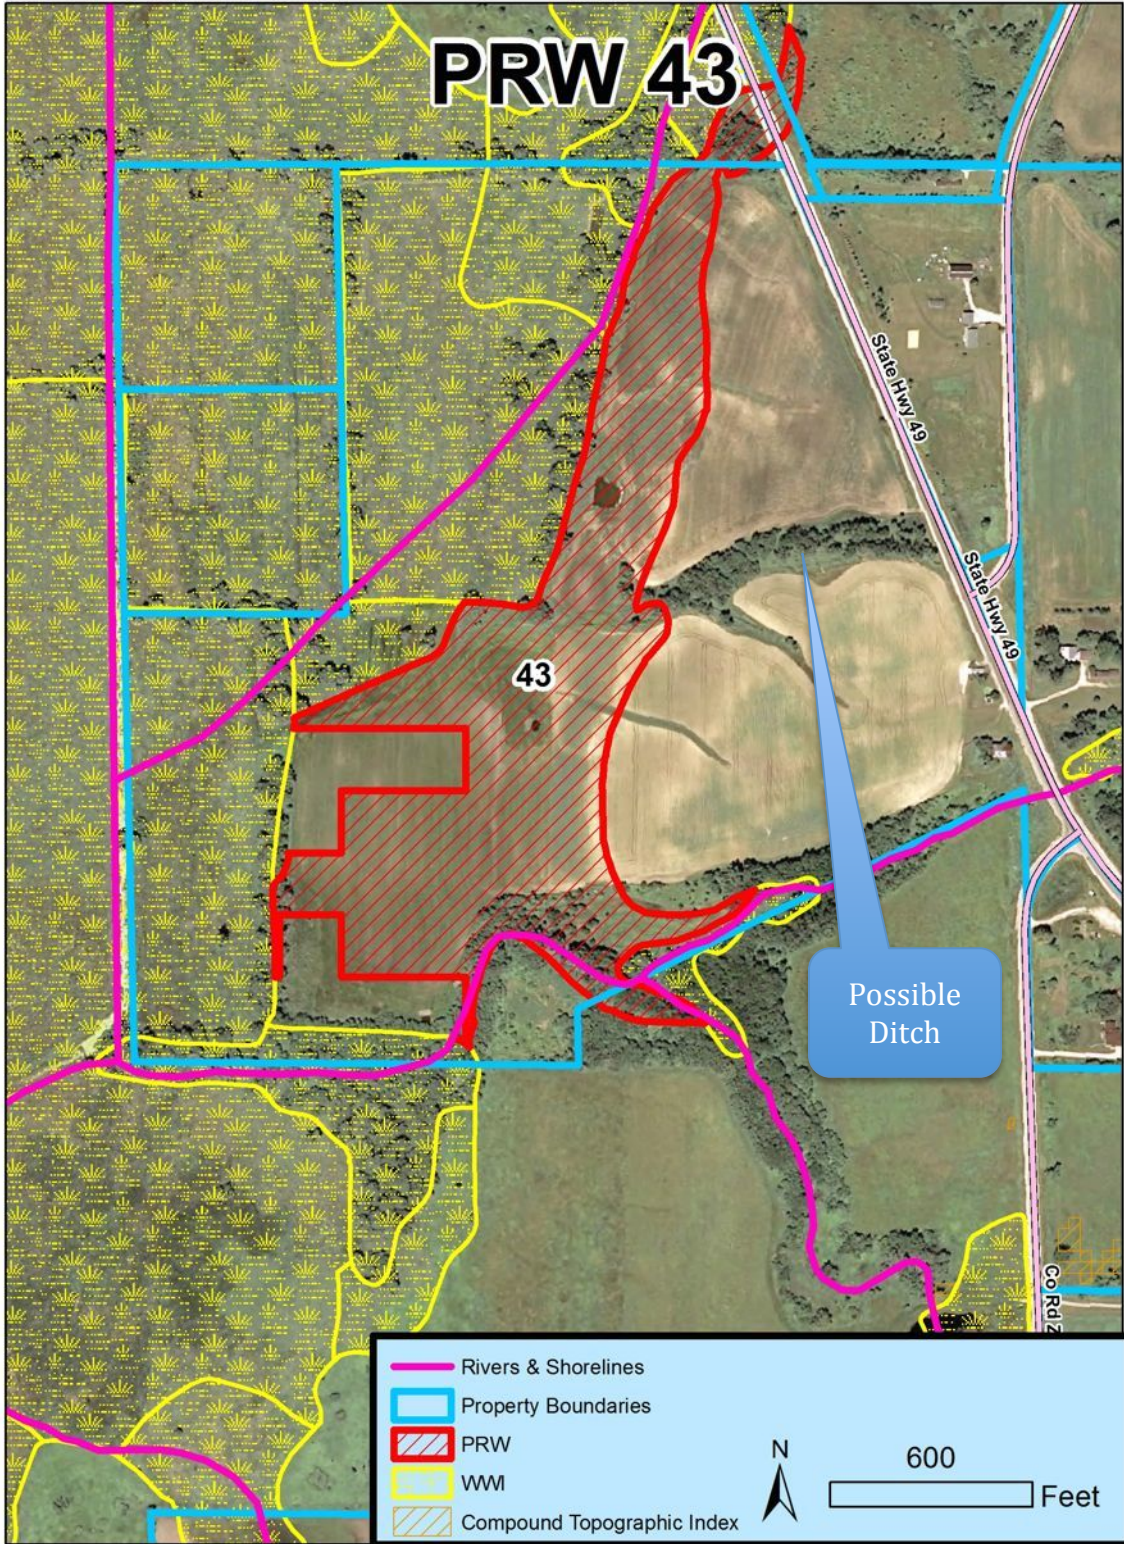
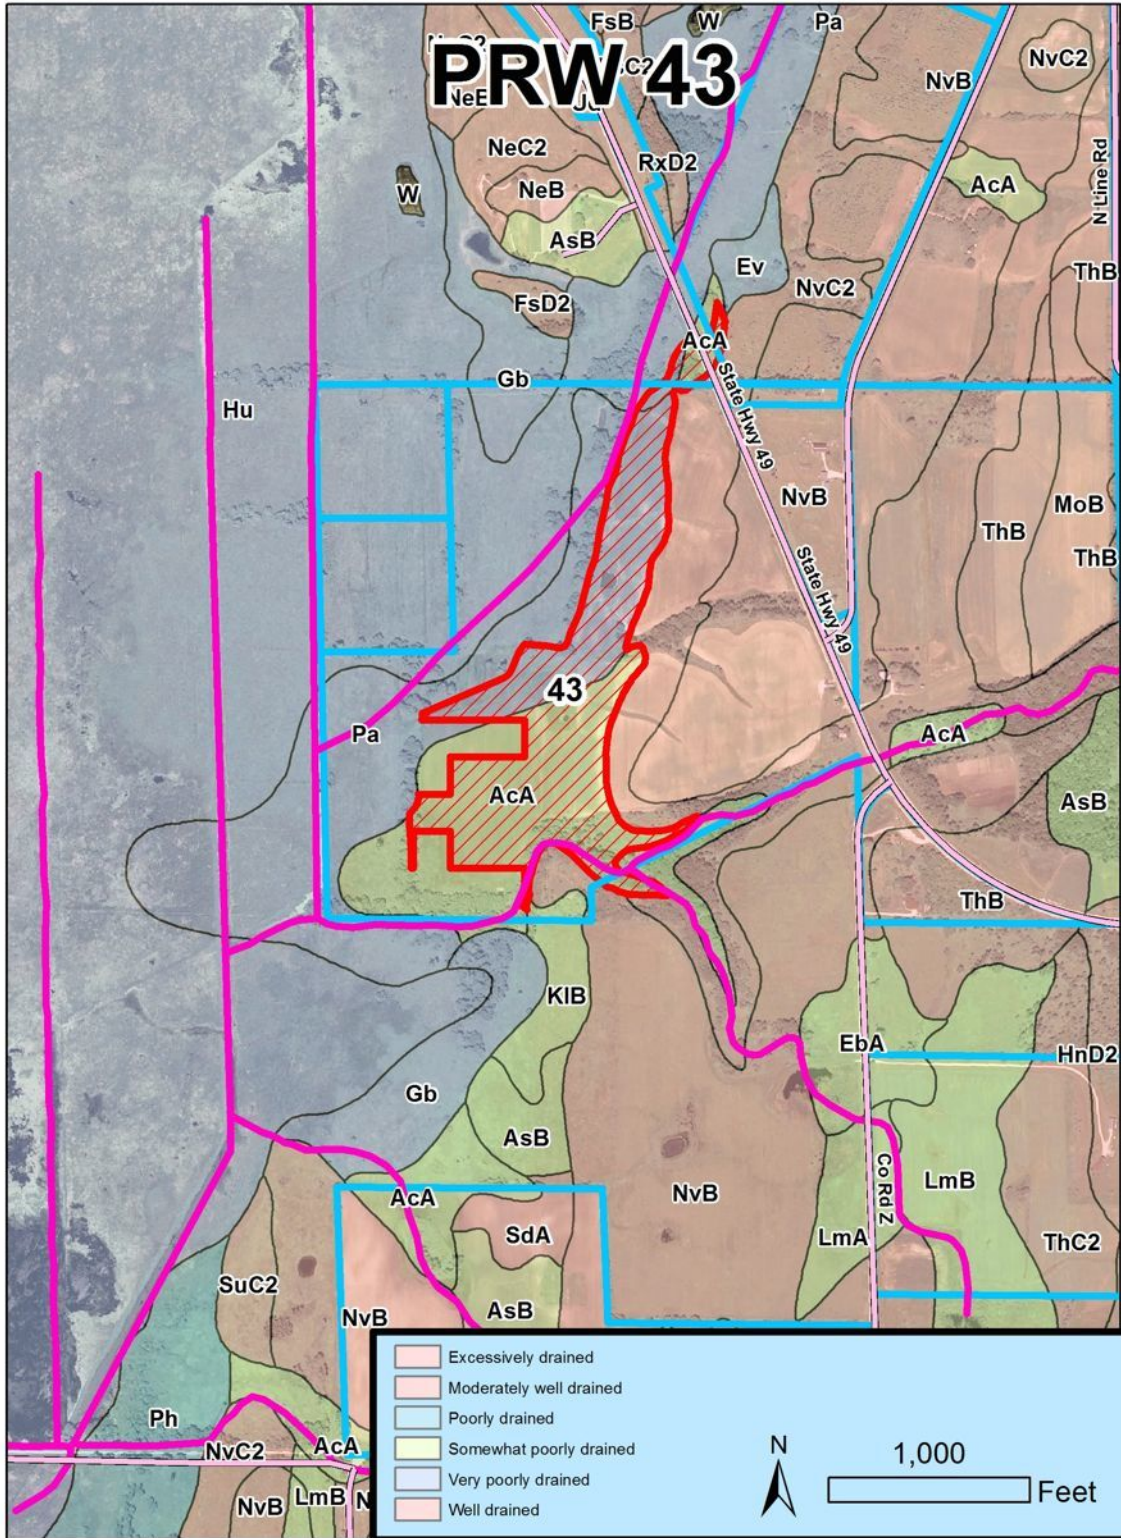
Could not see clearly enough to assess. Could ditch with lateral swales on south end, which was a reed canary grass flat. Might have restoration potential.

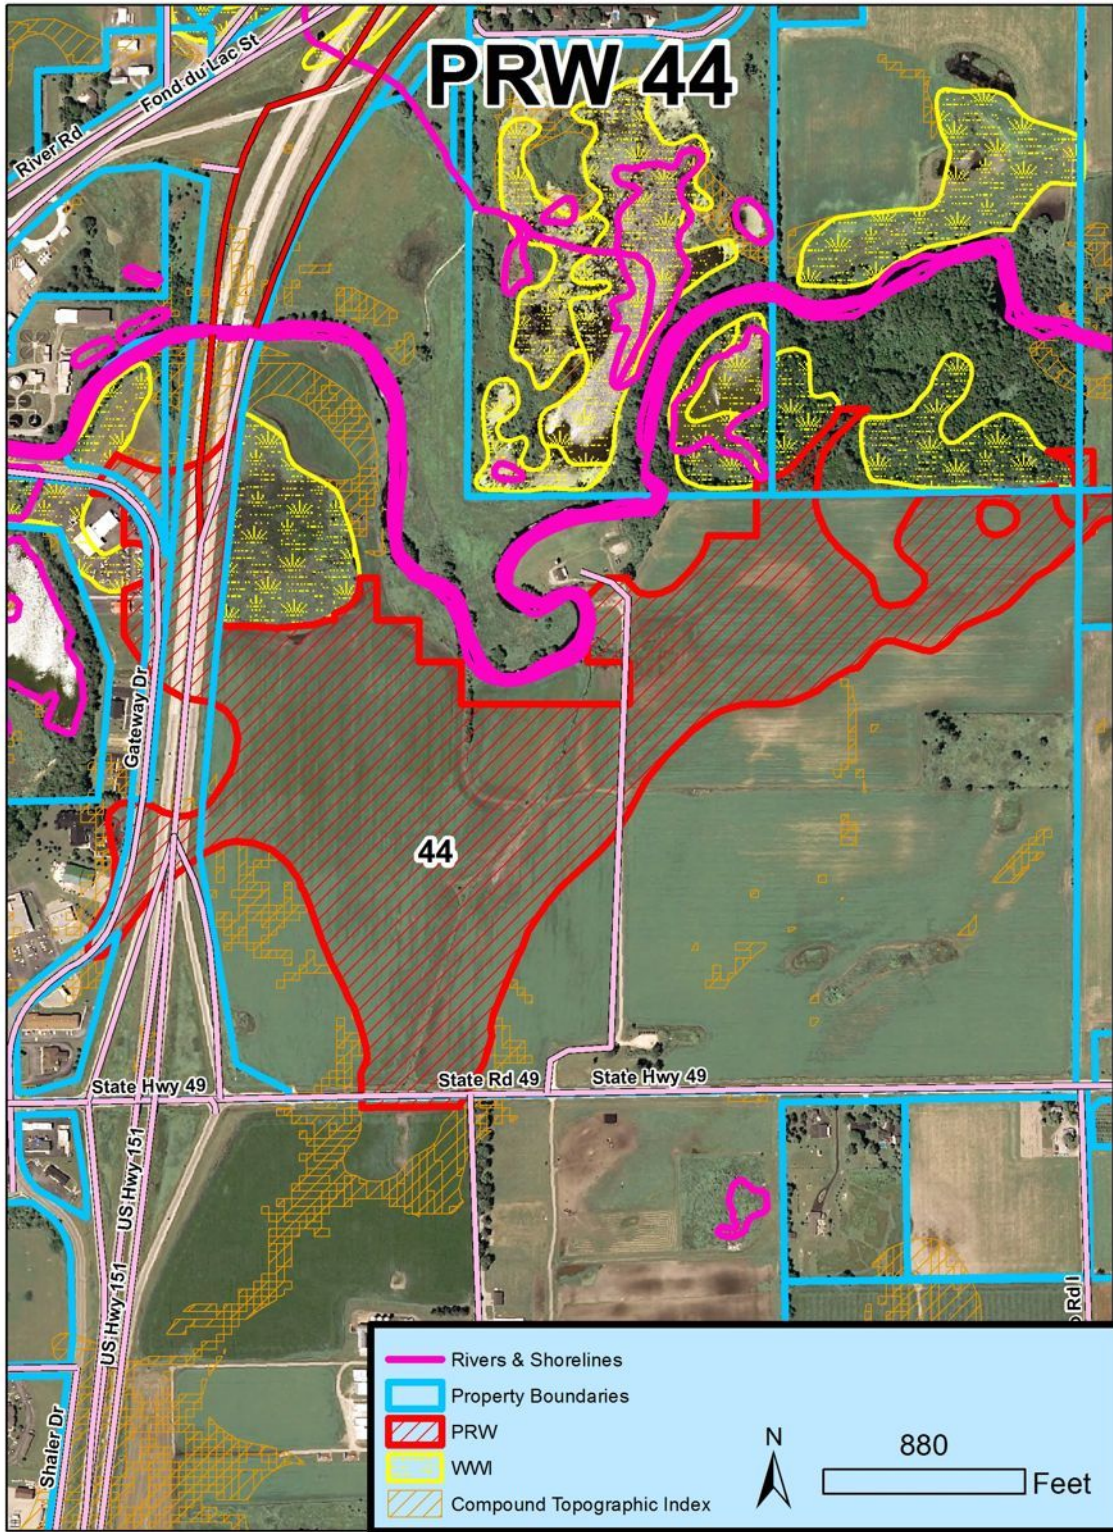
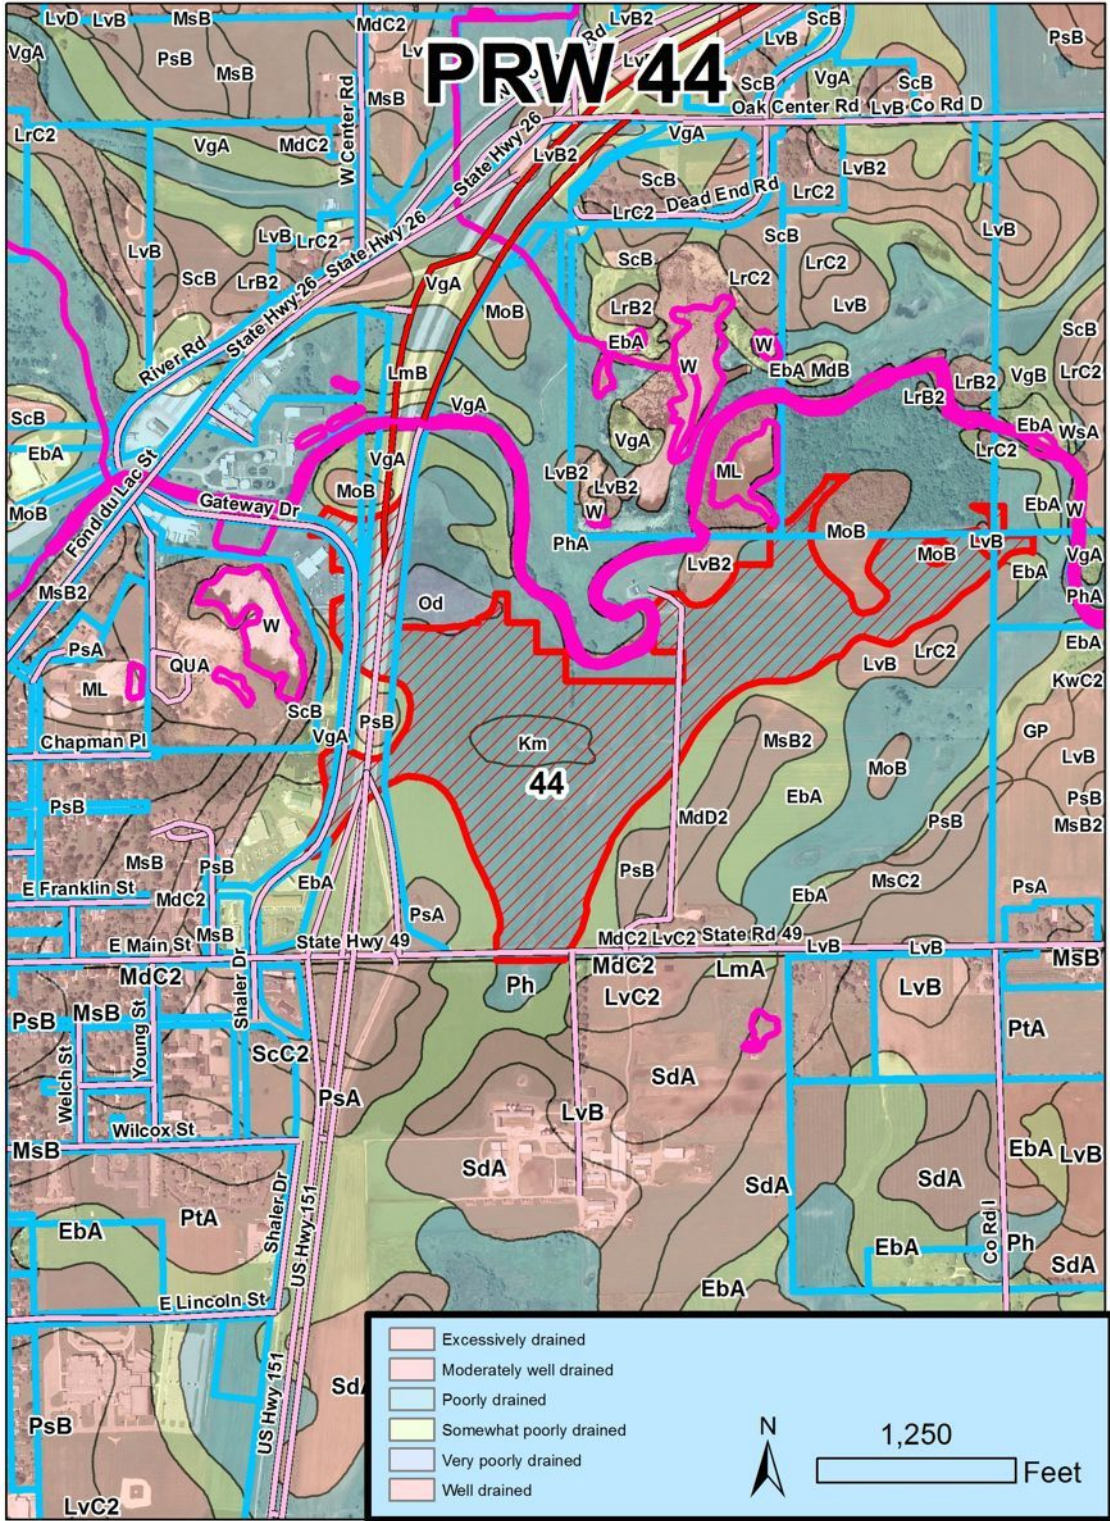
Large cropped basin with ditch draining north to river. Looks like a central depression drained by tile. Could be a large tile system with outlet by the river. Ditch could be filled at lower end with out affecting ROW Hwy. 49. Good Potential.
