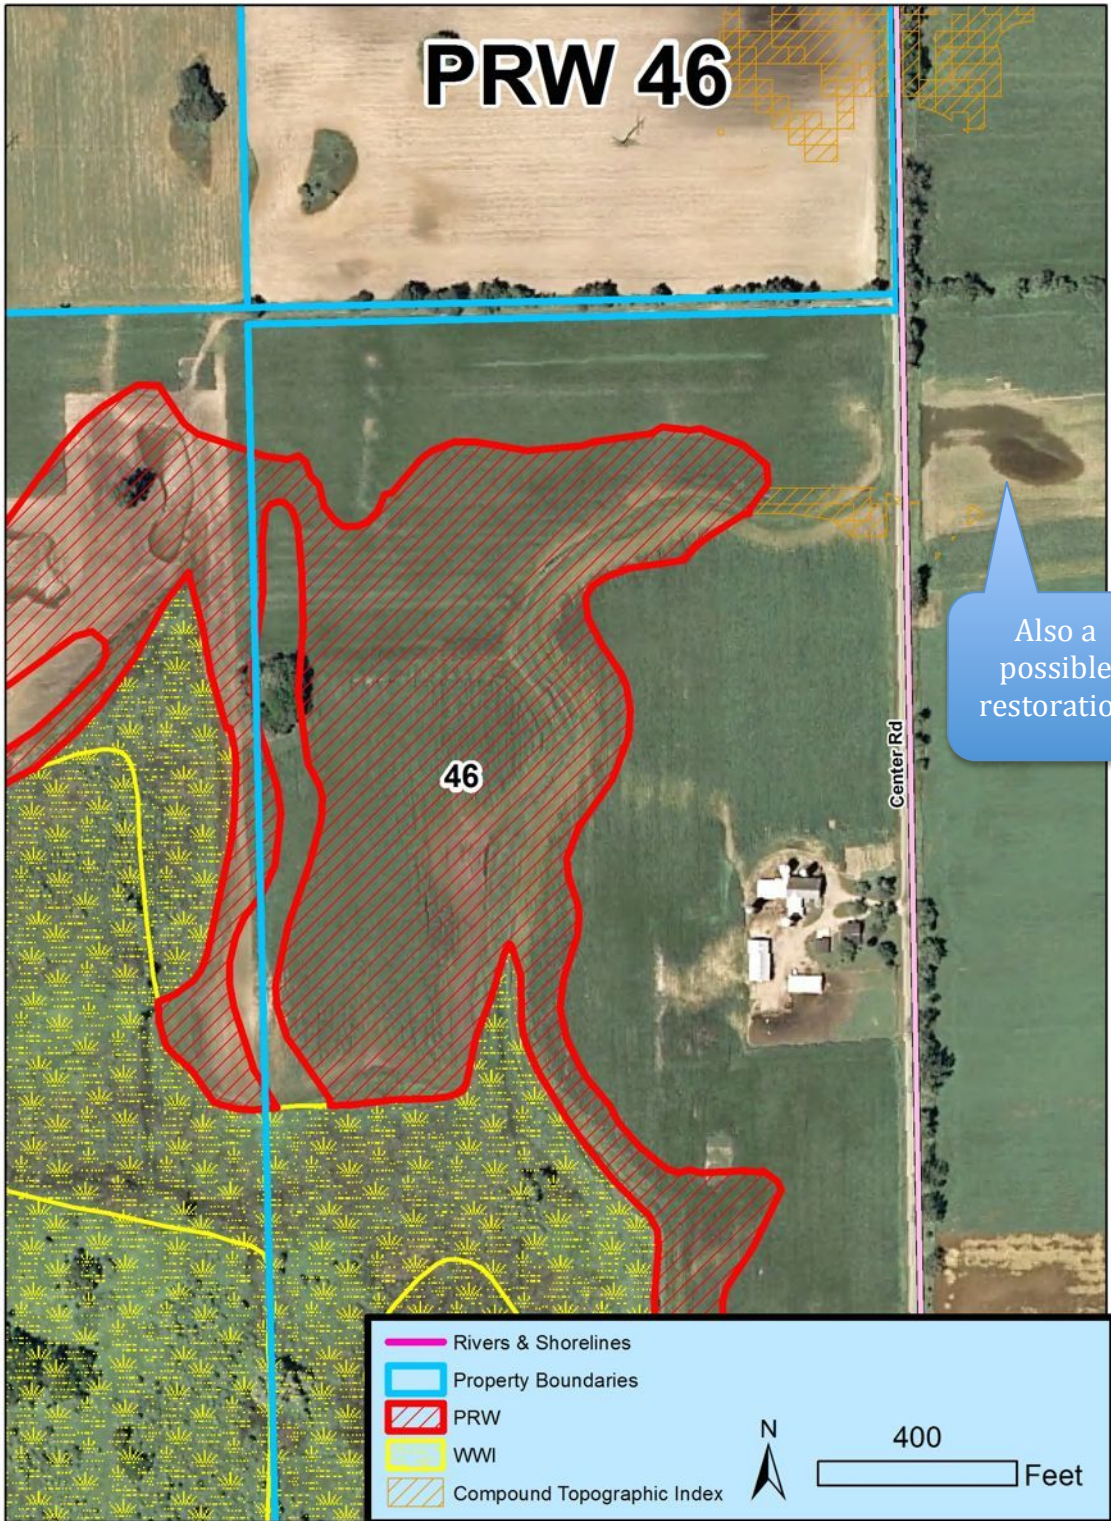
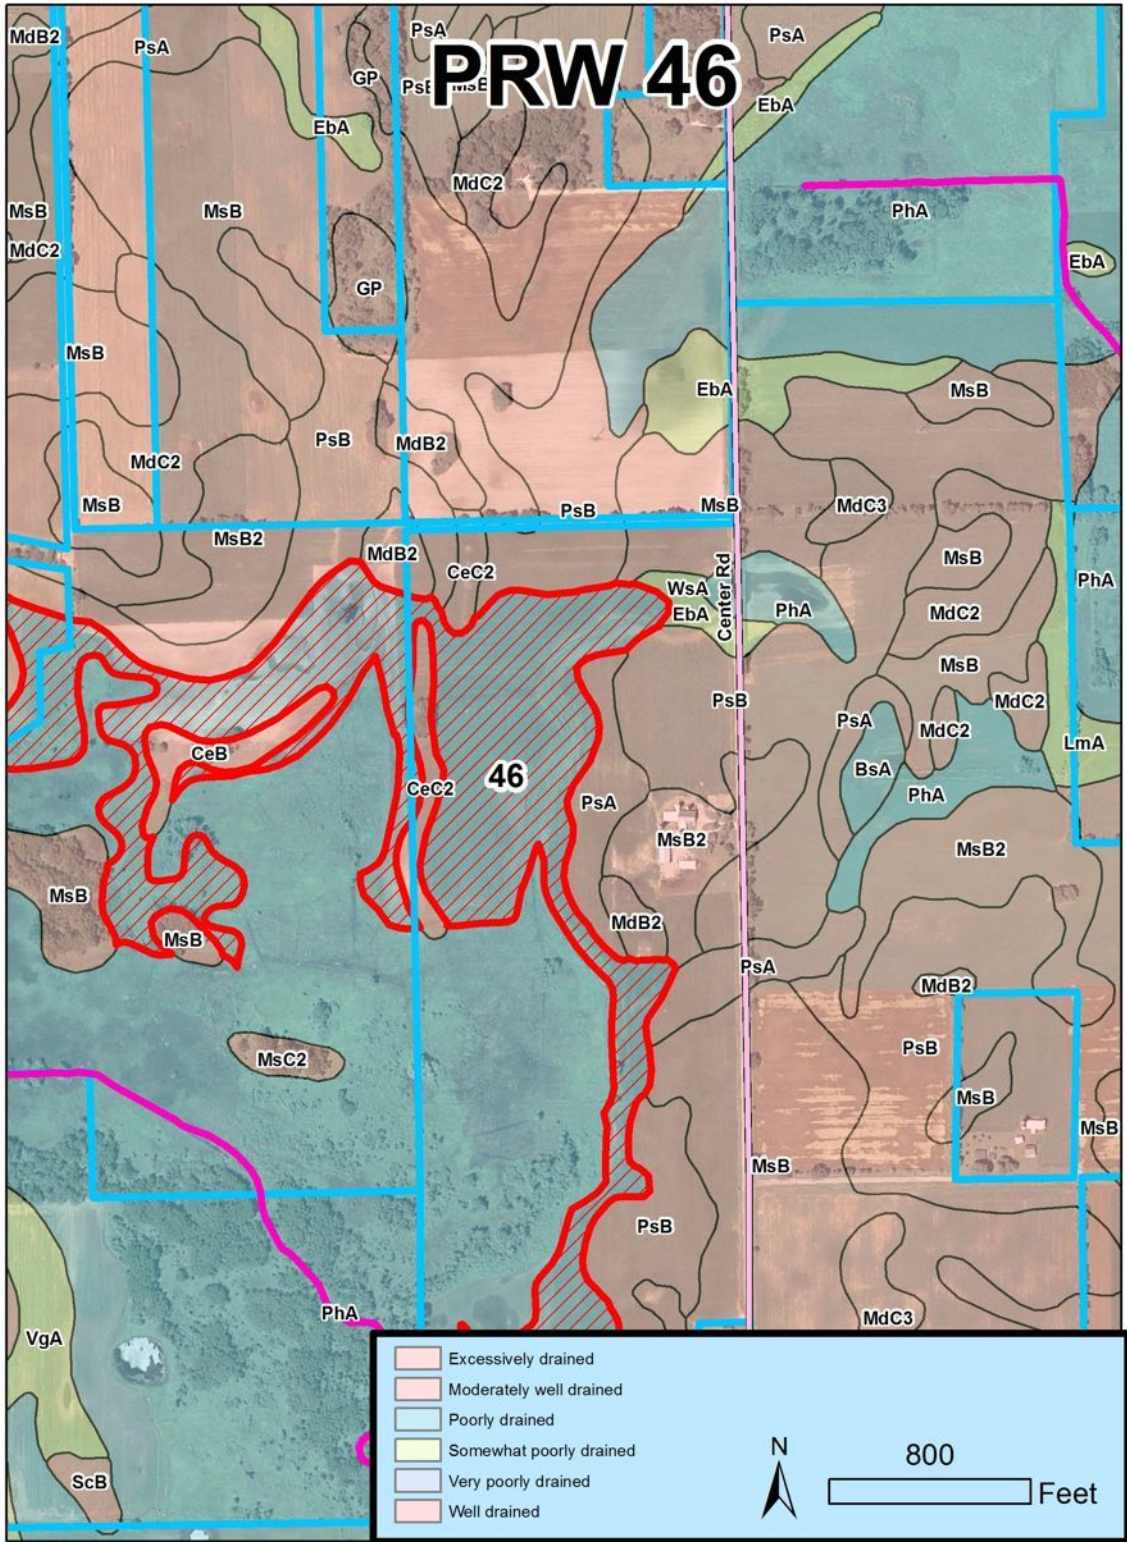
# PRW 46

Good drainage swale through center. Big flat area, part of it recently tiled. Good potential. Also potential for scrape and berm restoration just east of Center Rd.

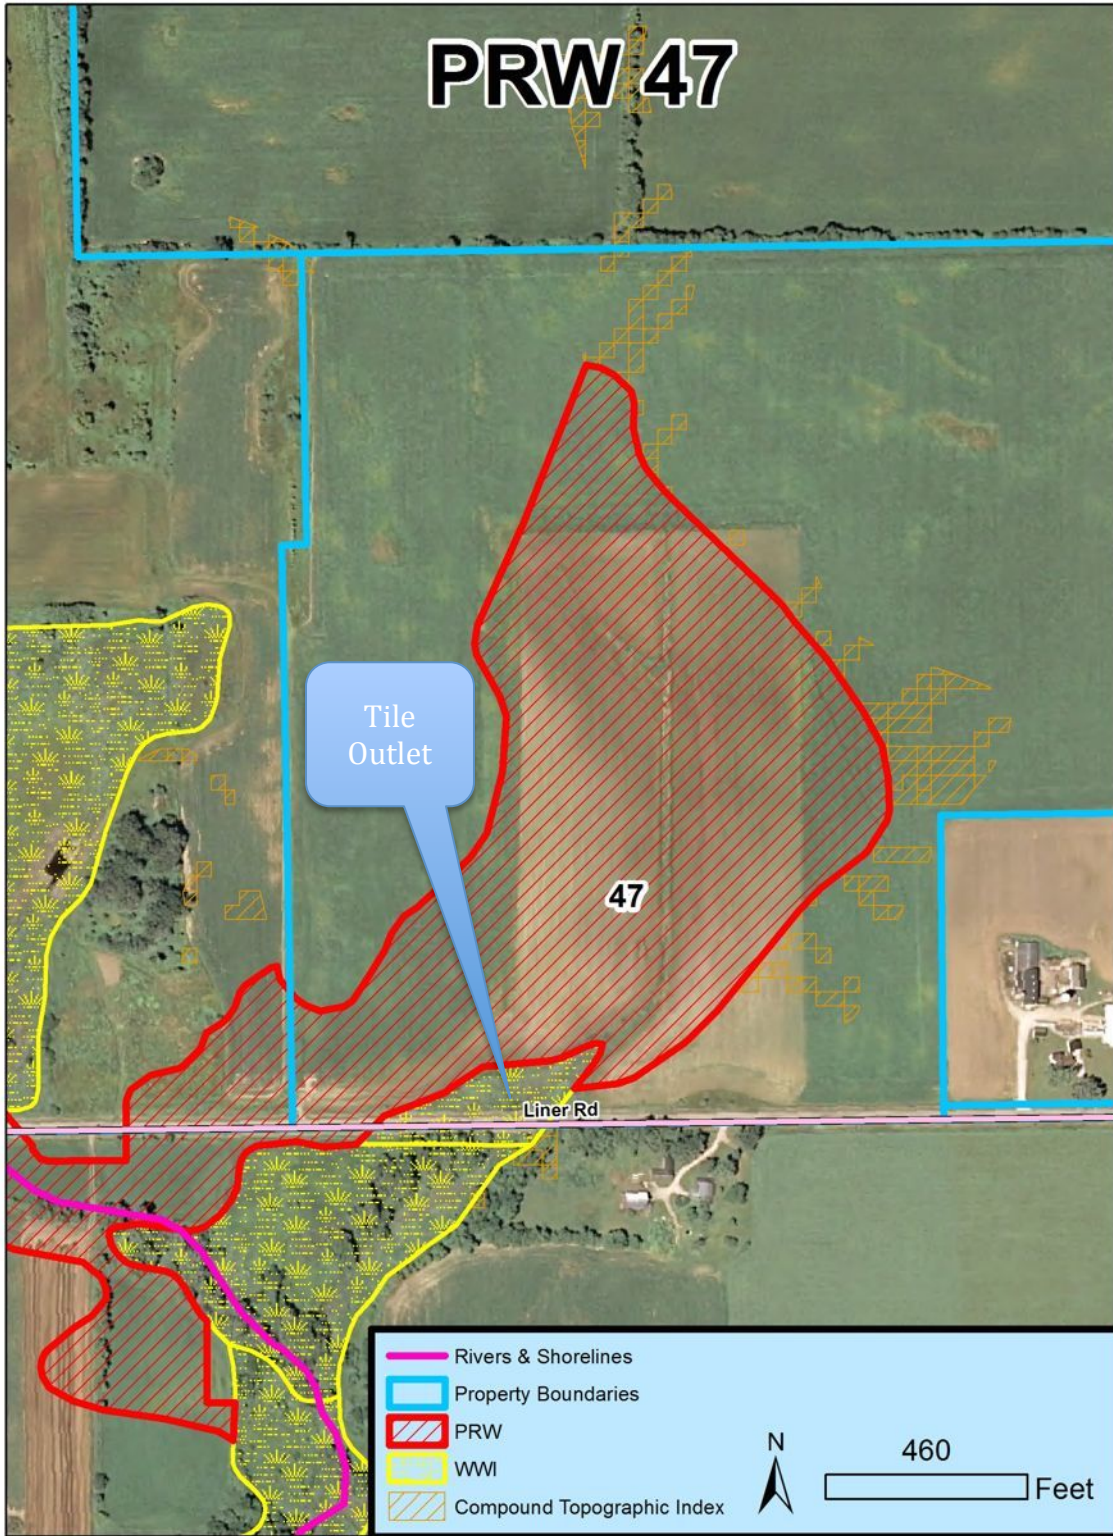
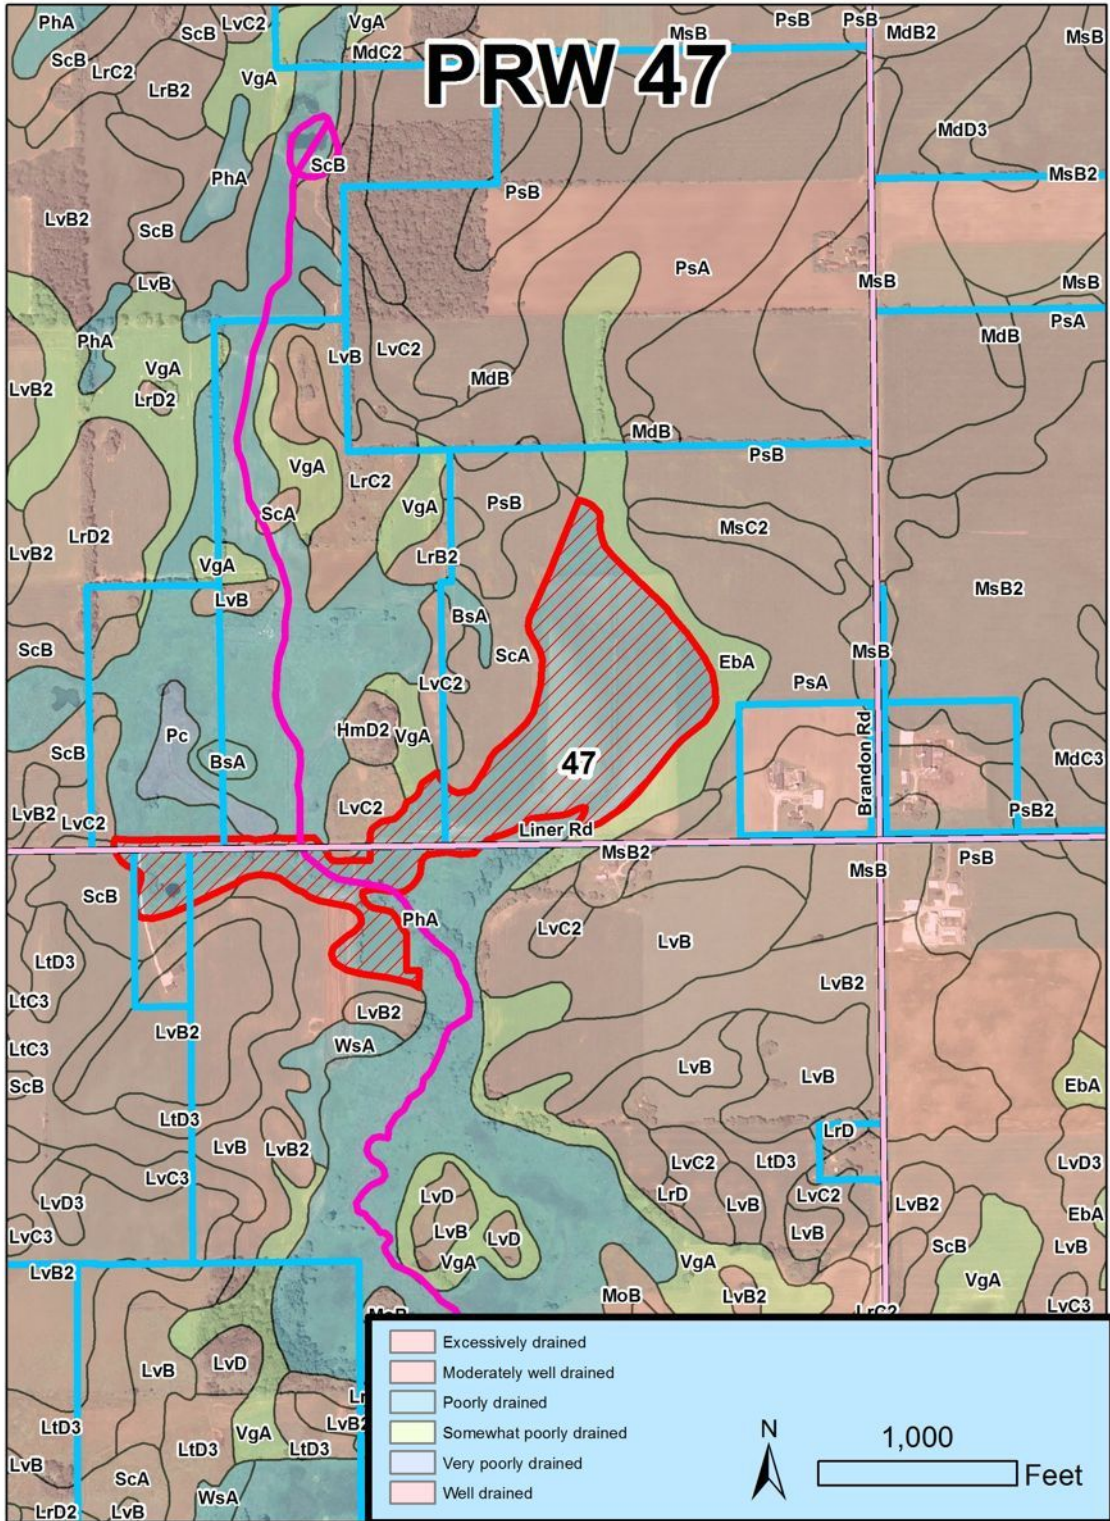
# PRW 47

Tile system drains wetland. Good restoration potential.

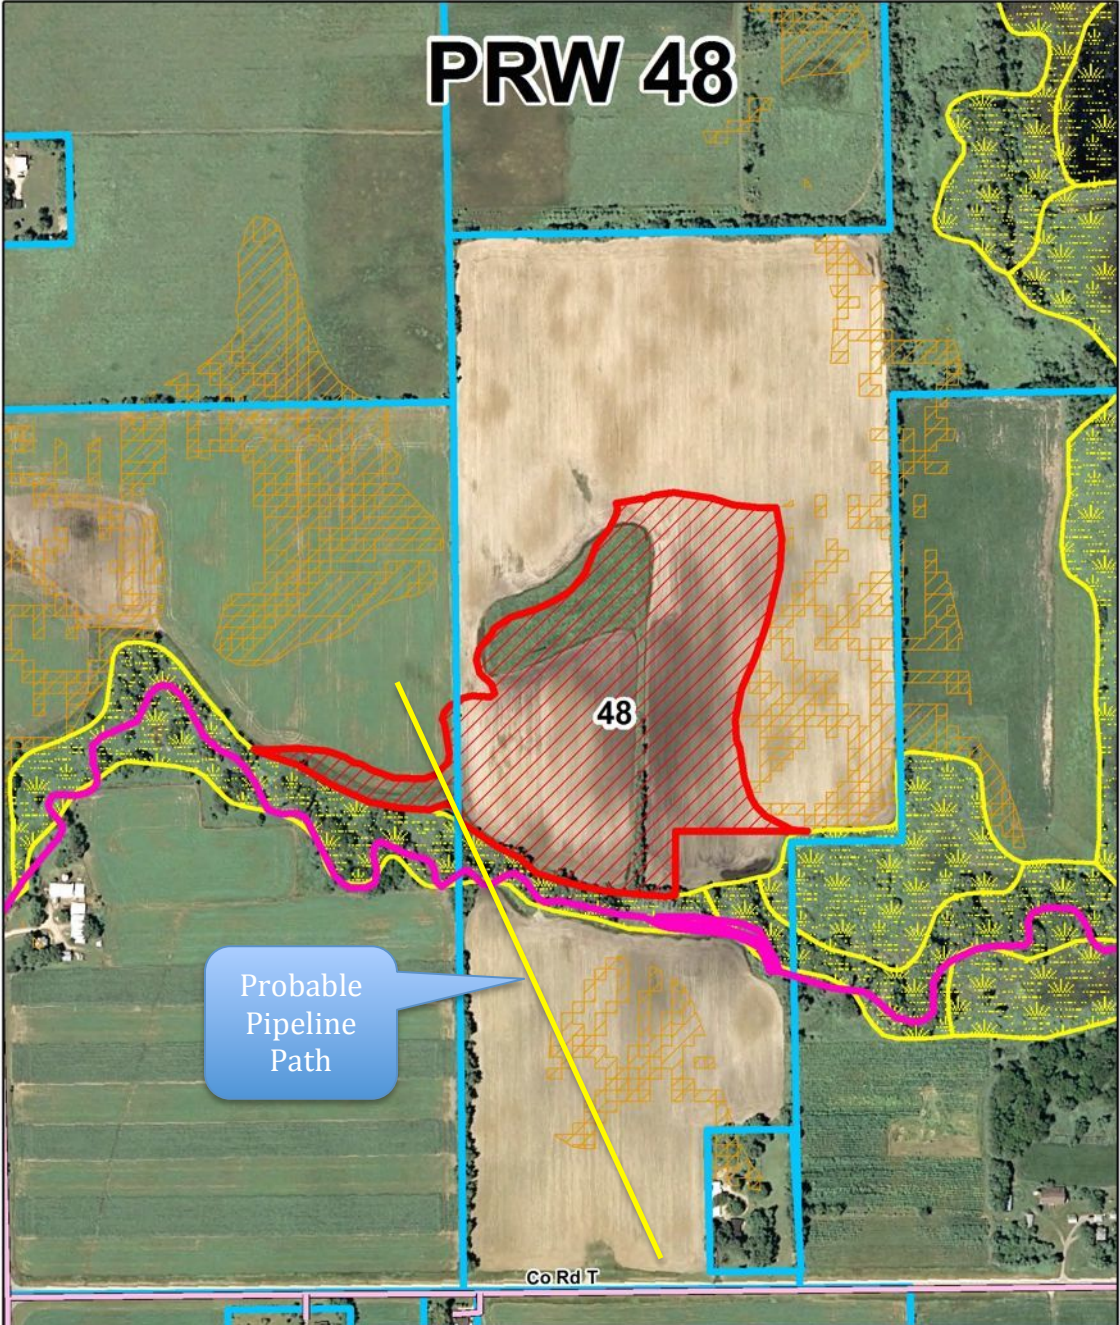
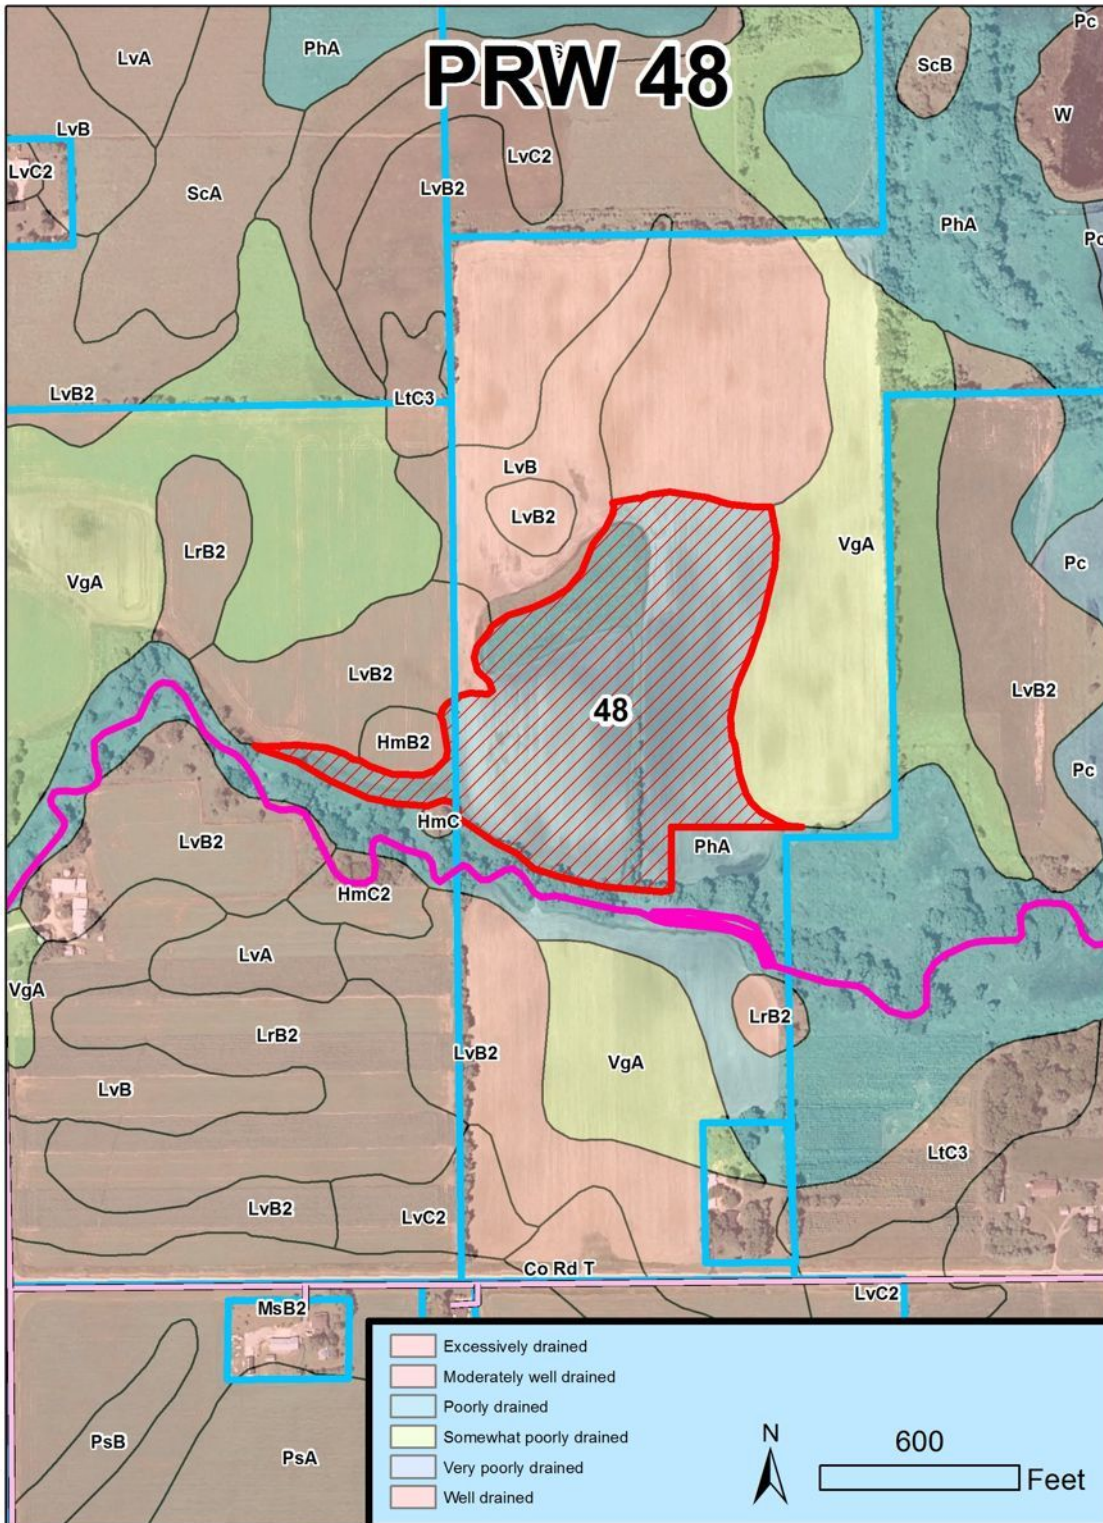
# PRW 48

Kitchen: Check in fall when leaves are off. Good restoration potential. May have tile system in addition to ditch. Have pipeline marked.

Ziegler: Long distance from road, can't see details but appears to have potential. Cattail basin on north end of PRW. Ditch runs to stream, could be plugged. Pipeline probably runs along edge of PRW. Overall, good potential.

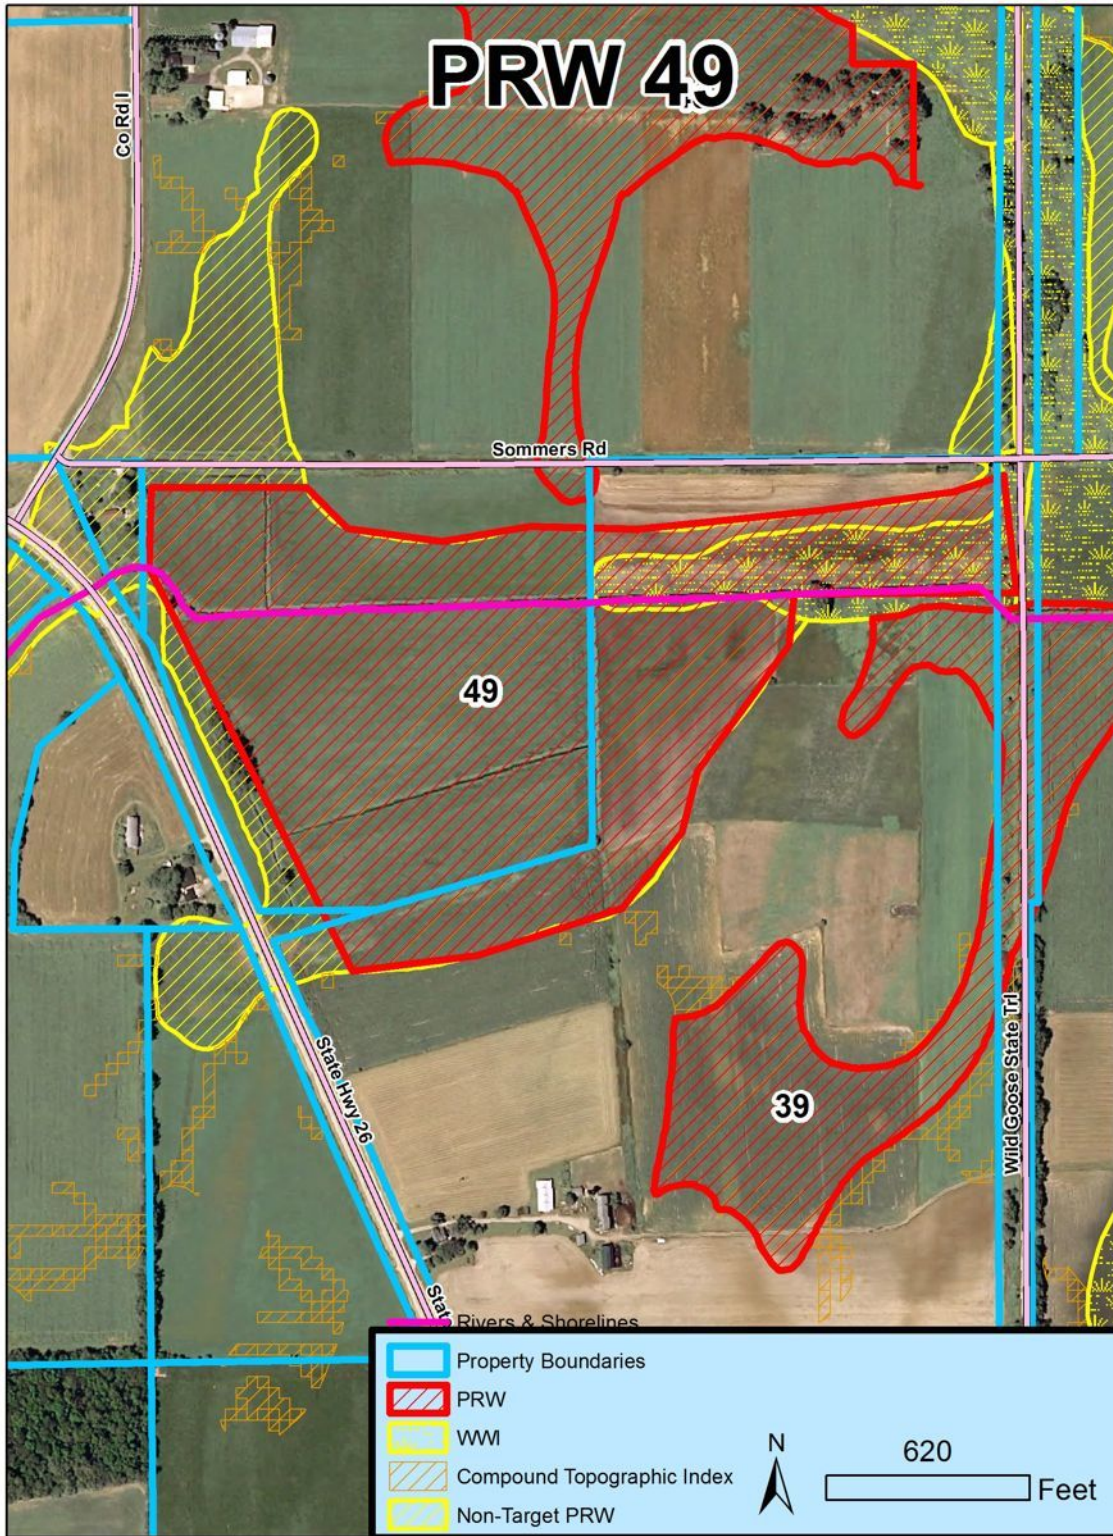
Kitchen: Very low, flat area with dark soils. Restorable by closing ditches but is a two landowner project.

Ziegler: Big network of ditches. Water moving through them. Ditches deep and well-maintained. Big flat area. Probably drained. Very good potential.

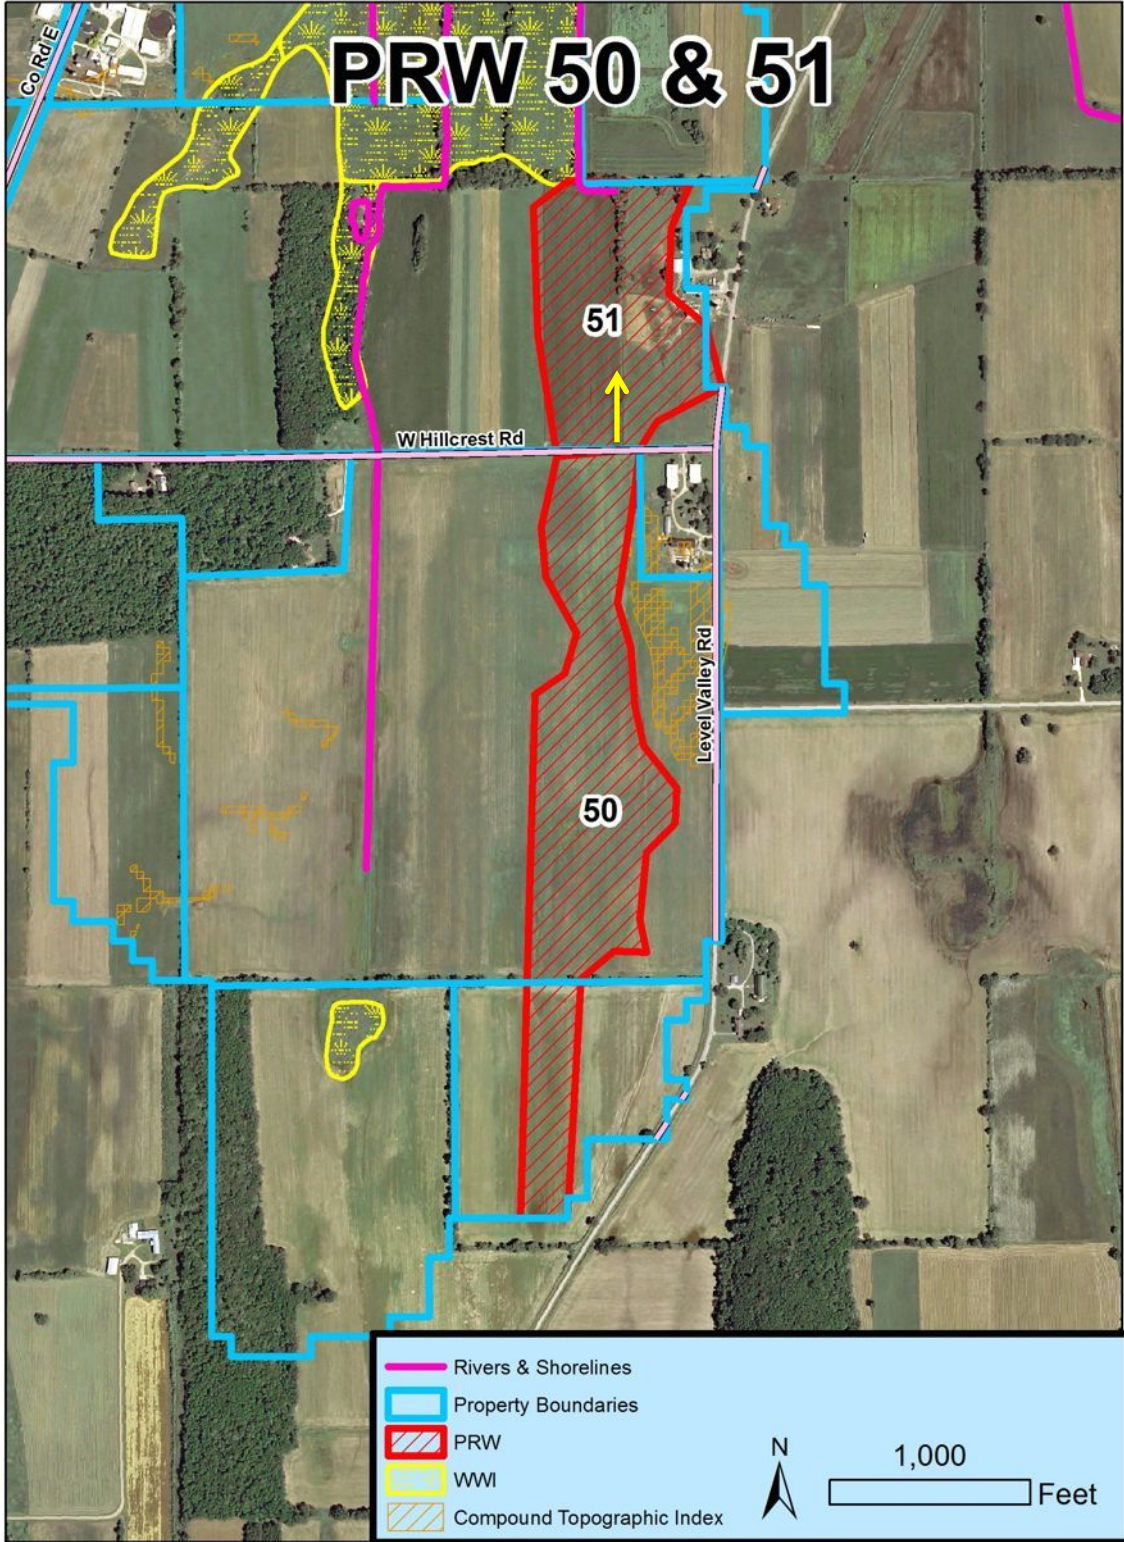
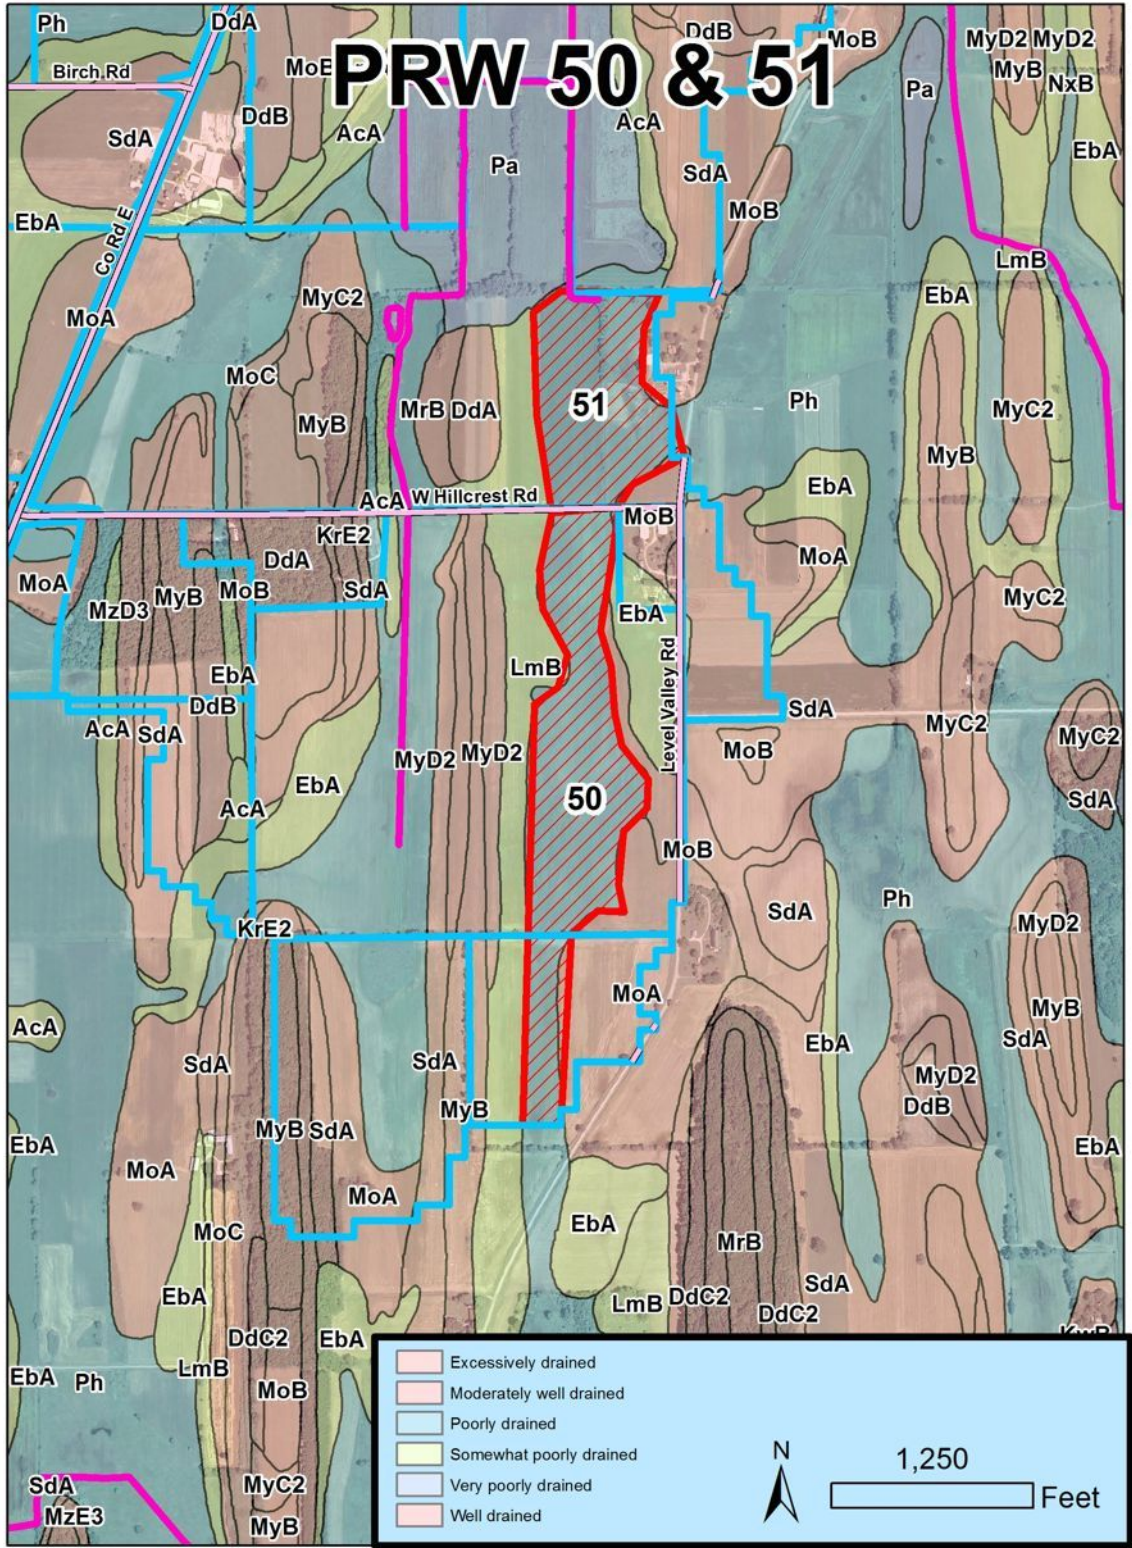
# PRW 50 & 51

PRW receives much surface runoff. Could be drain tile. Restoration could be done with scrape and berm.

Deep ditch running north. Reed canary grass in low, flat area. Good restoration potential.

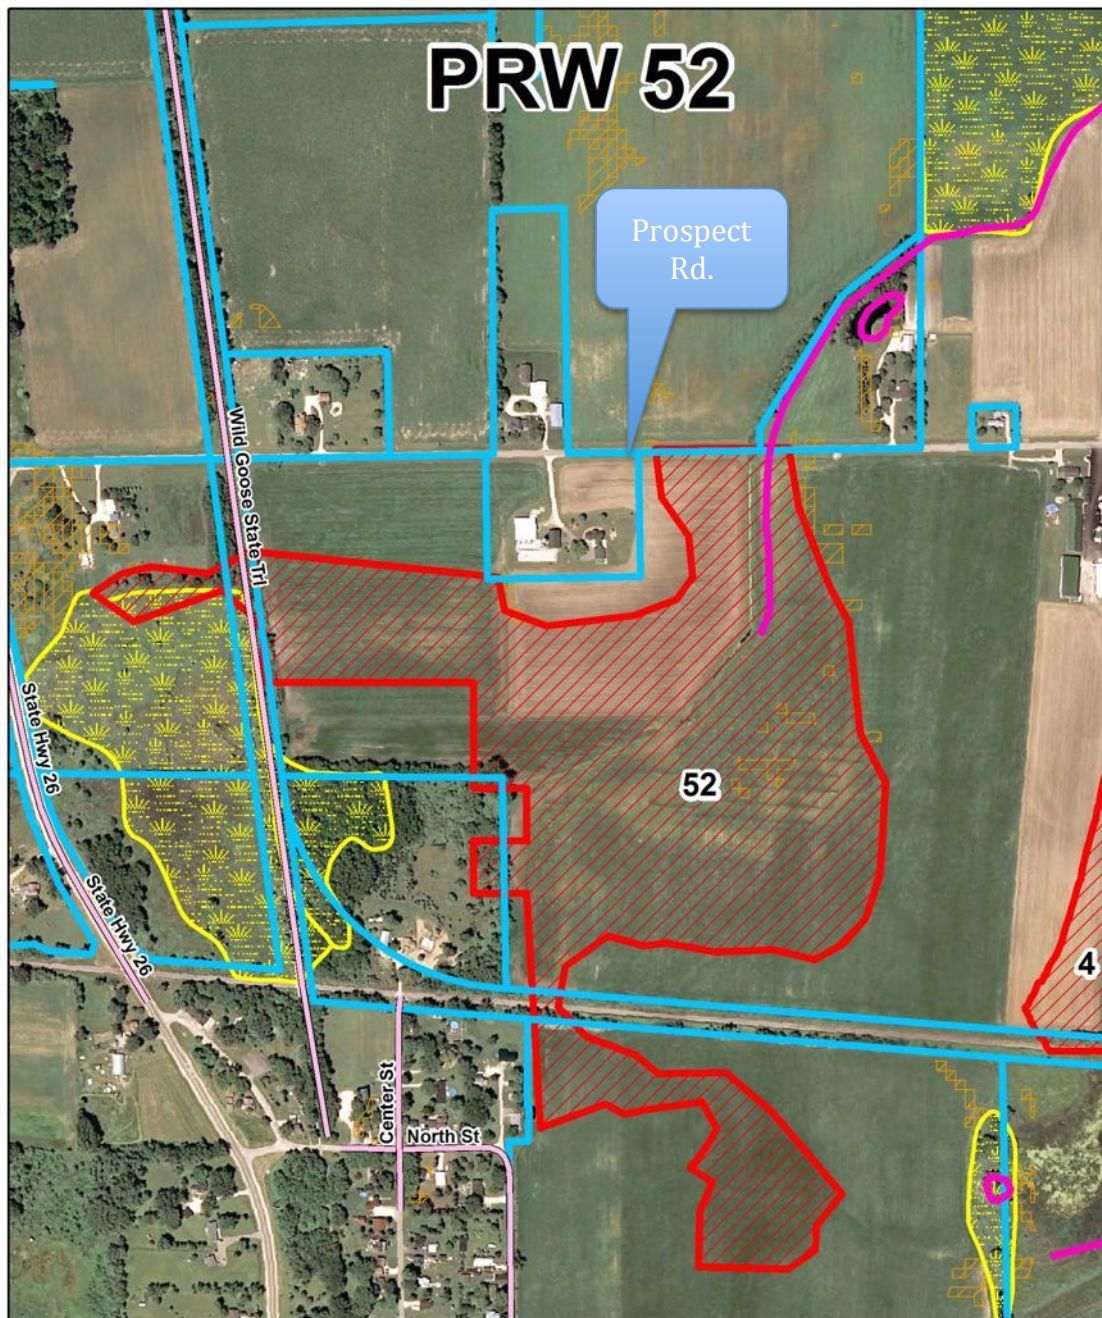
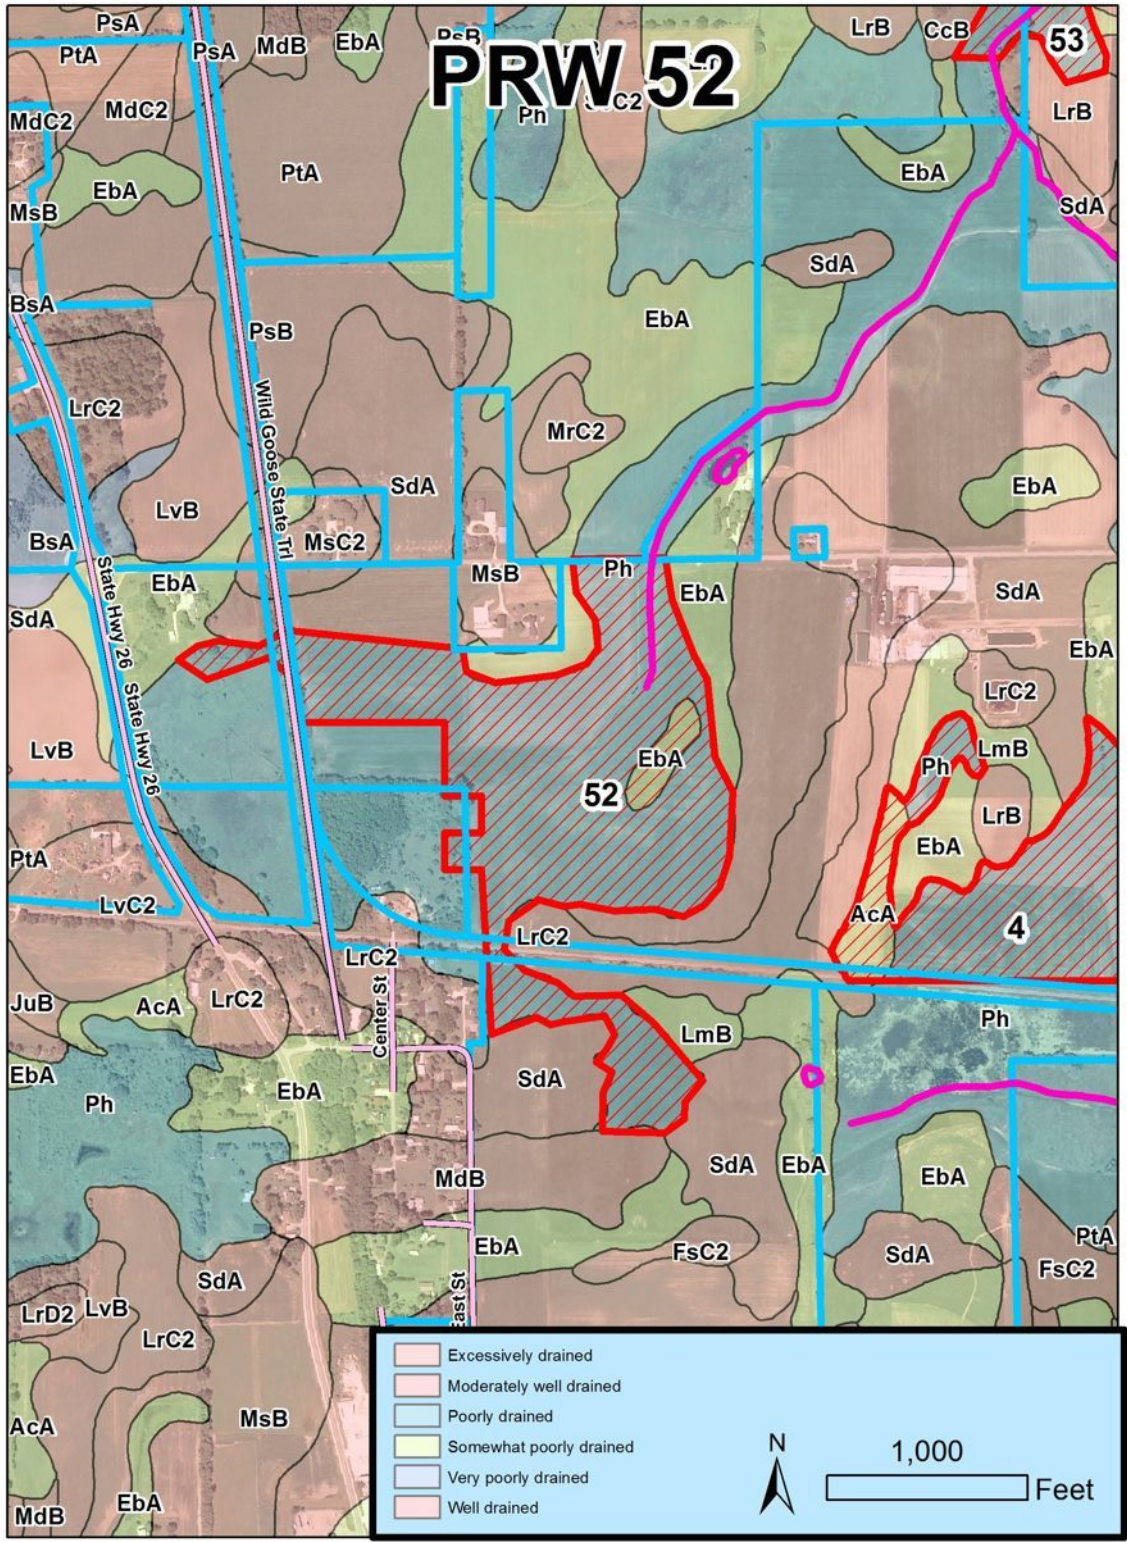
# PRW 52

Stub ditch south of Prospect Rd., could restore by manipulating ditch. Gas pipeline in ROW needs to be considered. Site may have drain tile as well.

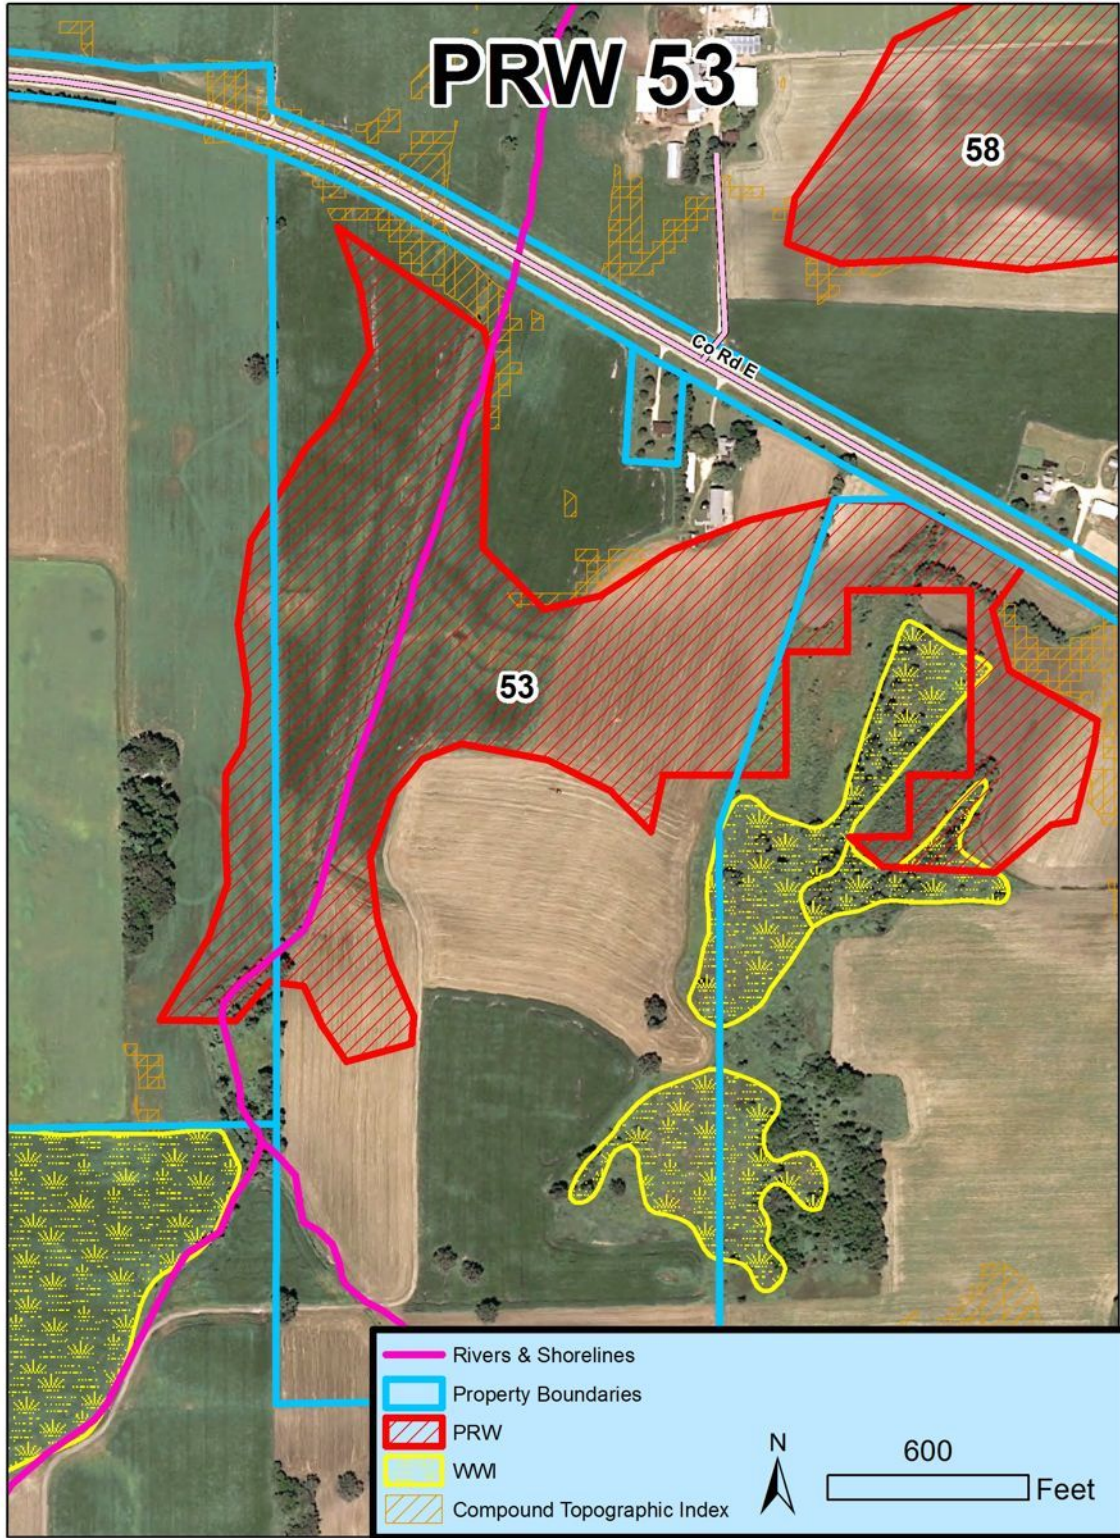
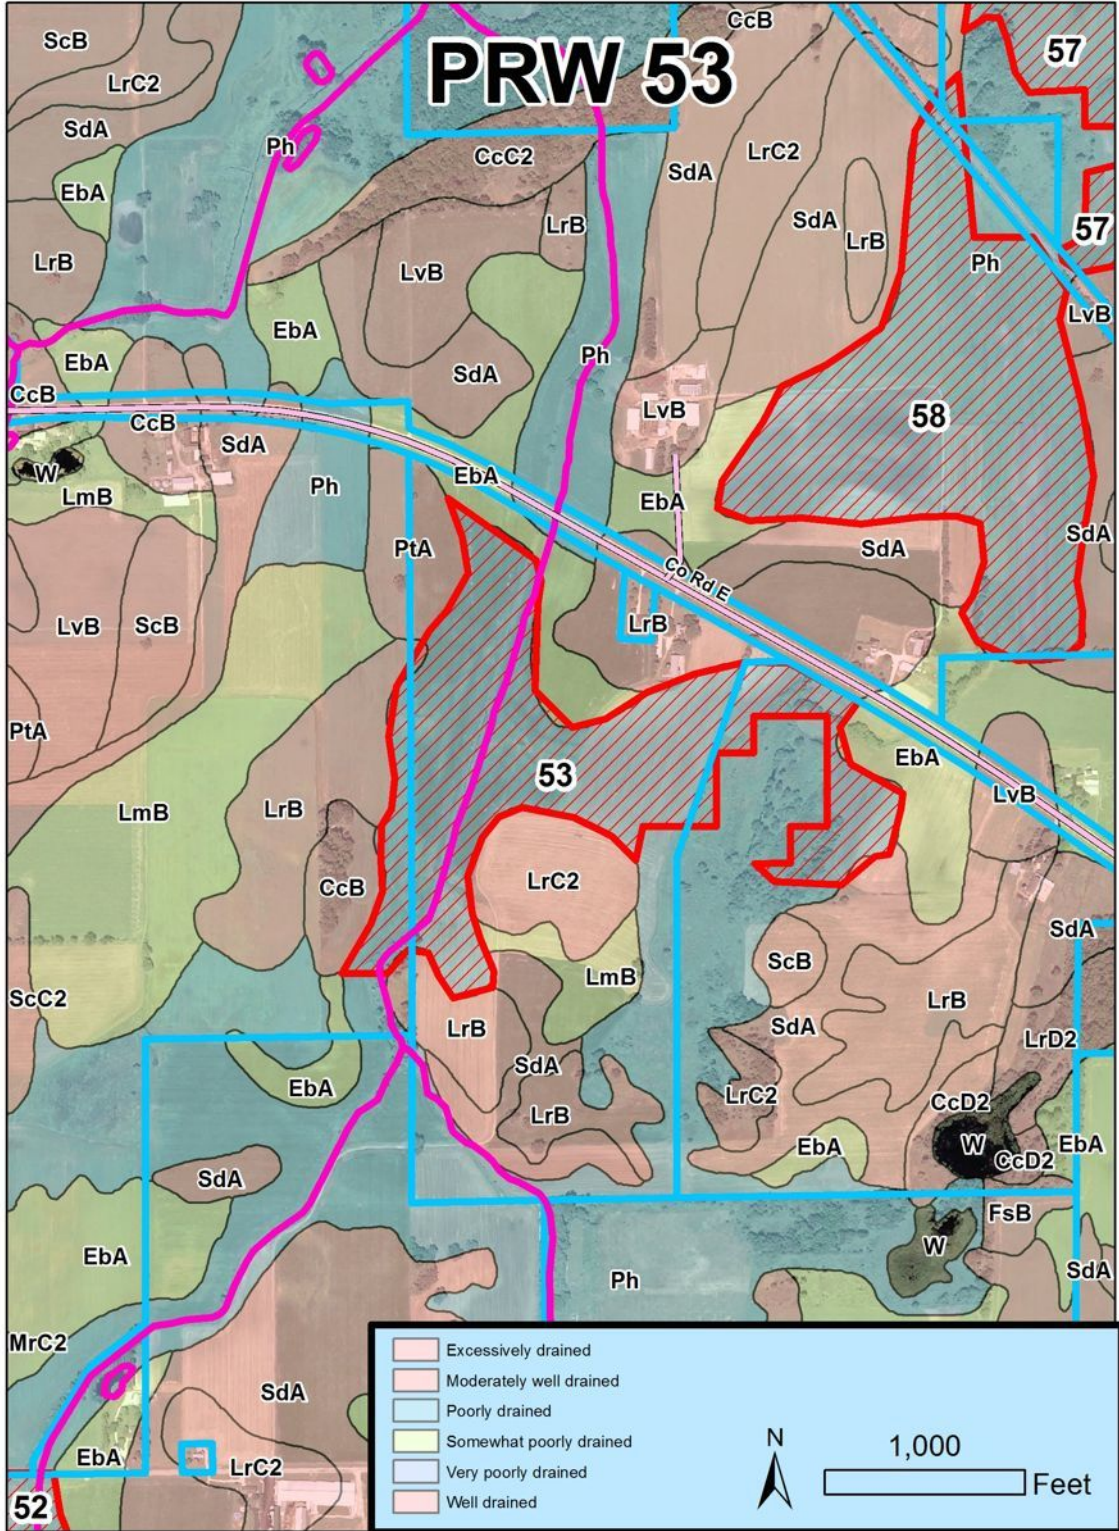
South of Hwy. E, tiled, could be restored but need to leave main ditch open.
