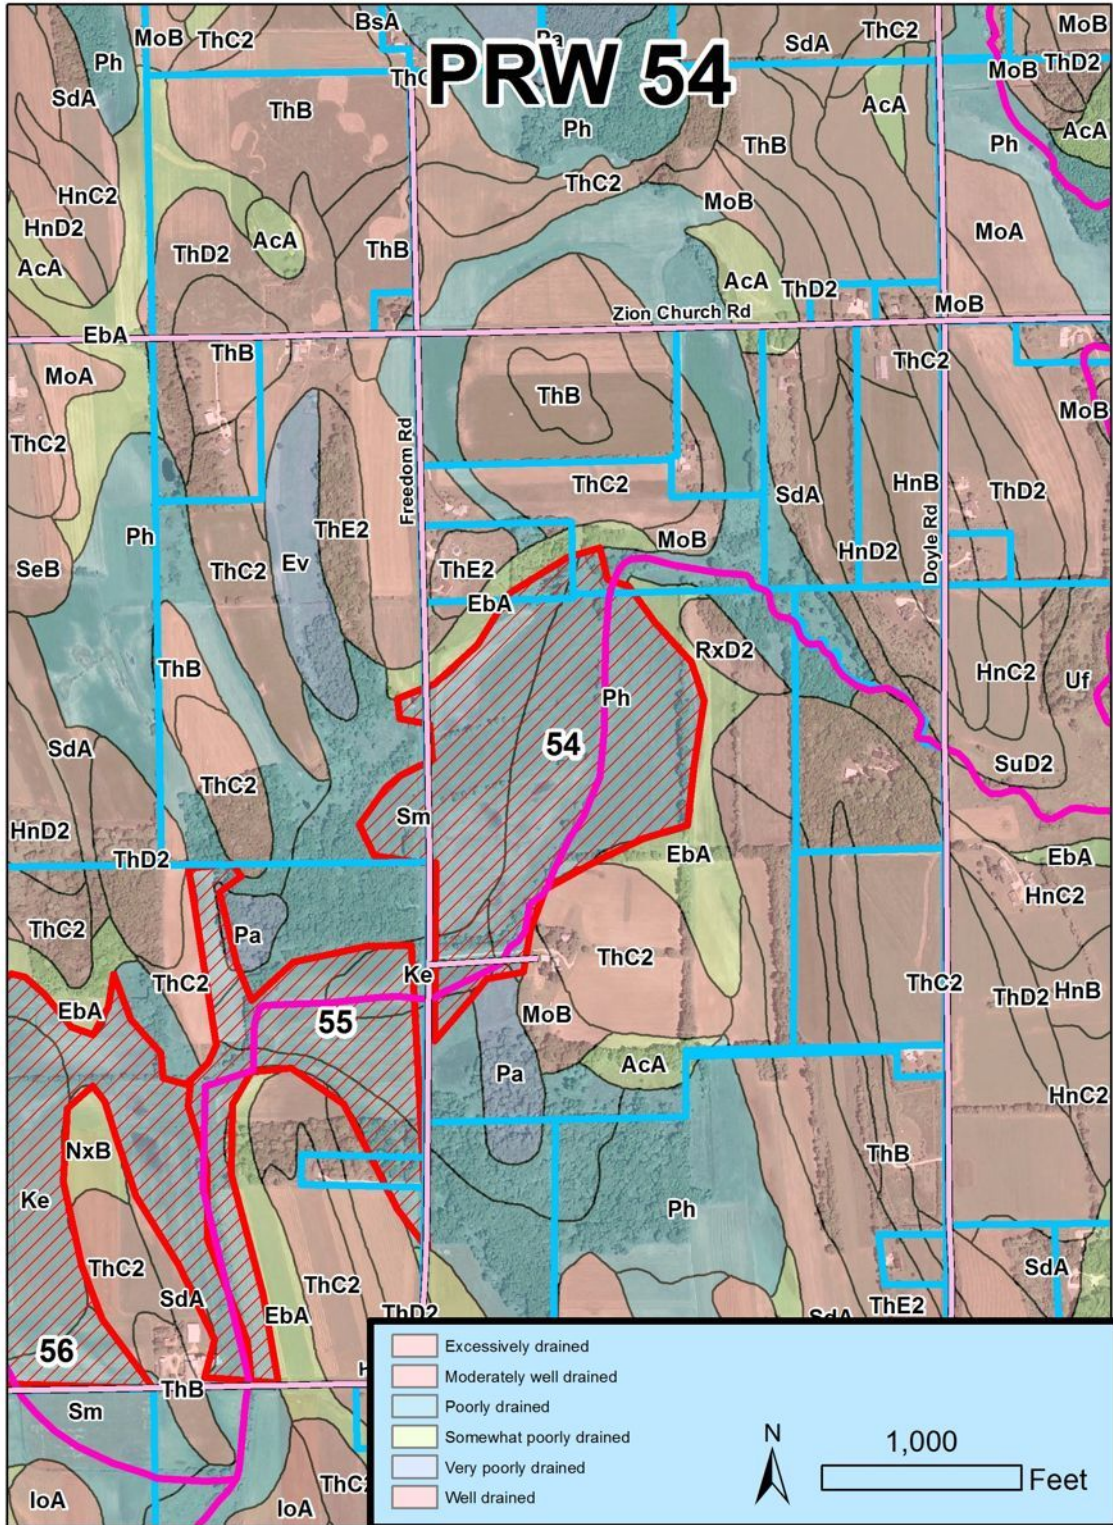
# PRW 54

Lateral ditches. Flat area of marsh hay. Much ponding in hay field and surrounding ag field. Ditches shallow, run to waterway with likely stream history. Possible restoration.

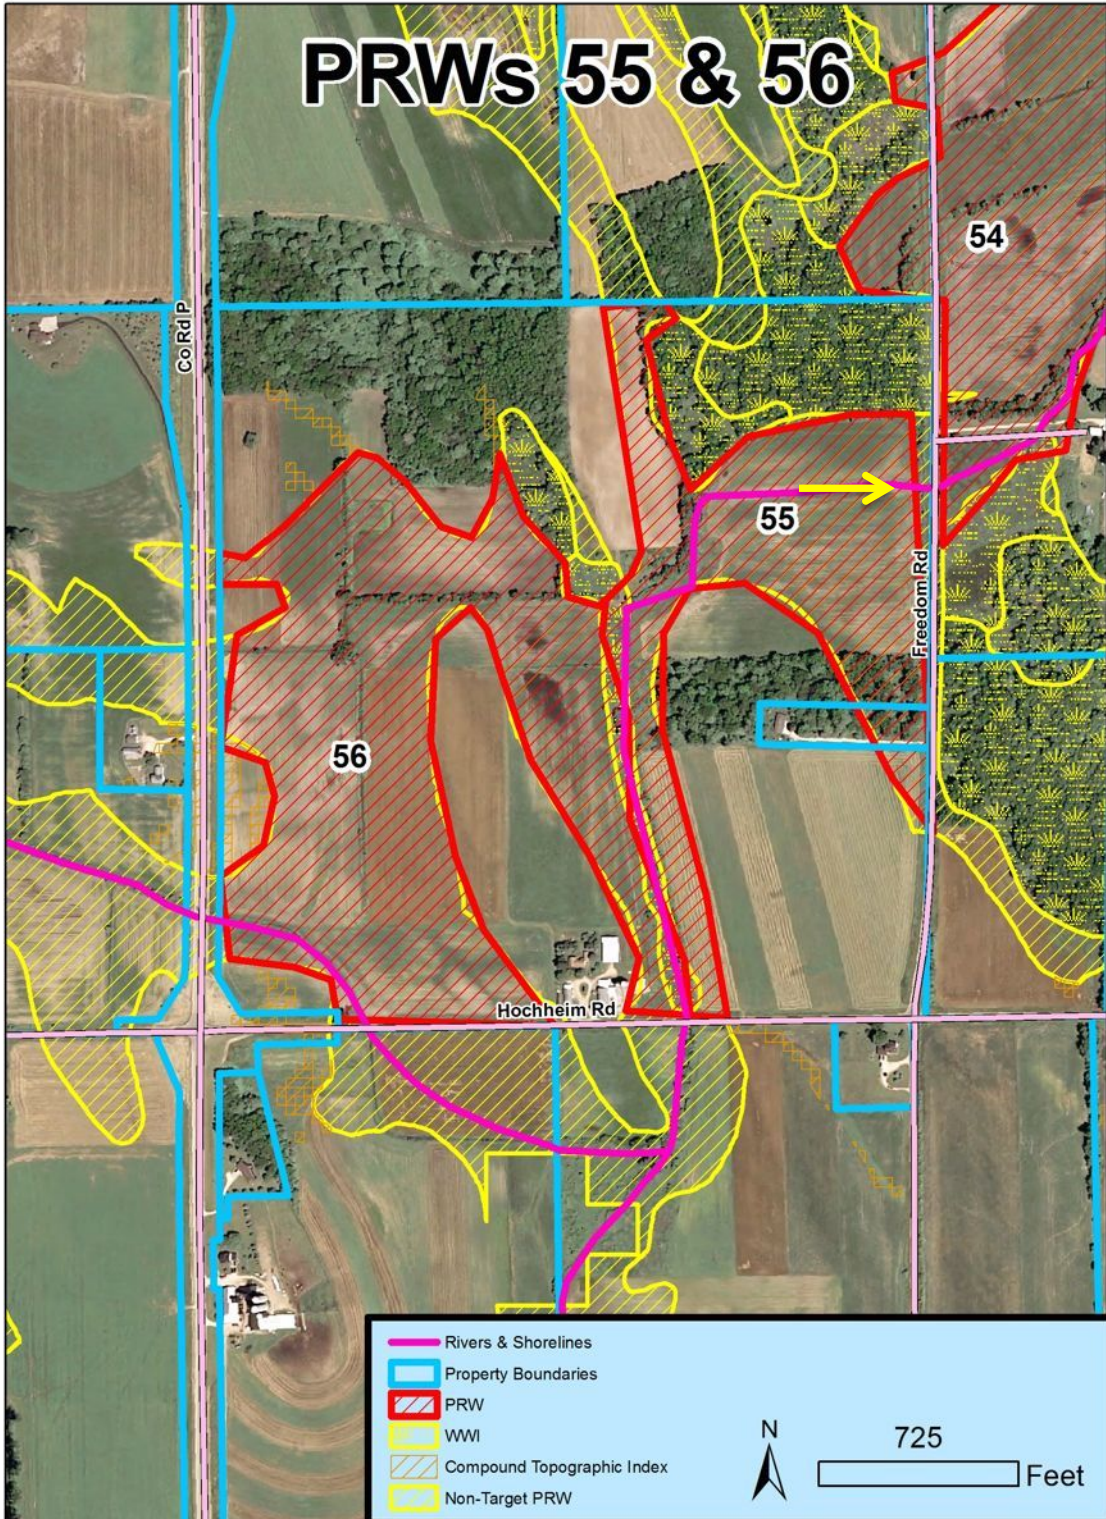
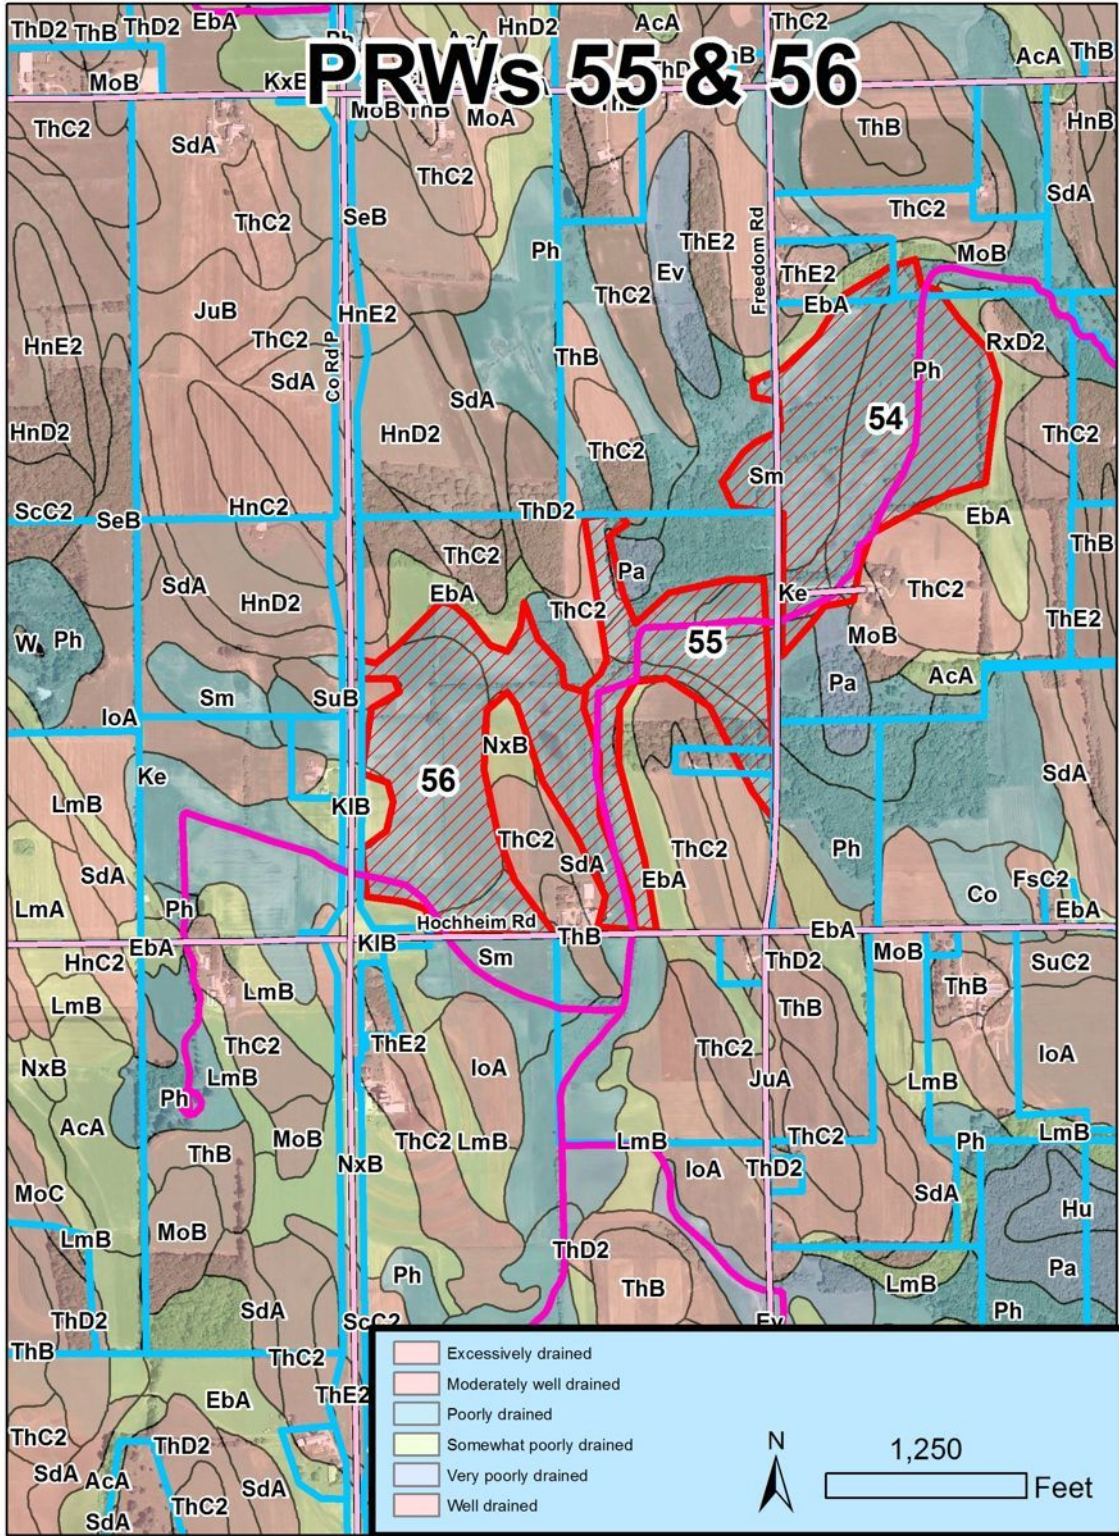
# PRWs 55 & 56

Gently sloped field, shallow grassed waterway in middle of field. Ditch map of wrong, ditch/stream runs along tree line. Not much restoration potential.

Large flat basin. Lateral ditches entering waterway. Good restoration potential.

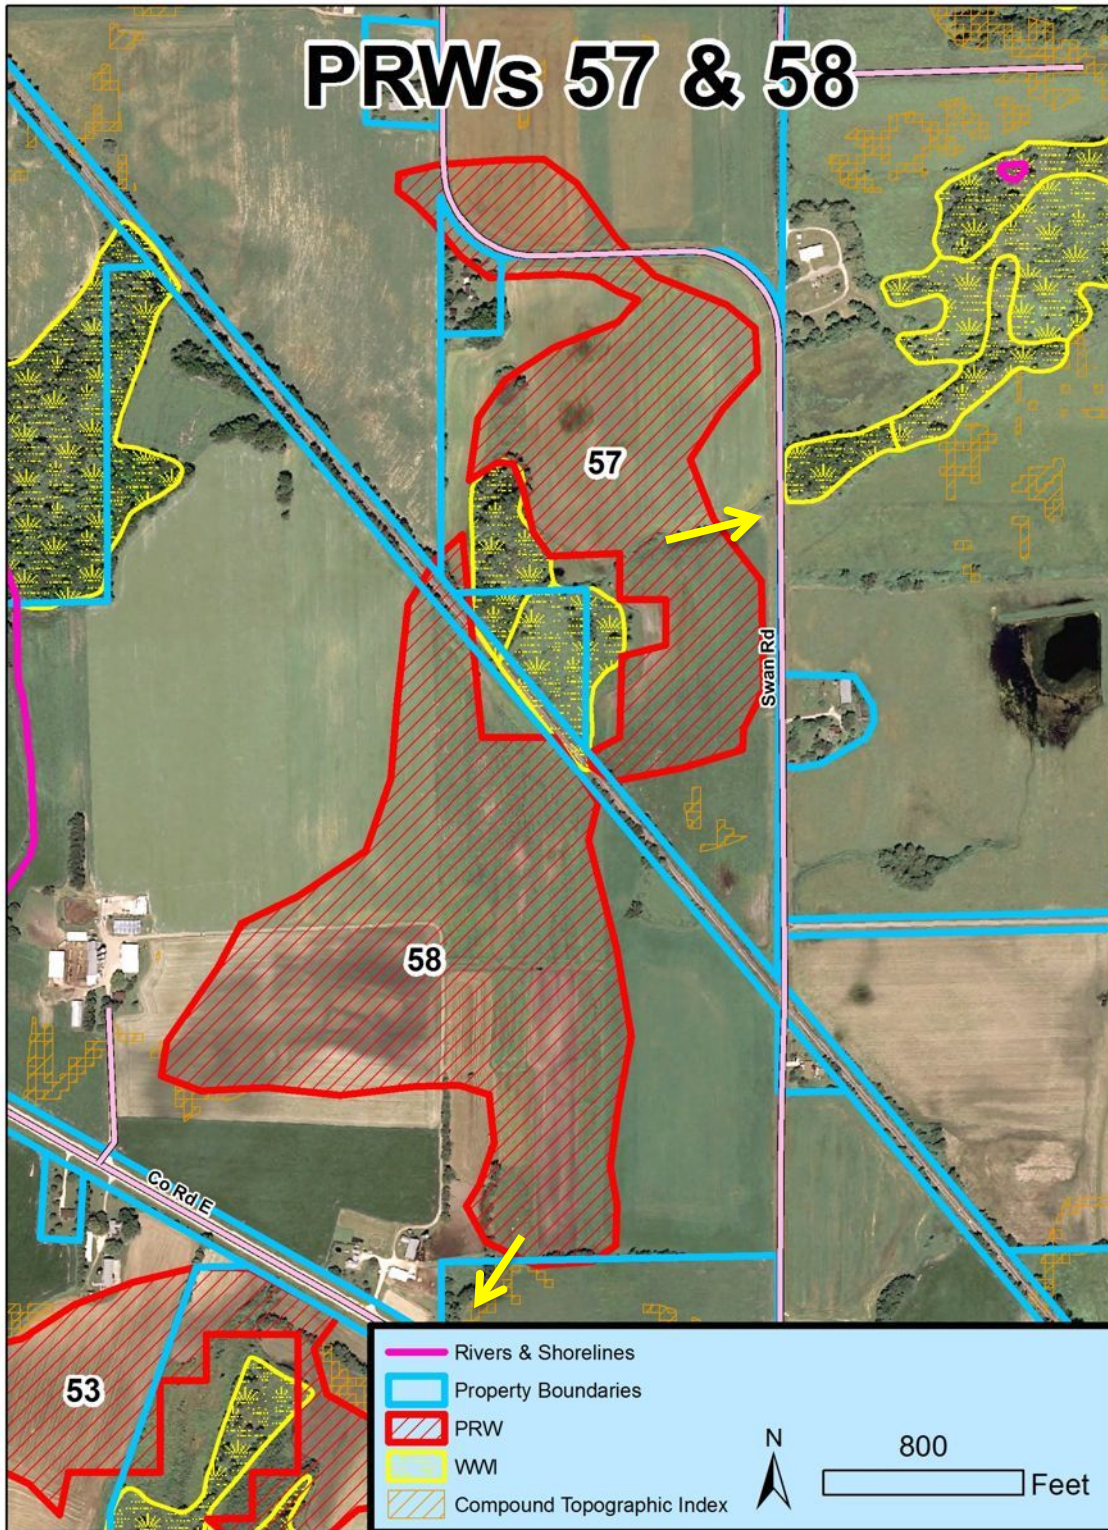
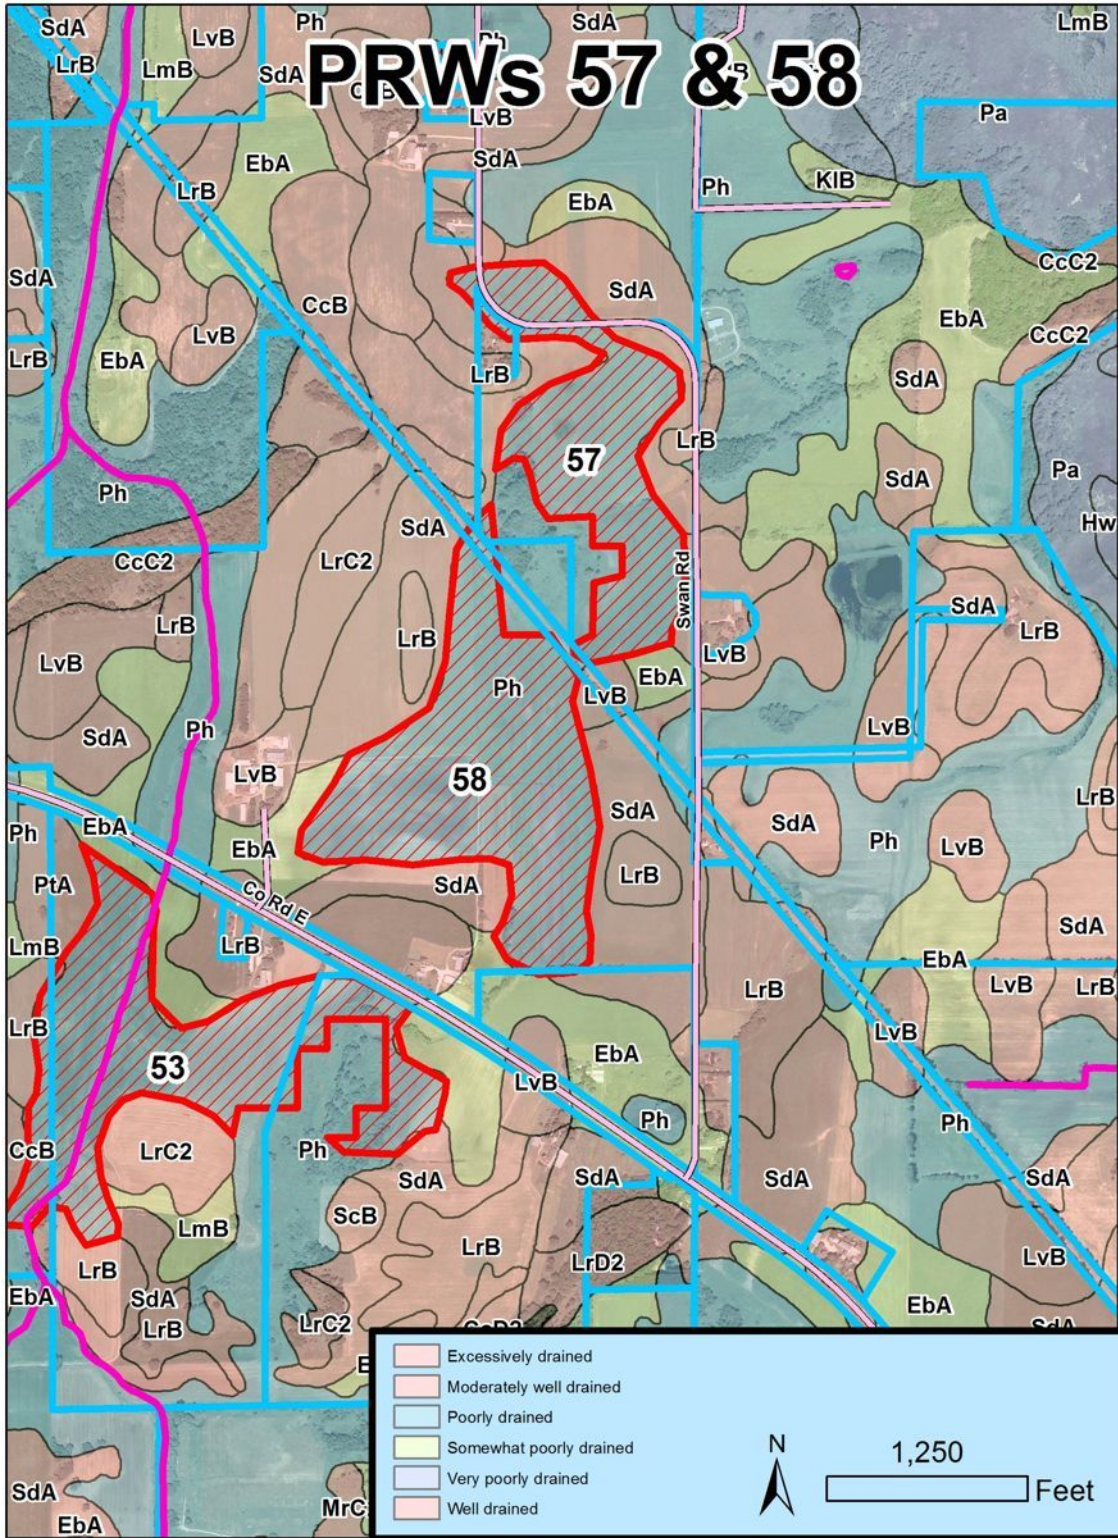
# PRWs 57 & 58

Restorable north of R/R. Ditch drains PRW to the east. Would affect 2 landowners.

Drains south under Hwy. E, small ditch could be manipulated if no impact to neighbor.

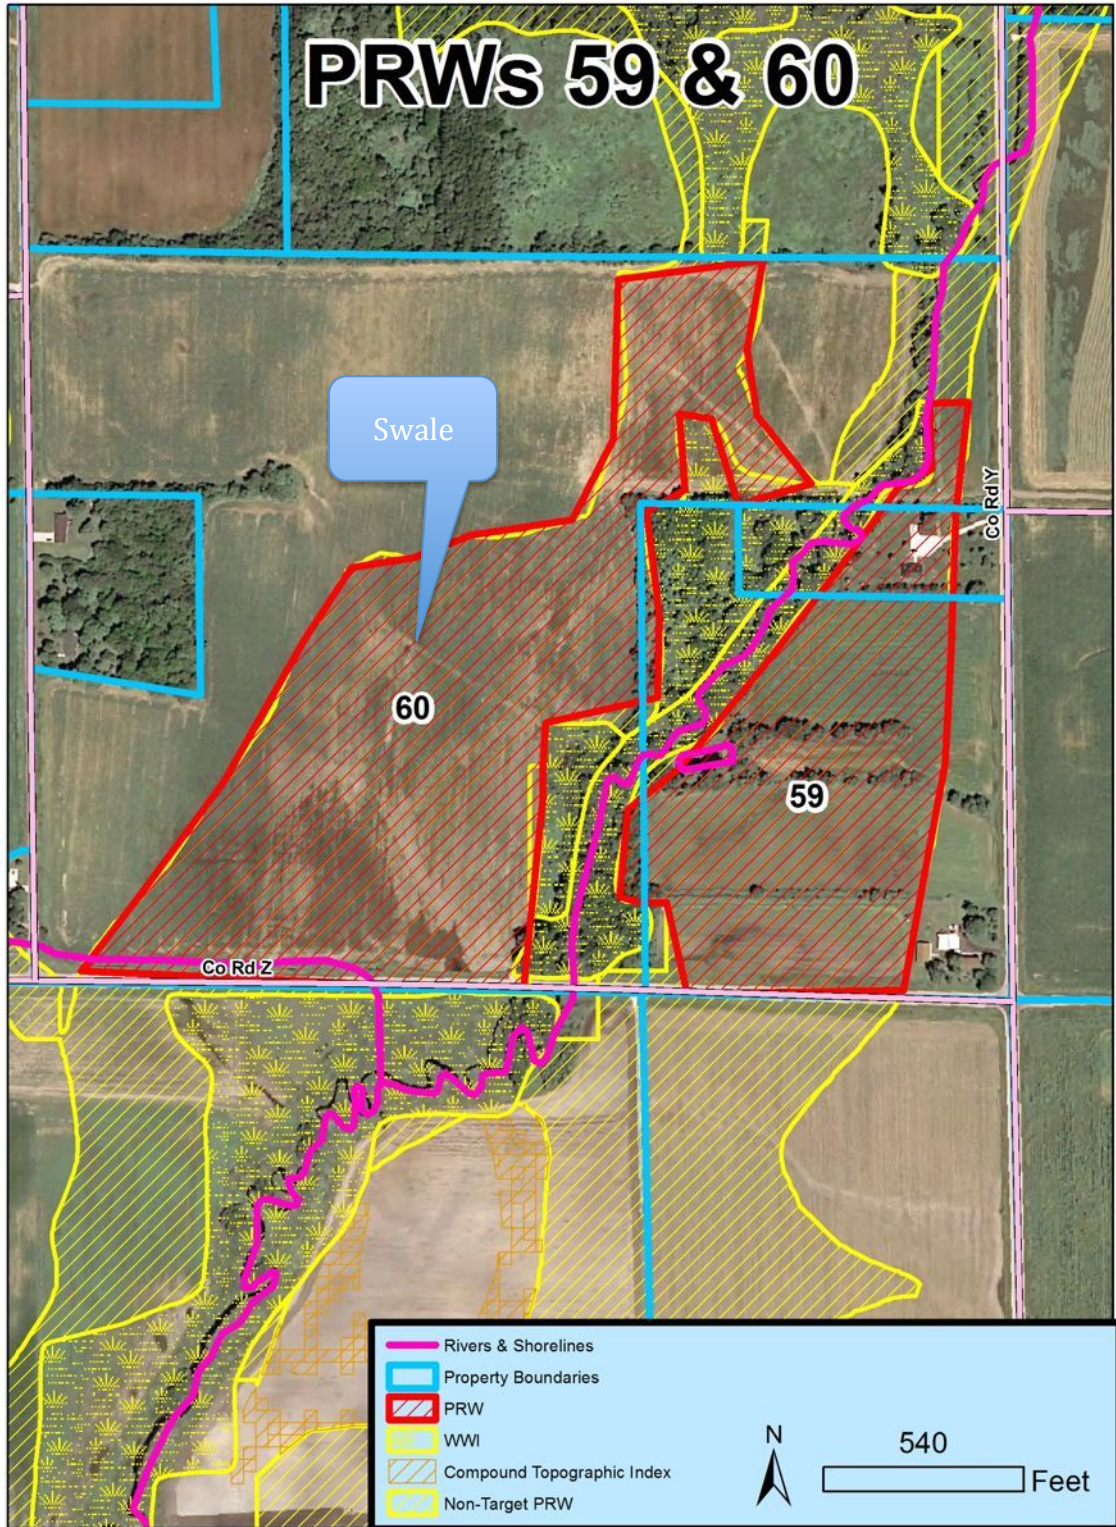
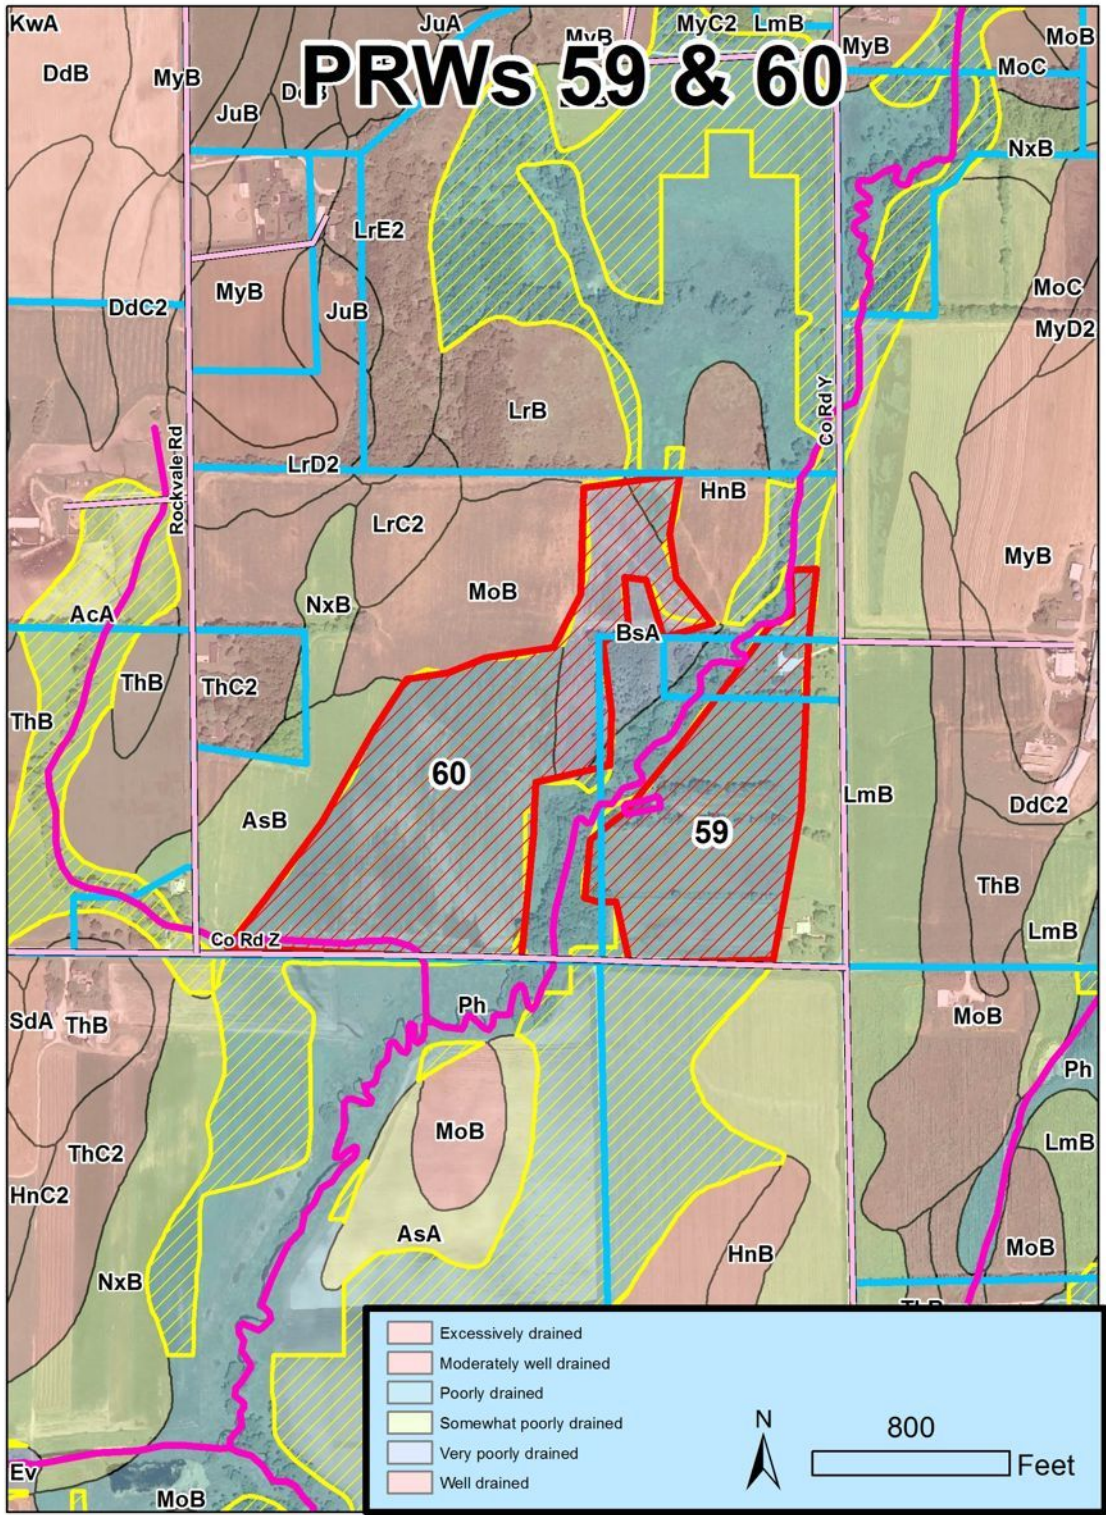
# PRWs 59 & 60

Small lateral ditches drain to river. Areas of field were unplanted due to wetness.  
Decent restoration potential.

PRW surface elevation close to river elevation. Many indications of wetness, i.e.  
unplanted and reed canary grass areas. If there are drain tiles, then could be restorable.

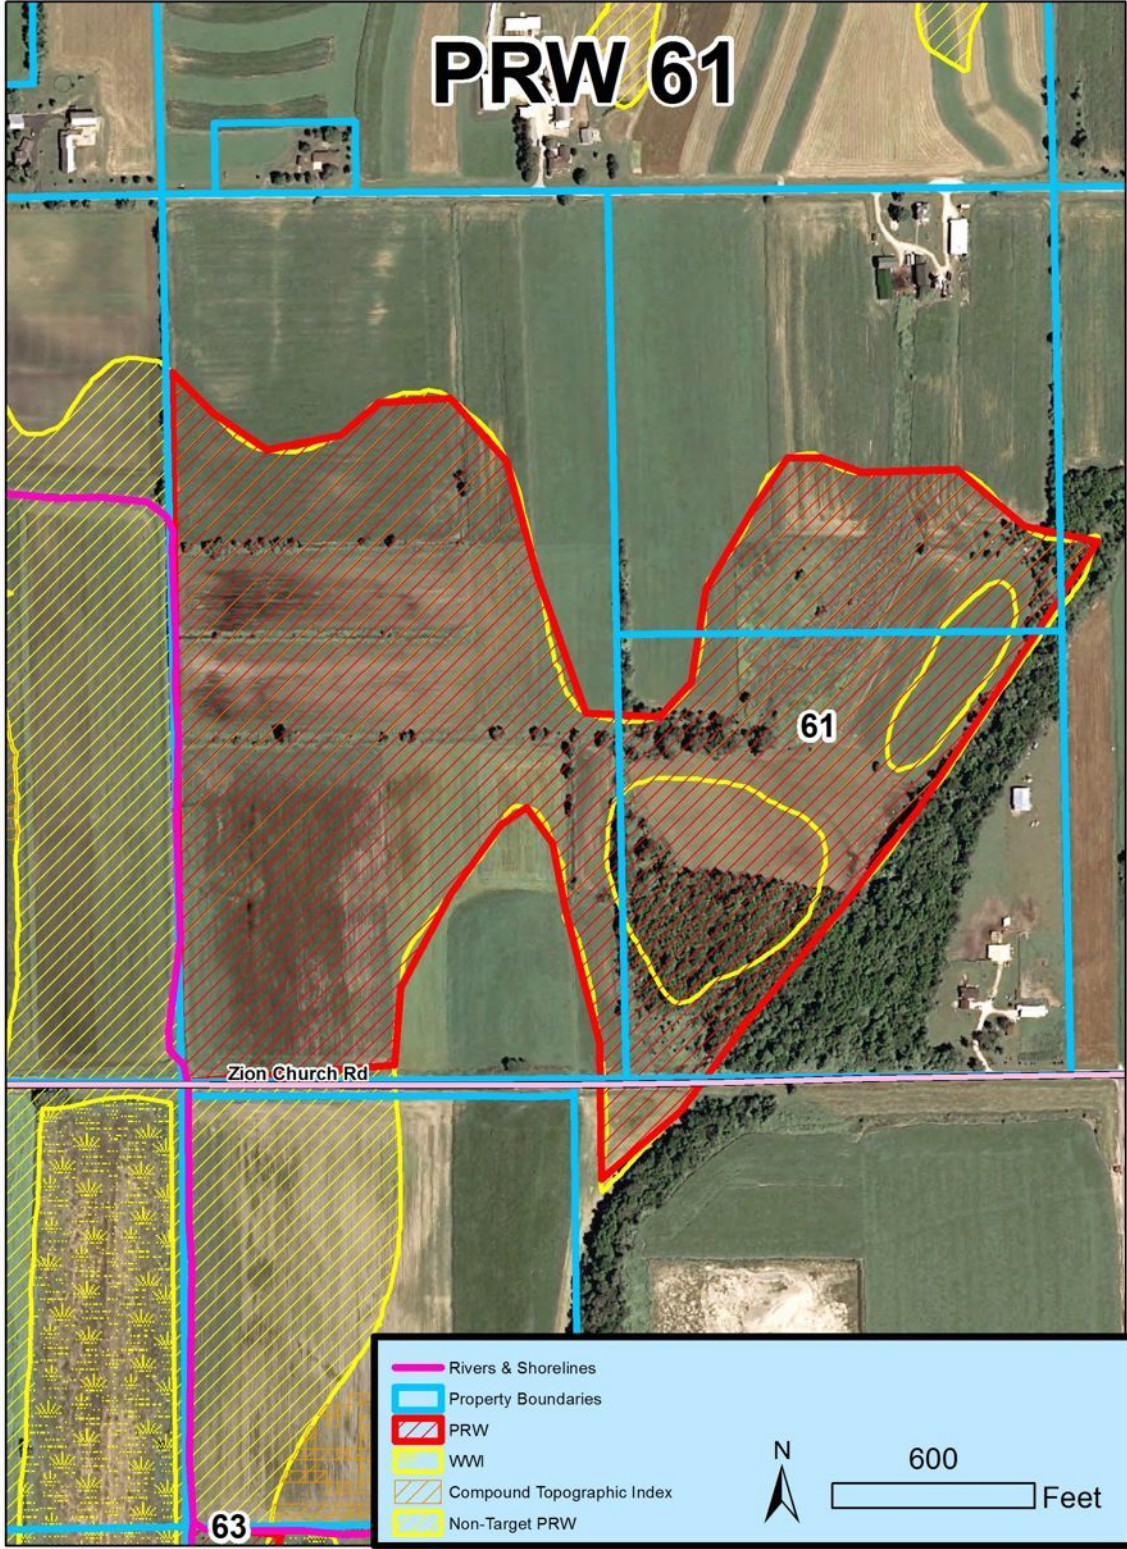
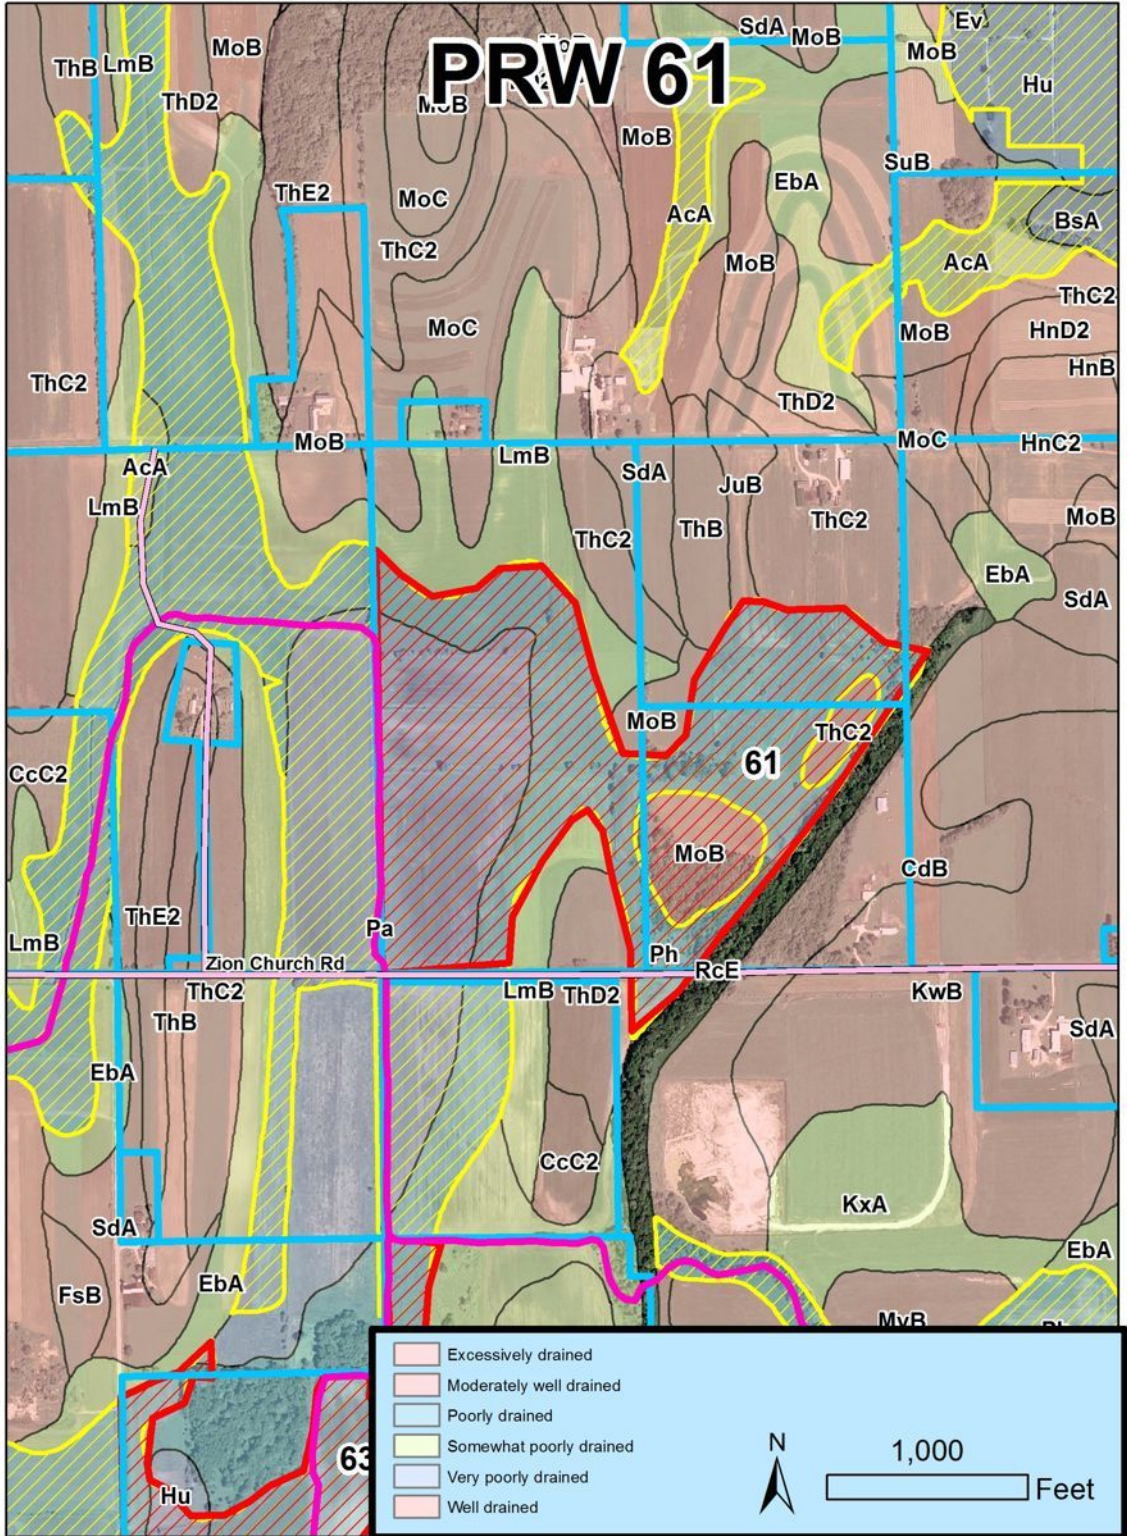
# PRW 61

Ditch flows north, moving water in deep ditch. Small lateral ditches cannot see, potential for filling. Could use 2 northernmost lateral ditches for restoration. Has restoration potential.

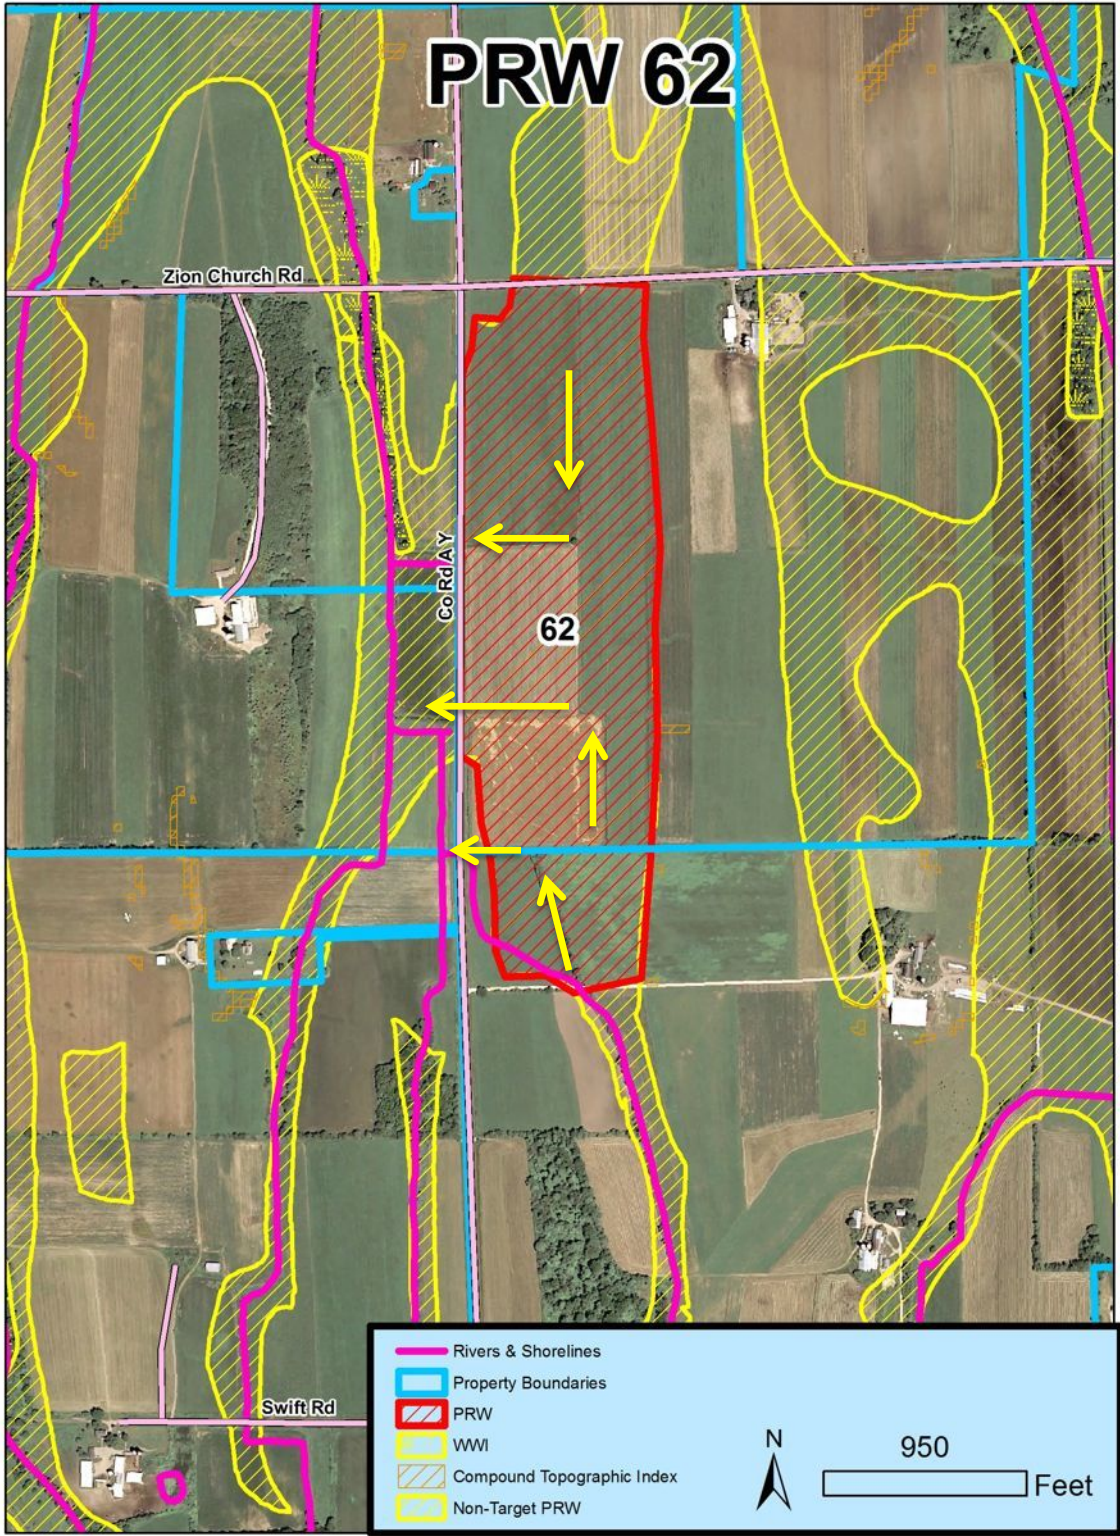
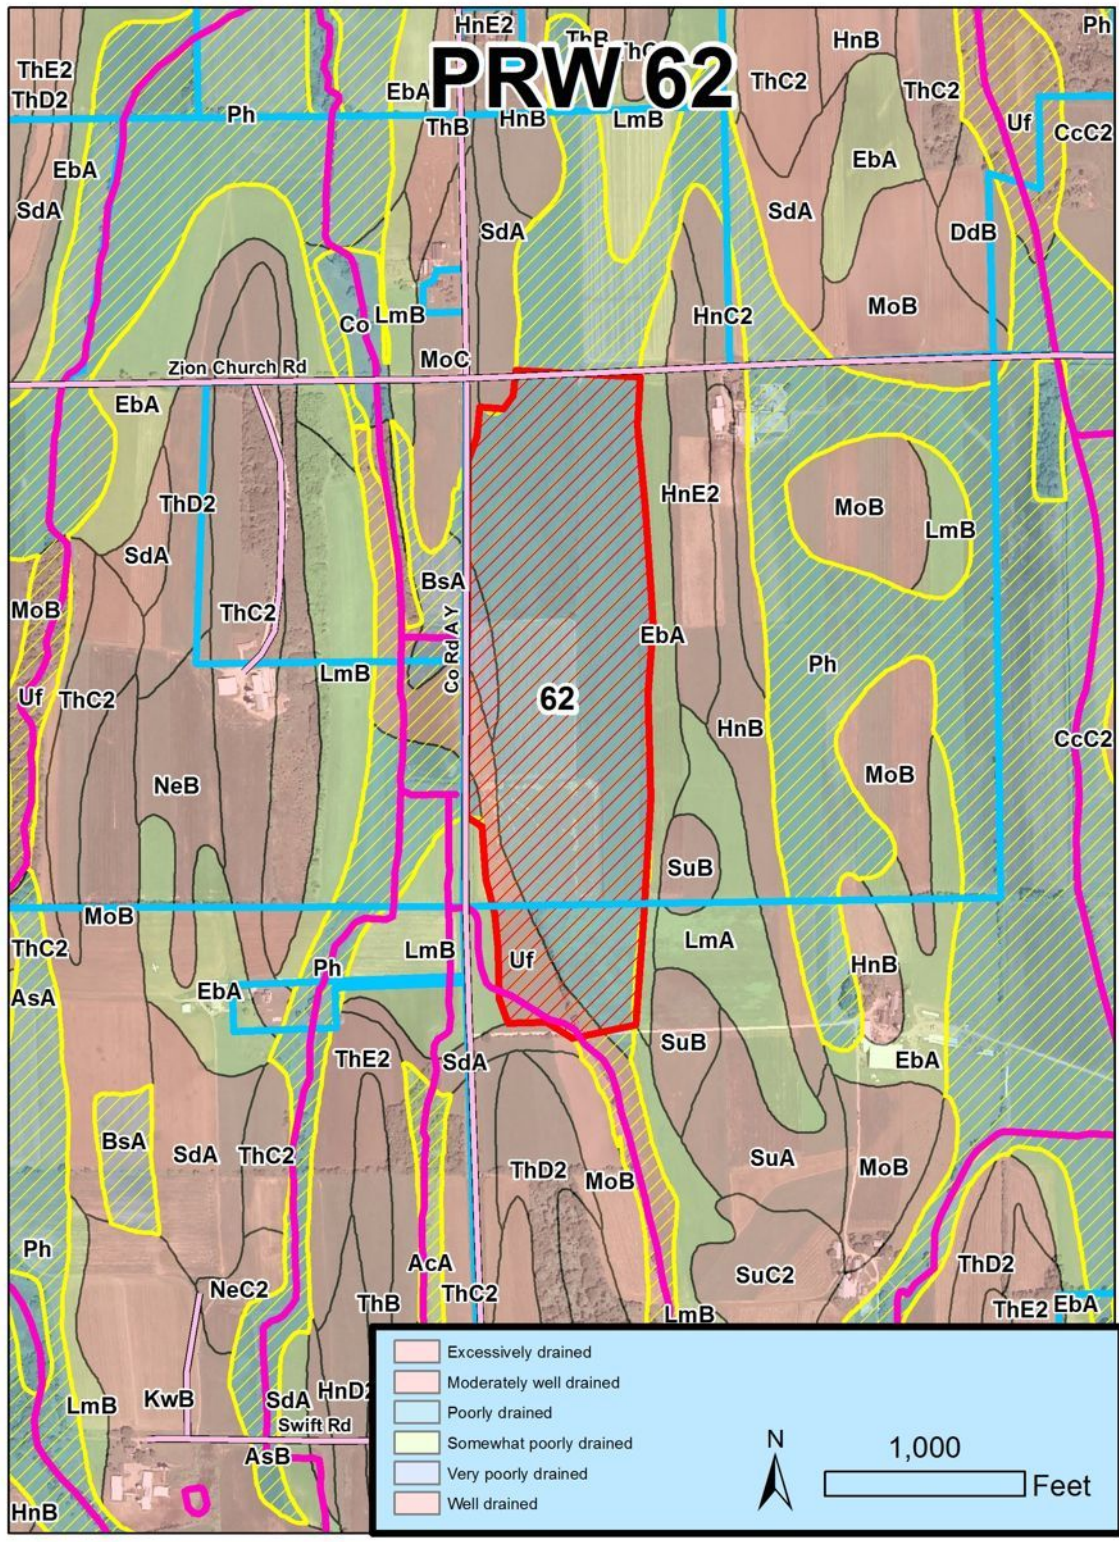
# PRW 62

Ditch originates on Zion Church Rd. Deep with moving water and 2 laterals exiting to west. Large field slopes gently to west and south. May be restorable, could only be mesic conditions.

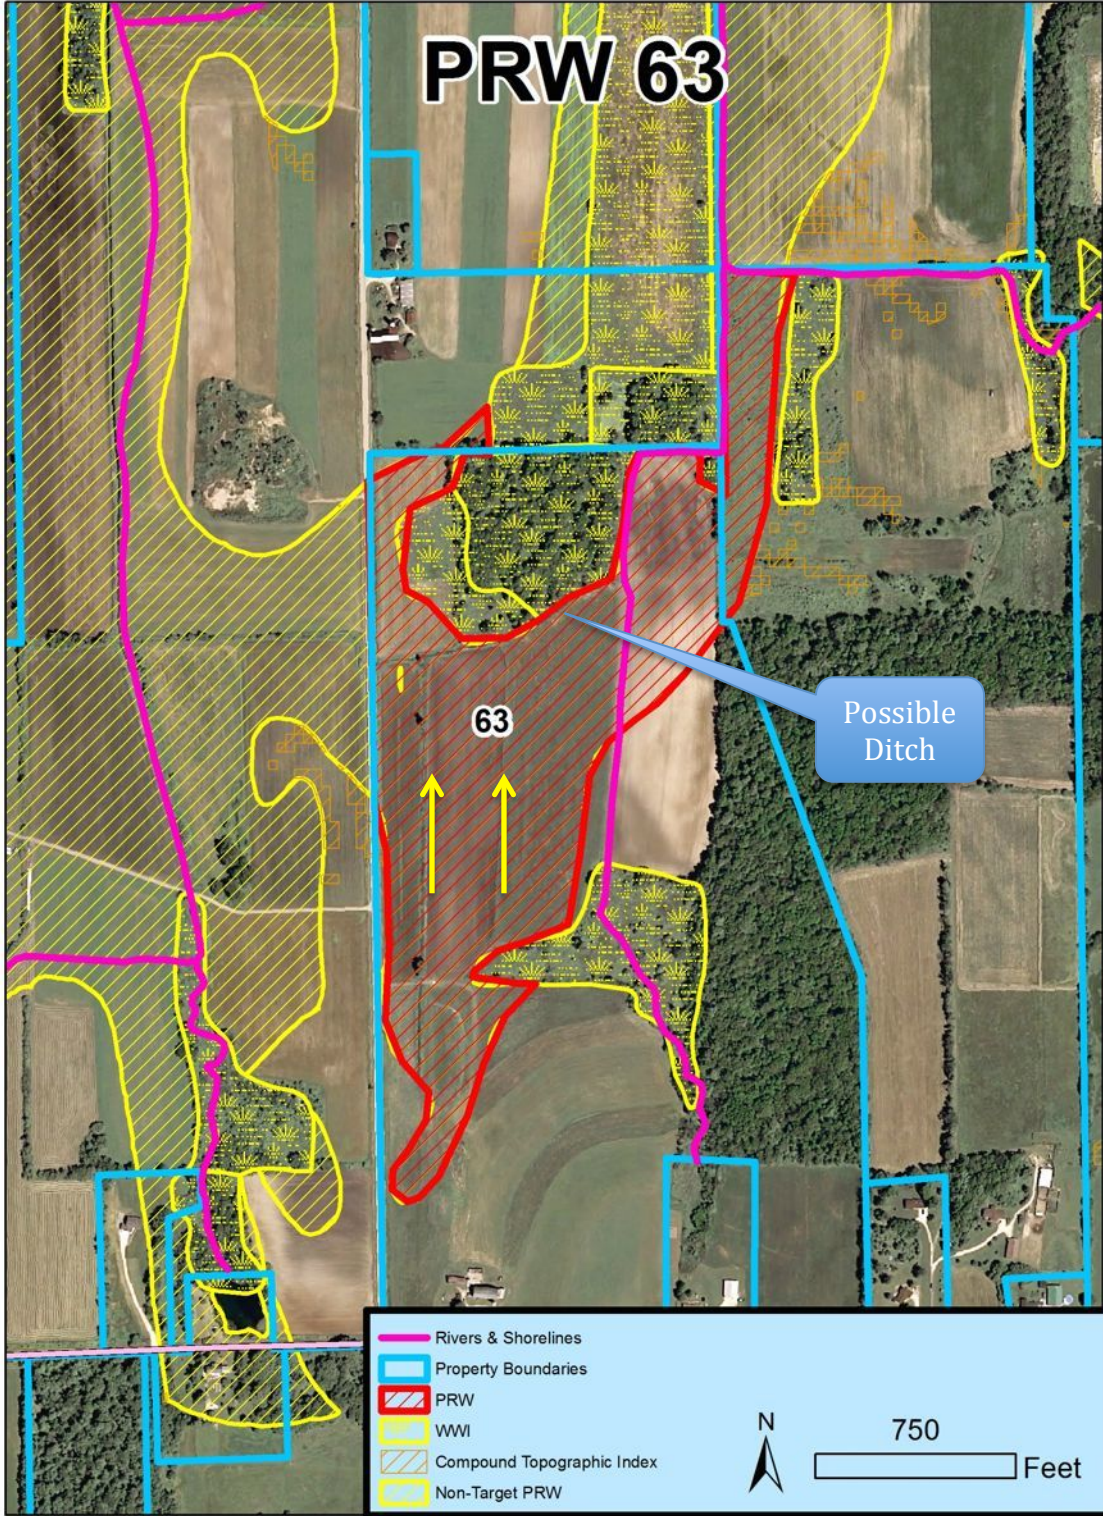
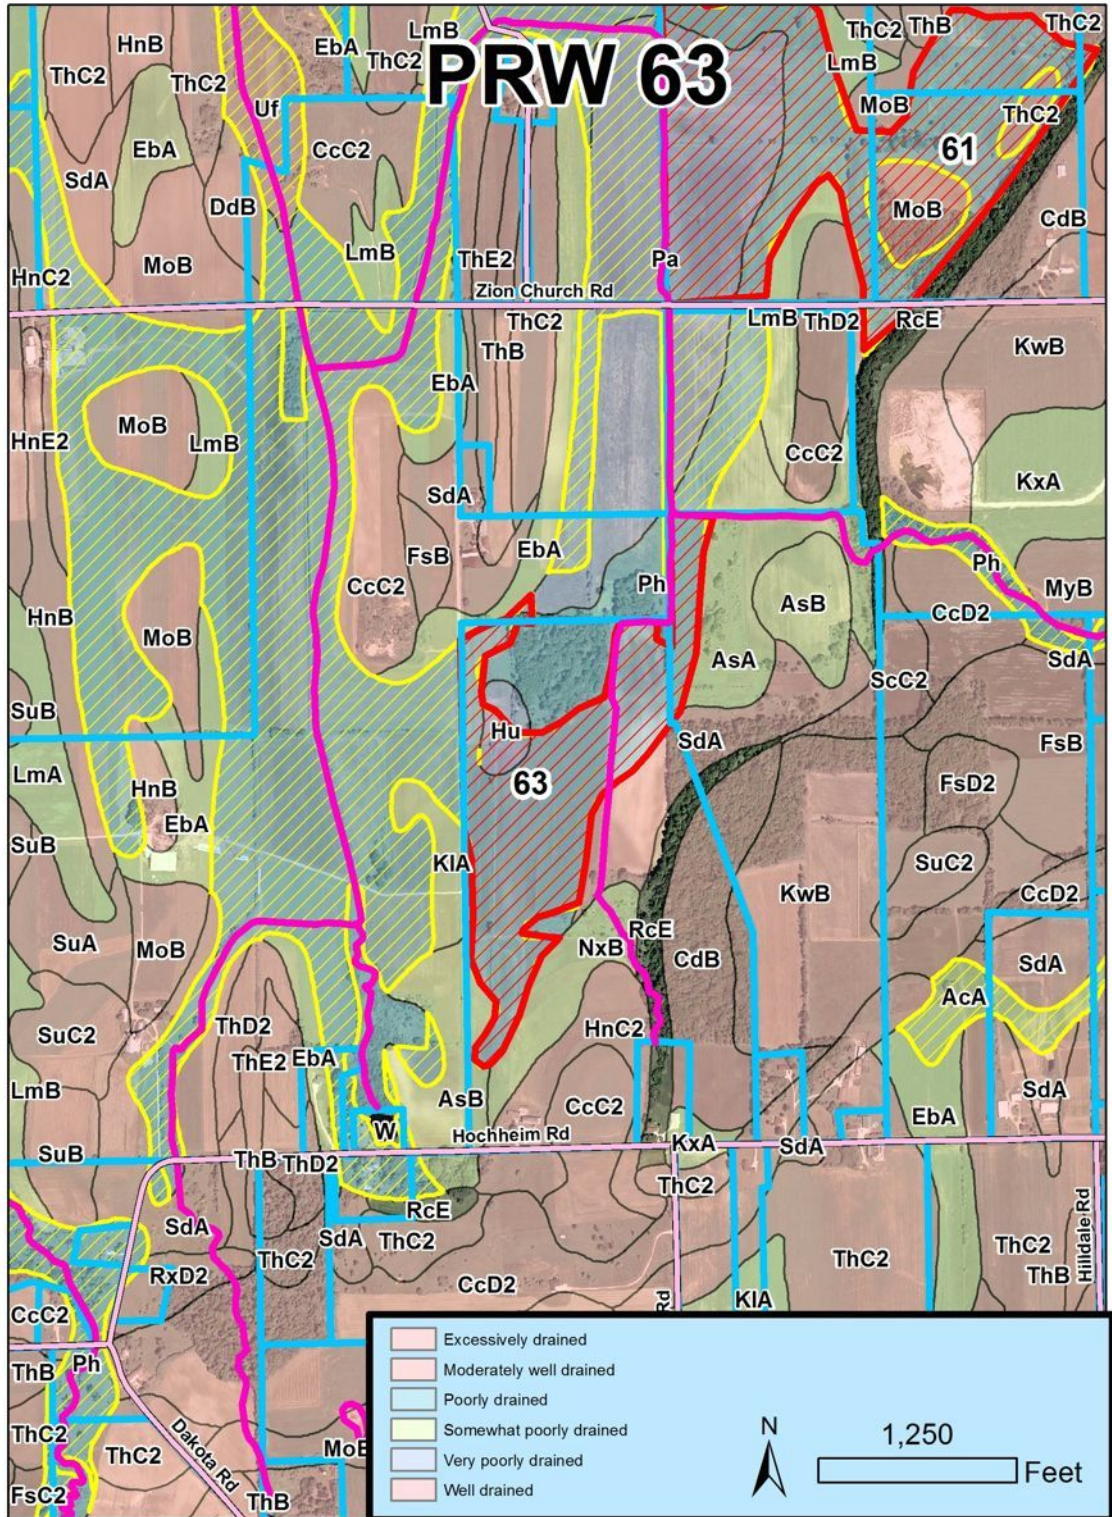
# PRW 63

One main ditch along east field. Two laterals we think flow west. All could be filled.  
North end shows signs of hydrology. Good restoration potential.
