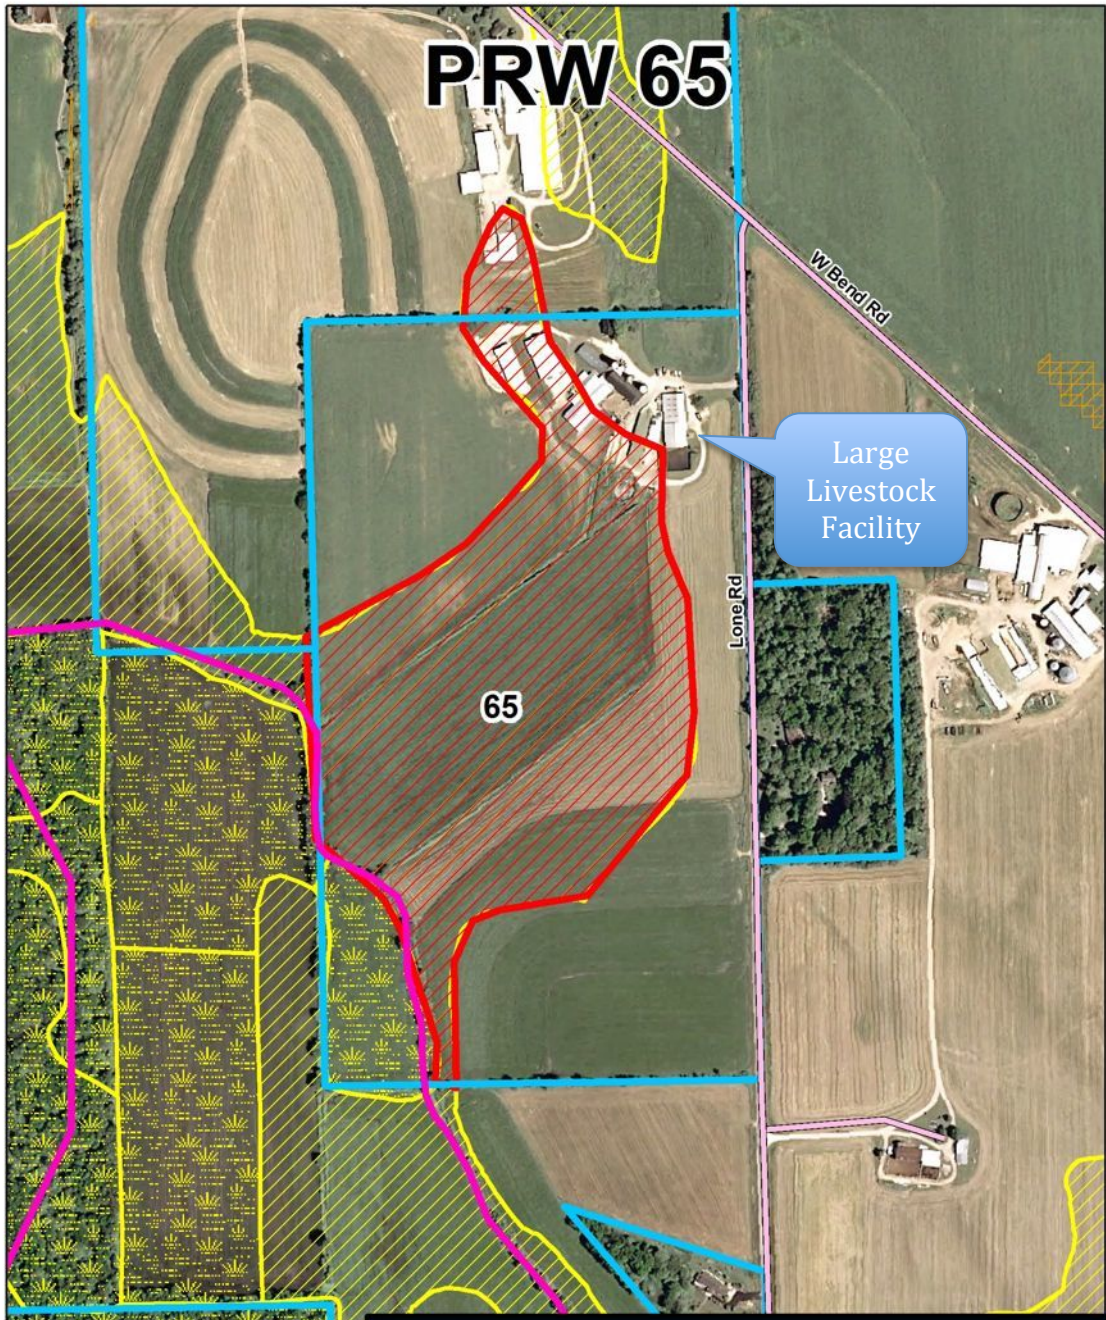
# PRW 65

Ditches through large flat basin. Ditches are holding water. Possible scrape/ditch plug. Probably a manure point source discharge. Heavy manure spreading. Would be a good water quality control project.

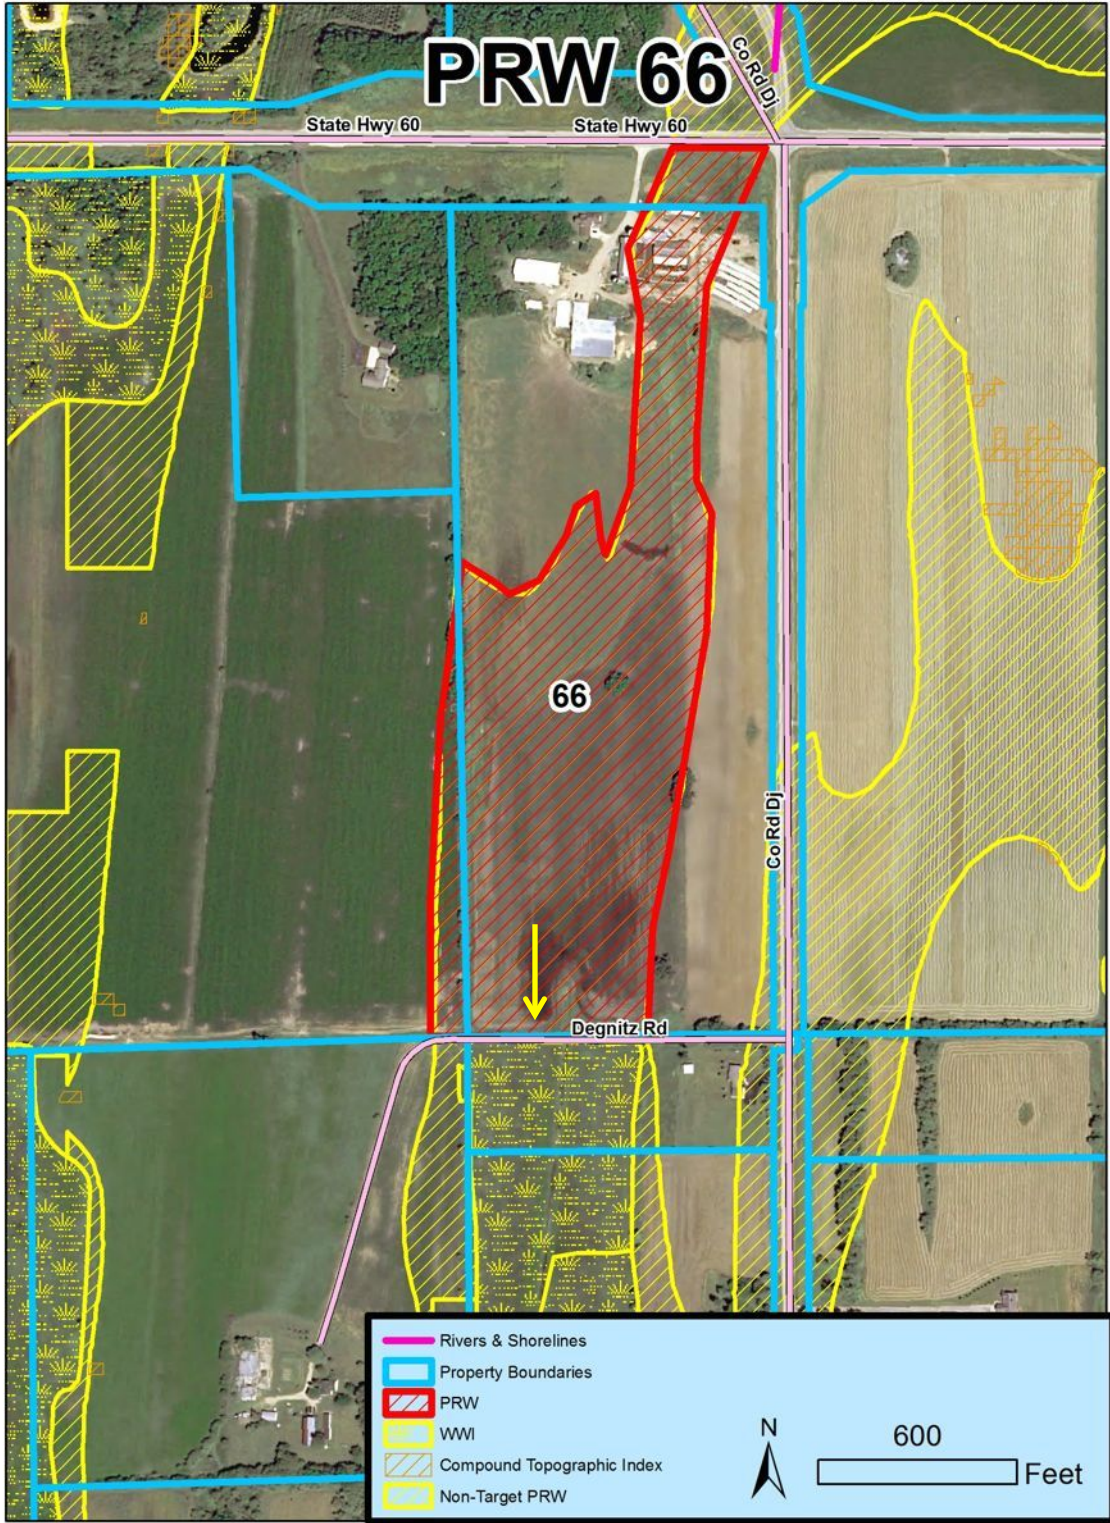
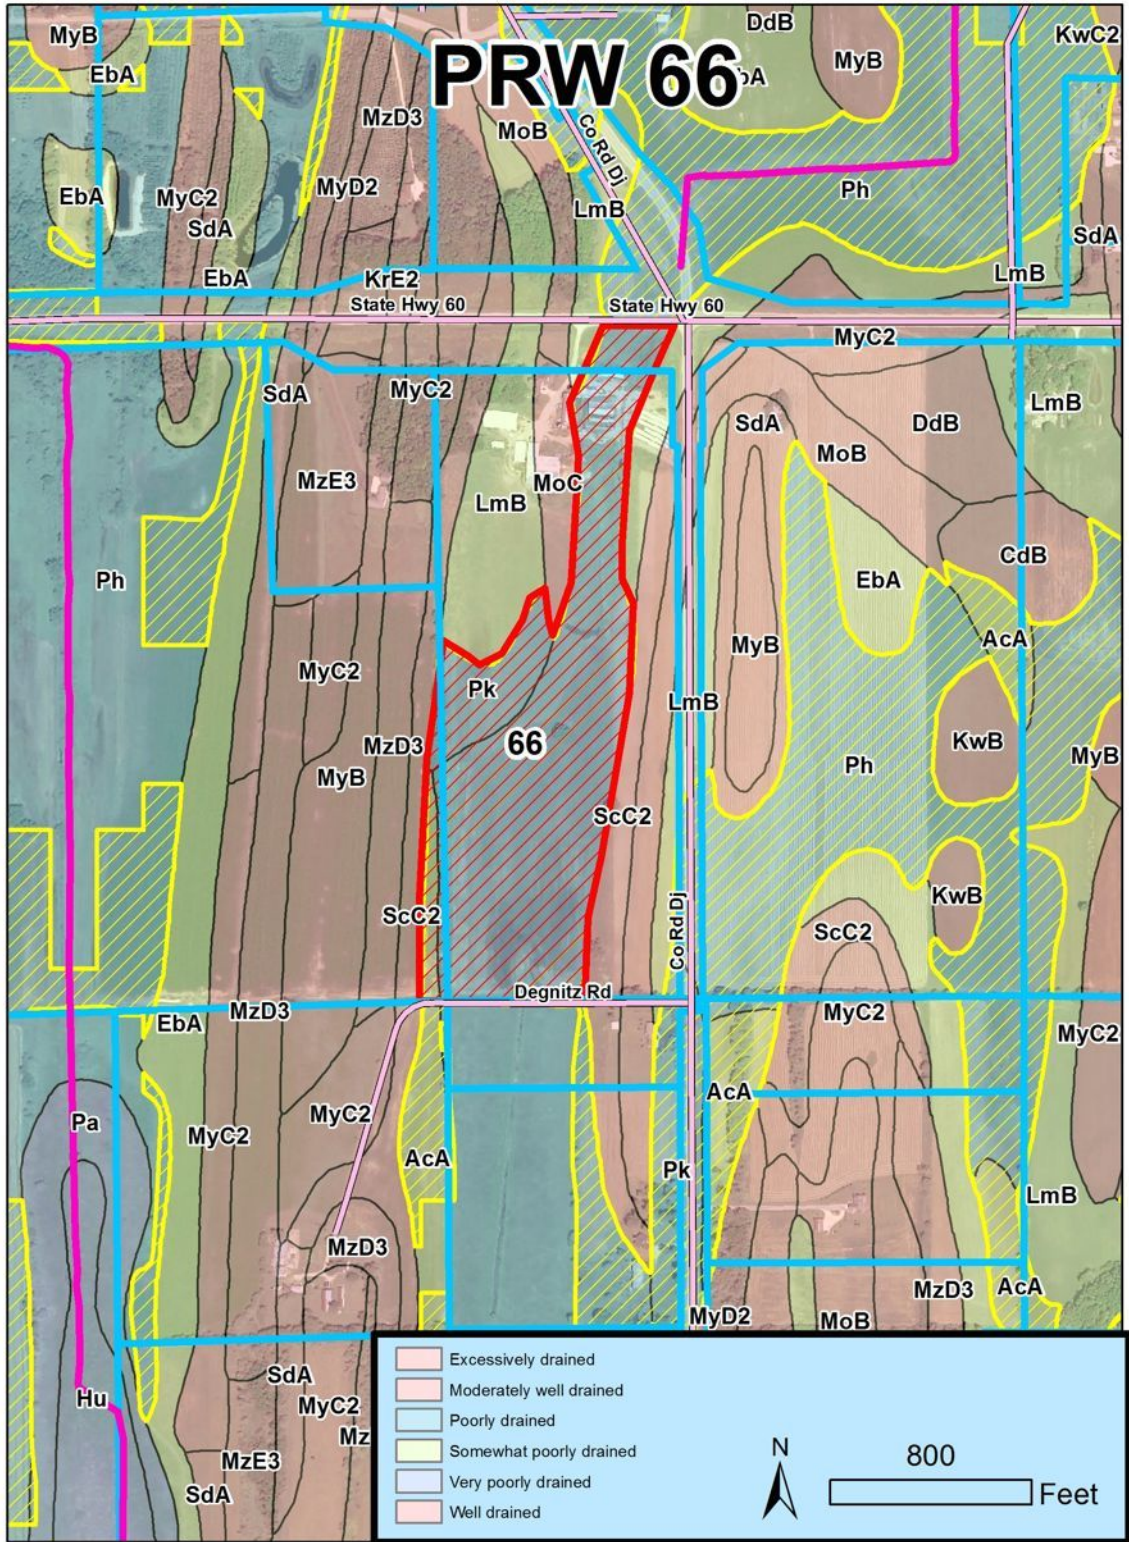
Flat basin with ditch, water moving through it. Evidence of drain tile. Crop stress, unplanted areas, cattails in field. Good restoration potential.

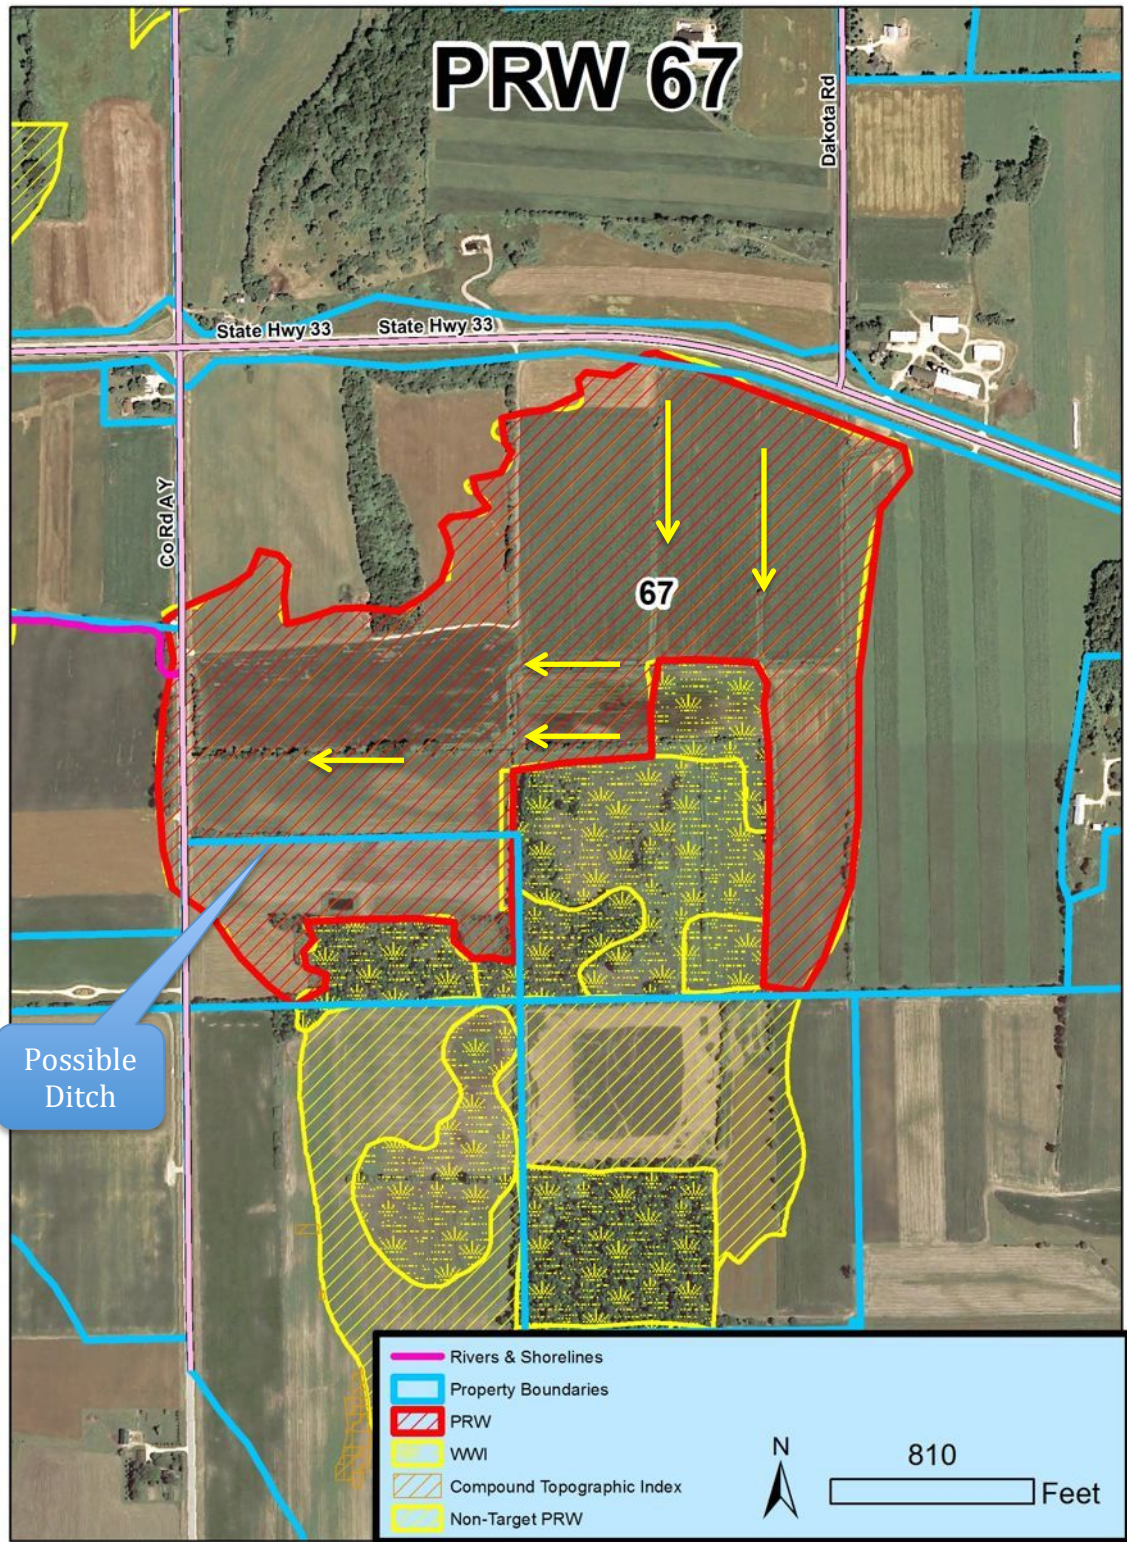
# PRW 67

Large site, many laterals converging at one point, flat basin where laterals meet appears to have wet soils with good restoration potential.

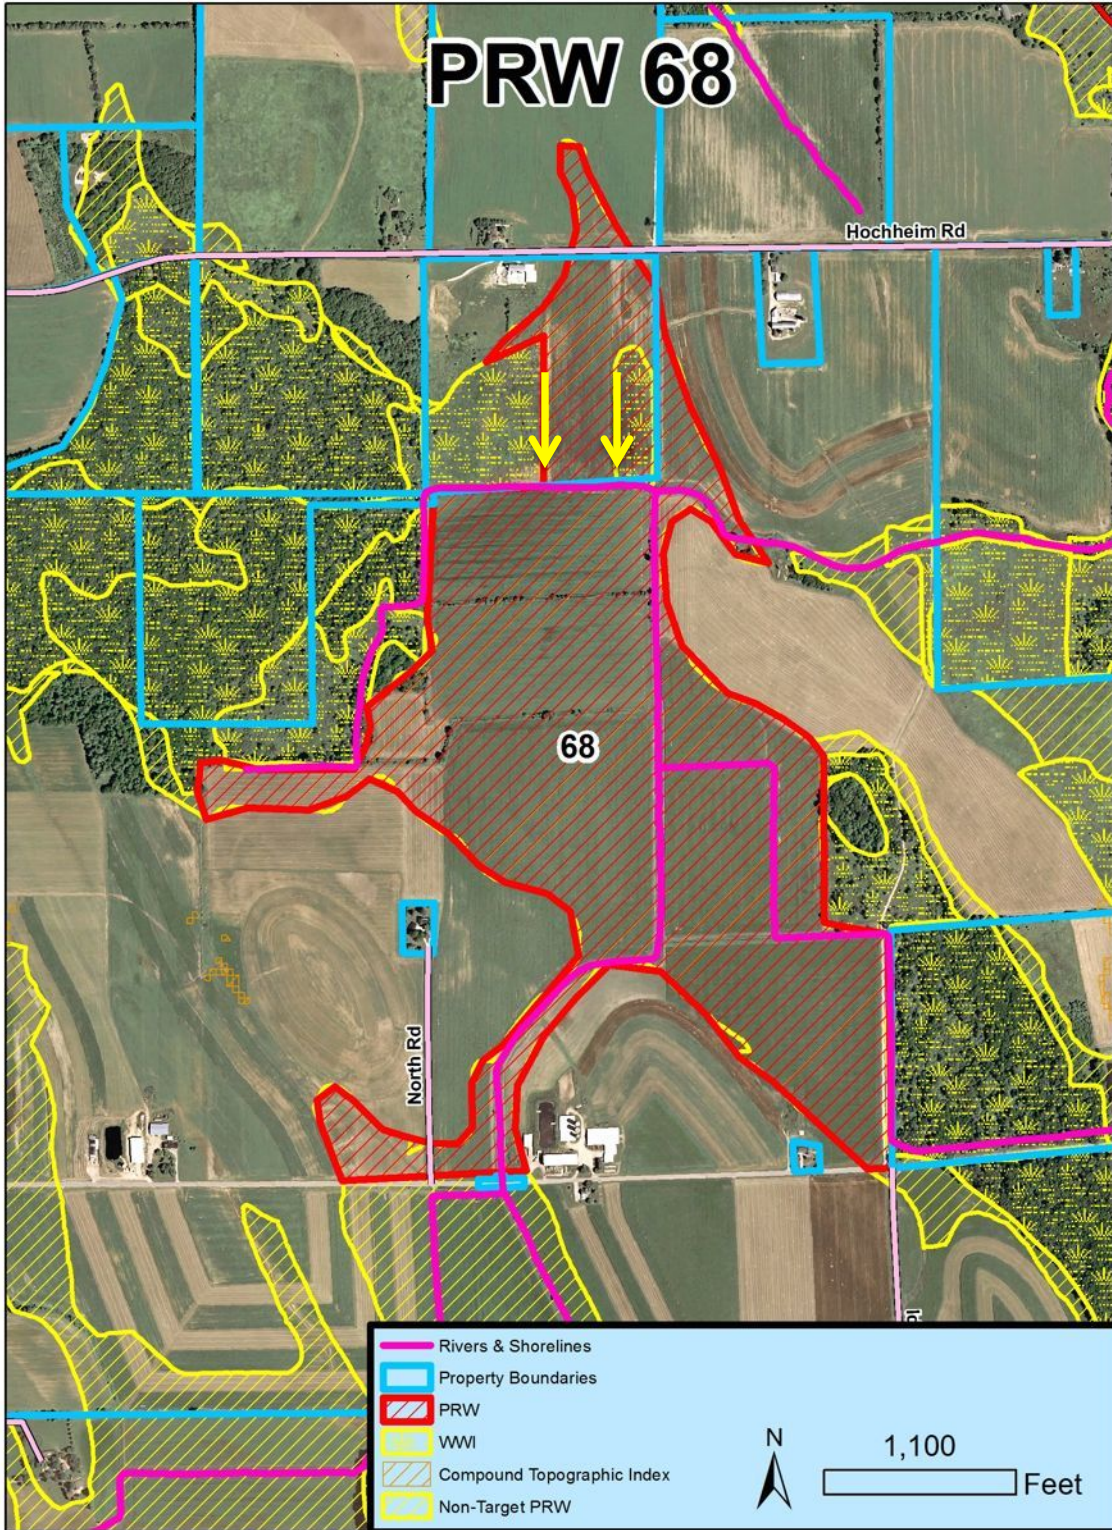
# PRW 68

Ditches originating on property. Big flat basin, portions are marsh hay, uncut due to wetness. Good restoration potential. More ditch south that cannot view, similar soil and land use (crops), probably similar potential.

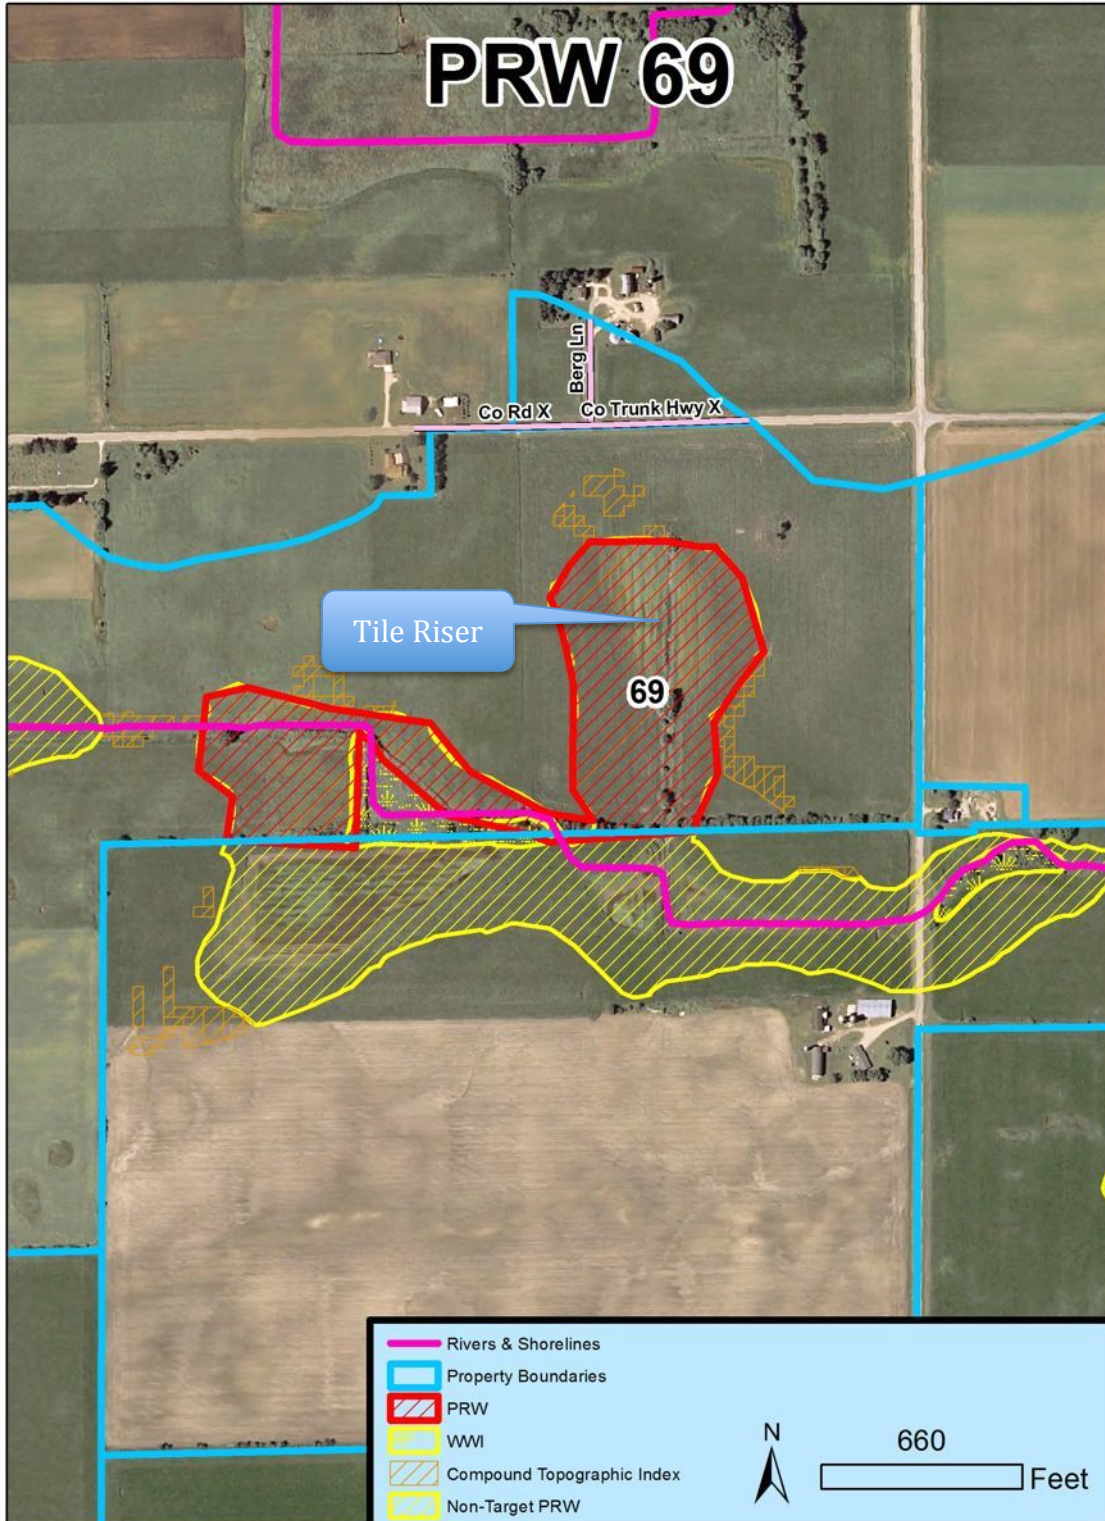
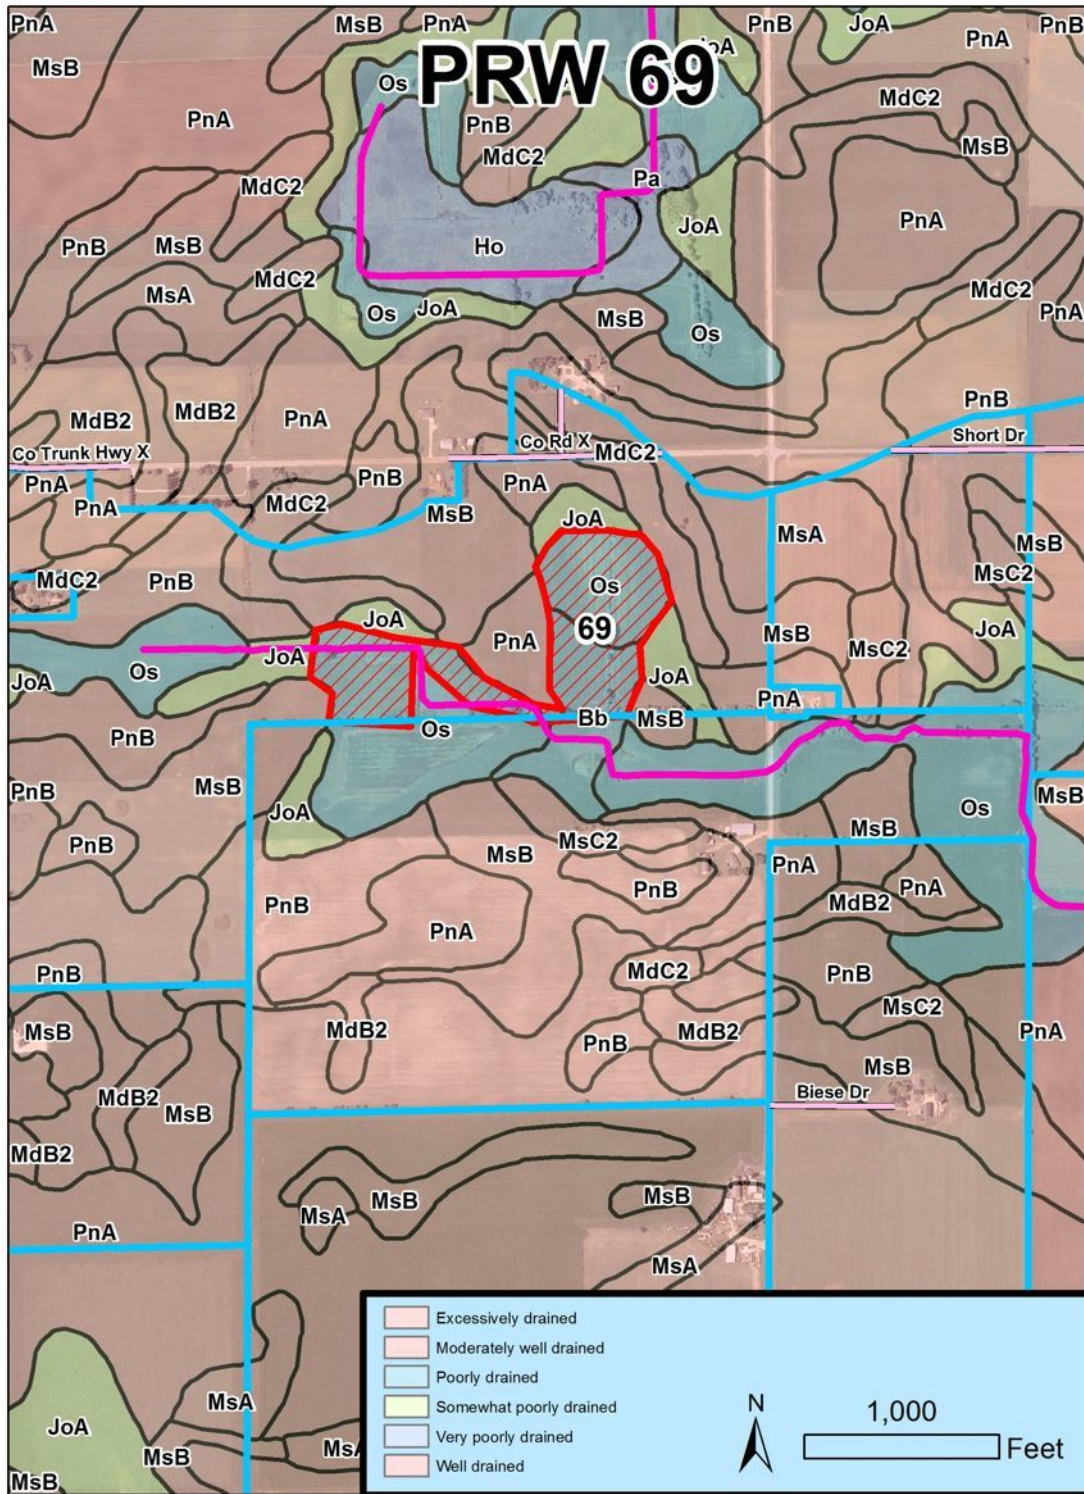
# PRW 69

Tiled basin in north segment is restorable. Cannot see basin to the west. Neighbor to the south shares tile and has main tile outlet to the east. Also has restorable wetlands.

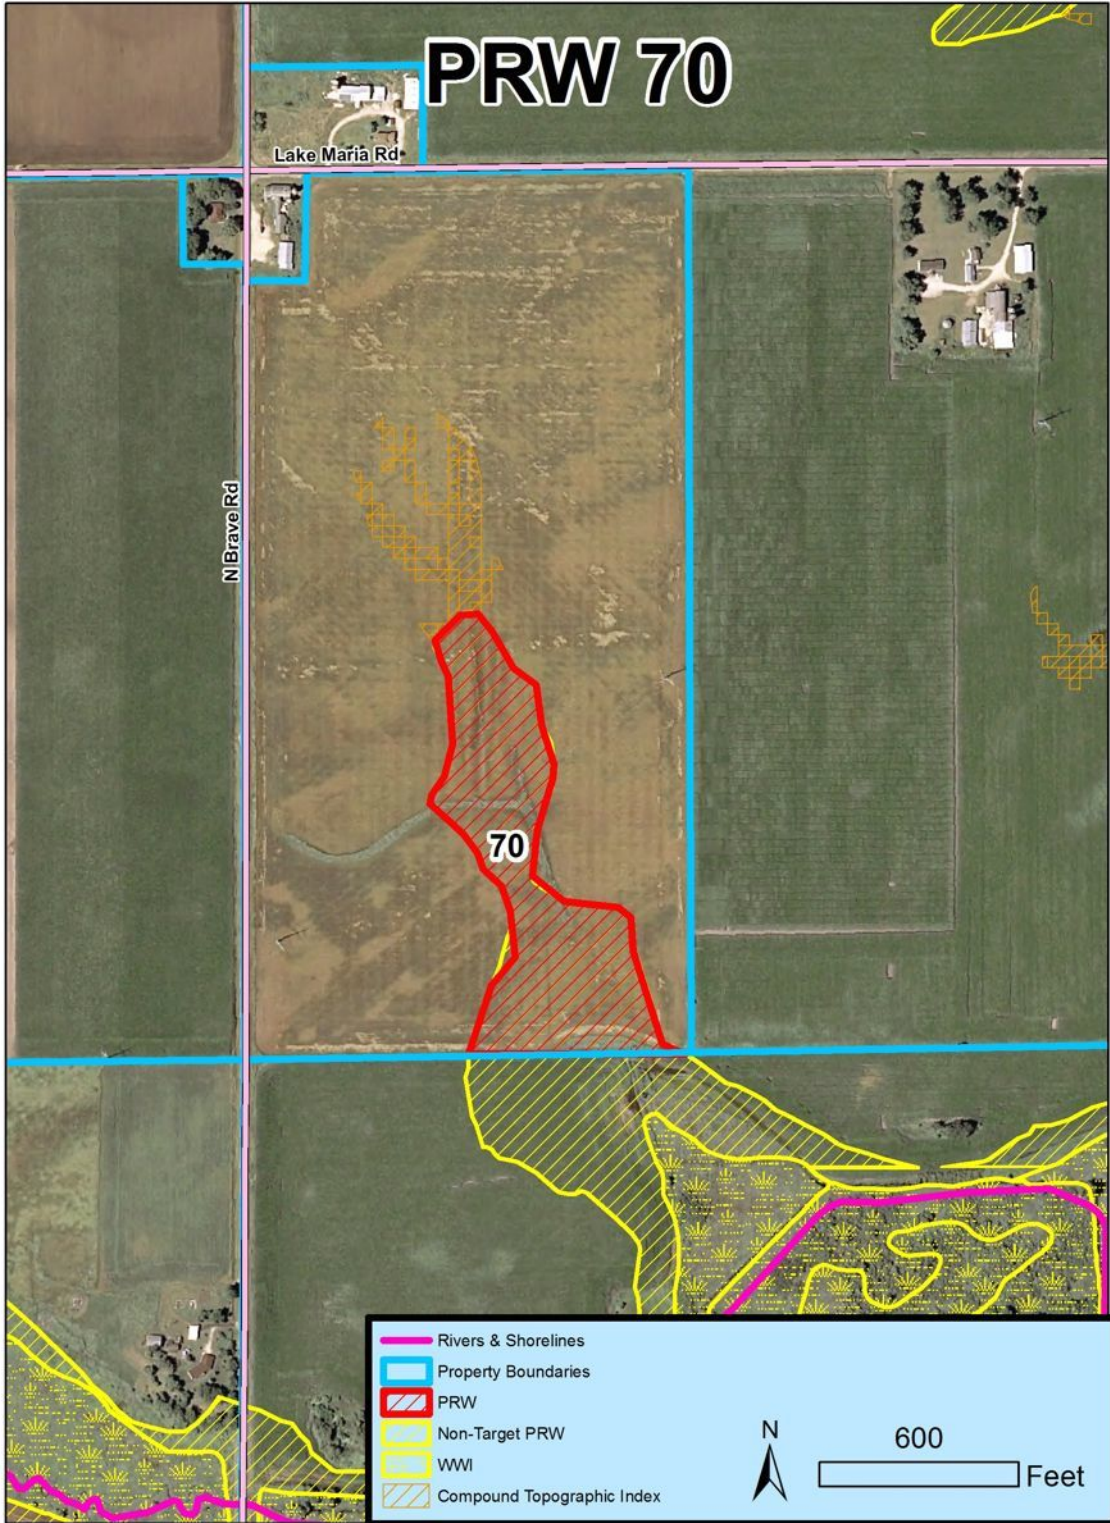
# PRW 70

Cropped upper area (MH soil) has probable tile system, no obvious ditches. Property to the south has ditch main with likely stream history. Could fill lateral ditch in association with neighbor to north.

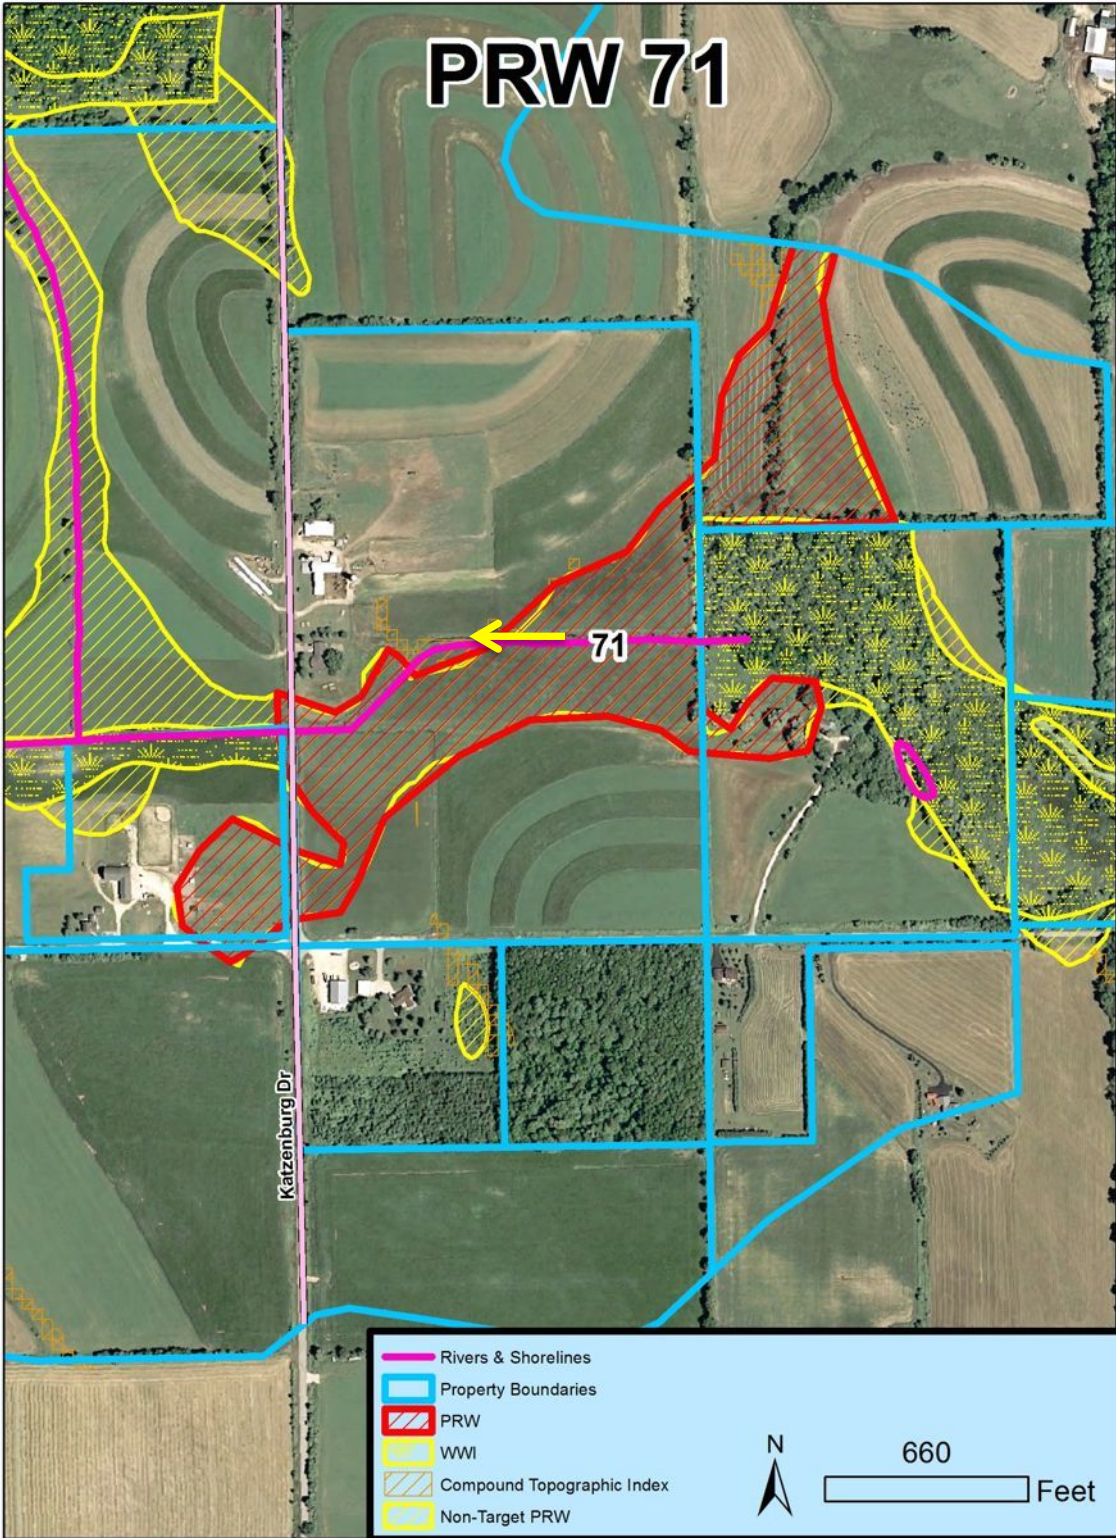
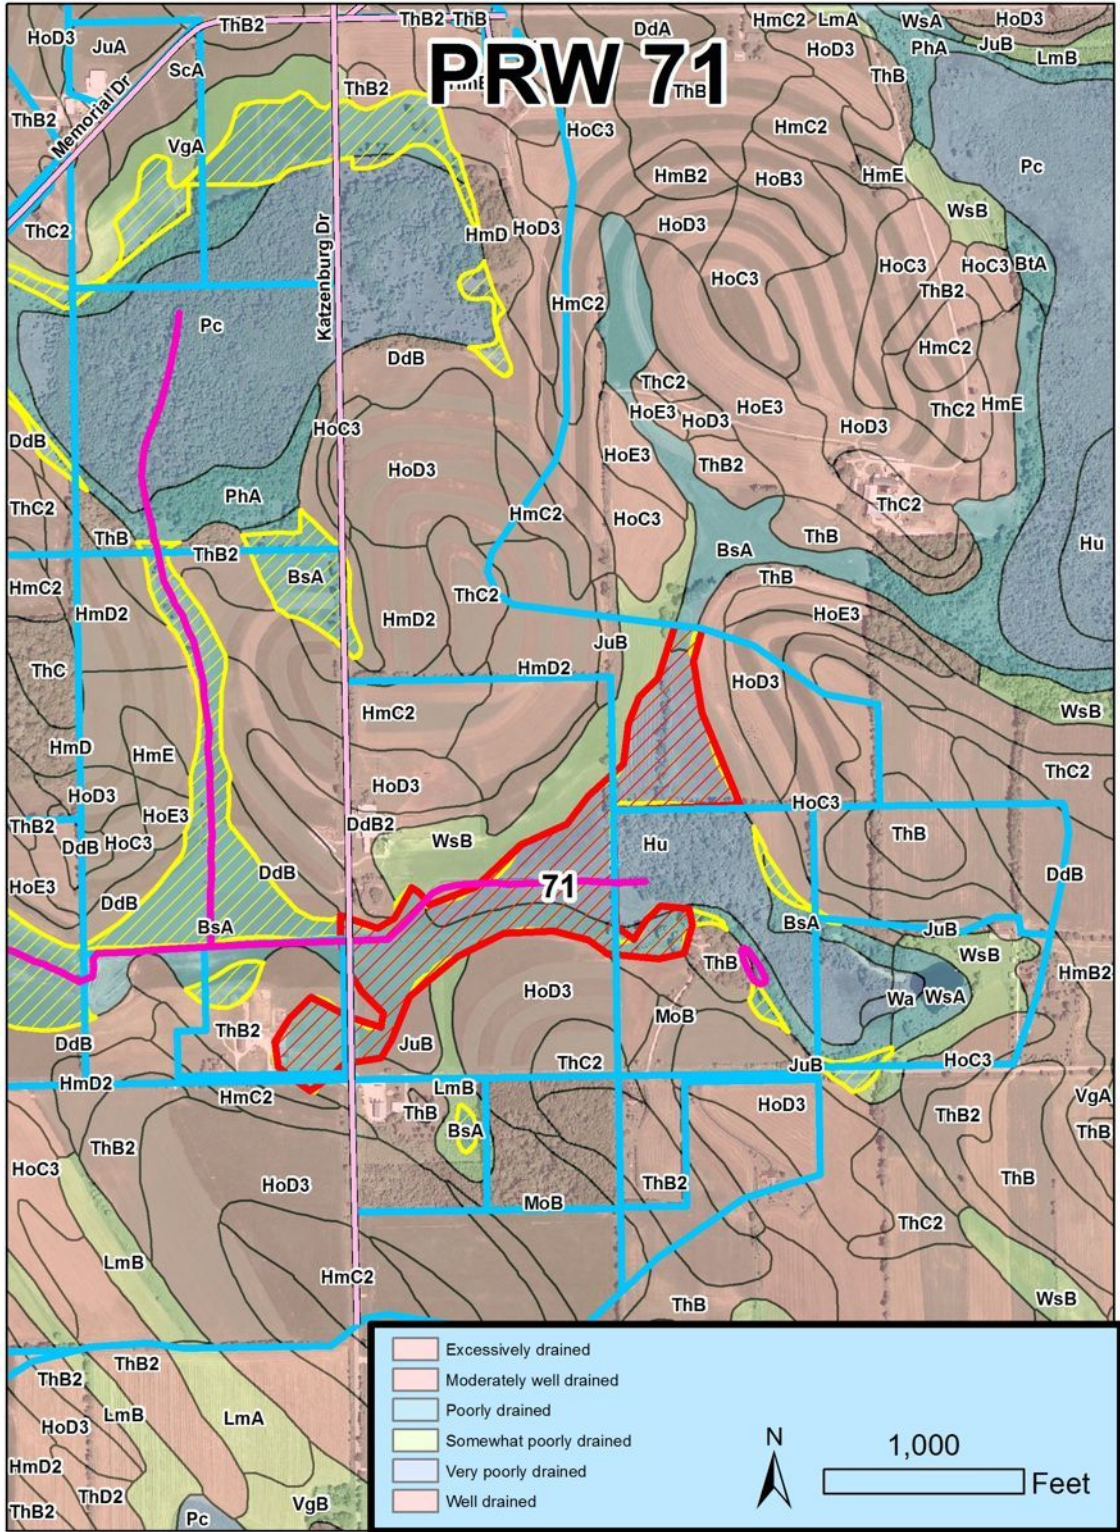
# PRW 71

Ditch drains wetland to east; is big and contains water. Most of PRW is a marsh hay field. Landowner is known by Peter Ziegler and is conservation minded. Medium restoration potential.

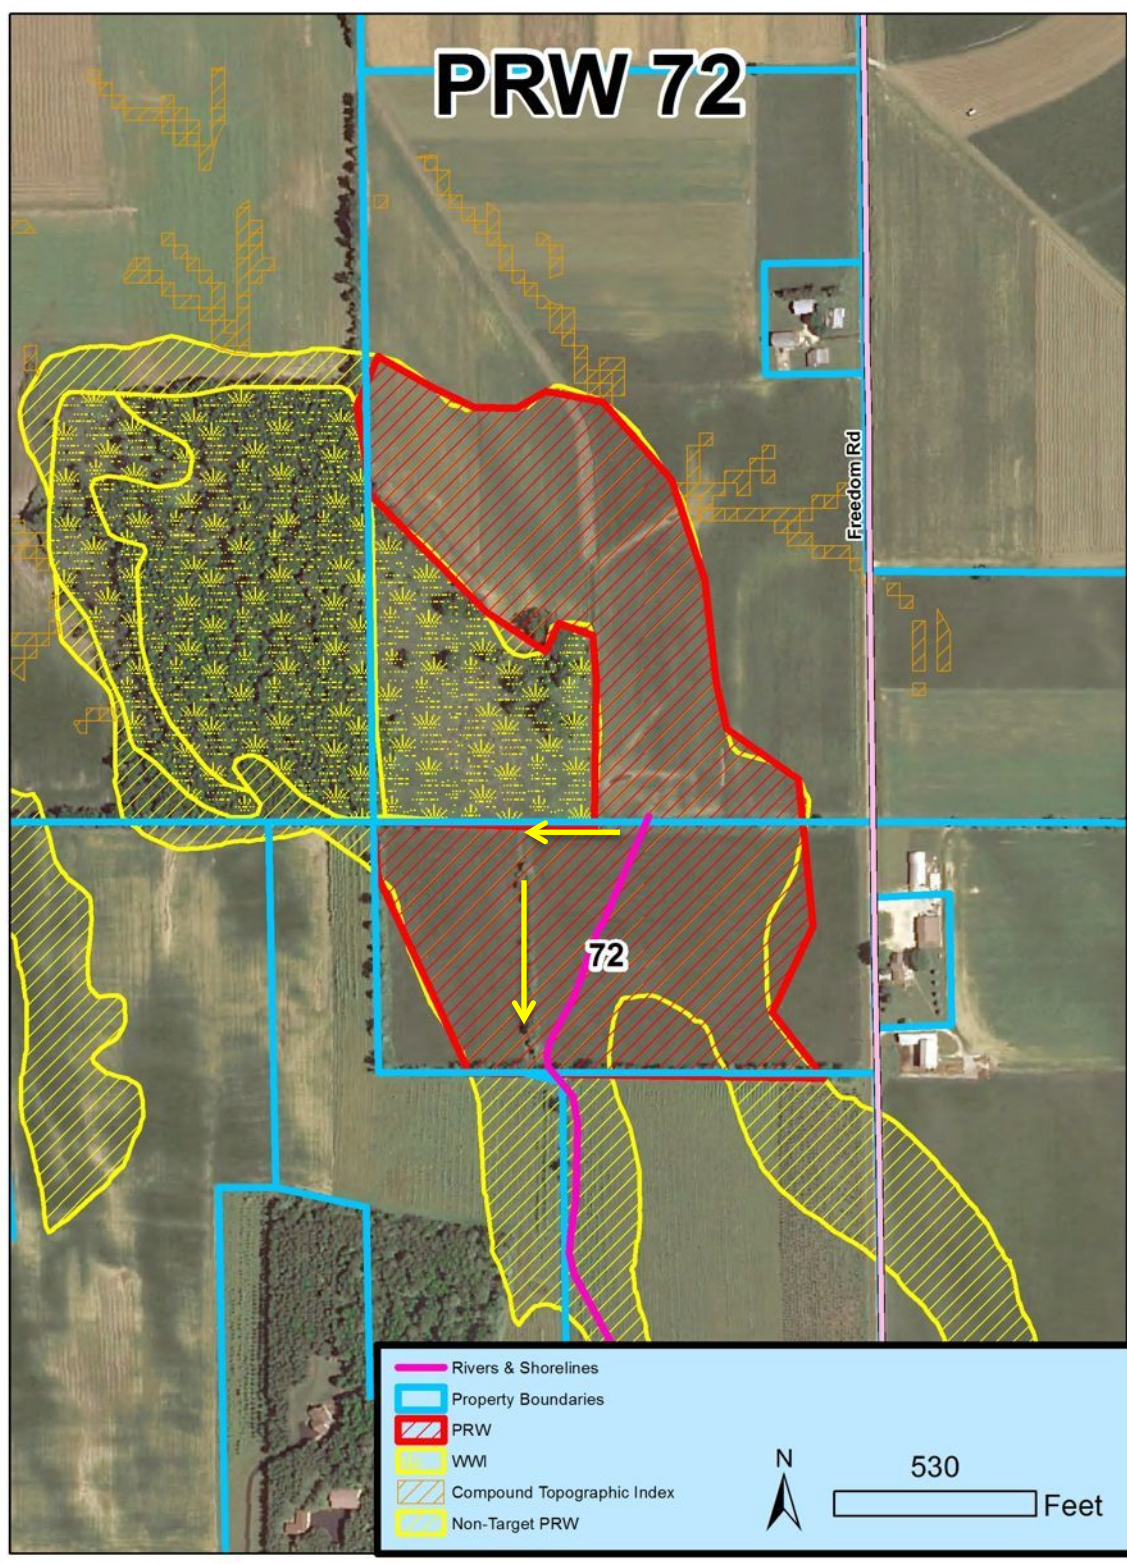
# PRW 72

Several swales feed ditch. Could not see ditch clearly. Would need two landowners to do ditch fill. Oak savanna in middle. Possibly good restoration.

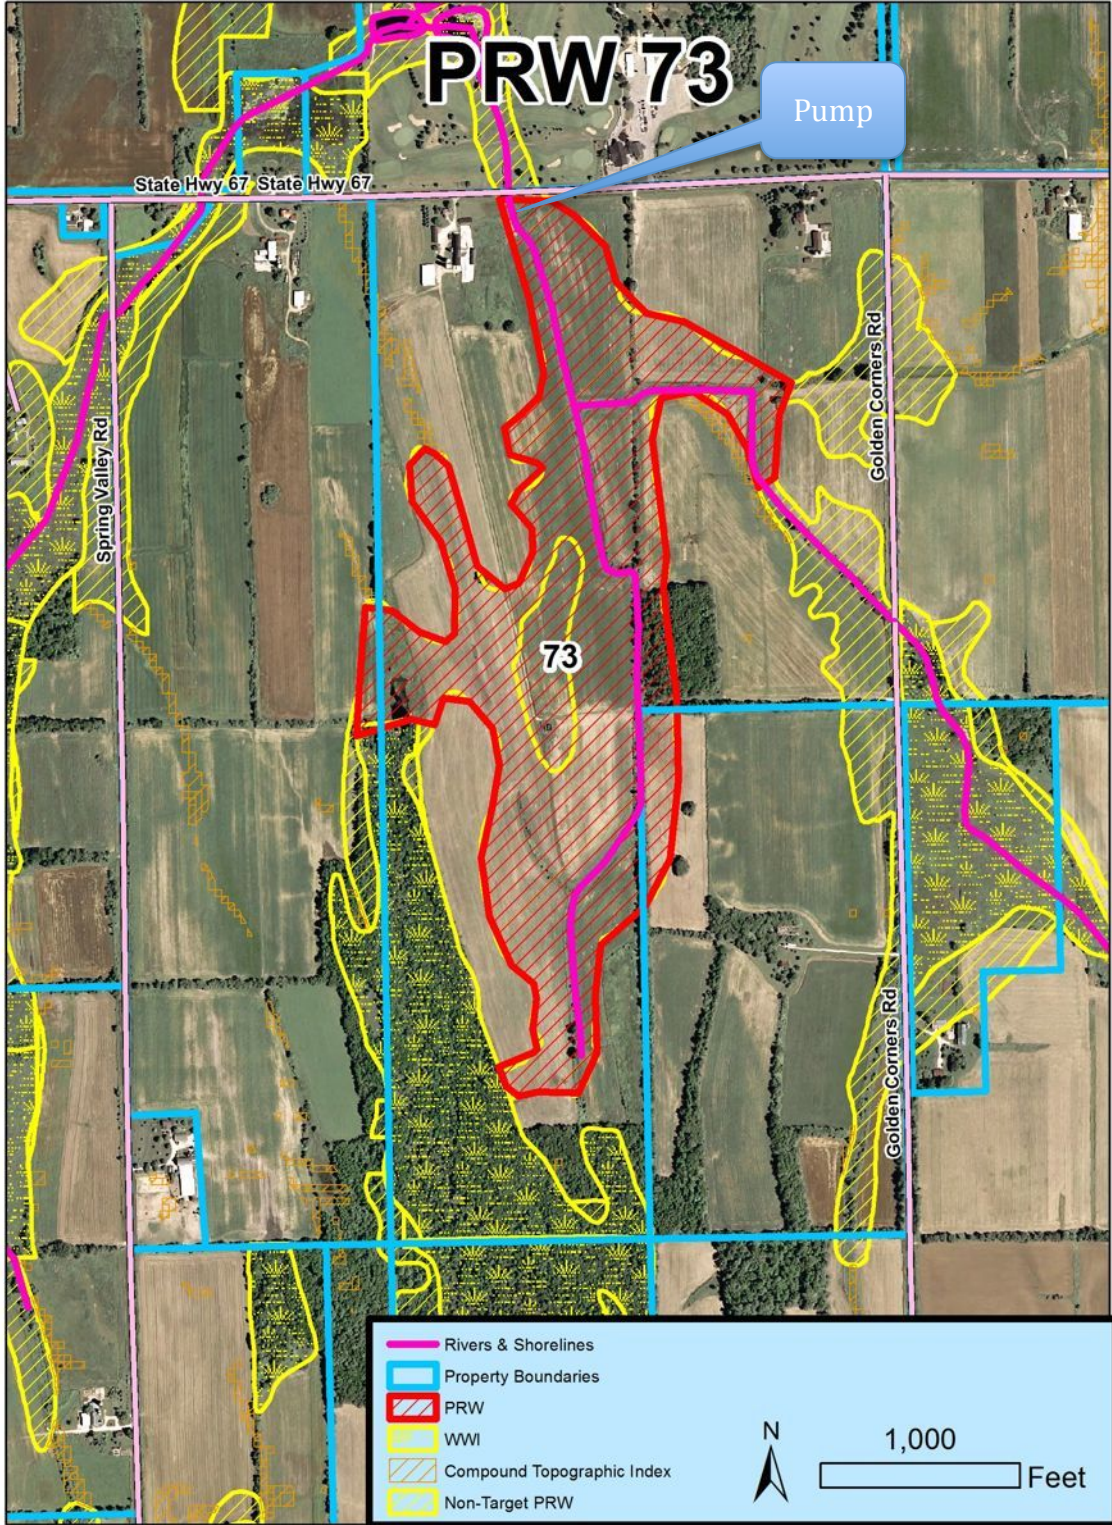
Long, large area. Ditch is a swale. Drain tile probably present. Electric pump with large volume of water being pumped into ditch flowing north. Can't see far southern end. East side has little restoration potential but otherwise good potential for this PRW.

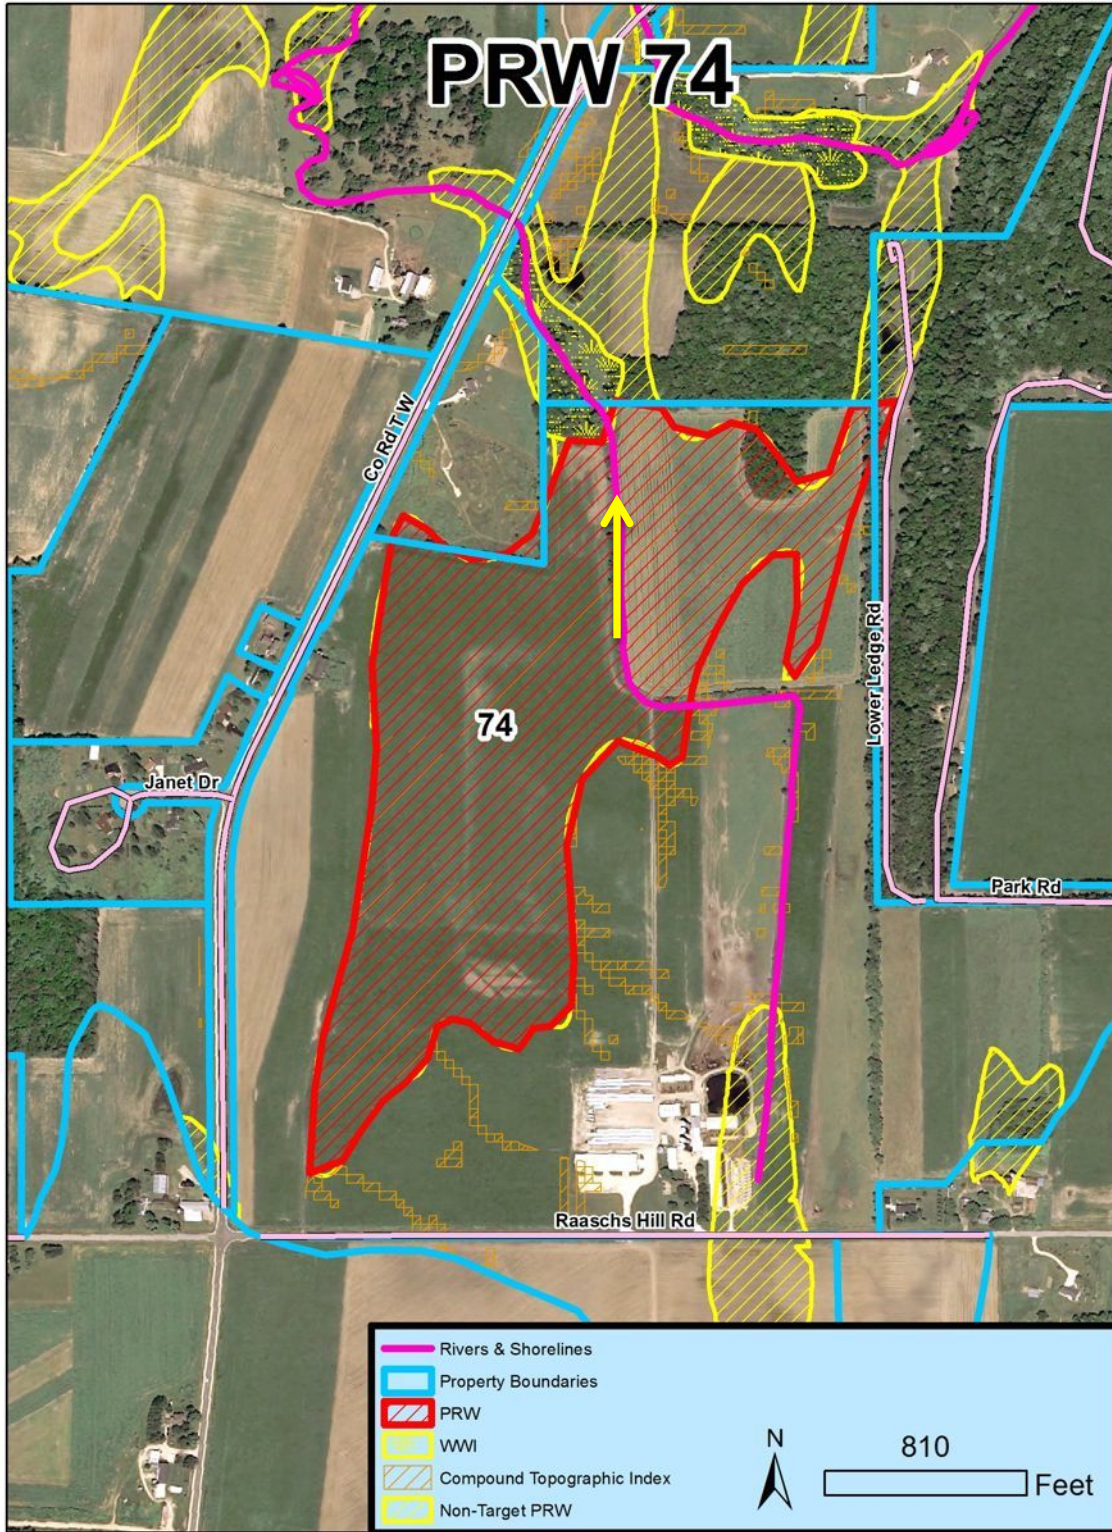
# PRW 74

Big flat basin, strong indicators of drain tile. Ditch in center on north end can be filled.  
Restoration potential on north end.
