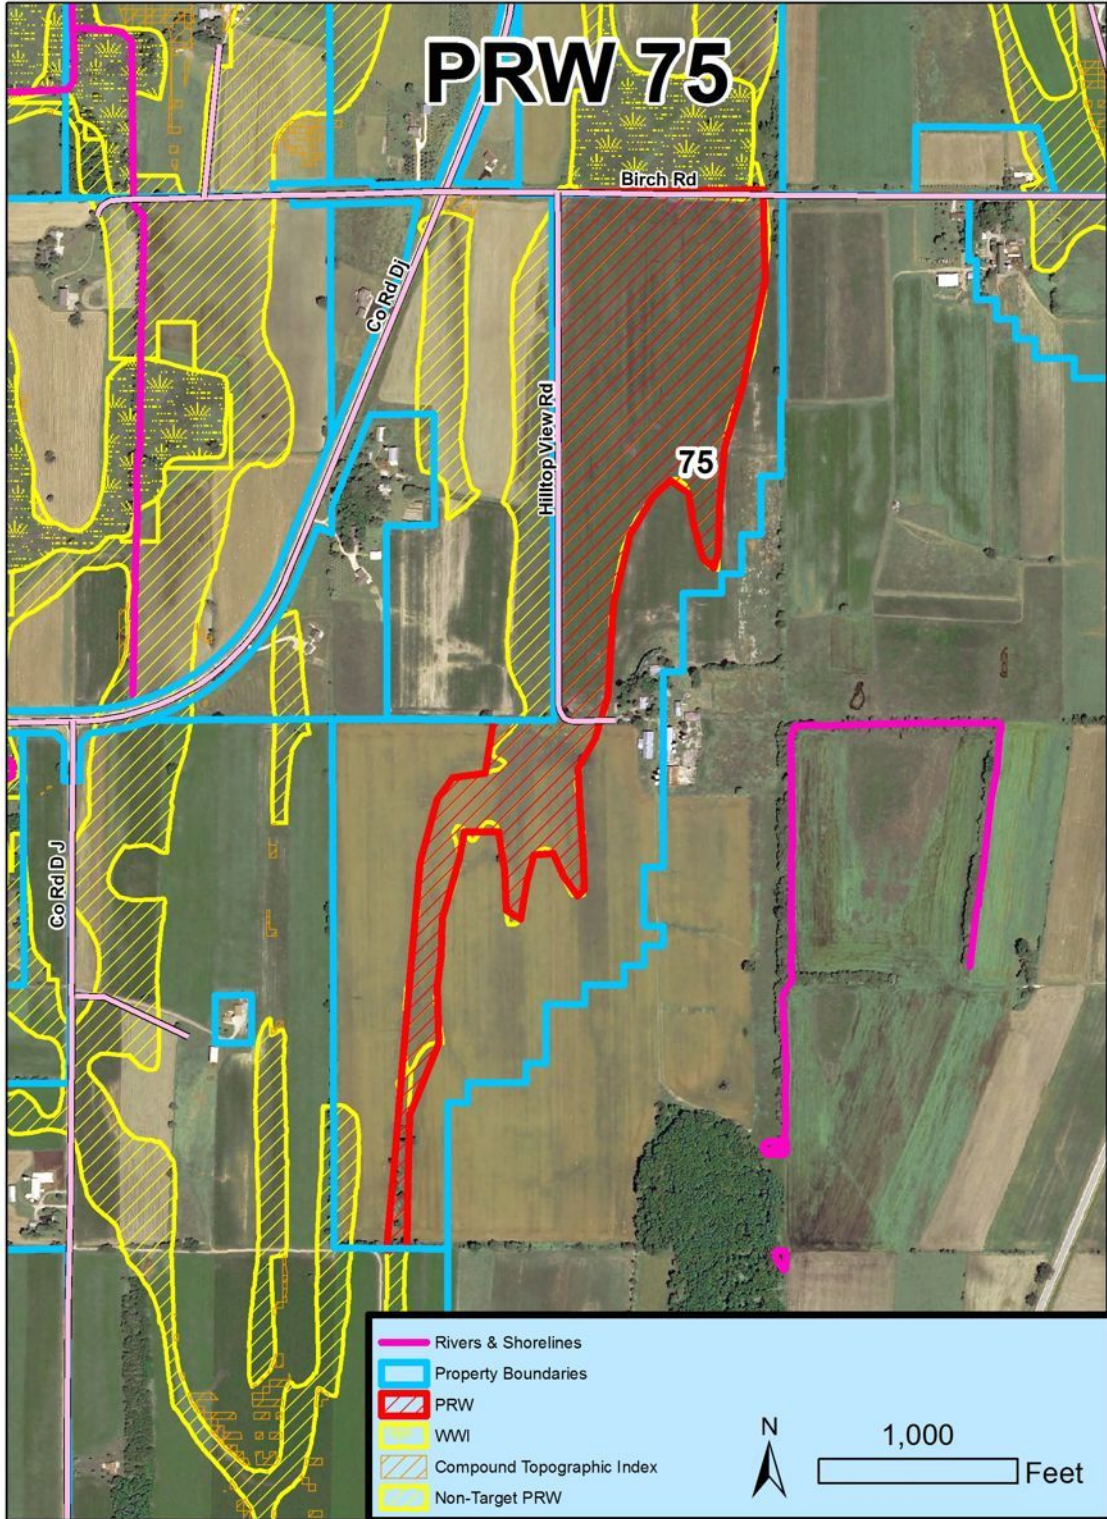
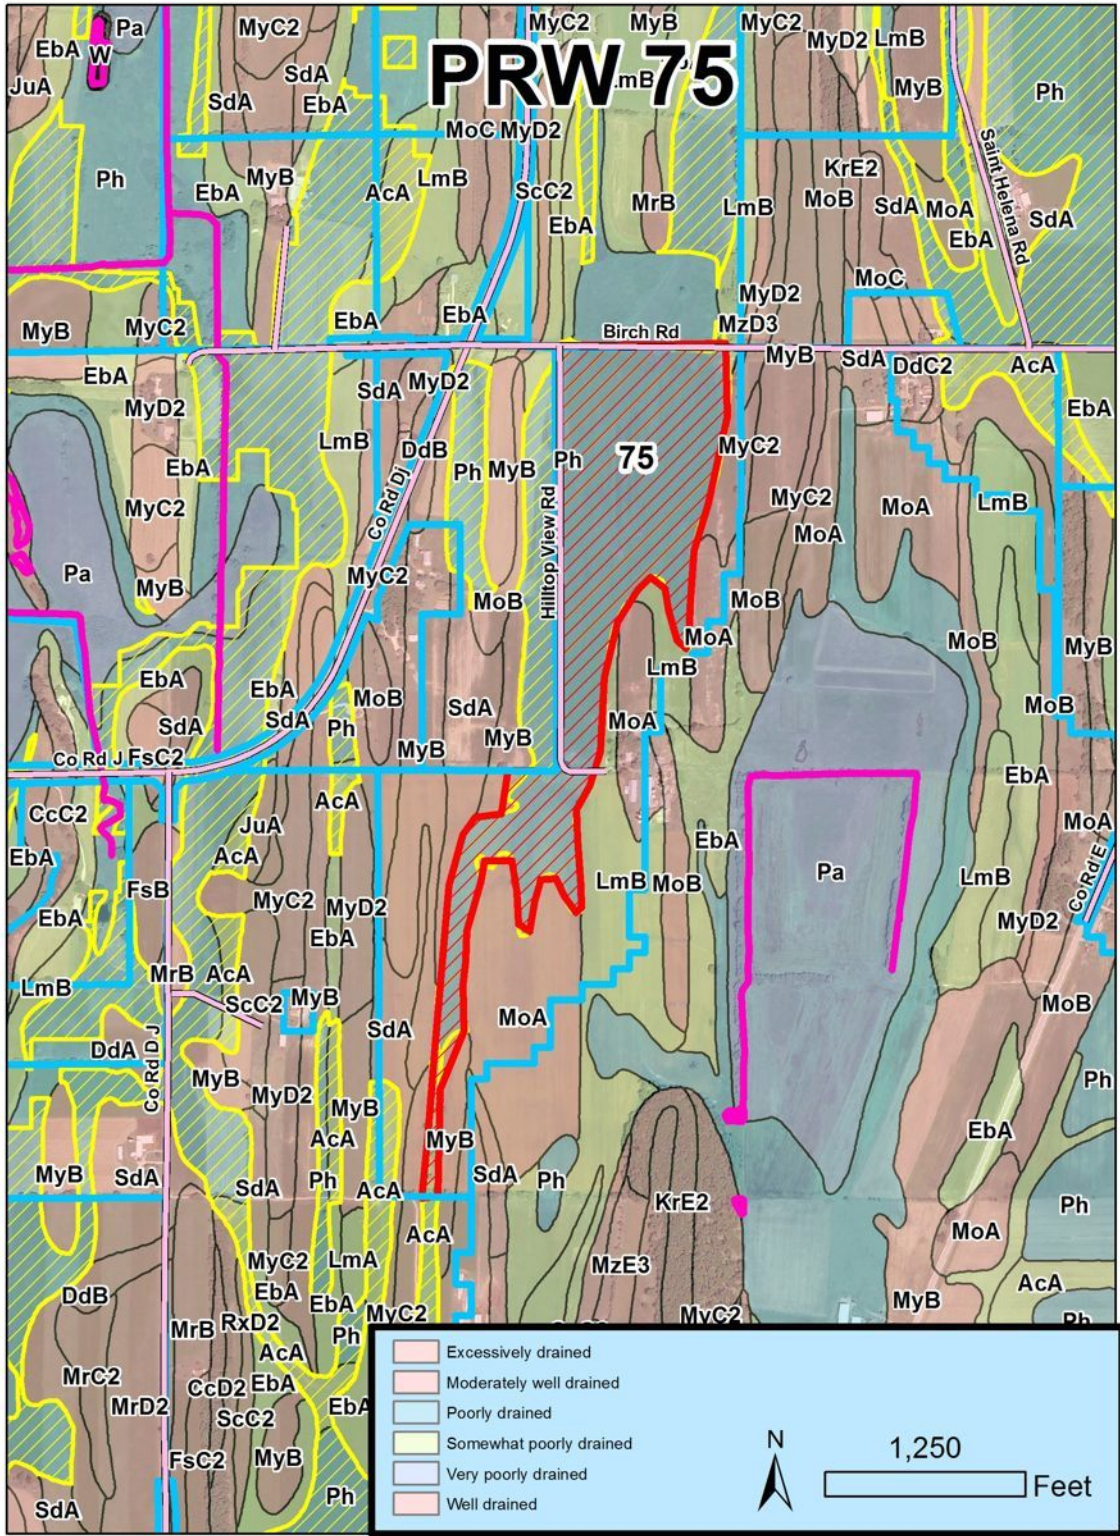
# PRW 75

Big flat basin, strong indicators of drain tile. Ditch in center on north end can be filled.  
Restoration potential on north end.
