**CalMan Lakes**  
Calumet and Manitowoc Counties, Wisconsin  
**Watershed Management Planning Project**  
**Phase II (Final) and Phase III (Draft) Report**  
June 2017

Created by: Paul Garrison, Emily Henrigillis, and Tim Hoyman  
Onterra, LLC  
De Pere, WI

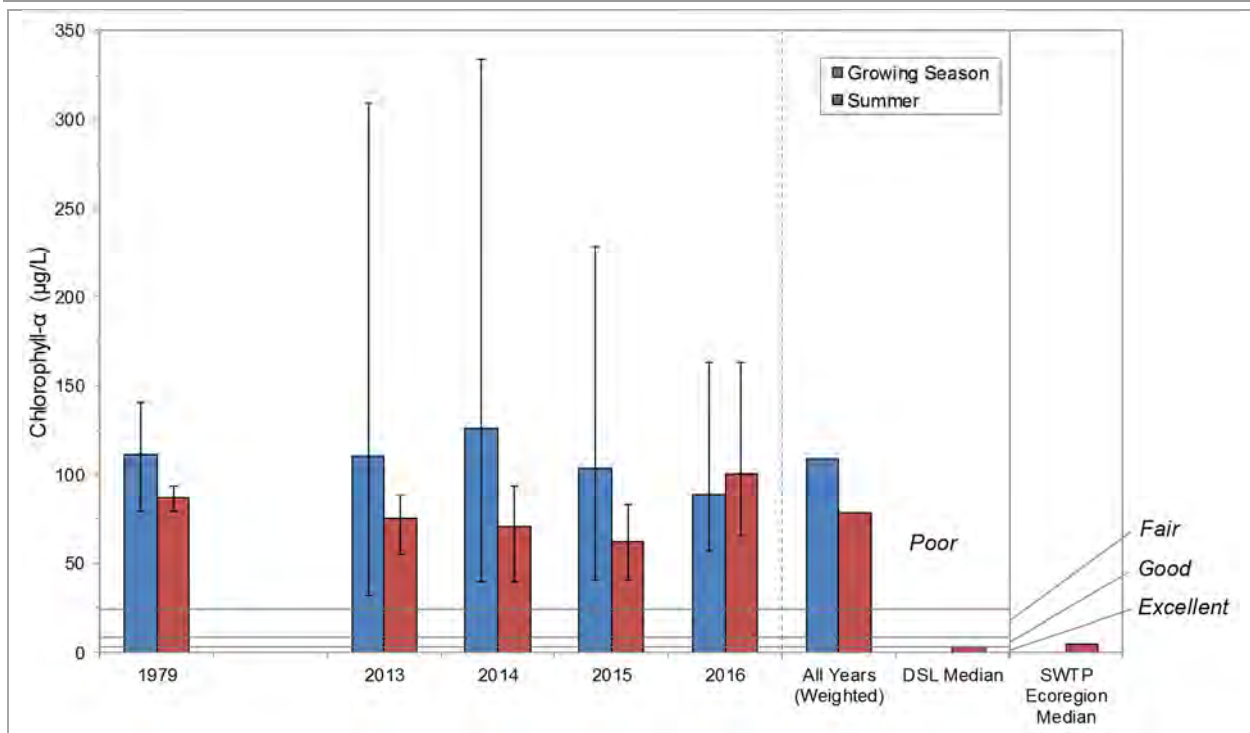
**Figure 3.1-10. Boot Lake near-surface chlorophyll-*a* concentrations and comparables.** The thin lines represent the maximum and minimum concentrations during each time period. Concentrations for 1996 are not shown as they were much higher (> 450 µg/L) than other years and including 1996 would make it difficult to compare with other years. Comparables include statewide deep seepage lakes and Southern Wisconsin Till Plains ecoregion median values.

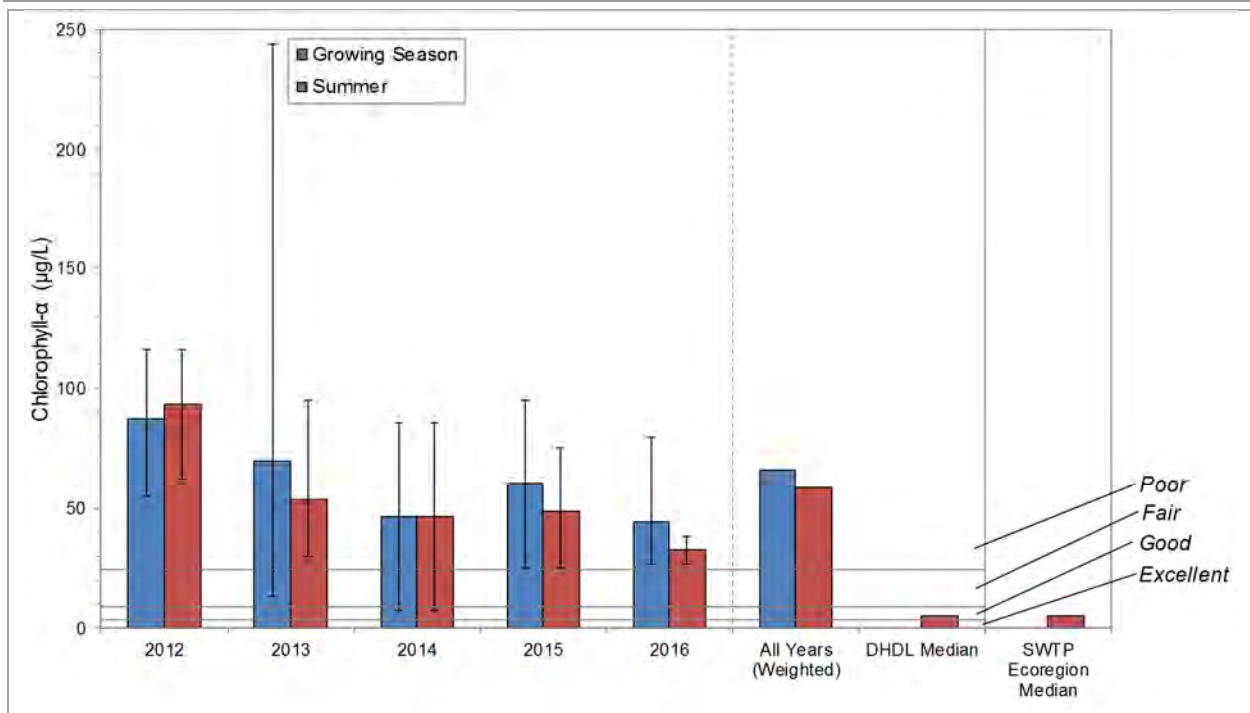
**Figure 3.1-12. Becker Lake near-surface chlorophyll-a concentrations and comparables.** The thin lines represent the maximum and minimum concentrations during each time period. Comparables include statewide deep headwater drainage lakes and Southern Wisconsin Till Plains ecoregion median values.

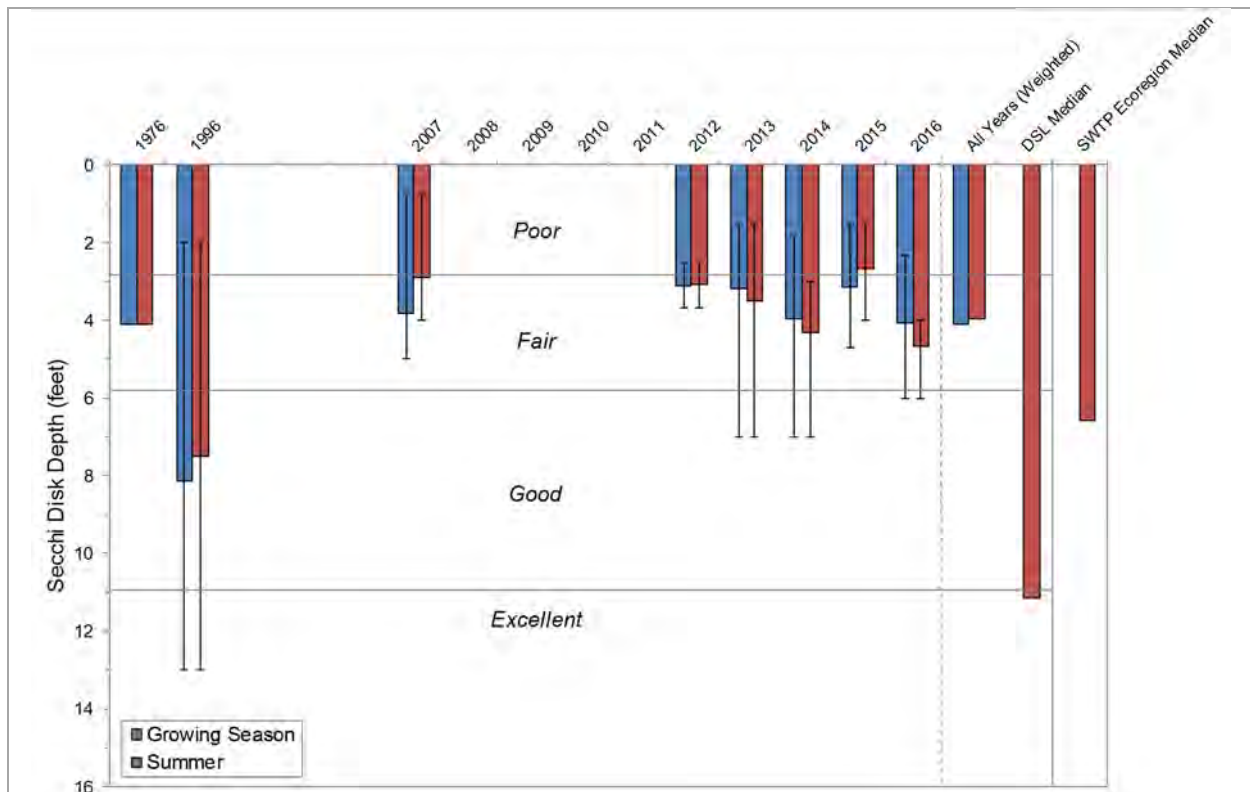
**Figure 3.1-13. Round Lake Secchi disk transparency and comparables.** The thin lines represent the maximum and minimum concentrations during each time period. Comparables include statewide deep seepage lakes and Southern Wisconsin Till Plains ecoregion median values.

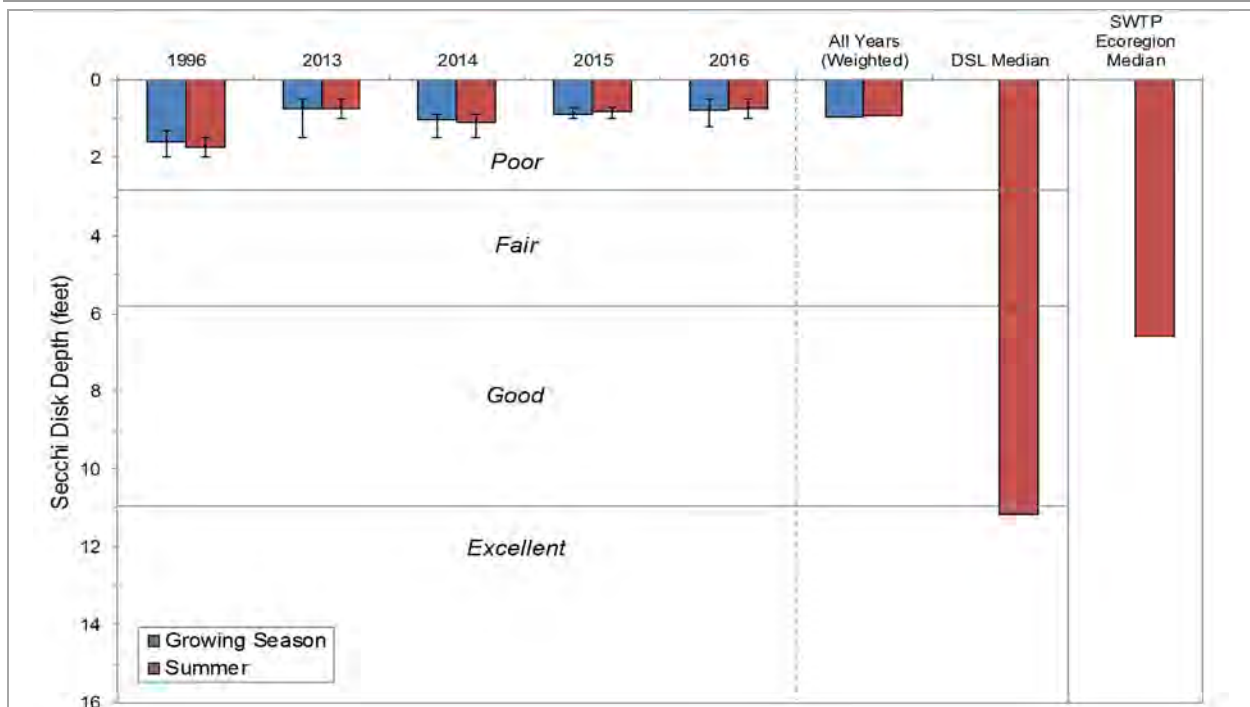
**Figure 3.1-14. Boot Lake Secchi disk transparency and comparables.** The thin lines represent the maximum and minimum concentrations during each time period. Comparables include statewide deep seepage lakes and Southern Wisconsin Till Plains ecoregion median values.

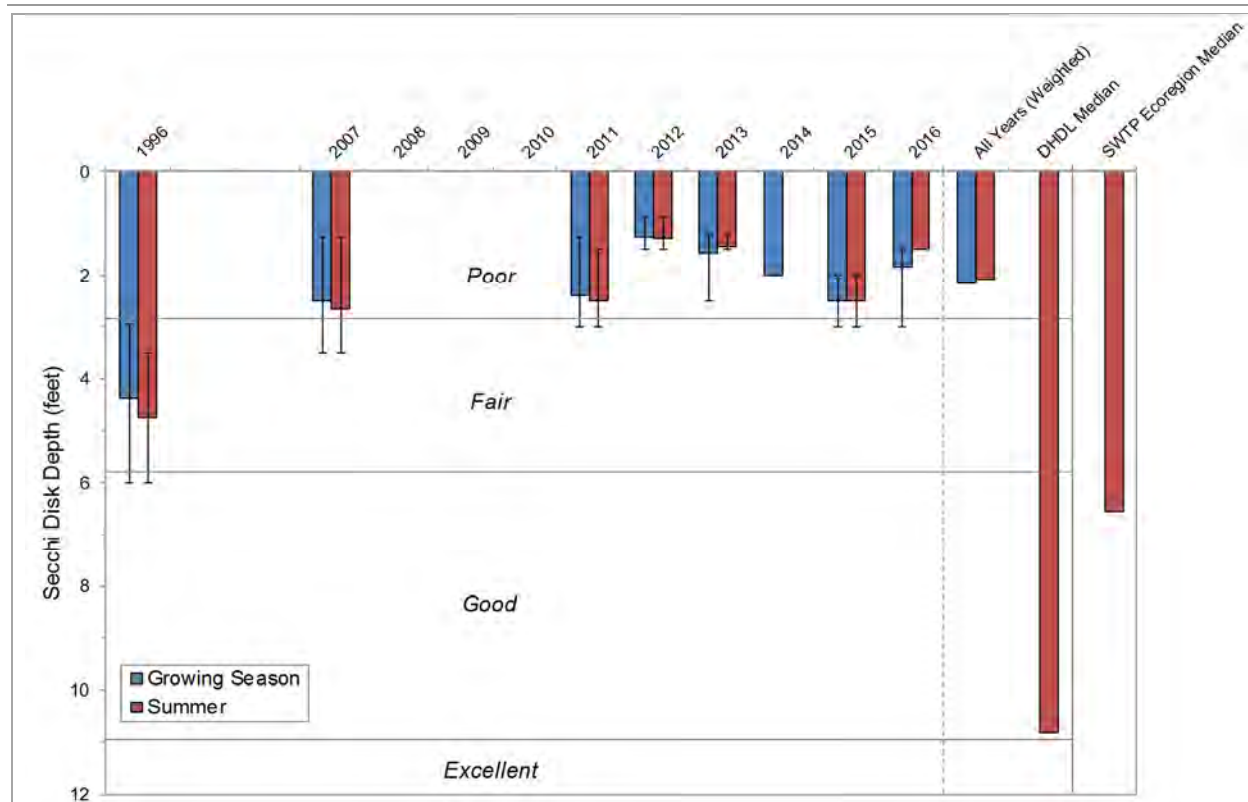
**Figure 3.1-16. Long Lake Secchi disk transparency and comparables.** The thin lines represent the maximum and minimum concentrations during each time period. Comparables include statewide deep headwater drainage lakes and Southern Wisconsin Till Plains ecoregion median values.

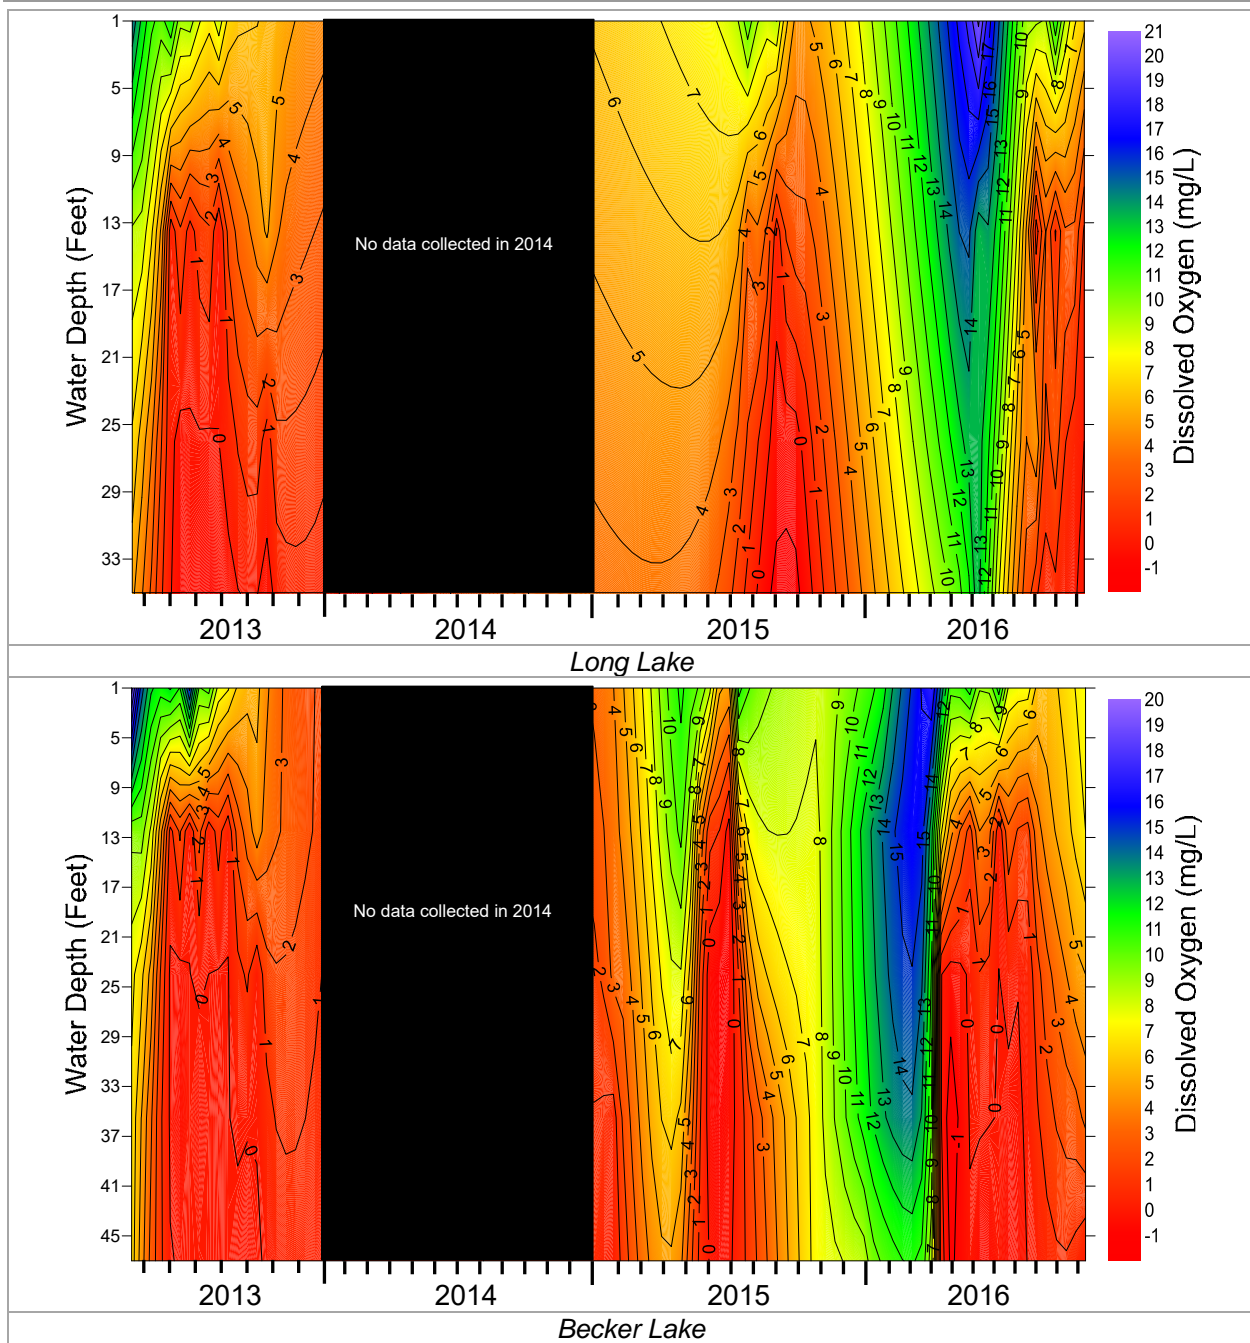
**Figure 3.1-21. CalMan Lakes dissolved oxygen isopleths.** Data was incomplete in Long Lake in 2014 and 2015 and only spring turnover data was collected from Becker Lake in 2014.

**Figure 3.1-21 continued. CalMan Lakes dissolved oxygen isopleths.** Data was incomplete in Long Lake in 2014 and 2015 and only spring turnover data was collected from Becker Lake in 2014.

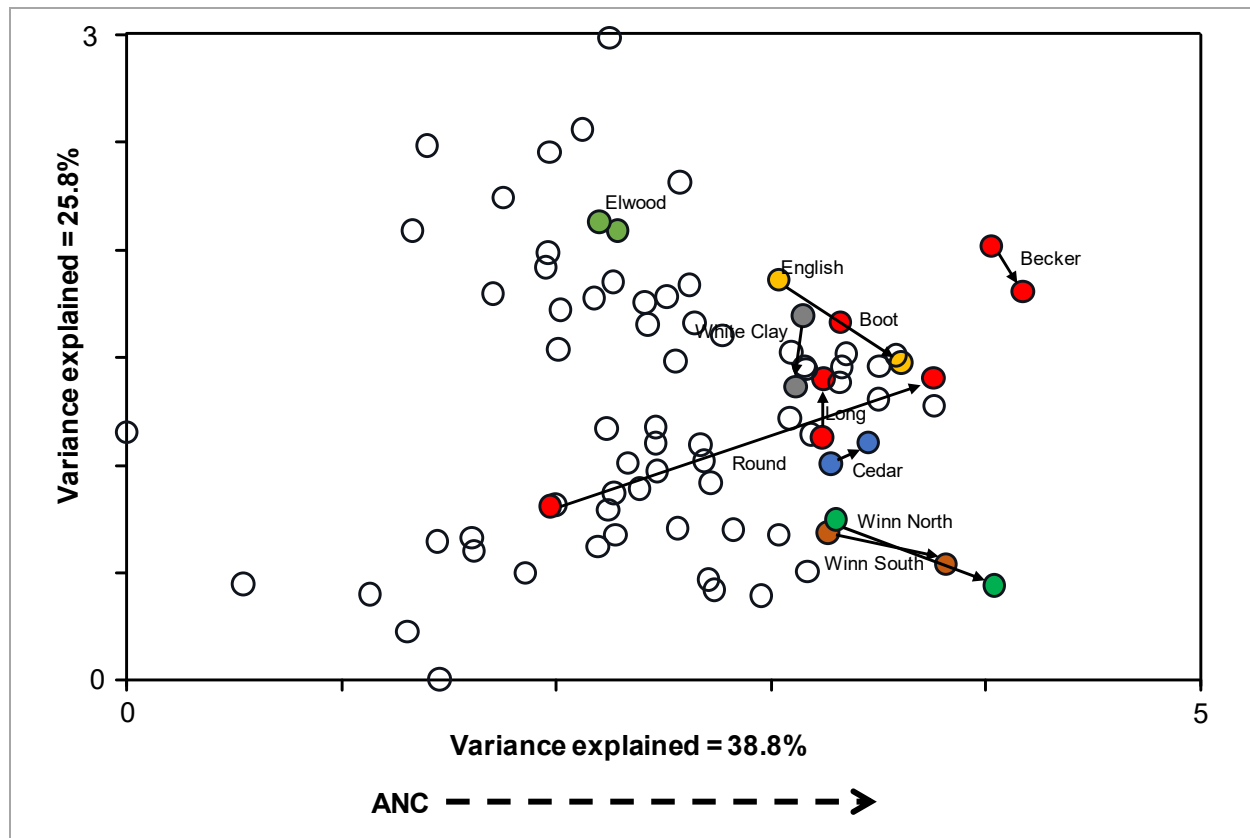
**Figure 3.3-2. DCA plot of CalMan Lakes as well as other lakes where top bottom samples have been analyzed.** The arrows connect bottom to top samples in the same lake. The open circles are other Wisconsin lakes where top/bottom samples have been analyzed. A suitable bottom sample was not obtained from Boot Lake but it is likely the bottom sample would be similar to Round Lake. The CalMan Lakes are colored red. White Clay, Cedar and English lakes are also in watersheds where most of the land use is agriculture.

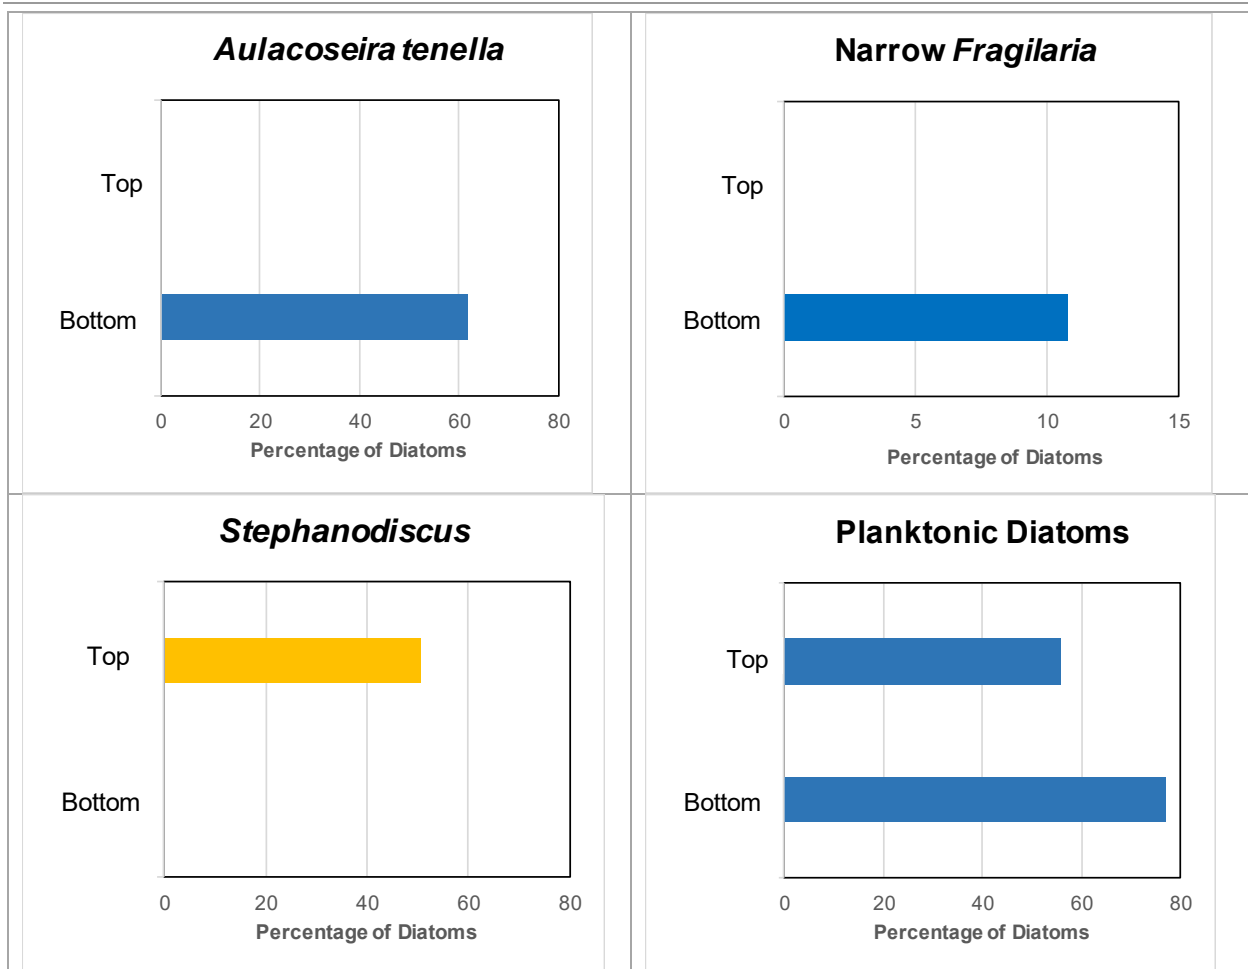
**Figure 3.3-3. Changes in abundance of important diatoms found in the top and bottom of the sediment core from Round Lake.** The bottom sample is indicative of a low pH bog lake while the top sample is characteristic of a eutrophic alkaline lake.

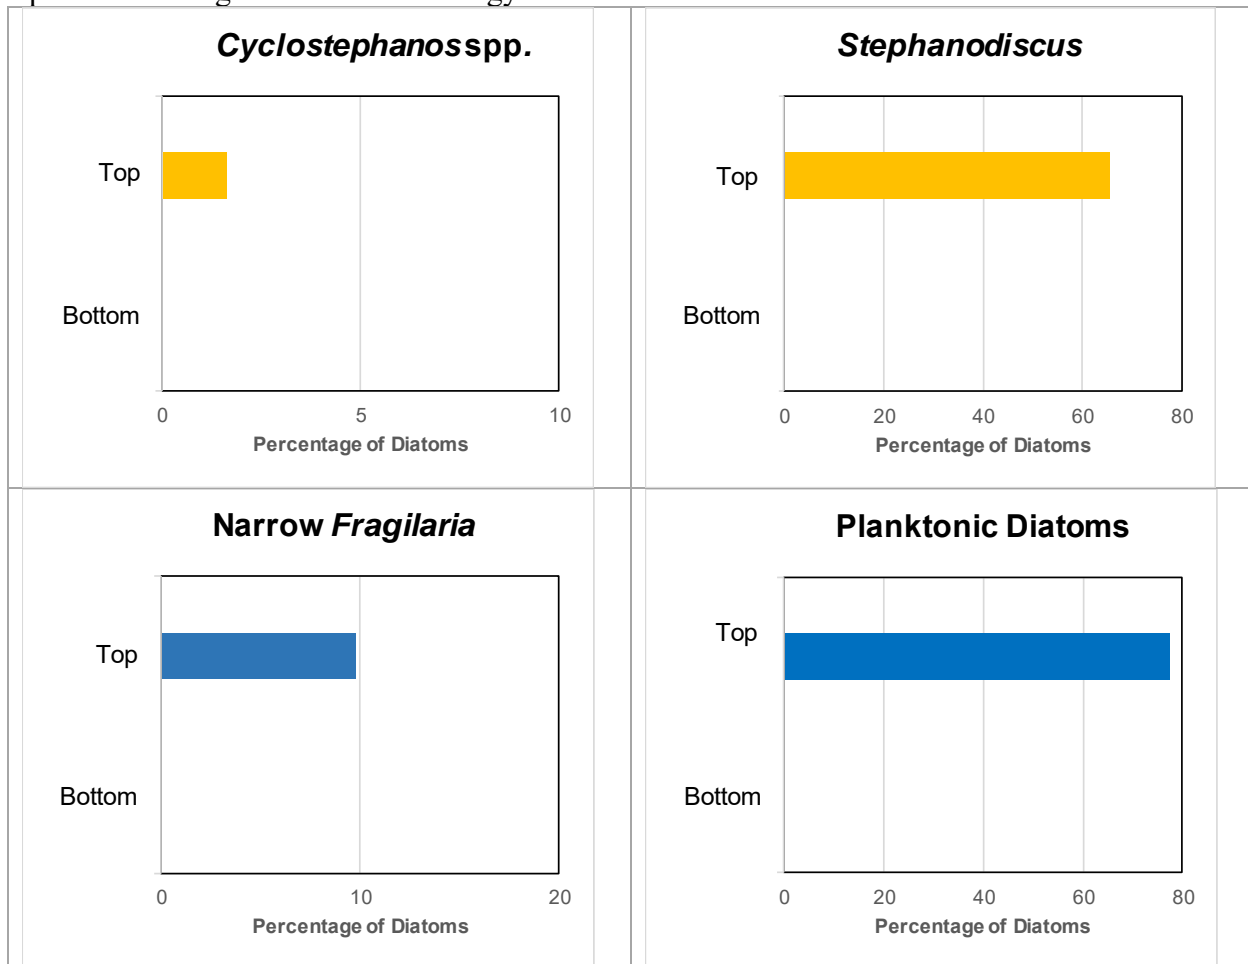
**Figure 3.3-4. Important diatoms found in the top of the sediment core from Boot Lake.** A suitable bottom sample was not collected from this lake but it is very likely the diatom community in the bottom sample would be similar to Round Lake. That is, a community indicative of a low pH bog lake.

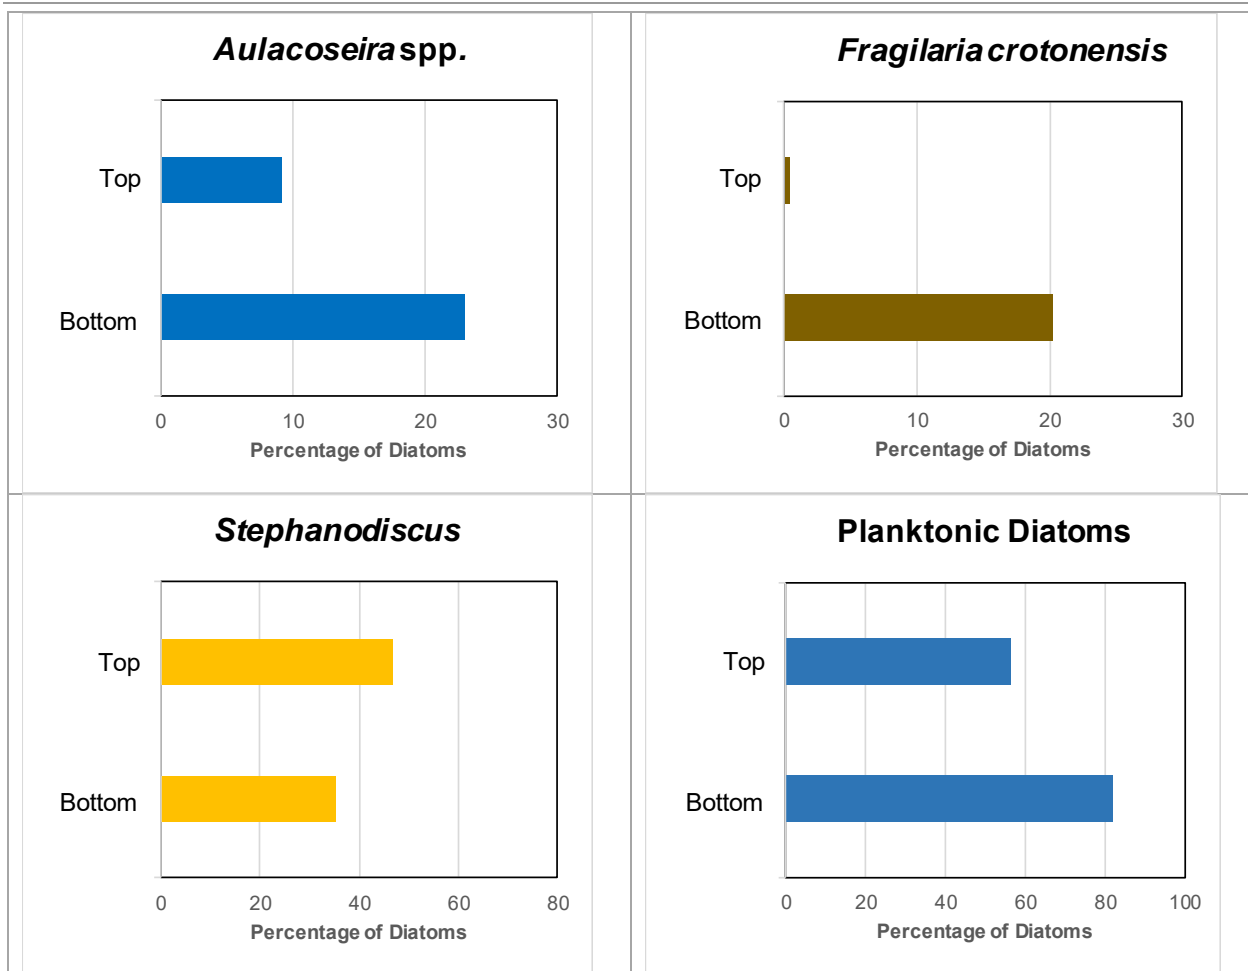
**Figure 3.3-5. Changes in abundance of important diatoms found in the top and bottom of the sediment core from Long Lake.** Unlike Round Lake, the diatom communities are somewhat similar between the bottom and top samples. The diatoms in the top sample indicate that lake presently has slightly higher phosphorus levels and more macrophytes.

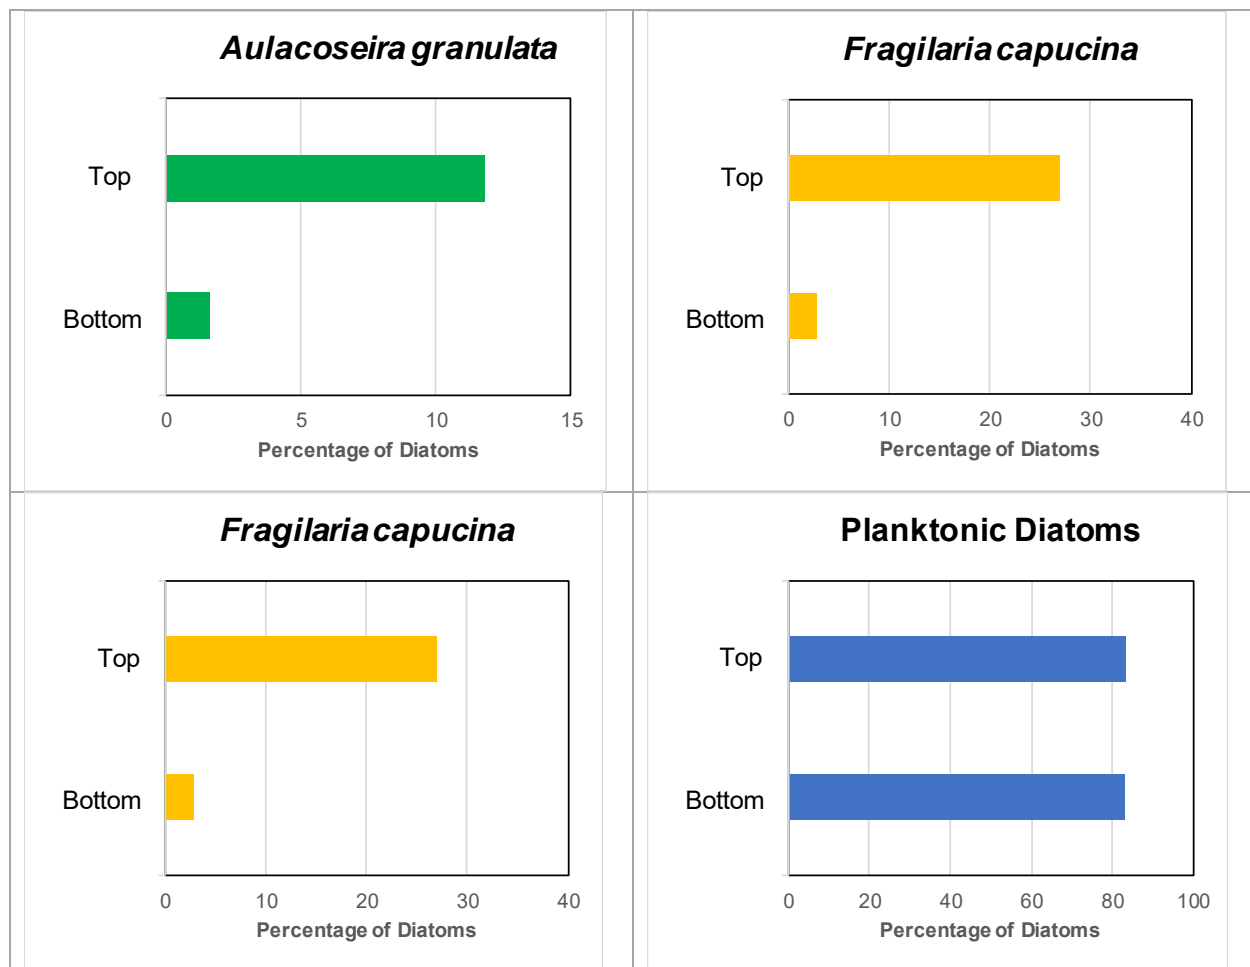
**Figure 3.3-6. Changes in abundance of important diatoms found in the top and bottom of the sediment core from Becker Lake.** Unlike Round Lake the diatom communities are somewhat similar between the bottom and top samples. The increase in *F. capucina* in the top sample likely indicates floating algal mats are more abundant at the present time.

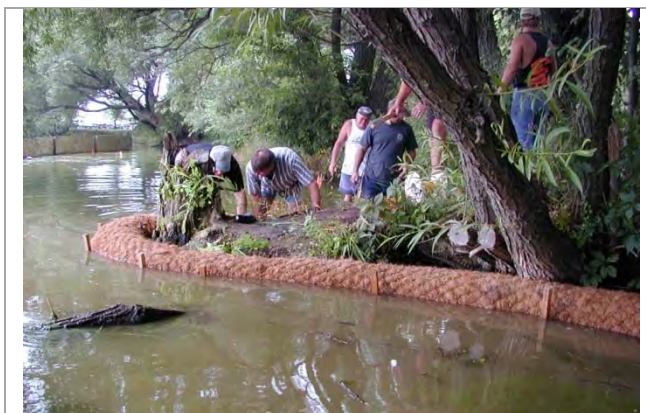
**Photograph 3.4-2. Example of a biolog restoration site.**

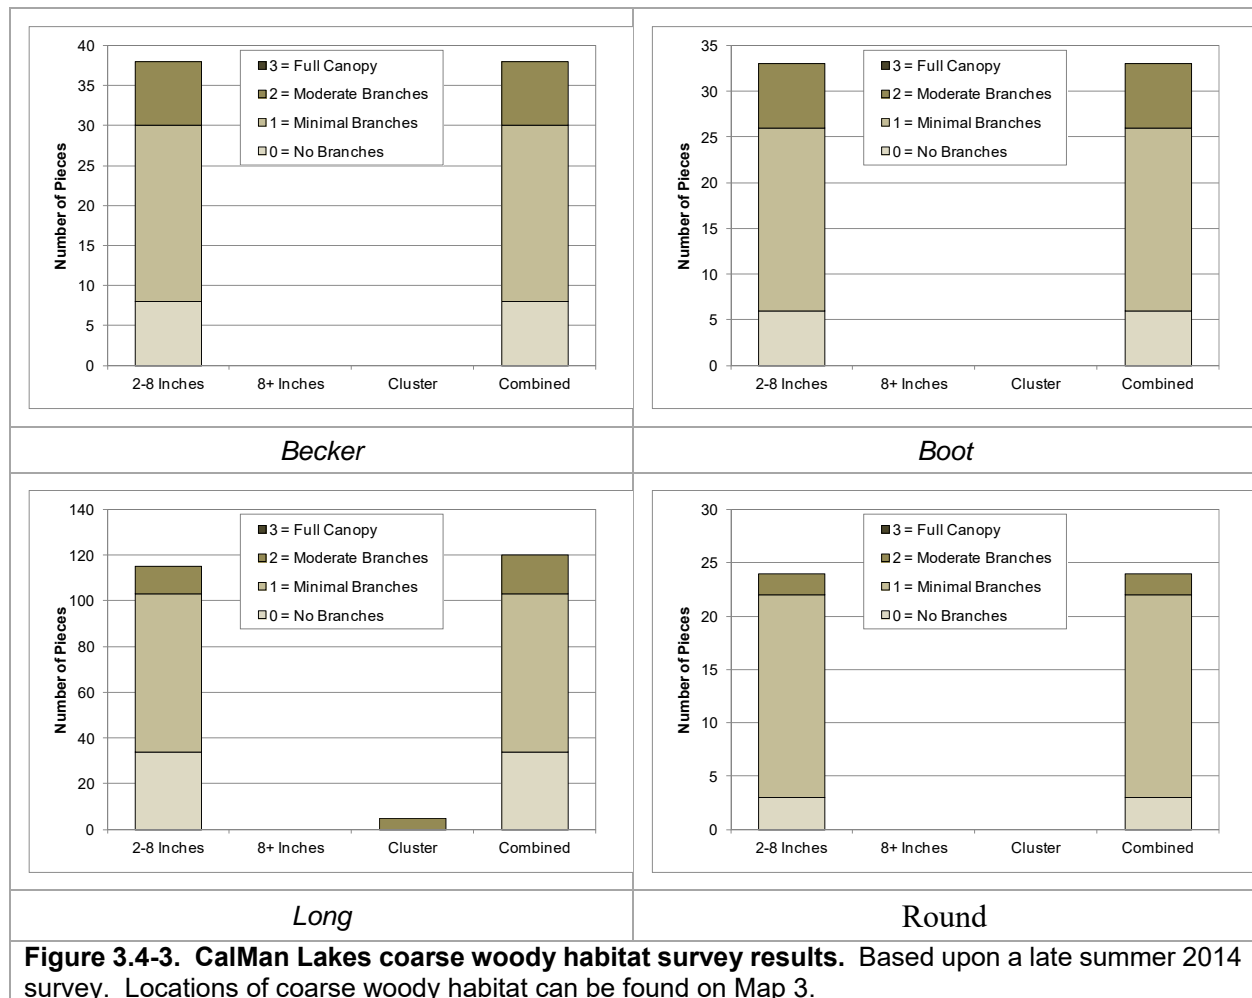
**Figure 3.4-3. CalMan Lakes coarse woody habitat survey results.** Based upon a late summer 2014 survey. Locations of coarse woody habitat can be found on Map 3.

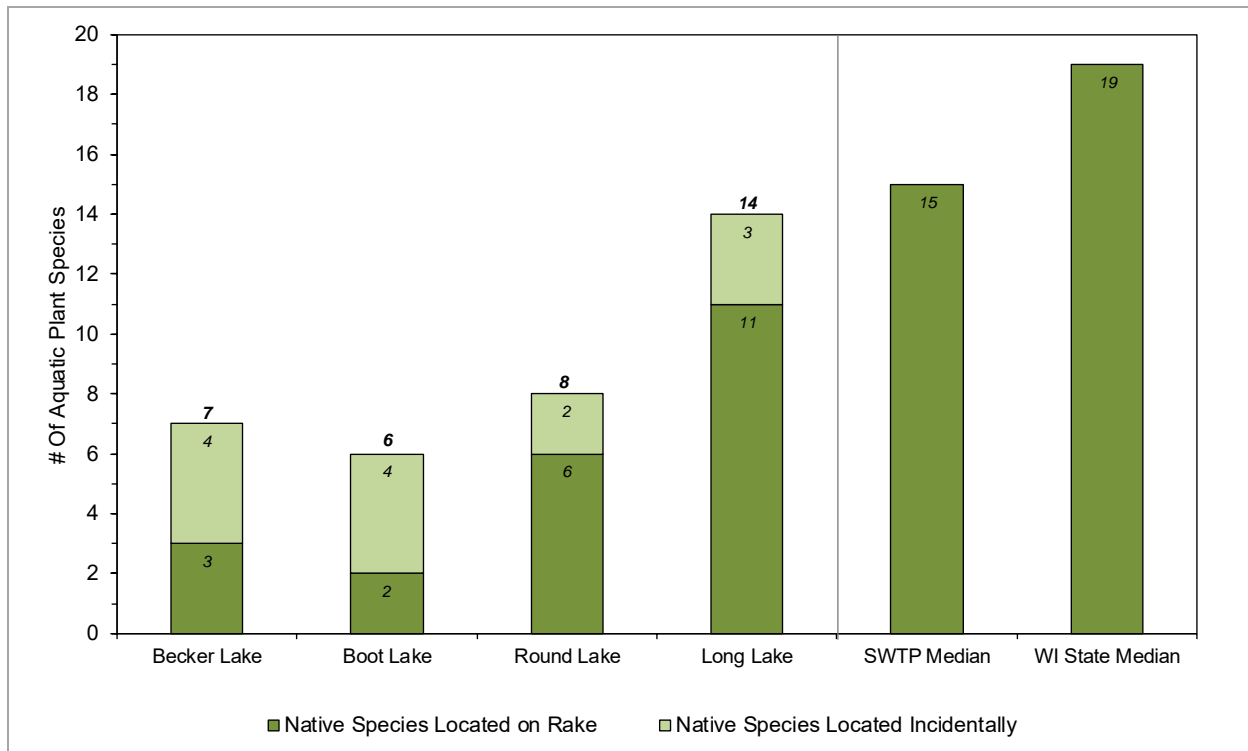
**Figure 3.5-3. CalMan Lakes native species richness.** Created using data from summer point-intercept and community mapping surveys. Chart includes species sampled directly during the point-intercept study (dark green) and species found incidentally (light green). Note that STWP is the Southeastern Till Plains ecoregion after Nichols (1999).

In the CalMan Lakes, the number of species observed per lake was notably low in 2012, 2013 and 2014 surveys. Figure 3.5-3 displays the number of plants found within the point-intercept survey,

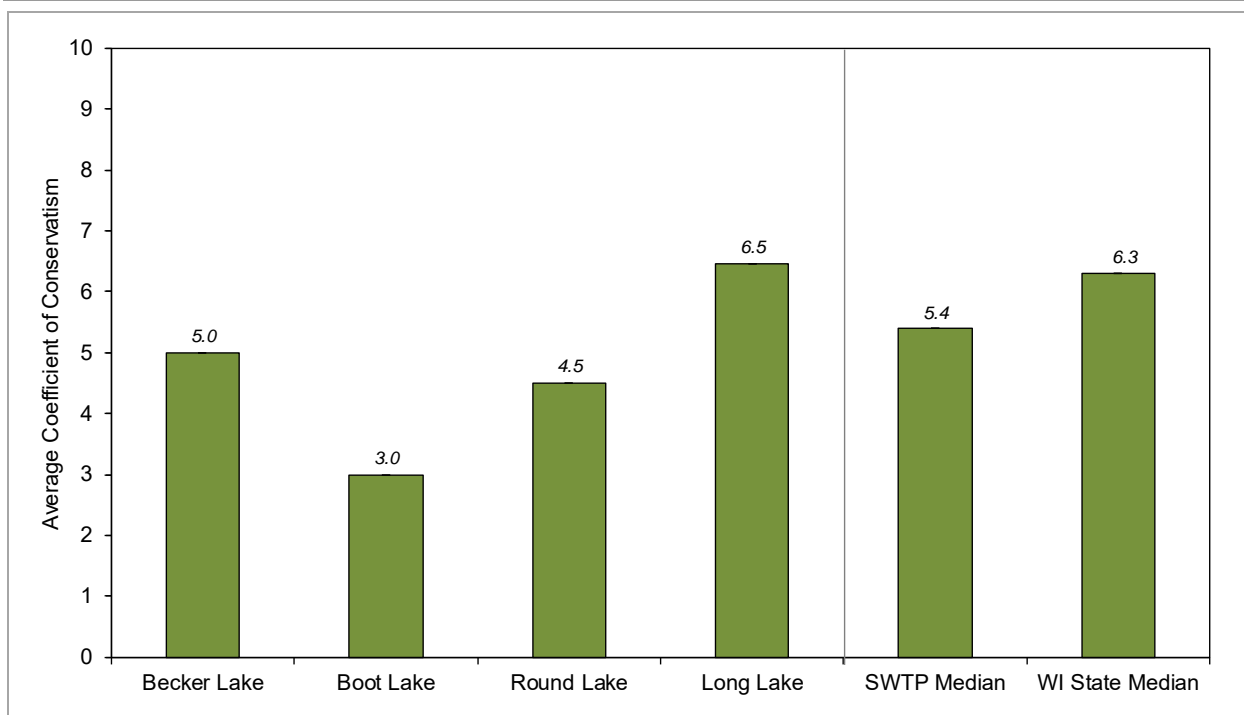
**Figure 3.5-6. CalMan Lakes average native species' coefficients of conservatism.** Created using data from summer point-intercept surveys.

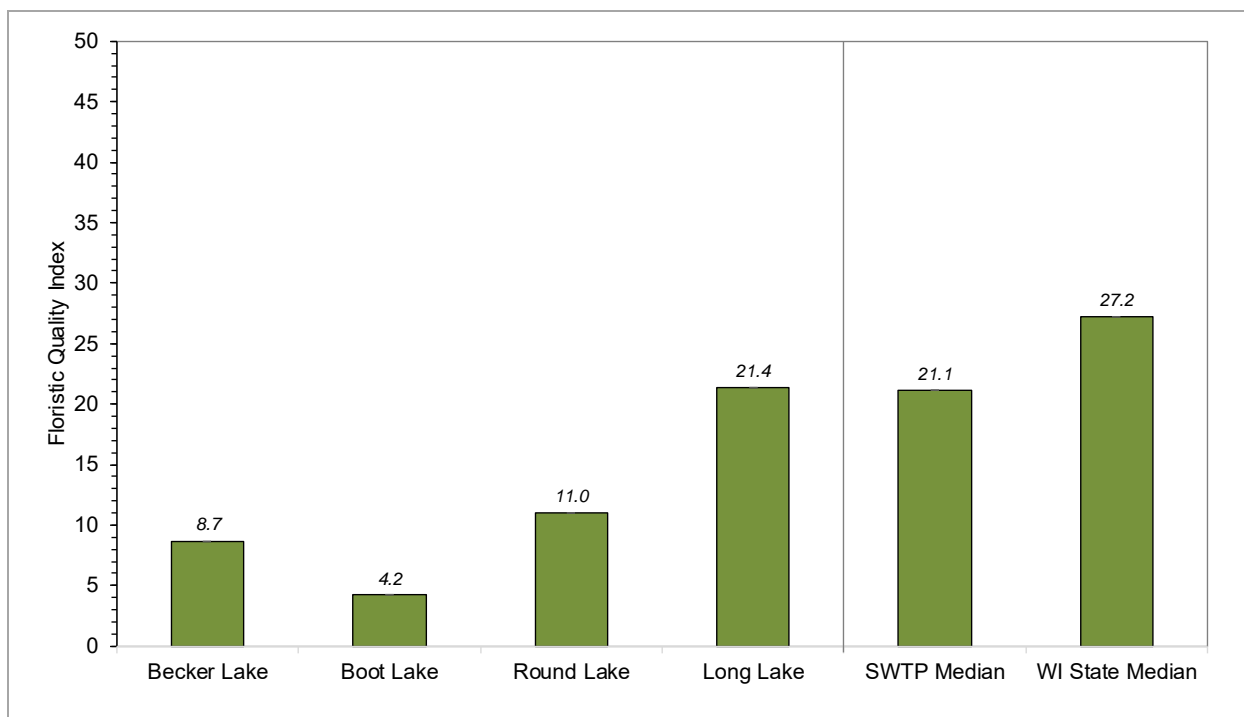
**Figure 3.5-7. CalMan Lakes Floristic Quality Assessment.** Created using data from summer point-intercept surveys.
