8.4 Tamarack Lake

An Introduction to Tamarack Lake

Lake at a Glance - Tamarack Lake

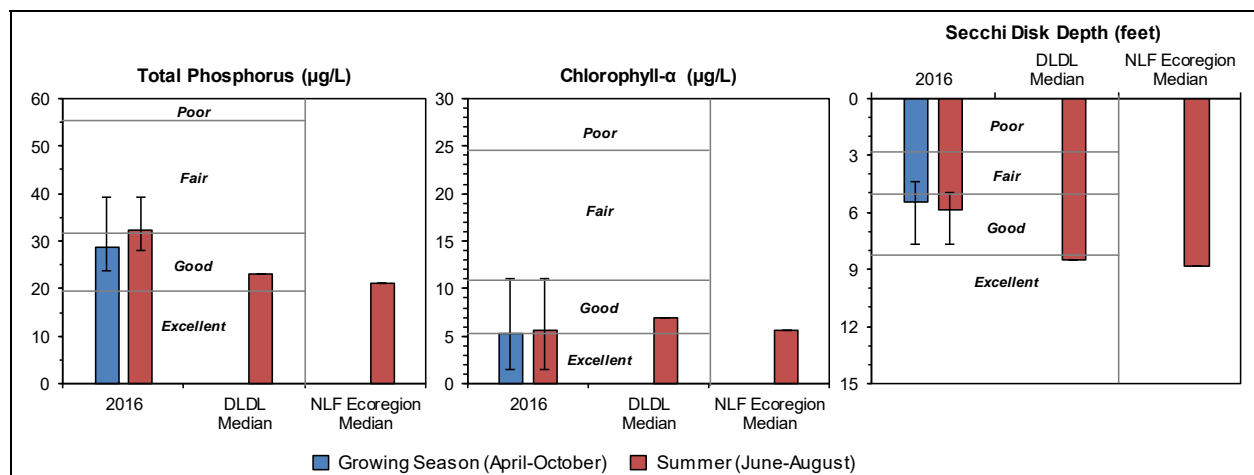
Figure 8.4.1-2. Tamarack Lake 2016 average growing season and summer total phosphorus, chlorophyll- α , and Secchi disk depth compared to median values for Wisconsin deep lowland drainage lakes (DLDL) and Northern Lakes and Forests (NLF) ecoregion lakes. Water Quality Index values adapted from WDNR PUB WT-913. Error bars represent maximum and minimum values.

The average growing season total phosphorus concentration measured in Tamarack Lake in 2016 was approximately 37% higher than the predicted phosphorus concentration generated by watershed modeling. As is discussed in further detail within the Tamarack Lake Watershed Assessment Section (Section 8.4.2), it is believed the higher-than-predicted phosphorus concentrations are not the result of human activity and are likely the result of the model underestimating phosphorus input from Tamarack Lake's direct watershed. While phosphorus concentrations were higher than expected, chlorophyll-*a* concentrations were lower than expected given the level of phosphorus within the lake. As is discussed further, phytoplankton production in Tamarack Lake is likely light-limited due to the dark-stained water found in the lake.

The average summer chlorophyll-*a* concentration measured in Tamarack Lake in 2016 was 5.6 µg/L, falling on the threshold between *excellent* and *good* for deep lowland drainage lakes in Wisconsin (Figure 8.4.1-2). The summer average chlorophyll-*a* concentration in Tamarack Lake is lower than the median concentration for other deep lowland drainage lakes in Wisconsin (7.0 µg/L) and the same as the median concentration for all lake types within the NLF ecoregion (5.6 µg/L). As mentioned, the measured chlorophyll-*a* concentrations from Tamarack Lake are lower than expected given the measured concentrations of phosphorus. This is an indication that another factor other than phosphorus is limiting phytoplankton production. It is likely that the phytoplankton are light-limited due to the dark-stained water found in Tamarack Lake. The sources of Tamarack Lake’s stained water are discussed further in this section.

The average summer Secchi disk depth measured in Tamarack Lake in 2016 was 5.9 feet, falling in the *good* category for Wisconsin’s deep lowland drainage lakes. Tamarack Lake’s average summer Secchi disk depth falls below the median depth for other deep lowland drainage lakes in Wisconsin (8.5 feet) and the median depth for all lake types within the NLF ecoregion (8.9 feet). The measured Secchi disk depth in Tamarack Lake is lower than predicted based on measured chlorophyll-*a* concentrations, and is an indication that a factor other than phytoplankton is influencing water clarity in Tamarack Lake.

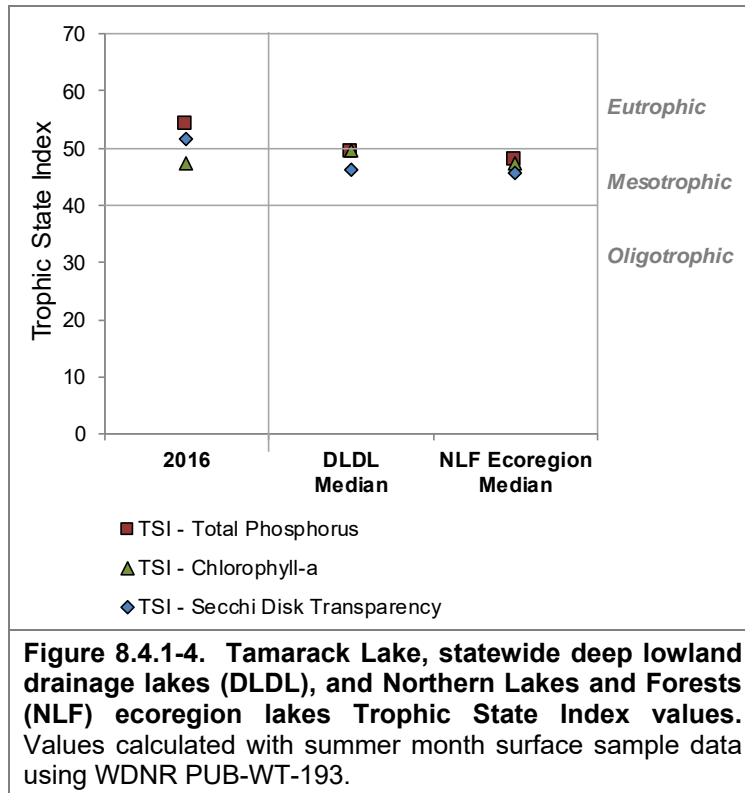
Figure 8.4.1-4 contains the Trophic State Index (TSI) values for Tamarack Lake calculated from the data collected in 2016. These TSI values are calculated using summer near-surface total phosphorus, chlorophyll-*a*, and Secchi disk transparency data. In general, the best values to use in assessing a lake's trophic state are chlorophyll-*a* and total phosphorus, as water clarity can be influenced by other factors other than phytoplankton such as dissolved organic compounds. The closer the calculated TSI values for these three parameters are to one another indicates a higher degree of correlation.

The weighted TSI values for total phosphorus and chlorophyll-*a* (and Secchi disk depth) in Tamarack Lake indicate the lake is at present in meso-eutrophic state. Tamarack Lake's

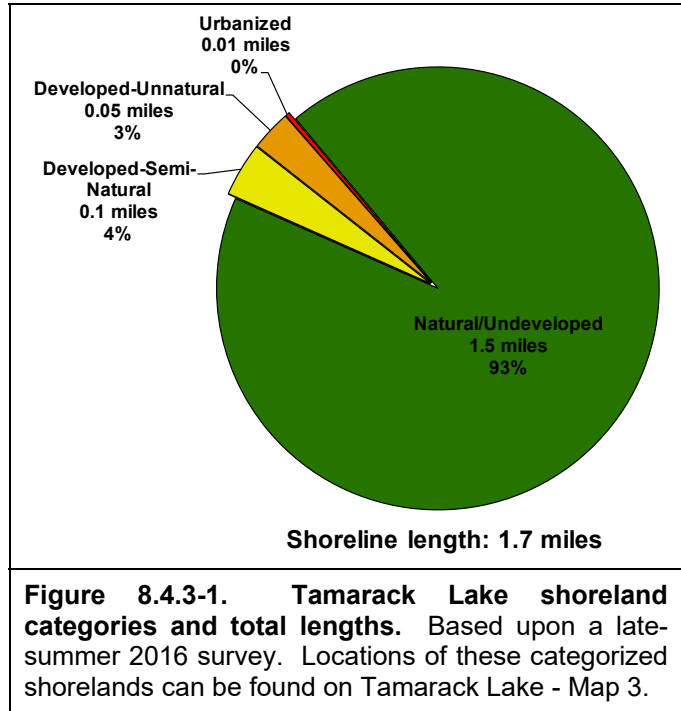
The 2016 survey revealed that Tamarack Lake has stretches of shoreland that fit four of the five shoreland assessment categories (Figure 8.4.3-1). In total, 1.5 miles (93%) of the 1.7-mile shoreland zone were categorized as natural/undeveloped or shoreland types that provide the most benefit to the lake and should be left in their natural state if possible. Approximately 0.06 miles (3%) of the shoreland was categorized as developed-unnatural or urbanized, shorelands which provide little benefit to and may actually adversely impact the lake. If restoration of Tamarack Lake’s shoreland is to occur, primary focus should be placed on these shoreland areas. Tamarack Lake – Map 3 displays the locations of these shoreland categories around the entire lake.

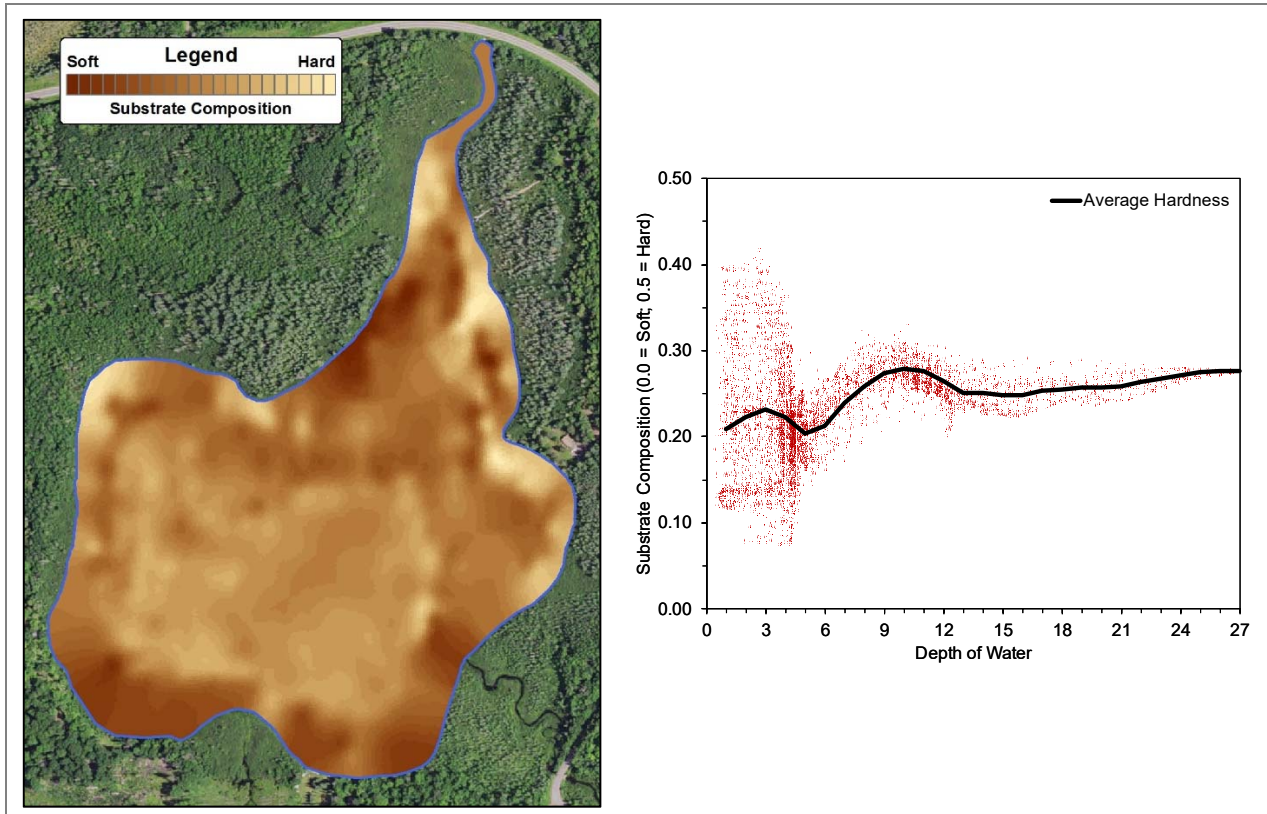
Figure 8.4.4-2. Tamarack Lake spatial distribution of substrate hardness (left) and substrate hardness across water depth (right). Individual data points are displayed in red. Creating using data from August 2016 acoustic survey.

Data regarding substrate hardness collected during the 2016 acoustic survey showed that substrate hardness varies widely in shallow areas of Tamarack Lake with both the hardest and softest substrates in the lake occurring within 1.0-5.0 feet of water (Figure 8.4.4-2). The softer substrates occurred near the mouths of inlet creeks and in areas of adjacent wetlands while areas of harder substrates mainly occurred along the lake's northern shorelines. Average substrate hardness increased between 6.0-11.0 feet before declining slightly and remaining relatively constant to 27.0 feet. Like terrestrial plants, different aquatic plant species are adapted to grow in certain substrate types; some species are only found growing in soft substrates, others only in sandy areas, and some can be found growing in either. Lakes that have varying substrate types generally support a higher number of plant species because of the different habitat types that are available.

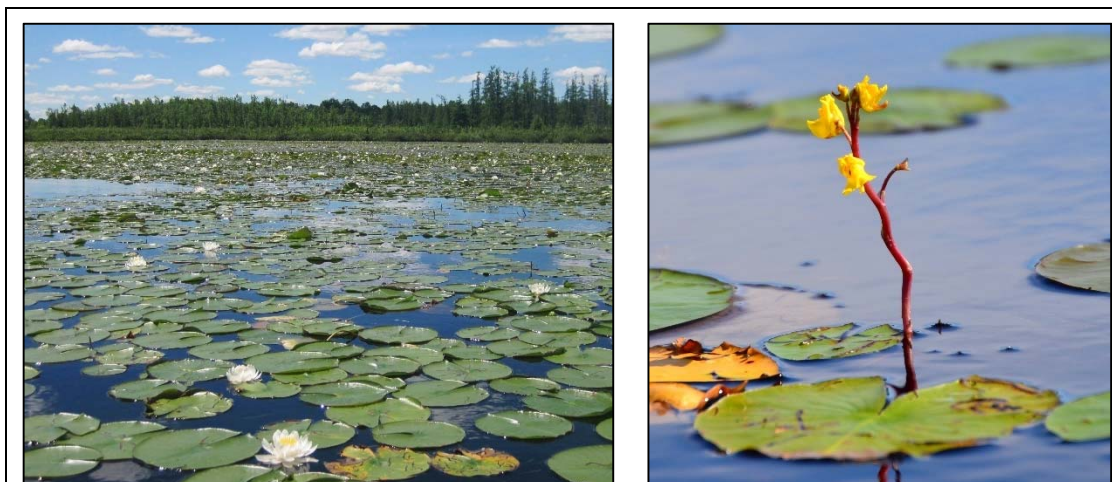
Photo 8.4.4-1. Large white water lily (*Nymphaea odorata*) community in Tamarack Lake (left) and flowers of common bladderwort (*Utricularia vulgaris*) from Rainbow Lake (right). Photo credit Onterra, 2016.

Common bladderwort was the third-most frequently encountered aquatic plant species in Tamarack Lake during the 2016 point-intercept survey with a littoral frequency of occurrence of 19% (Figure 8.4.4-6). Common bladderwort is one of seven species of bladderwort that occur in Wisconsin and one of two species located in Tamarack Lake. Bladderworts are a genus of carnivorous plants which produce bladder-like traps that are used to capture aquatic invertebrates. Common bladderwort is the most prevalent species in Wisconsin and can be found across a wider range of water quality within areas of quiet water. In summer, common bladderwort produces yellow snapdragon-like flowers on stalks held above the water’s surface (Photo 8.4.4-1). In Tamarack Lake, common bladderwort was most abundant between 4.0 and 8.0 feet of water.

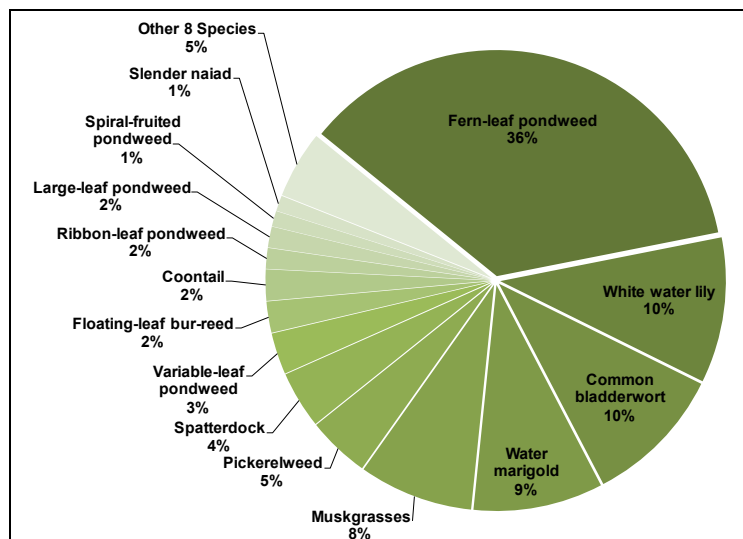
Figure 8.4.4-9. Tamarack Lake 2016 relative frequency of occurrence of aquatic plant species. Created using data from 2016 point-intercept survey.

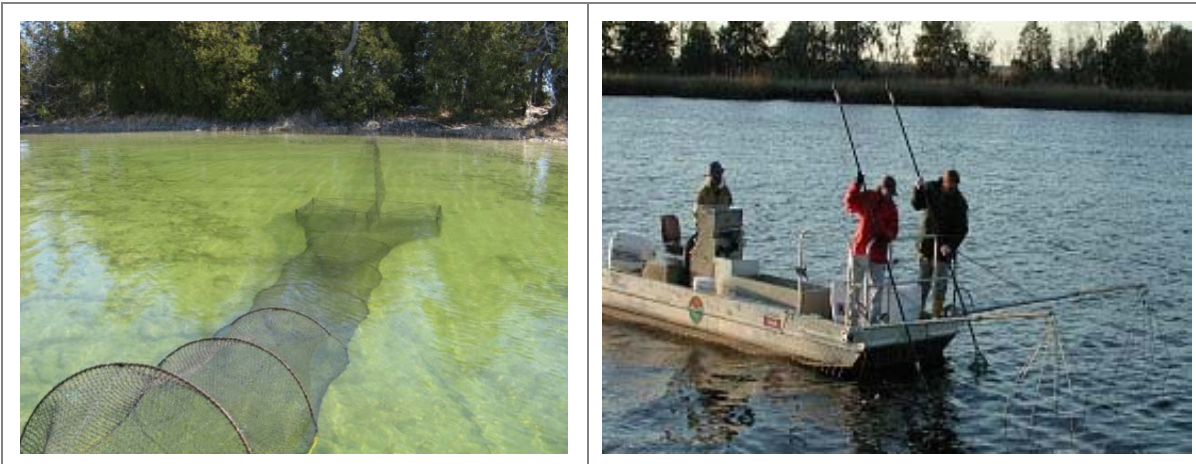
Photo 8.4.6-1. Fyke net positioned in the littoral zone of a Wisconsin lake (right) and an electroshocking boat (left).

The other commonly used sampling method is electroshocking (Photo 8.4.6-1). This is done, often at night, by using a specialized boat fit with a generator and two electrodes installed on the front touching the water. Once a fish comes in contact with the electrical current produced, *galvanotaxis* stimulates their nervous system and involuntarily causes them to swim toward the electrodes. When the fish are in the vicinity of the electrodes, they undergo *narcosis* (stunned), making them easy for fisheries technicians to net and place into a livewell to recover. Contrary to what some may believe, electroshocking does not kill the fish and after being placed in the livewell, fish generally recover within minutes.

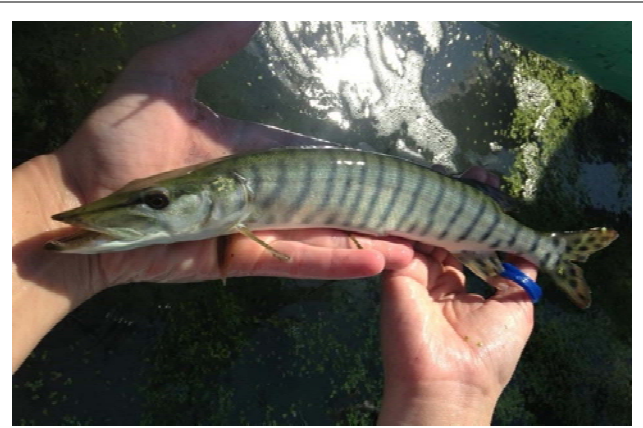
Photo 8.4.6-2. Fingerling Muskellunge.

To assist in meeting fisheries management goals, the WDNR may stock fry, fingerling or adult fish in a waterbody that were raised in nearby permitted hatcheries (Photo 8.4.6-2). Stocking of a lake may be done to assist the population of a species due to a lack of natural reproduction in the system, or to otherwise enhance angling opportunities. Historical stocking efforts for Tamarack Lake have included muskellunge and are displayed in Table 8.4.6-2.
