Re: *Lake Belle View Restoration Project – 2016 Monitoring Report*
MARS Project Number: 1428-011

Lake Belle View Restoration Project 2016 Lake Water Levels - Continuous Monitoring

2016 MONITORING REPORT
LAKE BELLE VIEW RESTORATION PROJECT

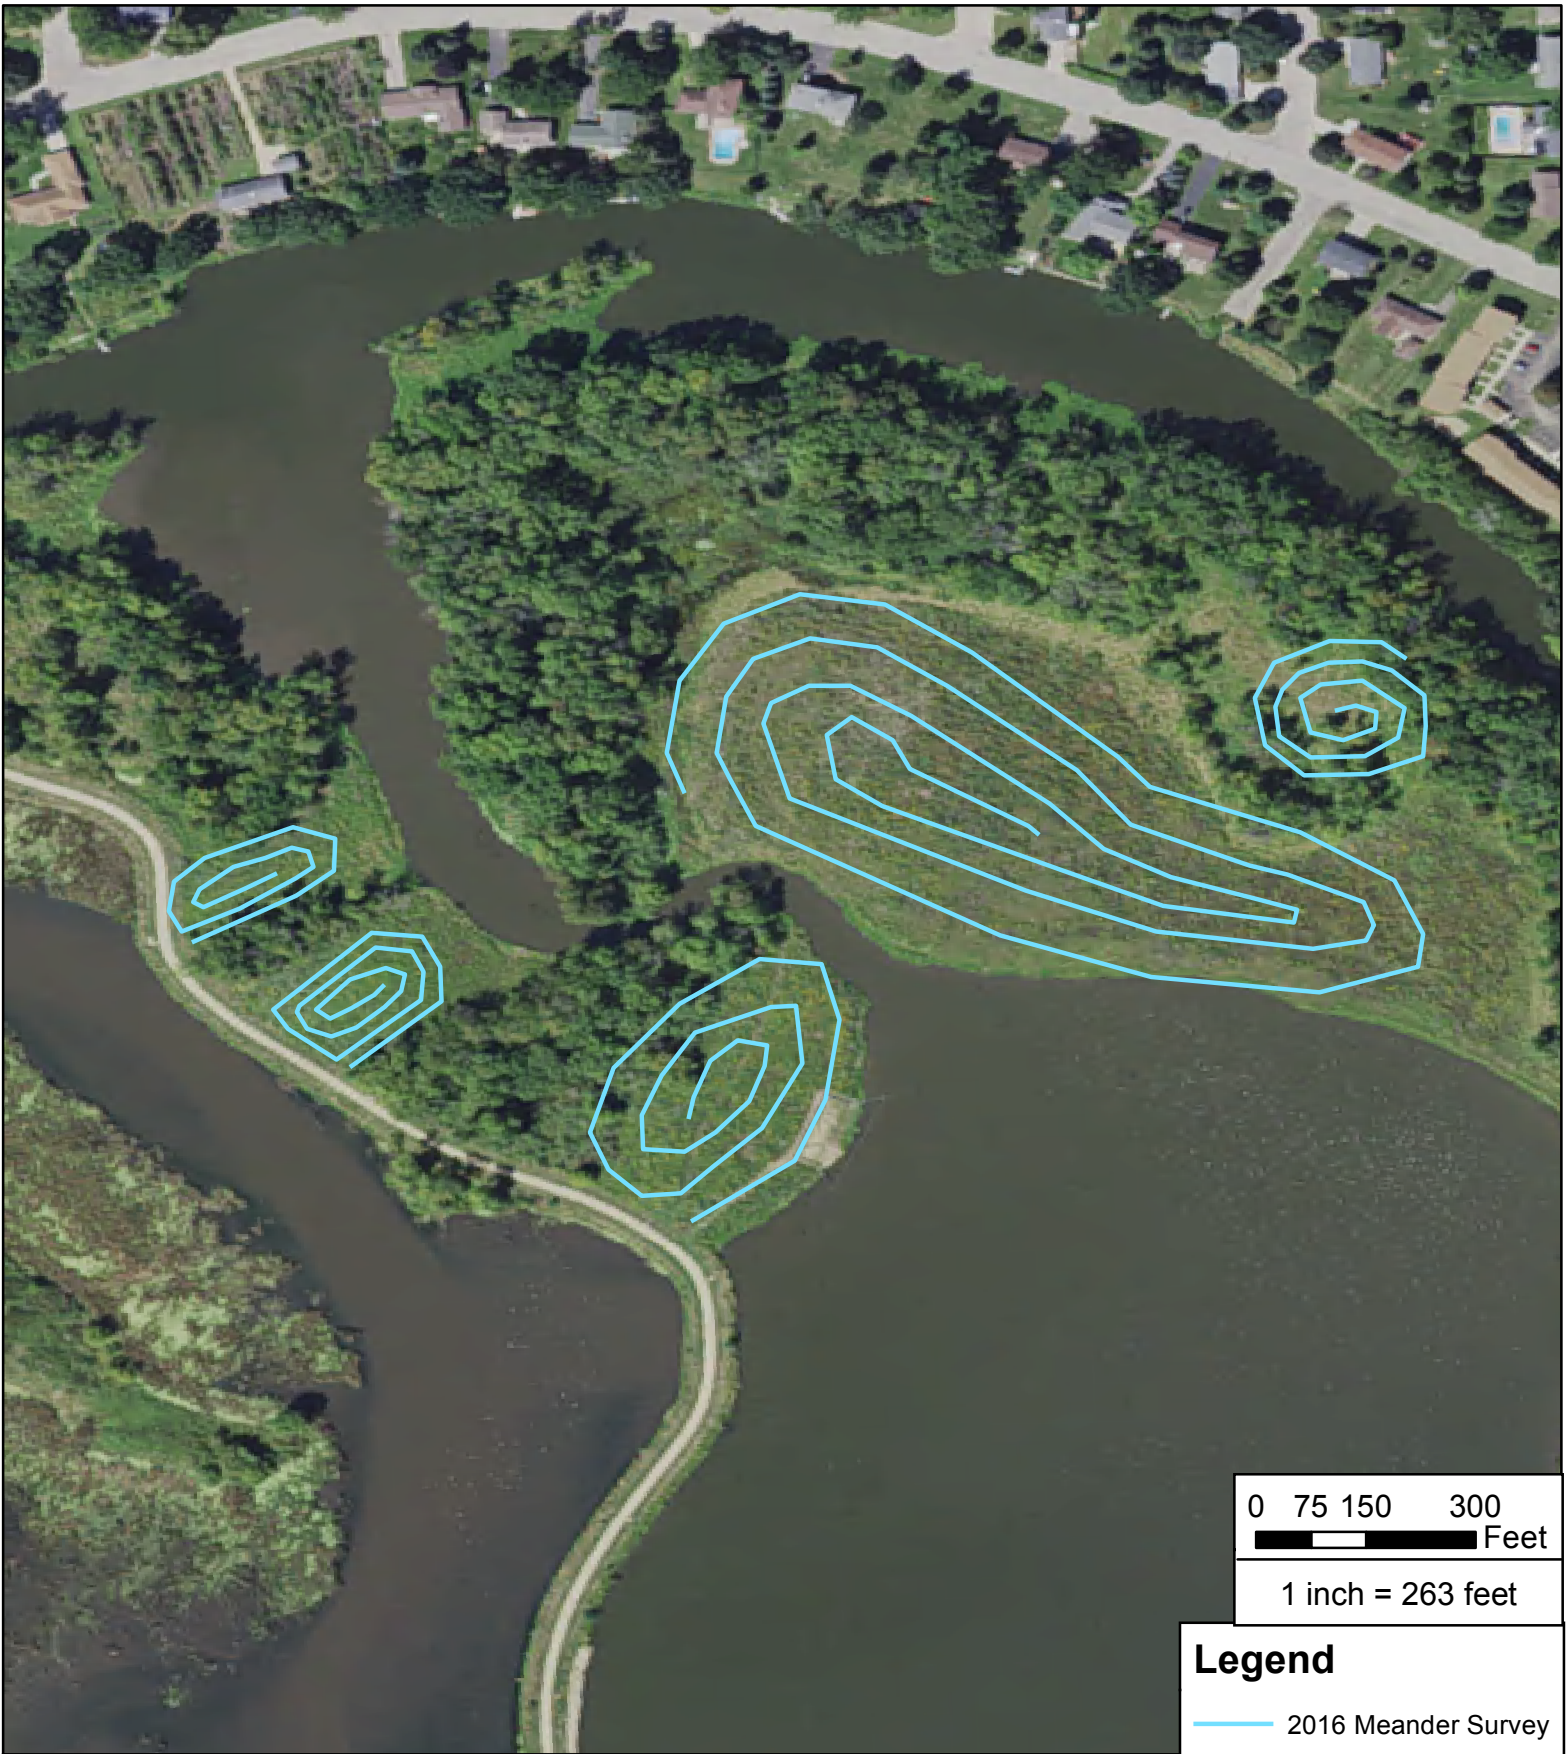
To assess the vegetation, a meander survey of the entire restoration area was conducted on July 11, 2016. ERC Senior Ecologists Tara Davenport and Scott Sauer traveled along the meander survey path(s) (Figure 2), and recorded all plant species observed. Although the meander path was continuous, it was conducted so all habitat types are included. Each species observed was assigned a vegetative cover class within each habitat type.

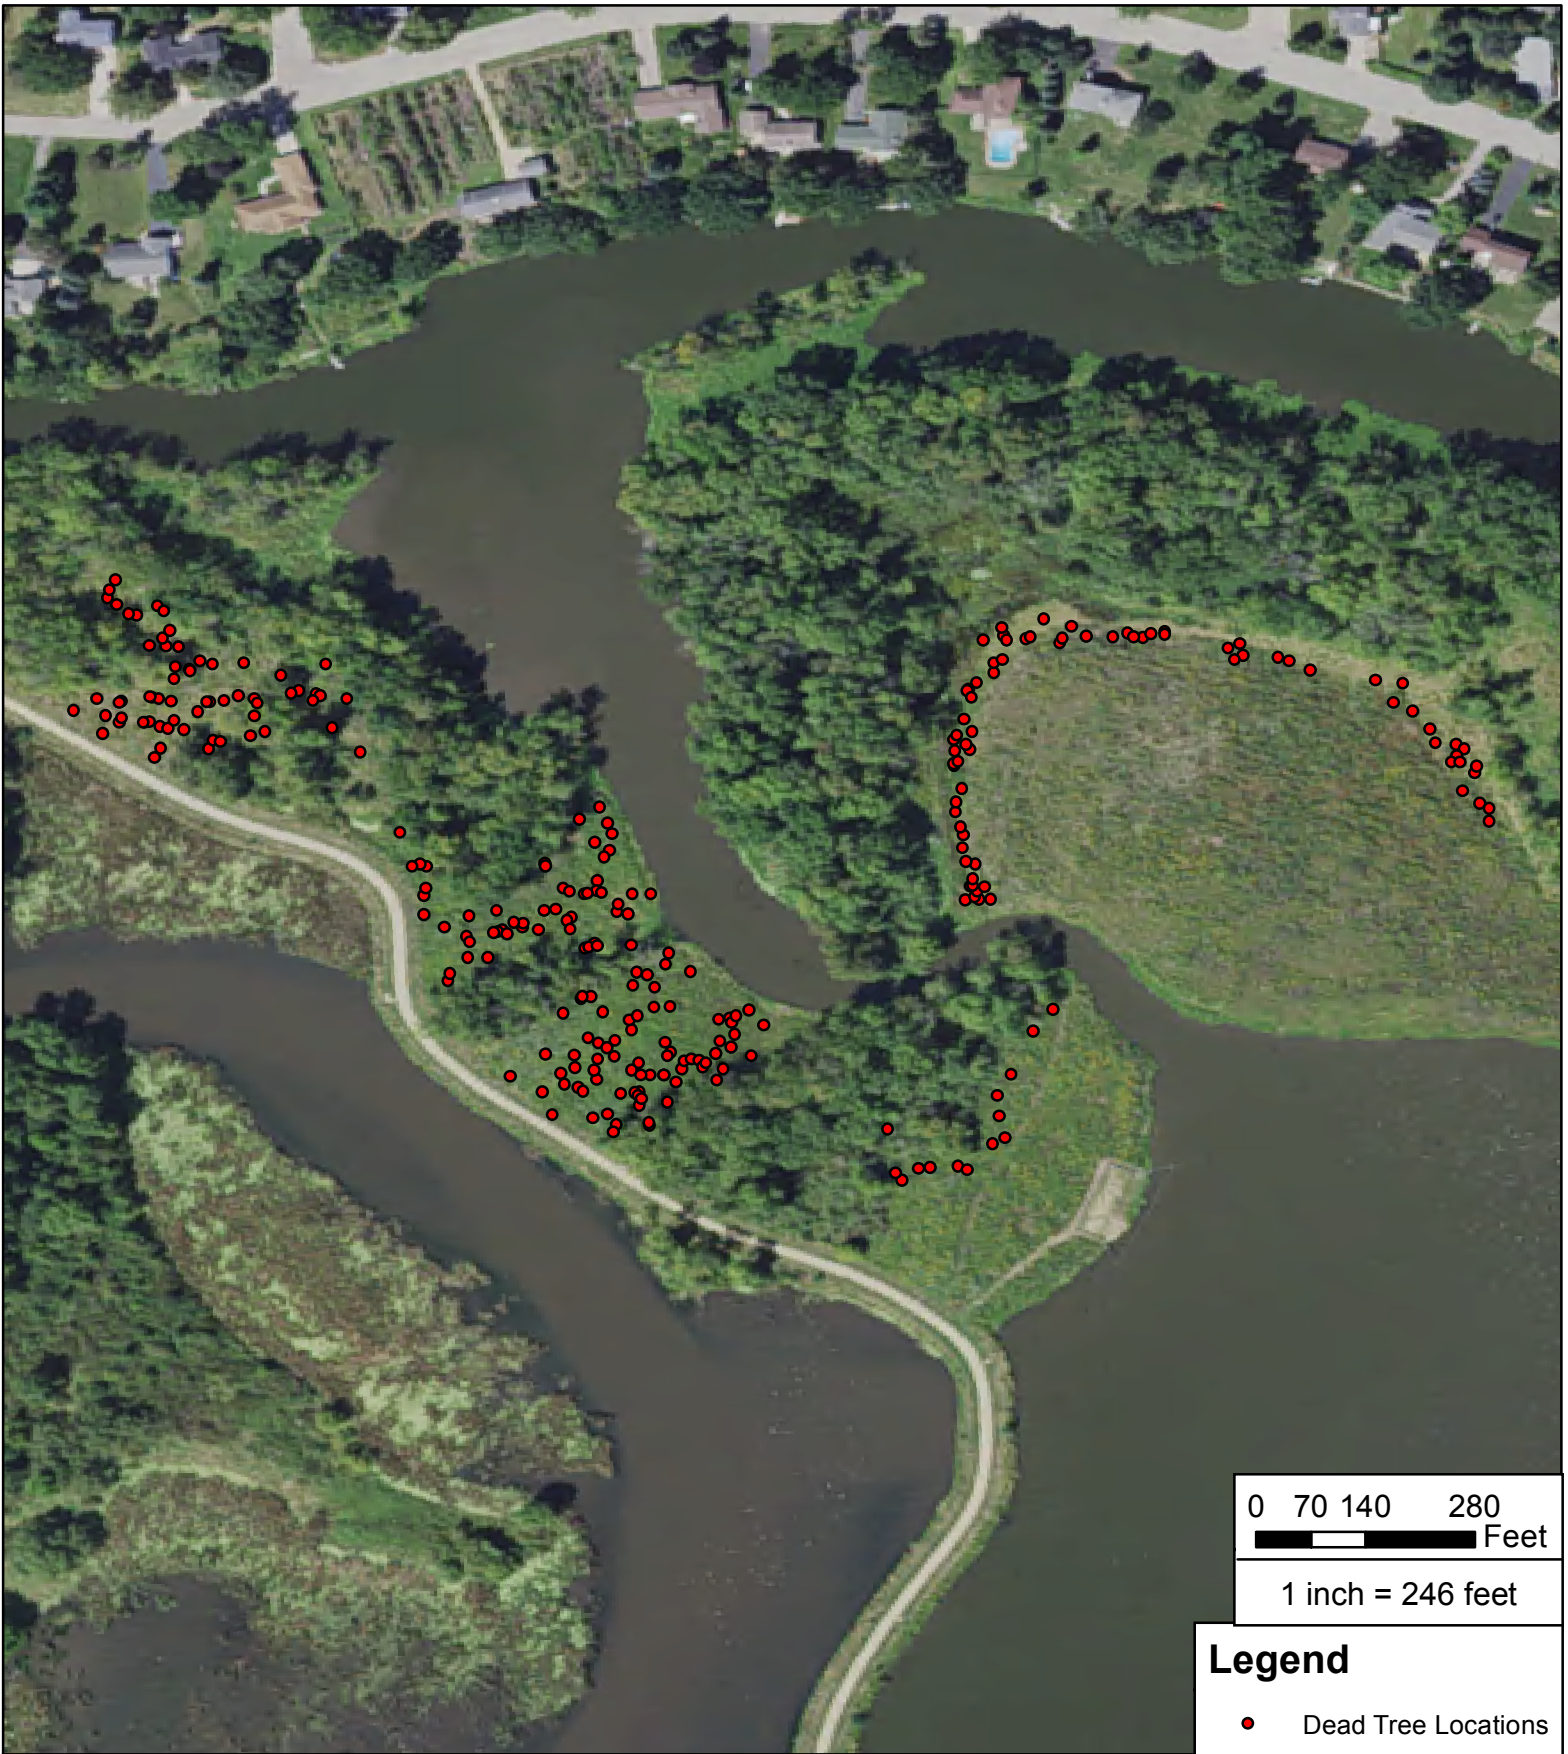
This letter provides our findings with regards to the Tree Survey ERC conducted at the Lake Belle View Restoration site from July 12-15, 2016. NES planted 2,642 trees in 2015. Of the 1,182 trees that ERC surveyed, approximately 32% of them were found to be dead or dying (see table below). Figure 1 (attached) shows locations of dead trees at the Lake Belle View Restoration site. Each red dot represents an individual dead tree or a cluster of dead trees. Dead trees did not appear to be location or species specific.
