Pike Chain of Lakes

Bayfield County, Wisconsin

Final Report for Wisconsin Department of Natural Resources Grant ACEI-169-15

June 2017

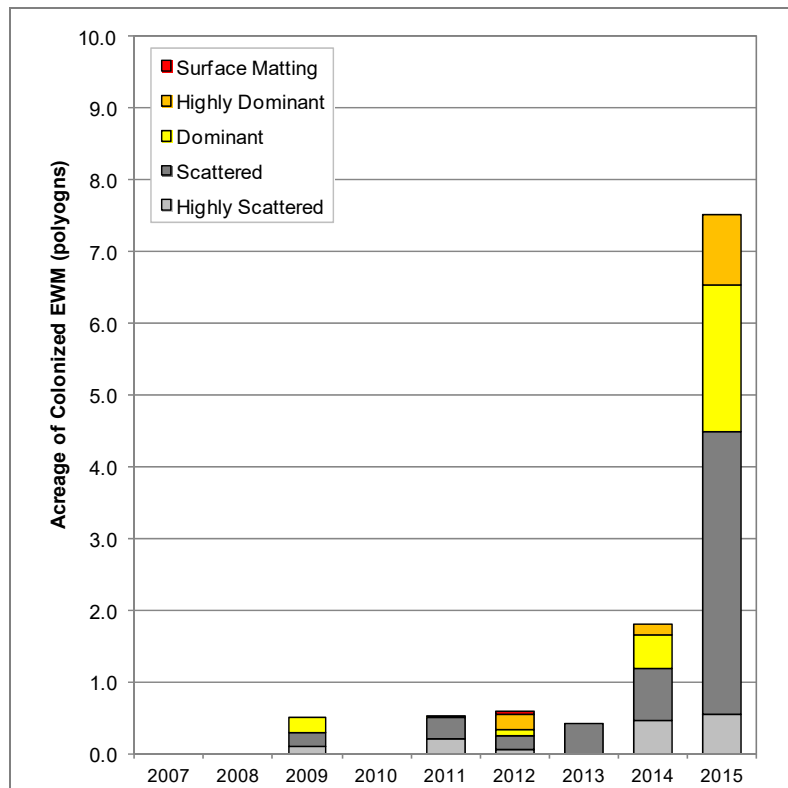
Figure 4. Pike Chain of Lakes Eurasian watermilfoil acreage, 2007-2015. Created using data from late-summer EWM peak biomass surveys.

During the summer of 2015, IRPCLA President Al Bochler noted during correspondence a “concerning” amount of EWM being located within the chain, both by himself and IRPCLA members. During Onterra’s peak-biomass mapping on August 25, 2015, the entire littoral zone of all six lakes, including herbicide and hand-harvesting sites, were assessed. Maps 1-6 shows the results of this survey. The resurgence described in Mr. Bochler’s summer 2015 correspondence was also observed by Onterra staff. In all, 7.5 acres of highly colonized EWM was observed within the chain lakes (Figure 4). As seen in Figure 4, the 7.5 acres represents the largest amount of colonized EWM mapped in the chain since EWM had first been discovered. However, to complete this picture,

the 2015 data on Maps 1-6 indicate that many *Clumps* and *Small Plant Colonies* were located within the chain’s littoral zone as well. Though these occurrences do not represent true, continuous colonies, their number and distribution around the littoral zones of Buskey Bay, Millicent and Hart Lakes (and the northern shoreline of Twin Bear) raises concern.

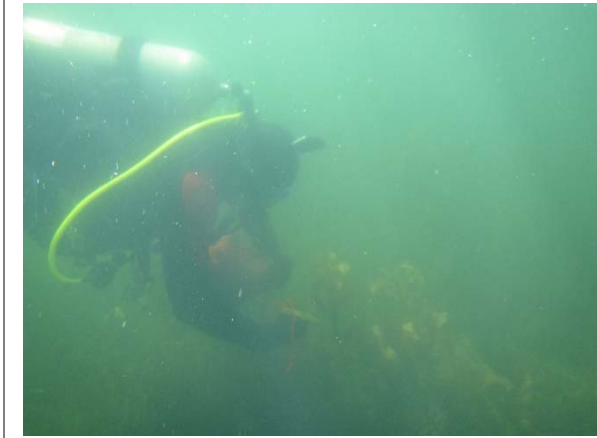
Photo 1. Onterra staff member harvesting apical cuttings at Pike Chain of Lakes.

On May 15, 2015, Onterra ecologists visited the Pike Chain of Lakes to harvest large-leaf pondweed cuttings from a dense population of the plants that exist in the channel between Twin Bear and Hart lakes (Map 11). Approximately 50 cuttings, all from the top of plants, were collected from the area (Photo 1). With the help of Al Bochler, 36 total stem cuttings were replanted for root production in a separate pot each. To weigh the pots down, about two inches of gravel were placed in the bottom of each pot. A single cutting, along with lake bottom sediments collected at the cutting site, were placed in each of the 36 pots (Photo 2). Four plastic bins, each holding nine pots and two large paving bricks for weight, were staked to the lake bottom with rope and metal spikes in approximately two feet of water near shore in Hart Lake (Map 11, Photo 3). In mid-June, a storm event occurred and to protect the plantings, Al Bochler created a wave break in front of the four bins from fence posts and 2x12 boards. No pots were lost as a result of the mid-June storm or others that occurred that summer.

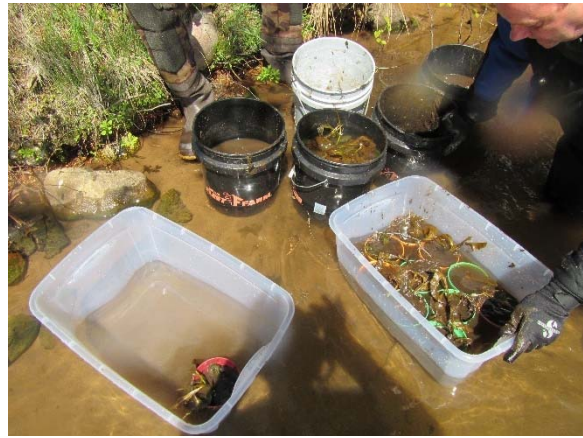
Photo 2. Propagating equipment.

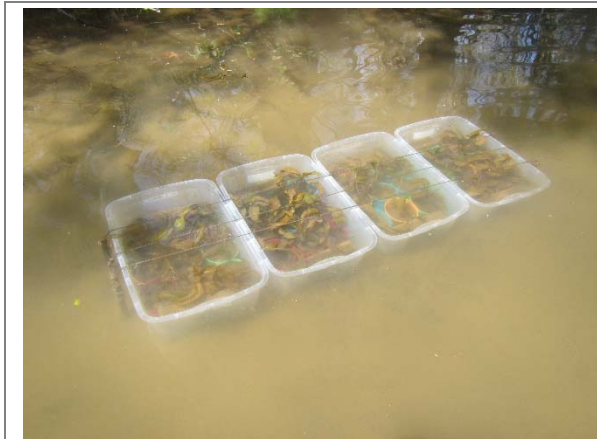
Photo 3. Secured bins, each with nine apical cuttings.

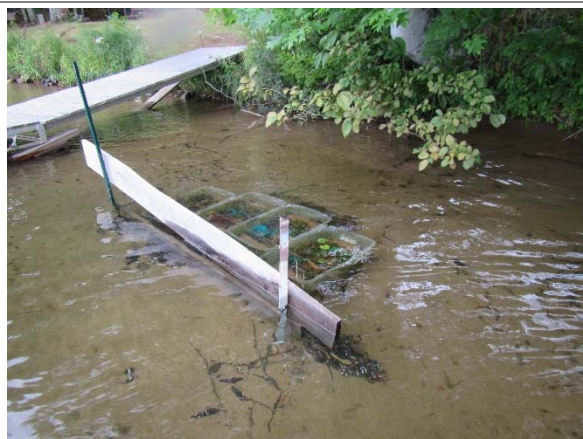
Photo 4. Bins with wavebreak after approximately 14 weeks of cutting growth.

On August 24, 2015, approximately 14 weeks after the cuttings were harvested, Onterra staff members returned to Hart Lake and found that of the original 36 cuttings, 25 survived (per bin: 9, 4, 5, 7) and produced roots (Photos 4 and 5). Further, what appeared to be a white water lily and common waterweed also sprouted in two of the containers (they were planted at the site propagating site).

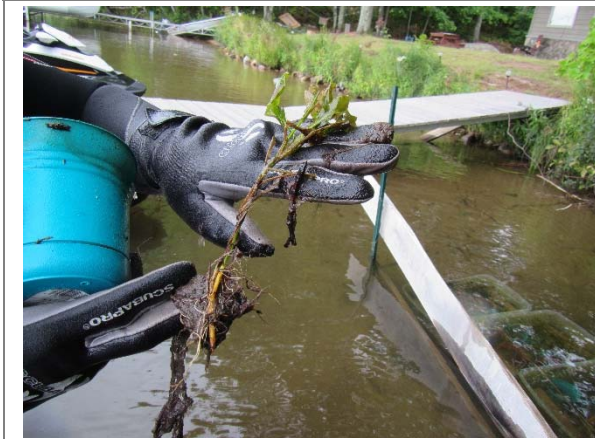
Photo 5. Apical cutting with root growth after approximately 14 weeks of propagation.

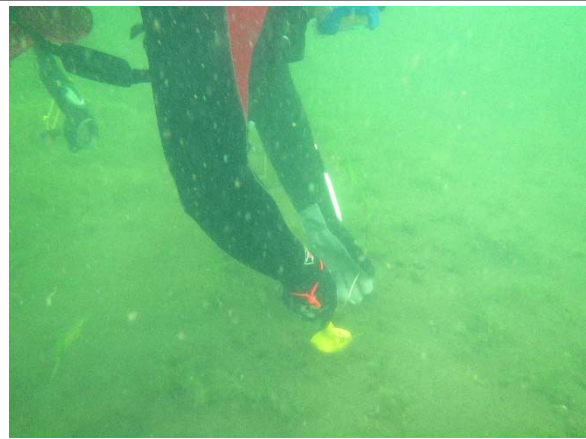
Photo 6. Planting fresh cuttings and propagated cuttings in Hart Lake.

Two approximately 9'x9' sites were marked out adjacent to each other with fiberglass rods. The two plots were located east and west of each other. Hart Lake was relatively rough that day with large waves and as a result, visibility at the site was not ideal, especially considering the clear water conditions that are typically found on the chain. Laying out the plots and subsequently planning the fresh cuttings and the propagules proved to be somewhat difficult because the divers

could not see the rods marking the borders of the plots. The idea of trying to complete the plantings in straight, ordered rows and columns was abandoned and the plants were scattered as evenly among the plots as possible. Soft sediments made planting difficult, but at the time, it appeared that they would stay in place (Photos 6 and 7). Upon finishing the plantings, the west plot contained the 25 plants that were collected in May (all with roots) and the east plot contained 25 stem clippings collected that morning.

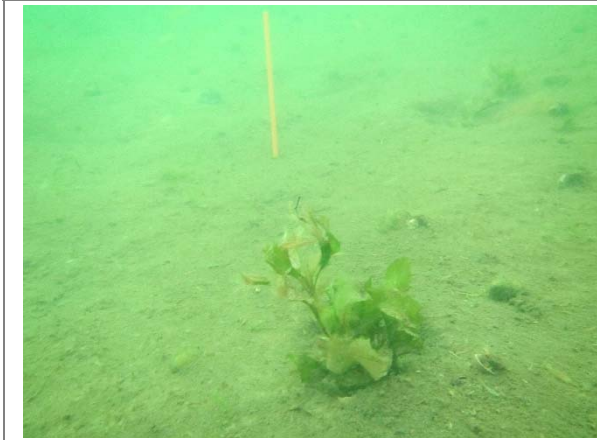
Photo 7. Planted propagated cutting within western plot at Hart Lake.

Eighteen large-leaf pondweed stems were located in the western plot where the rooted plants were installed. Through inspection, it was determined that many of the plants were actually connected via runners, so it was evident that some of the surviving plants were spreading via rhizomes and creating new plants in the area (Photos 8 and 9). This of course made it impossible to determine which were the original plantings and which were new growth.

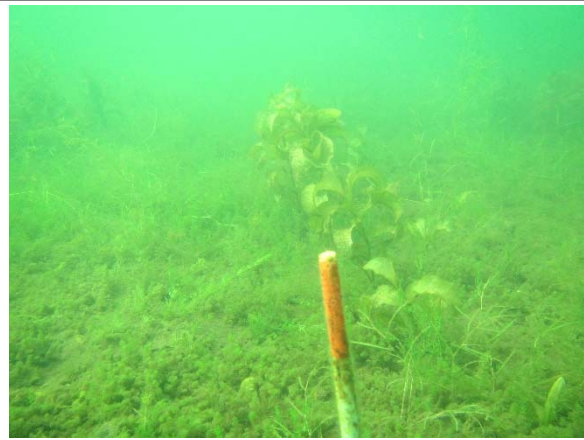
Photo 8. Large-leaf pondweed growth 55 weeks after planting within western plot in Hart Lake.

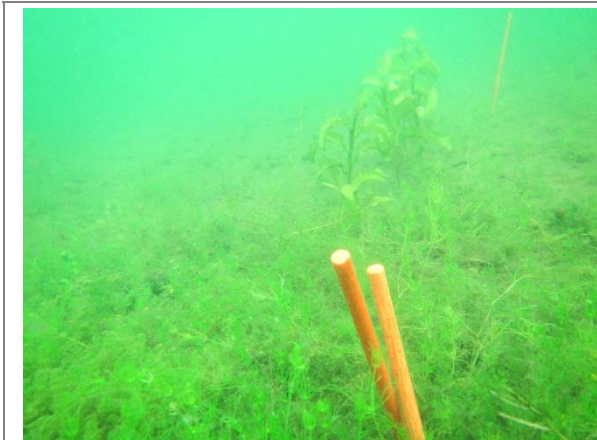
Photo 9. Large-leaf pondweed growth 55 weeks after planting within eastern plot in Hart Lake.

In the eastern site that contained the cuttings collected the morning of installation, 38 stems were located within the plot and an additional 10 stems were found to be growing via rhizomes outside the plot from plants within the plot (Photo 10). As with the western plot, determining which of the stems were planted and which were new growth via runners (not including those outside the plot), was impossible.

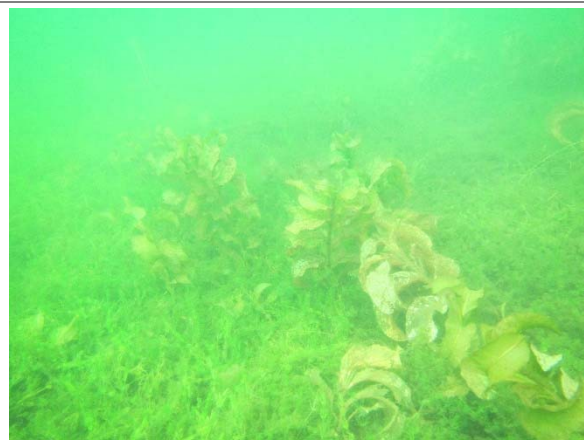
Photo 10. Large-leaf pondweed growth 55 weeks after planting outside of eastern plot in Hart Lake.
