Final Report
for
Comprehensive Lake Management Planning Grant
Project #LPL162317
Forestville Millpond

June 2018

Door County

Soil and Water Conservation Department

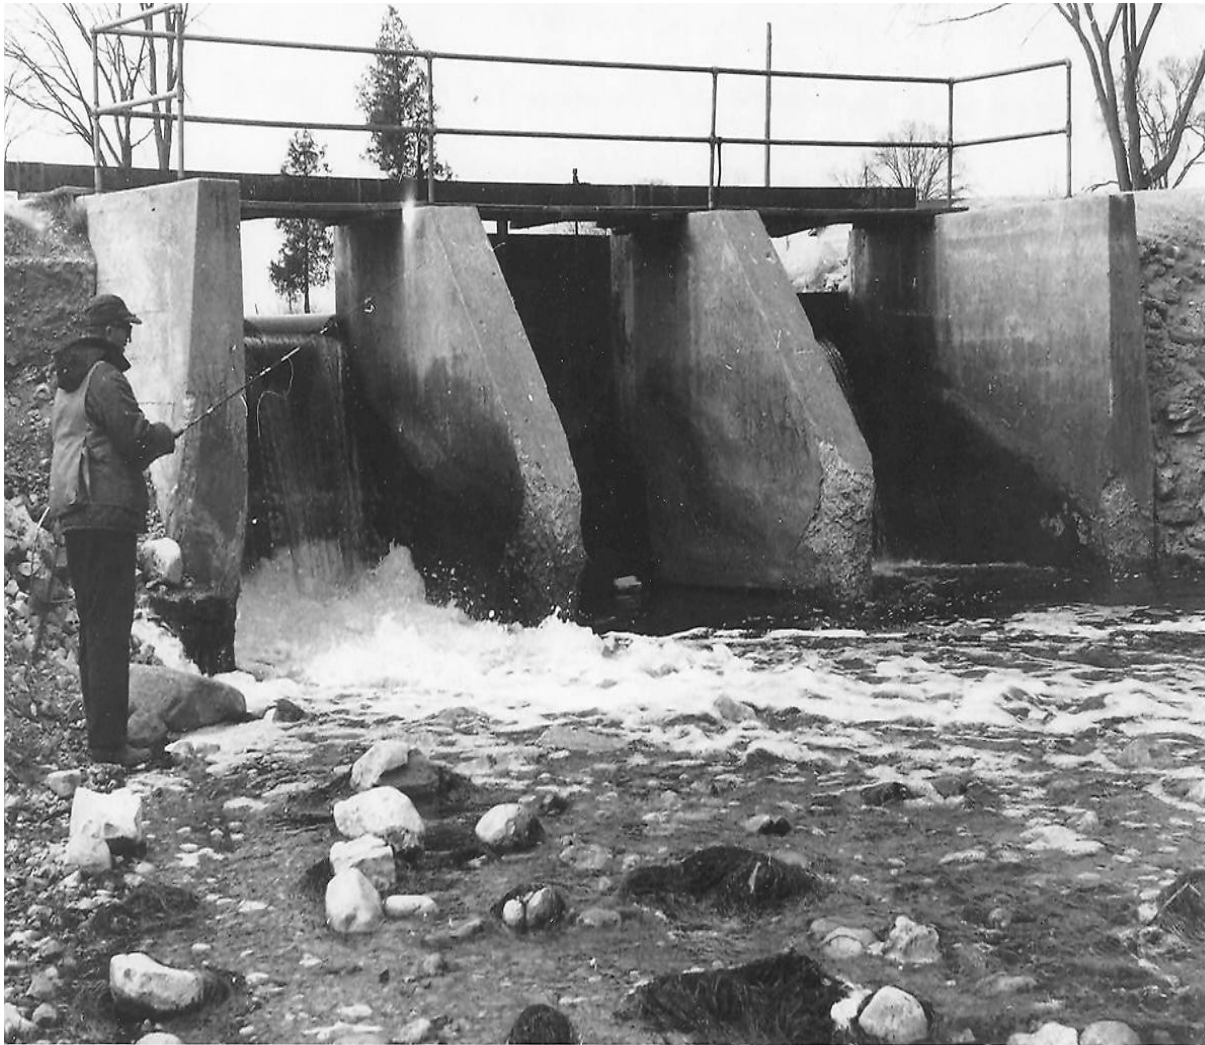
Figure 1-3. Forestville Dam in 1934

Through efforts of the Works Progress Administration, a new concrete dam was constructed in 1934 (see Figure 1-3). This dam was dedicated as the Poh Community Dam and Lake in 1935. In 1949, the dam and the surrounding property were sold to the Town of Forestville by John Poh Jr. May of 1960 brought heavy rains and a breach of the earth-and-rock-filled portion of the dike. This failure drained the impoundment and flooded downstream areas. In 1963, the town gave the park and dam structure to the Door County Board to develop a county park. The name Poh Community Dam was lost at this time and going forward, the dam became known as the Forestville Dam.

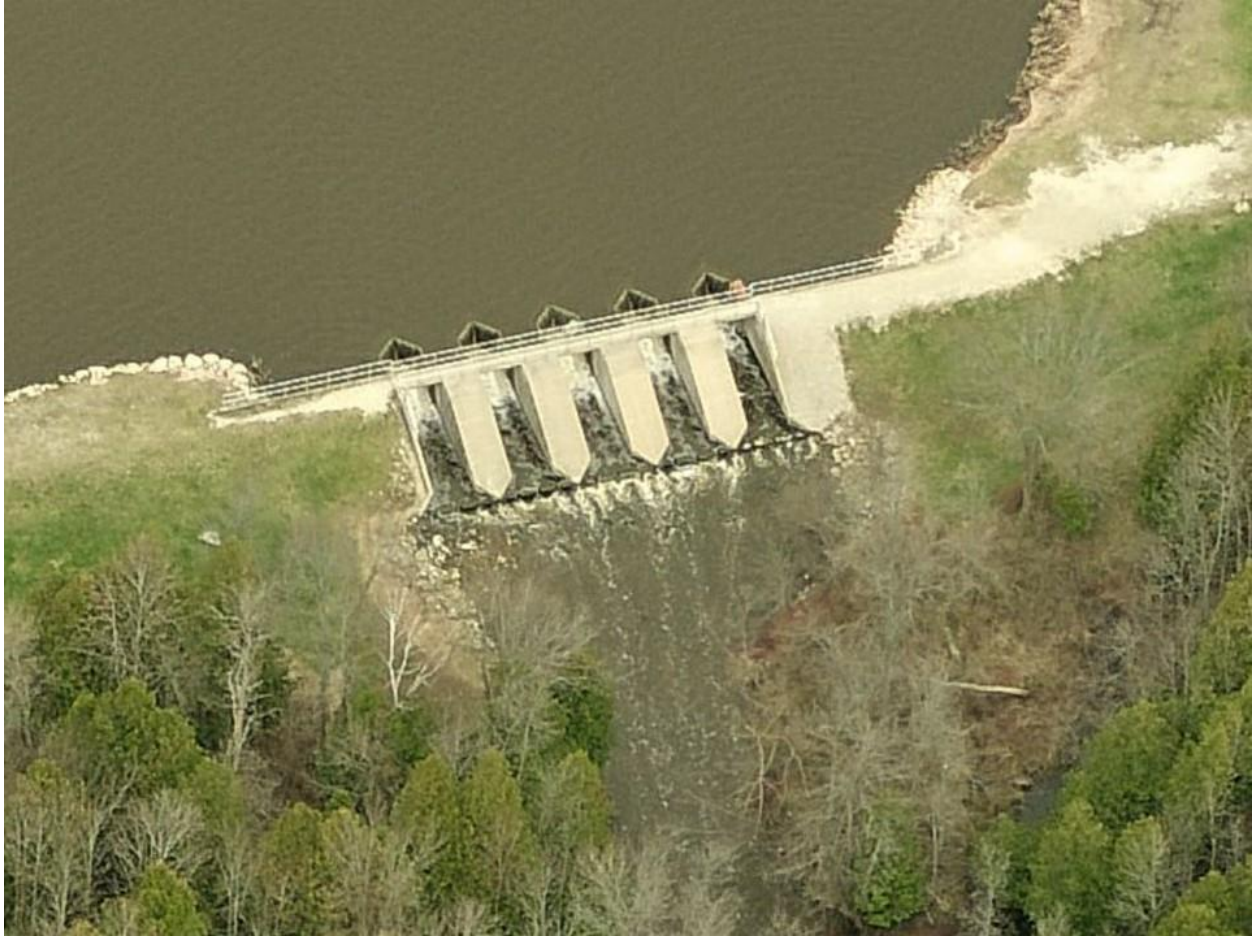
Figure 1-4. Forestville Dam in 2011

In 1982, the Forestville Dam entered its current configuration with a replacement of the spillway structure and a reconfiguration of the outflow through the bottom (see Figure 1-4 – Figure 1-6). This project coordinated with an effort to dredge near the dam structure to improve the swimmable areas in the park.

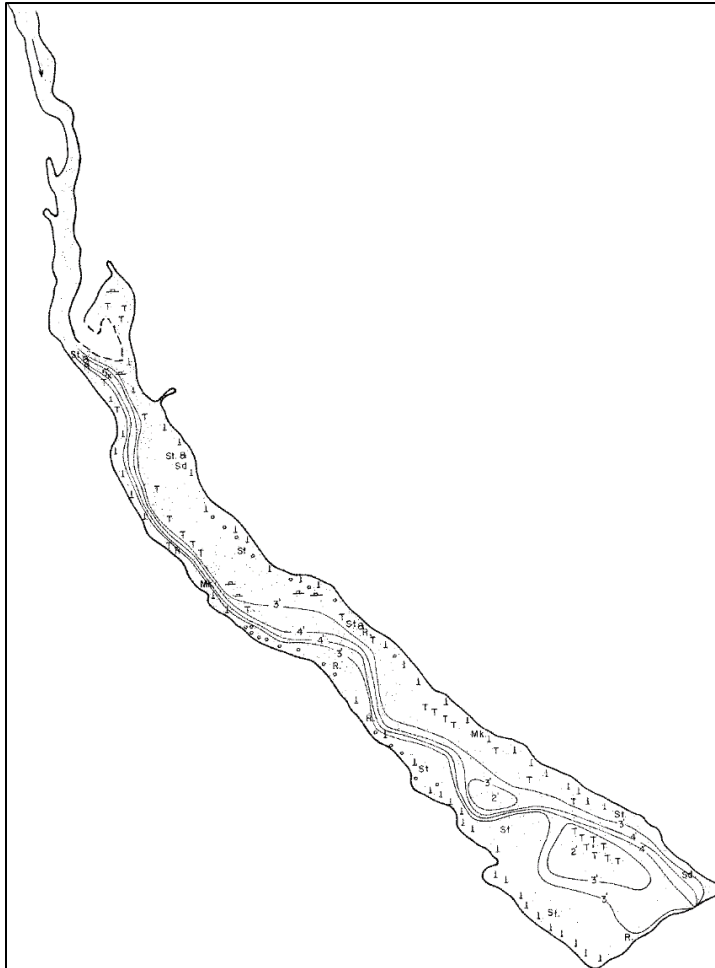
Figure 4-1. 1974 Bathymetric Map – Wisconsin DNR

The last complete bathymetric survey of the Forestville Millpond was conducted in 1974 (see Figure 4-1).

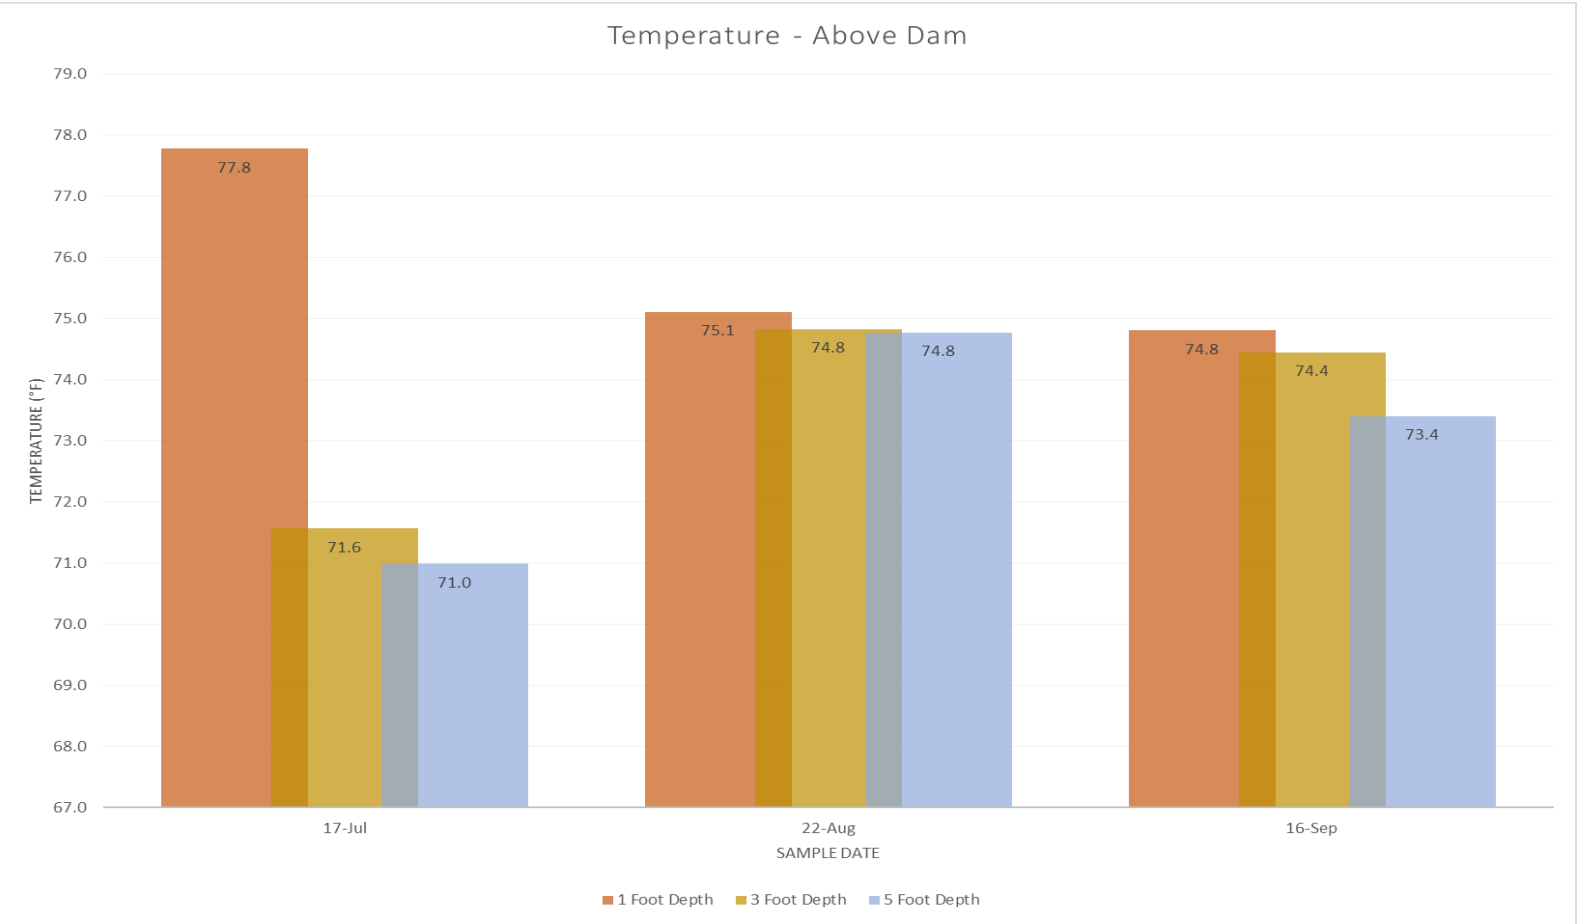
Chart 5-4. Temperature above the Dam

The acute temperature criteria has been established for each month by water type. The Ahnapee River is considered a small, warm-water fishery. The acceptable temperature threshold for the Ahnapee ranges from 80°F - 85°F throughout the field season; all of the samples were well below the acute temperature criteria (see Chart 5-3). Temperatures in the Millpond fell within 71°F – 77.8°F (see Chart 5-4).

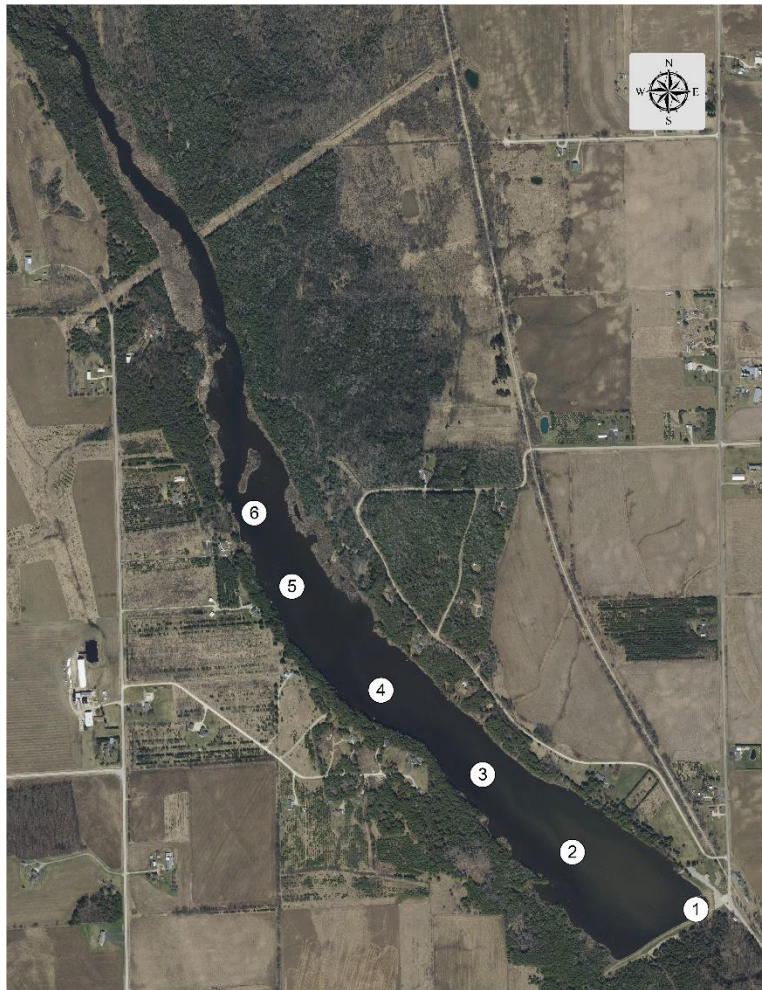
Figure 6-1. Location of Sediment Cores

Six coring locations were identified (see Figure 6-1) and a plan which outlined procedure and analysis to be done was submitted to the Wisconsin Department of Natural Resources for review. Locations were chosen to provide a representative assemblage of the Millpond sediment. A partnership of the SWCD and UW-Oshkosh staff collaborated on October 31 and November 5 of 2017 to collect the samples. A Livingstone-type rod piston corer was used with split tubes to extrude the cores for visual inspection and collection of sample material (see Figure 6-2).

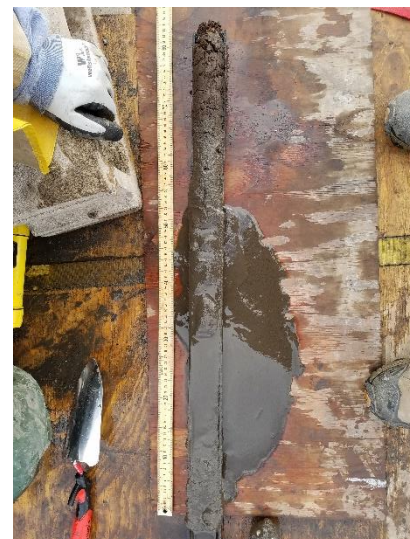
Figure 6-3. Sediment Core #3

Each core was examined for stratigraphic layers, and representative samples for analysis were taken from each layer. Each sample was split into three layers with the top being loose unconsolidated material, the middle “muckier” sediments and the bottom layer was more compact (see Figure 6-3).

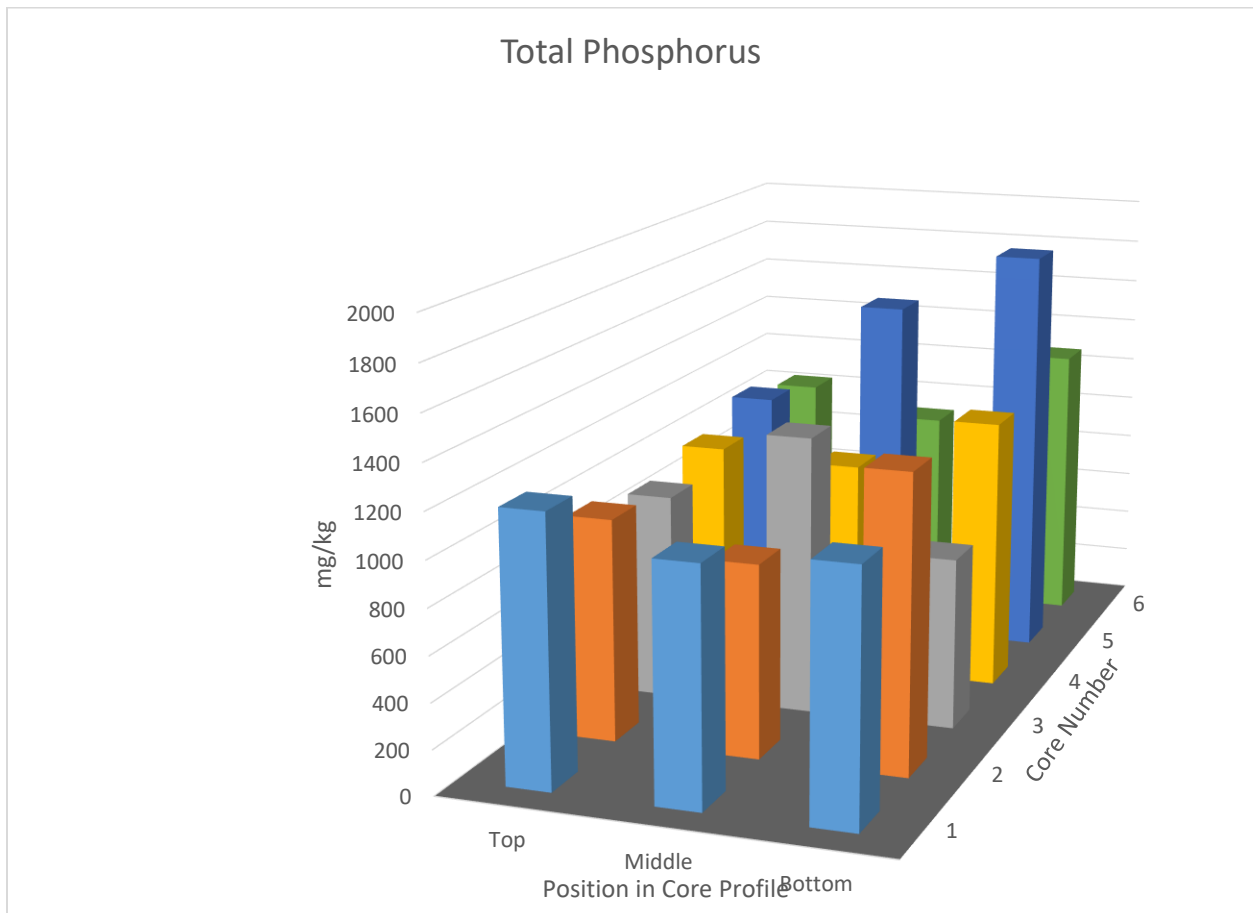
Chart 6-1. Total Phosphorus in Sediment Cores

High concentrations of phosphorus are a common cause of eutrophication in fresh water lakes, reservoirs and impoundments. Phosphorus contributions in a waterbody can be from both external phosphorus sources, as well as its release and retention in the sediments. Accumulated sediments act as a sink where legacy phosphorus can be stored, and also as an ongoing source of phosphorus for the overlying water. Recycling of phosphorus from the underlying sediments that have been enriched by years of high nutrient inputs can cause a lake to remain eutrophic well after external inputs of phosphorus have been decreased. Determination of Total Phosphorus concentrations that have accumulated in the Millpond sediments is necessary for an understanding of the nutrient budget of the waterbody as a whole, as well as to provide guidance on the next steps needed to address issues in the Millpond. Total Phosphorus concentrations were quite high in all of the analyzed sample, with values ranging from 764 mg/kg to 1,870 mg/kg (see Chart 6-1); the Limit of Quantification for Phosphorus is 119 mg/kg.

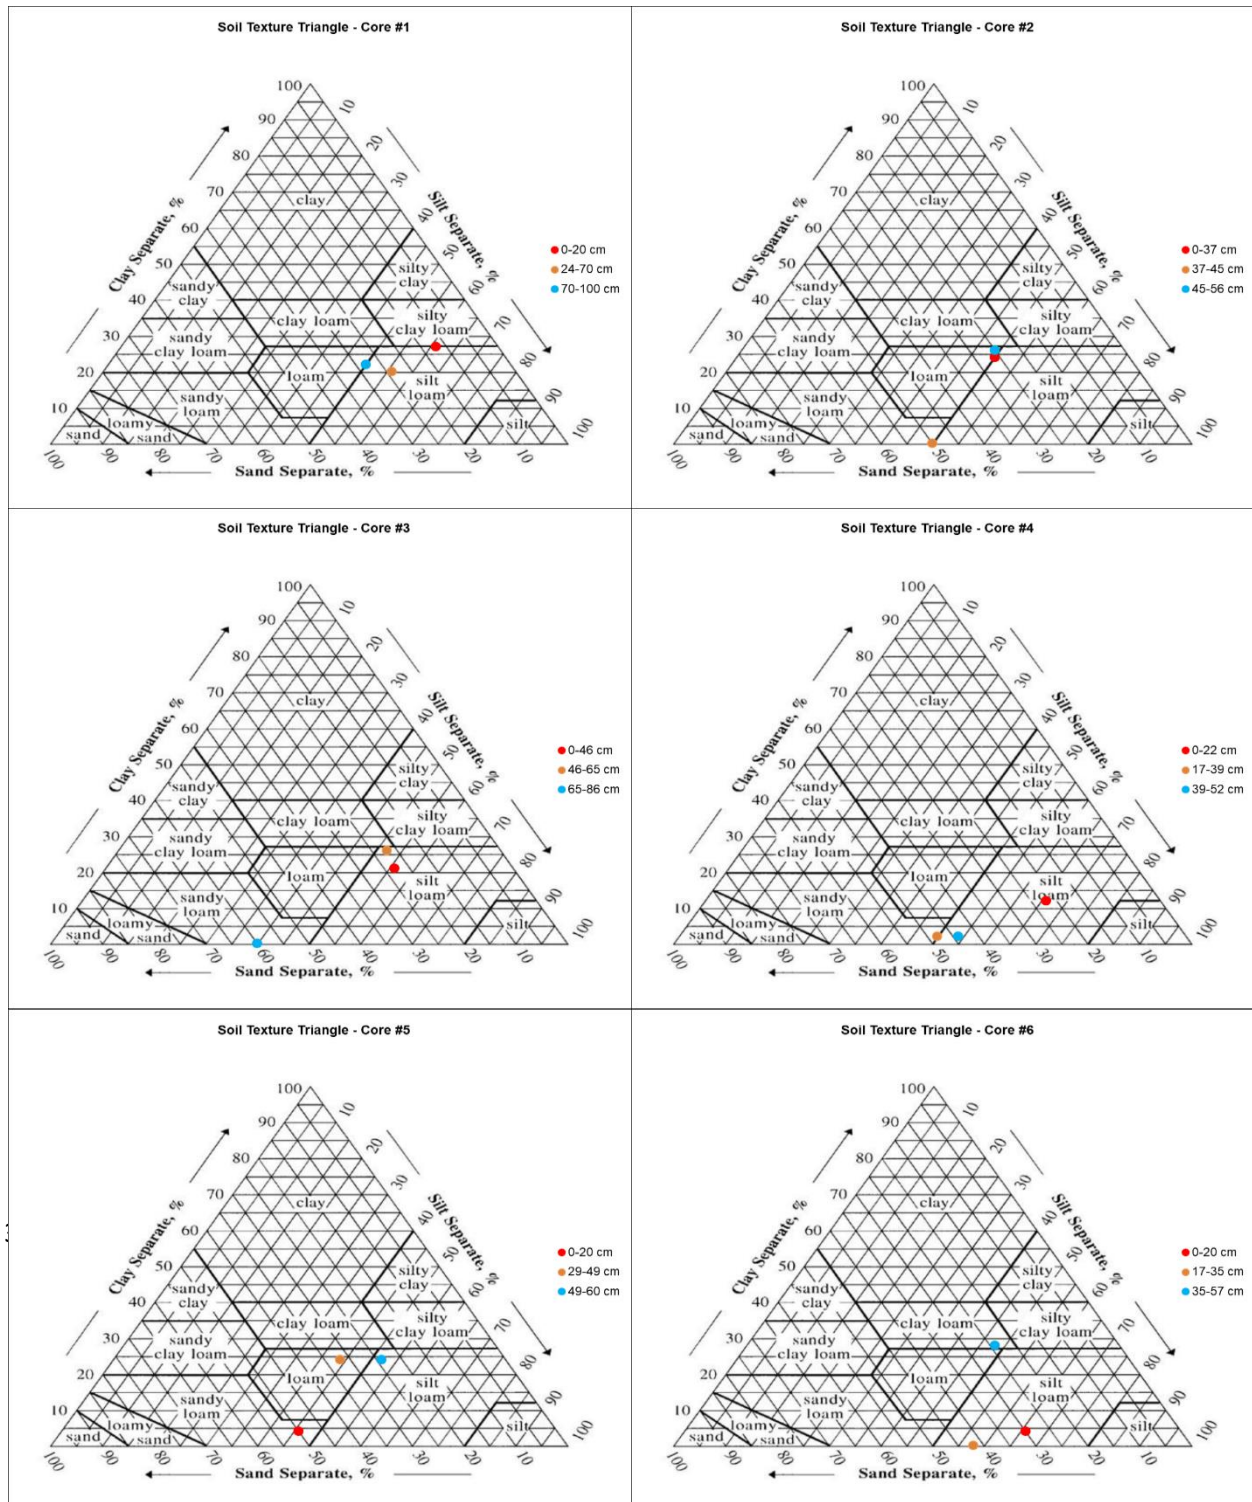
Figure 6-5. Particle Size Distribution

One of the parameters generated from material collected in sediment cores is a breakdown of the constituent mineral components of the sediment; the analysis is represented by a ratio of the sand, silt and clay particles present. Analysis of the Millpond cores classifies most of the samples as silty loam with some falling into the classification of sandy loam and clay loam (see Figure 6-5).

Overall, the accumulated sediments in the Millpond fall into a classification of a silty loam, with a high percentage of very fine particles. This is to be expected with the high degree of suspended sediments and poor clarity resulting from turbid waters. From the information gathered in the samples, there is roughly two feet of loose, unconsolidated material overlying the more competent soils in the subsurface.
