Oconto County Lakes Project

MACHICKANEE FLOWAGE STUDY

SUMMARY REPORT

2018

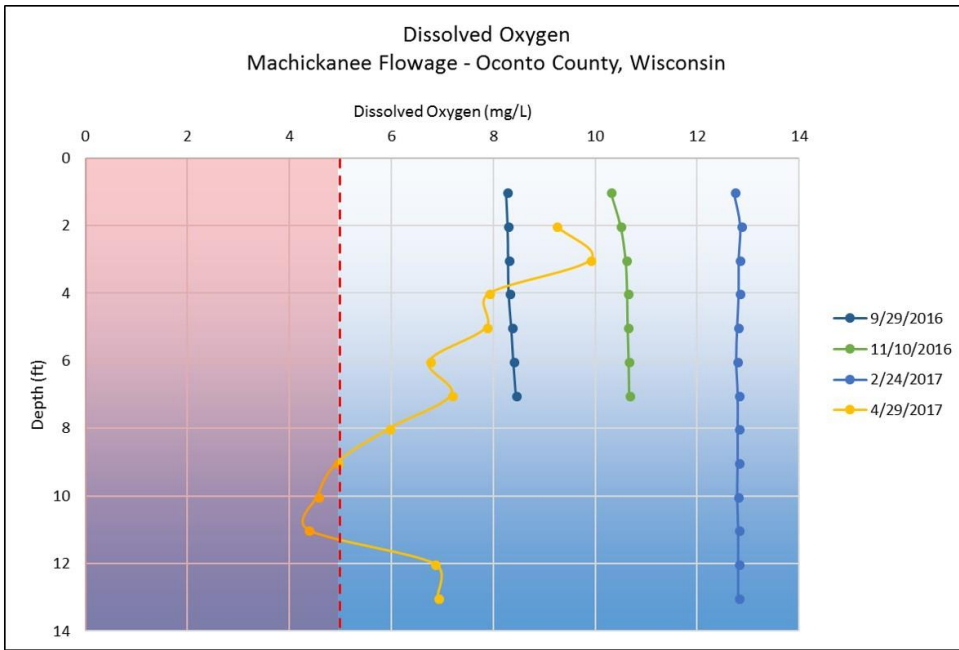
Sufficient **dissolved oxygen** in lake water is essential to the survival of aquatic organisms. The amount of dissolved oxygen present within a lake varies by season and depth. It is determined by the biological activity that consumes or produces oxygen, by water mixing through wind, changes in temperature, and inputs of surface and groundwater. Generally, at least 5 mg/L oxygen is required for fish.

◆ Sufficient oxygen is available in the top 8 feet of the water column in Machickanee Flowage throughout the year.

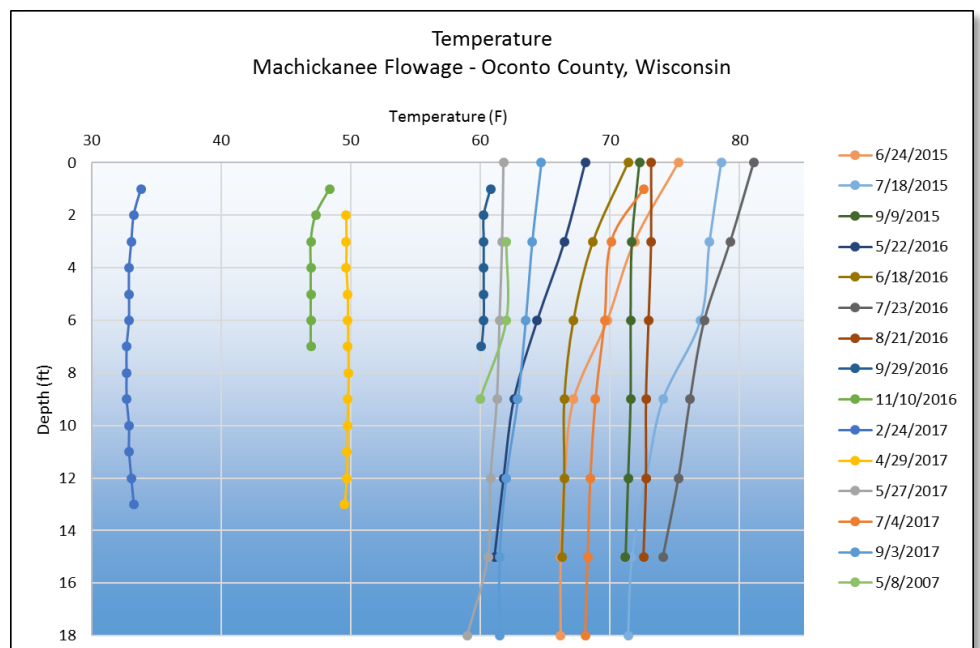
Lake water **temperature** has a significant impact on water chemistry, spatial distribution of fish, microbial growth and oxygen content.

◆ The temperature gradient in Machickanee Flowage is relatively uniform most of the year, typical of a shallow, mixed lake.
