Oconto County Lakes Project

OCONTO FALLS POND STUDY

SUMMARY REPORT

2018

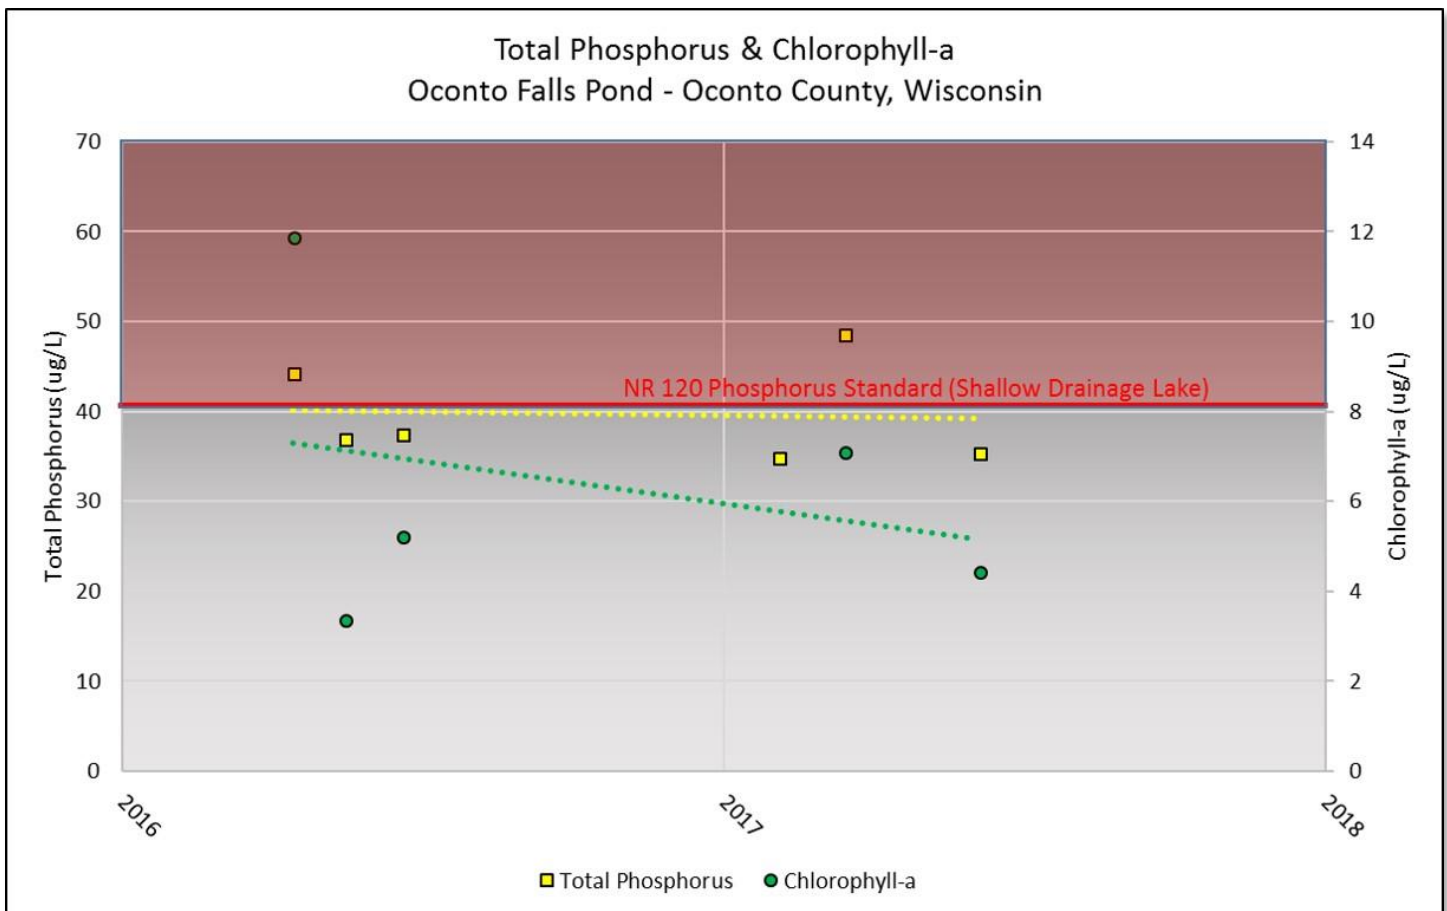
- ◆ Total Phosphorus was occasionally **above** the Wisconsin state phosphorus standard of 40 ug/L for shallow drainage lakes during the two-year study, however, the 2-year trend is stable.
- ◆ Inorganic nitrogen (0.28 mg/L) was just below the threshold of 0.3 mg/L when algal blooms increase.
- ◆ Chlorophyll-a, an indirect measure of algae, was occasionally above the threshold of 6 ug/L when algae blooms tend to increase. Limited data shows a decreasing trend.

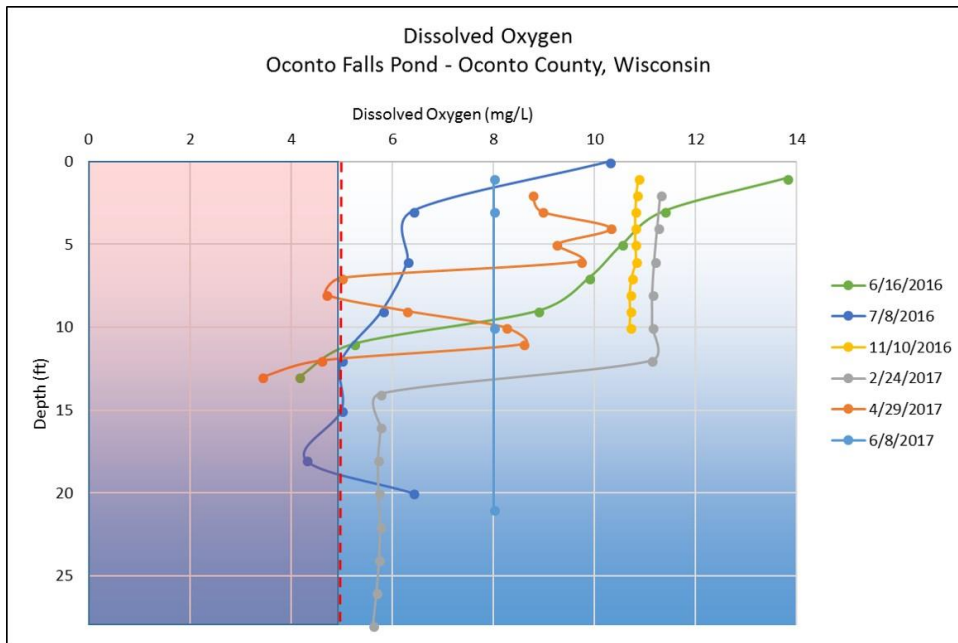
◆ The lake is well mixed with sufficient oxygen available in the top 8 feet of the water column in Oconto Falls Pond throughout the year.

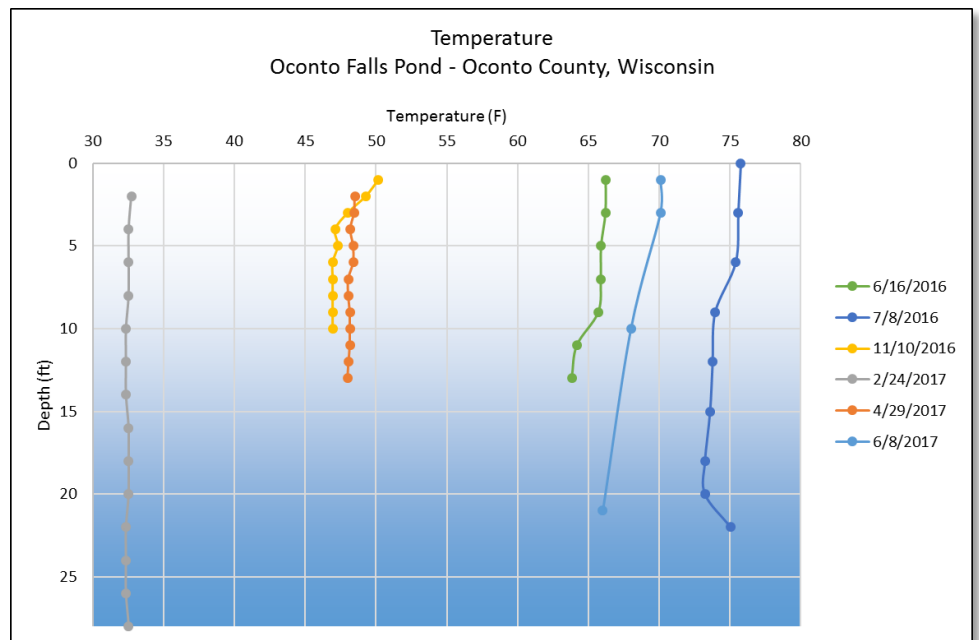
◆ There is little temperature gradient in Oconto Falls Pond. Profiles are relatively uniform most of the year, typical of a shallow, mixed lake.

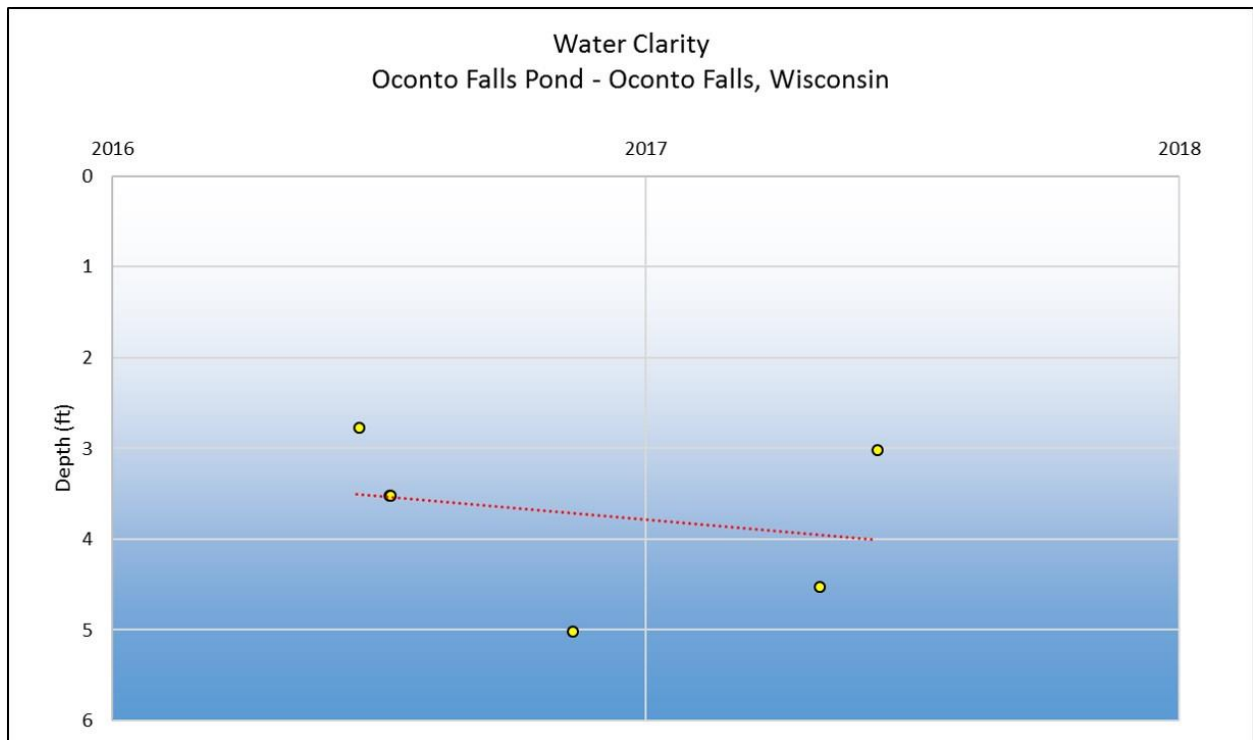
- In general, water clarity is considered poor in Oconto Falls Pond. No trend is apparent from the limited data available.

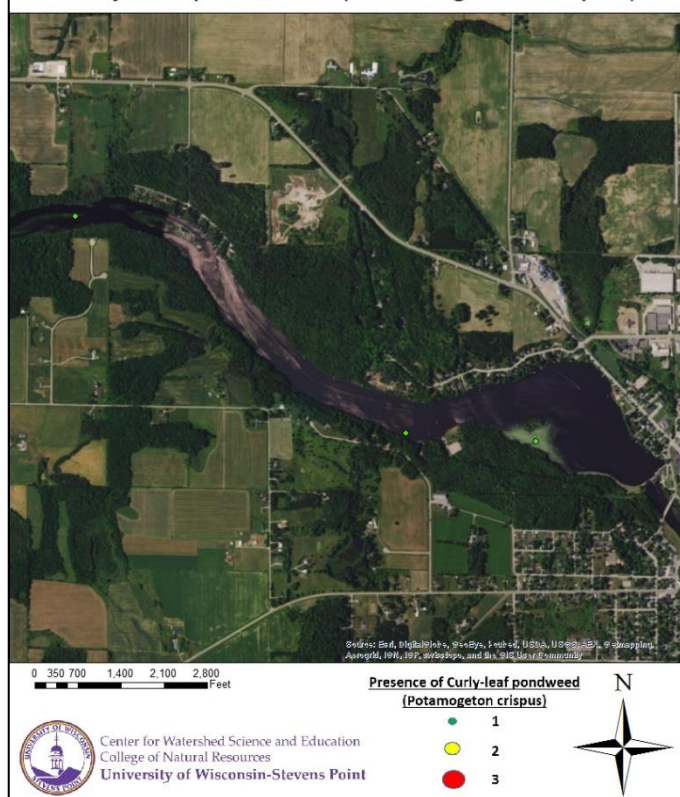
Oconto Falls Pond Aquatic Plant Survey 2017:
Curly-leaf pondweed (*Potamogeton crispus*)

Curly-leaf pondweed invades freshwater lakes and can become dominant due to its tolerance of a variety of habitats. CLP grows primarily during the winter and dies off by June, just as water is warming up, which can drastically increase nutrient concentrations.
