# Oconto County Lakes Project

## PAYA LAKE STUDY

### SUMMARY REPORT

2018

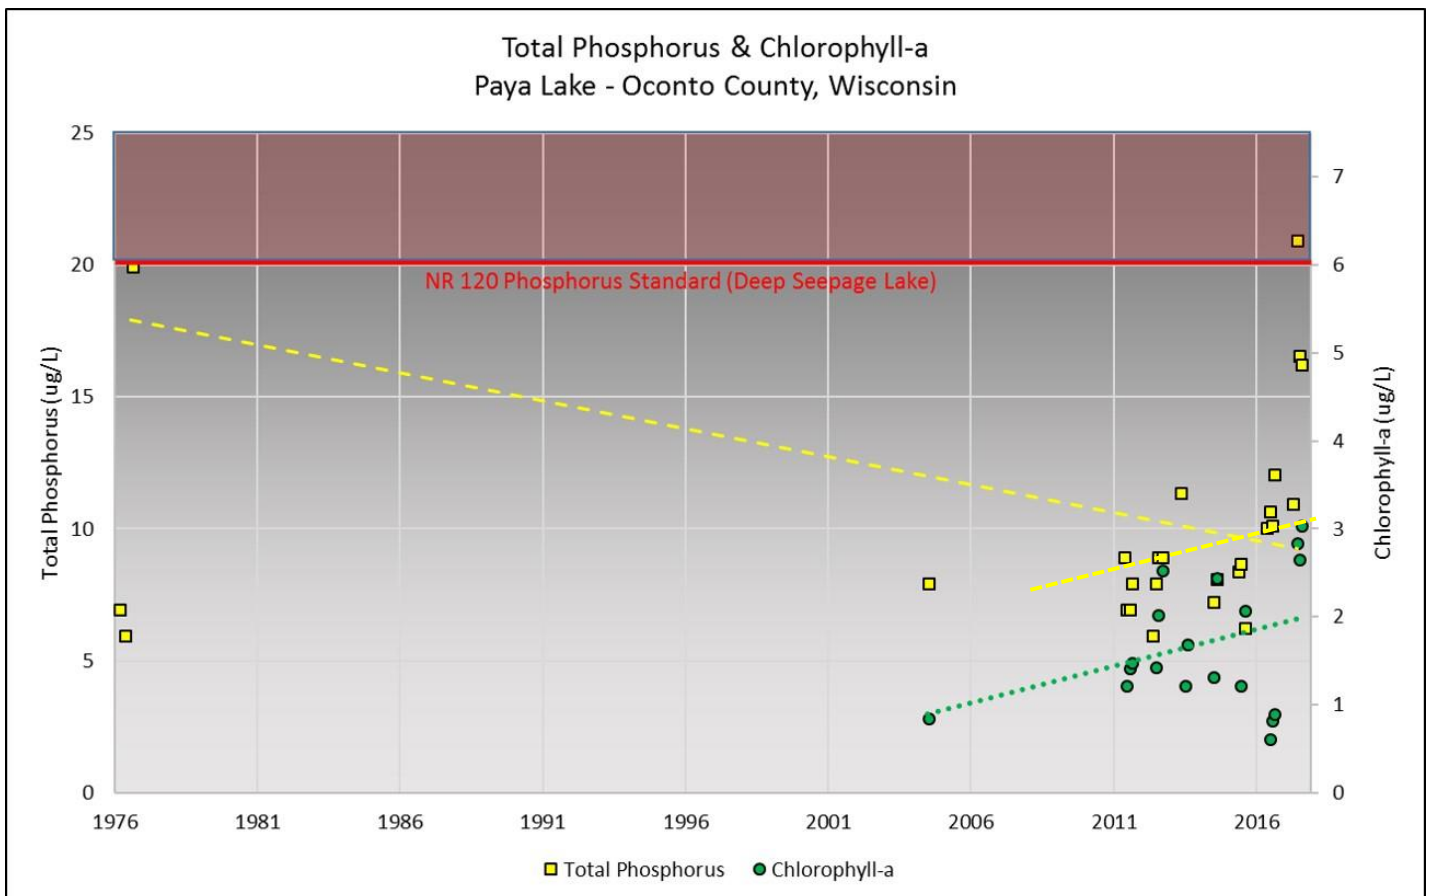
- ◆ Total Phosphorus was typically **below** the Wisconsin state phosphorus standard of 20 ug/L for deep seepage lakes during the two-year study. Though the long-term trend (based on few samples) shows a decreasing trend, data within the past 6 years suggests concentrations may be on the rise.
- ◆ Inorganic nitrogen (0.02 mg/L) was below the threshold of 0.3 mg/L when algal blooms increase.
- ◆ Chlorophyll-a, an indirect measure of algae, remained well below the threshold of 6 ug/L during the study, however, the short-term trend suggests increasing concentrations.

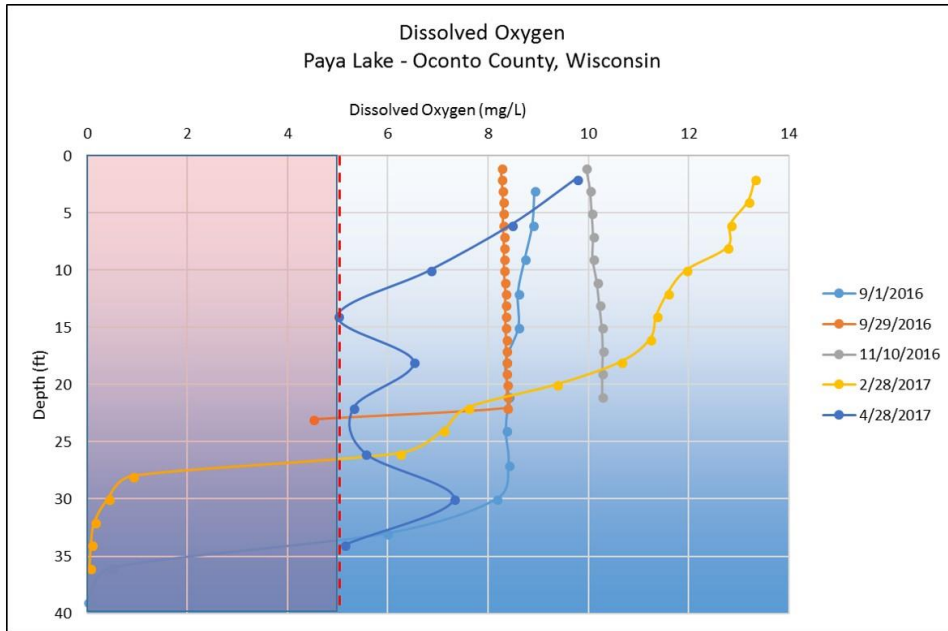
Sufficient **dissolved oxygen** in lake water is essential to the survival of aquatic organisms. The amount of dissolved oxygen present within a lake varies by season and depth. It is determined by the biological activity that consumes or produces oxygen, by water mixing through wind, changes in temperature, and inputs of surface and groundwater. Generally, at least 5 mg/L oxygen is required for fish.

- ◆ During most of the year, sufficient oxygen is available in Paya Lake throughout the water column. Oxygen is depleted during the winter while the lake is ice covered, however, with the only the upper 10 feet having enough to support fish.
- ◆ Bumps in dissolved oxygen concentrations at 20-30 feet suggest mild algal activity.

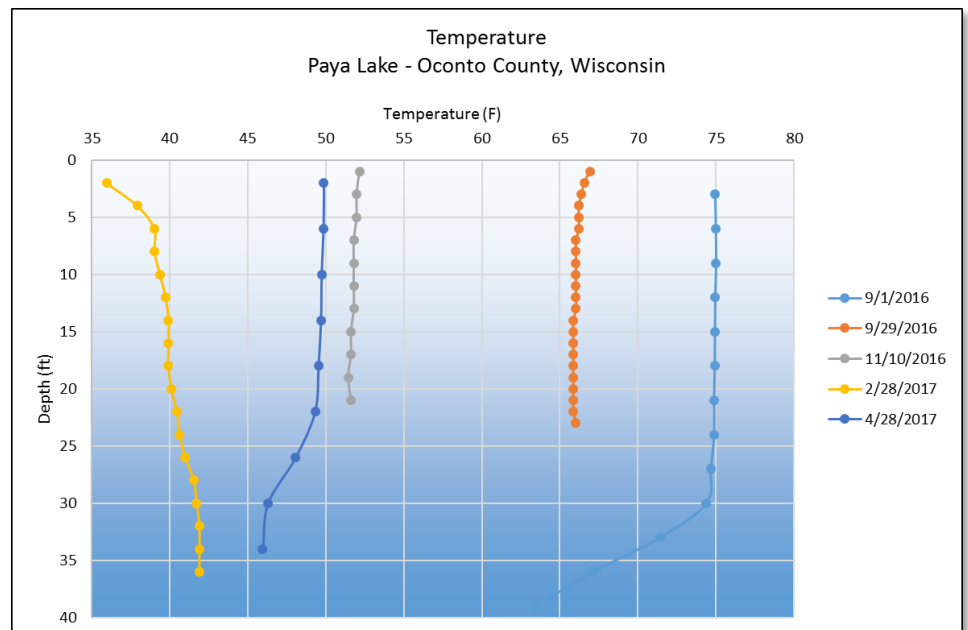
Lake water **temperature** has a significant impact on water chemistry, spatial distribution of fish, microbial growth and oxygen content.

- ◆ The temperature gradient in Paya Lake is relatively uniform most of the year, typical of a shallow, mixed lake.

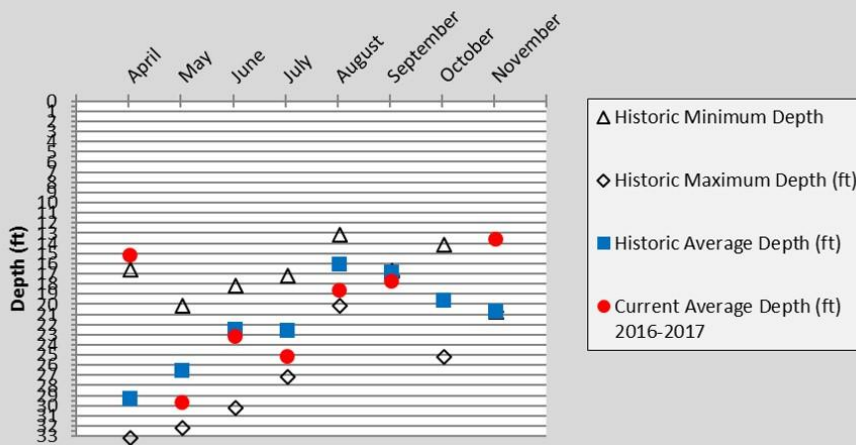
## Water Clarity

**Water clarity** is a measure of how deep light can penetrate (Secchi depth). Clarity is affected by water color, turbidity (suspended sediment), and algae. Water clarity helps determine where rooted aquatic plants can grow. It is typical for water clarity to vary throughout the year.

- The graph to the left shows water clarity measurements taken between April and November.
- During 2016-17, on average, the poorest water clarity in Paya Lake was in April and November (well below historic averages) and the best was in May. The long-term trend (based on July data) is similar to the short-term trend and appears stable.

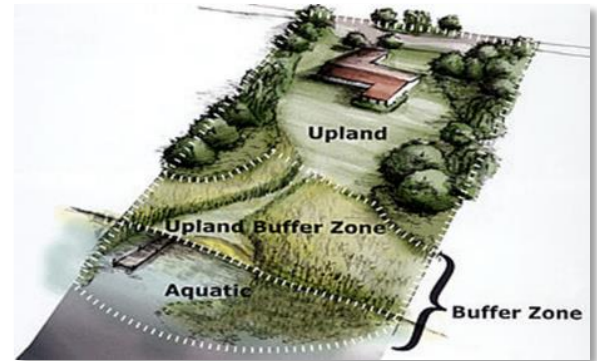
- ◆ Shorelands around Paya Lake were surveyed in September 2017. Much of Paya Lake's shoreland is healthy, but some stretches are in need of restoration.

Total lakefront footage	No. Riparian lots	Measured shoreland disturbance (feet)	Measured shoreland disturbance (%)
8,884	65	4,465	50%

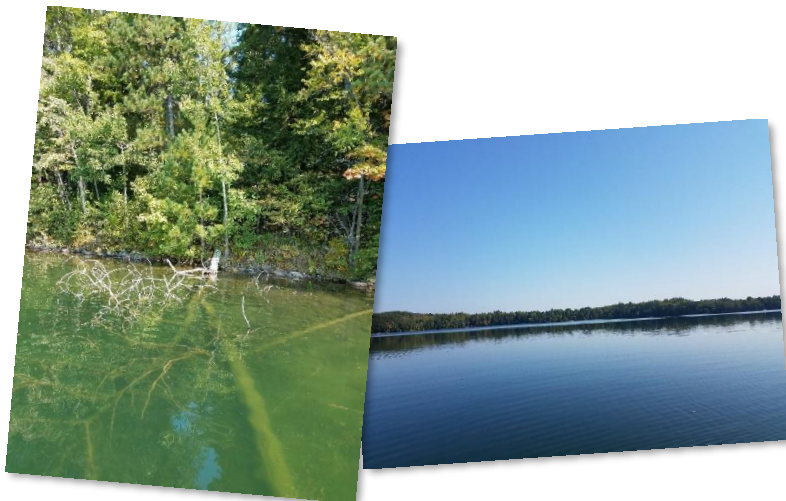
Modifications, Structures, Erosion	Measured Occurrence
Artificial Beach	140 ft
Rip Rap	745 ft
Sea Wall	140 ft
Impervious Surface	76 ft
Mowed Lawn	1,715 ft
Erosion	55 ft
Nonconforming Buildings	15
Piers	61
Coarse Woody Habitat	29 logs/mile
