# Oconto County Lakes Project

## MUNGER LAKE STUDY

### SUMMARY REPORT

2018

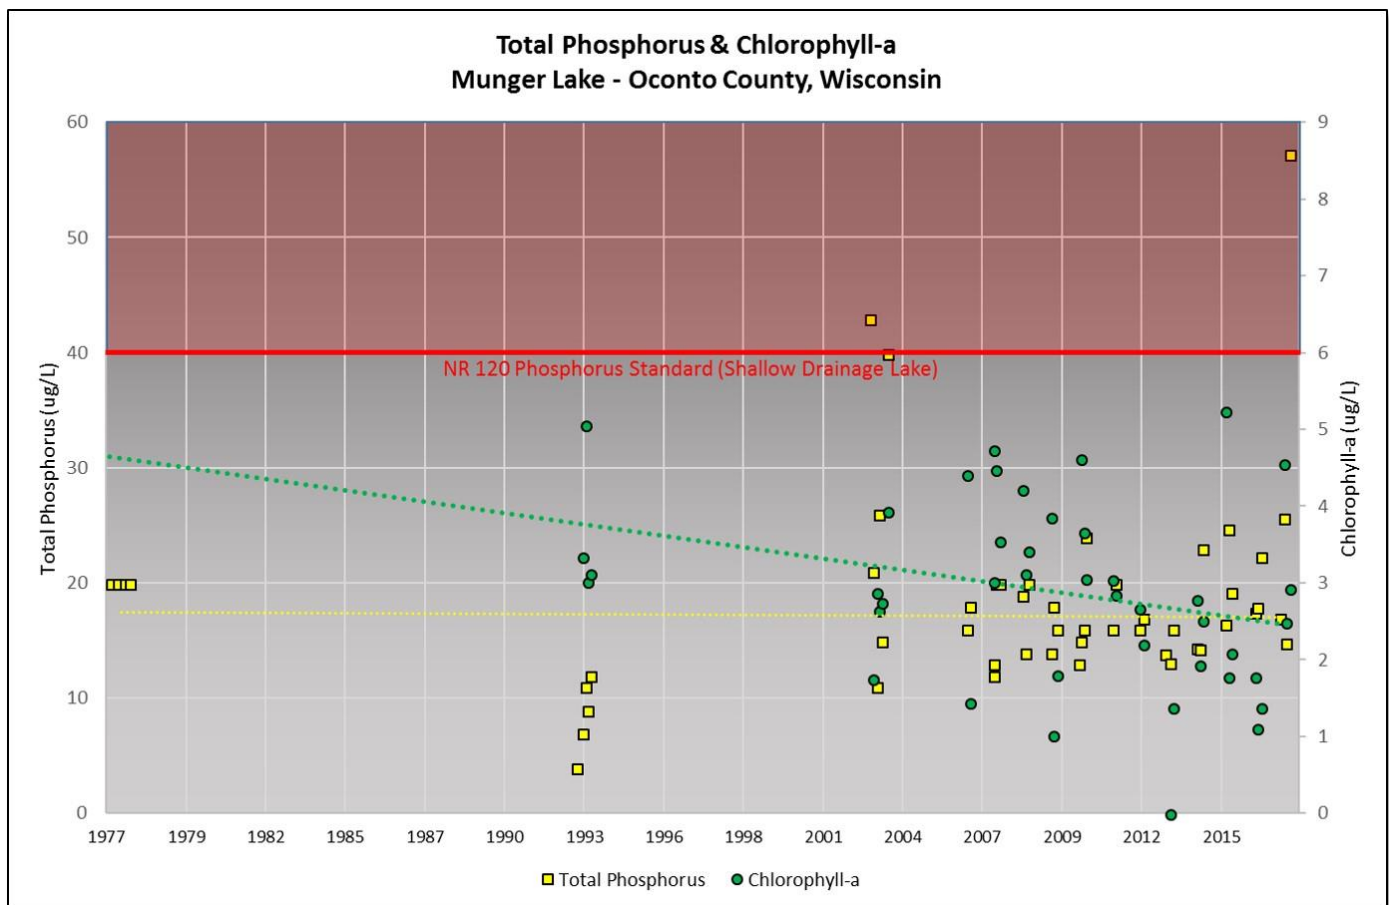
- ◆ Total Phosphorus was routinely **below** the Wisconsin State phosphorus standard of 40 ug/L for shallow drainage lakes during the two-year study. The 14-year trend is stable (based on July data).
- ◆ Inorganic nitrogen (0.02 mg/L) was below the threshold of 0.3 mg/L when algal blooms increase.
- ◆ Chlorophyll-a, which is an indirect measure of algae, remained below the threshold of 6 ug/L and shows a decreasing trend.

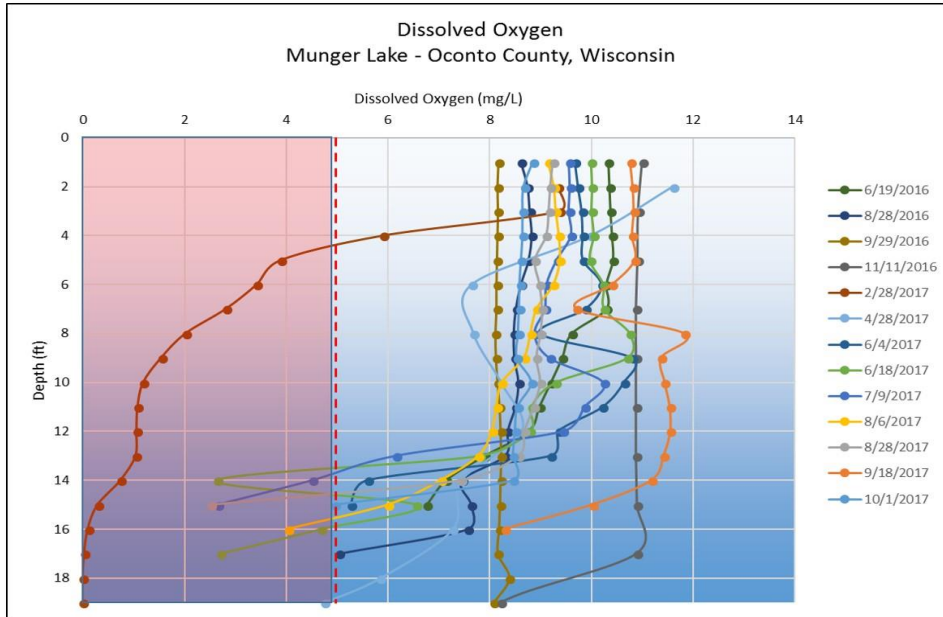
- During most of the year, sufficient oxygen is available in Munger Lake throughout the water column. Oxygen is depleted during the winter while the lake is ice covered, with only the upper 5 feet having enough to support fish.
- Bumps in dissolved oxygen concentrations at 7-10 feet suggest mild algal activity.

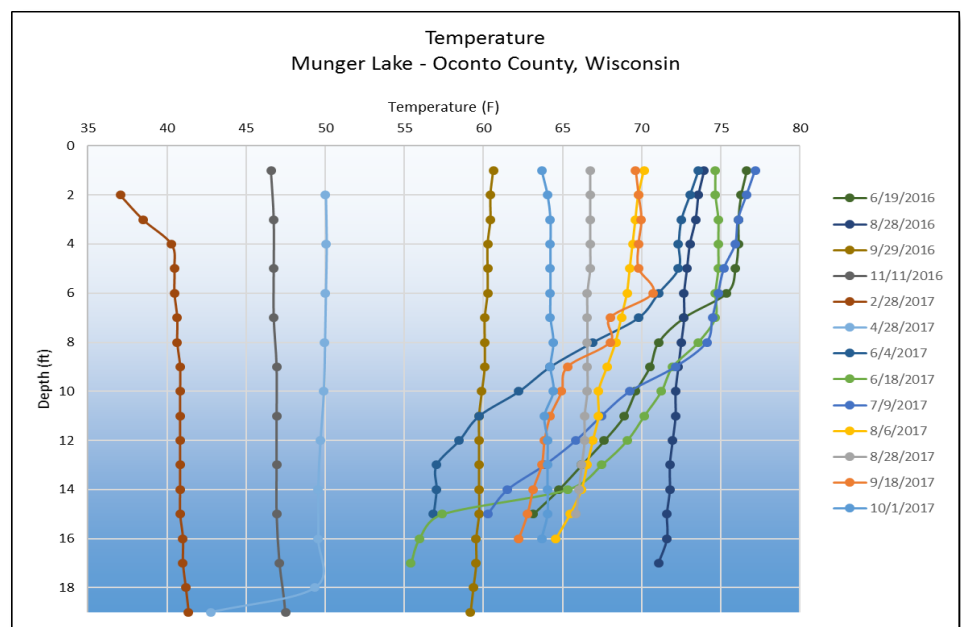
- The temperature gradient in Munger Lake is relatively uniform most of the year, typical of a shallow, mixed lake.

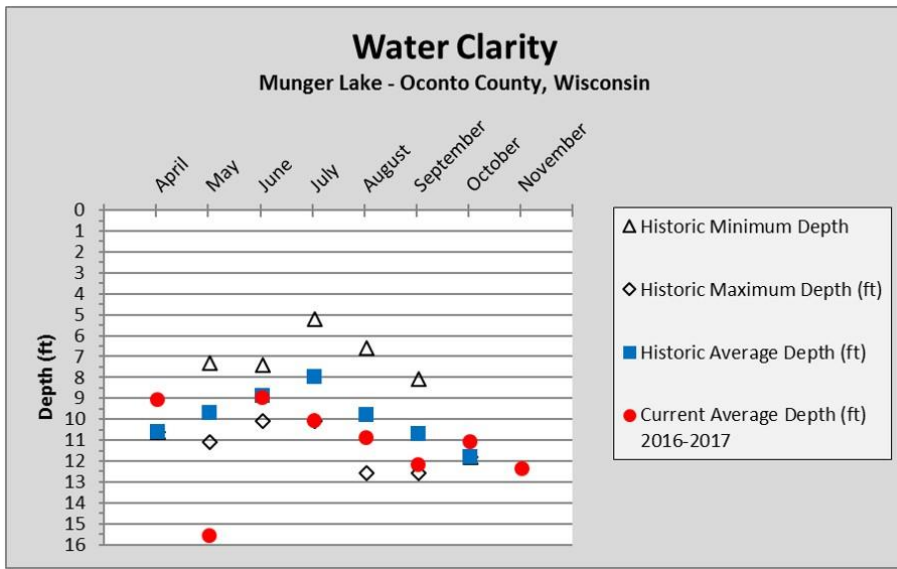
- The graph to the left shows water clarity measurements taken between April and November.
- During 2016-17, on average, the poorest water clarity in Munger Lake was in June and the best was in May. This is consistent with previous observations and demonstrates a slightly increasing trend over the long term (based on July data).

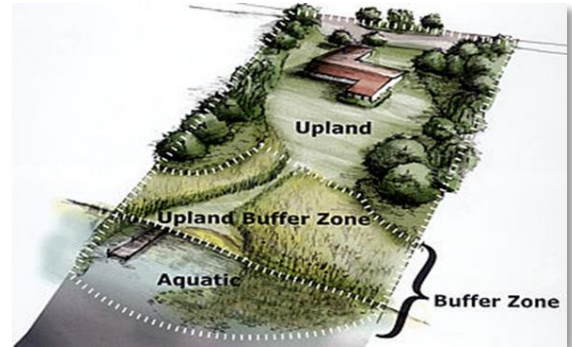
- Shorelands around Munger Lake were surveyed in July 2017. Much of the lake's shoreland is healthy, but many stretches are in need of restoration.

Total lakefront footage	No. Riparian lots	Measured shoreland disturbance (feet)	Measured shoreland disturbance (%)
11,188	73	3,916	35%
