Oconto County Lakes Project

MAIDEN LAKE STUDY SUMMARY REPORT

2018

*University of Wisconsin-Stevens Point and
Oconto County Staff and Citizens*

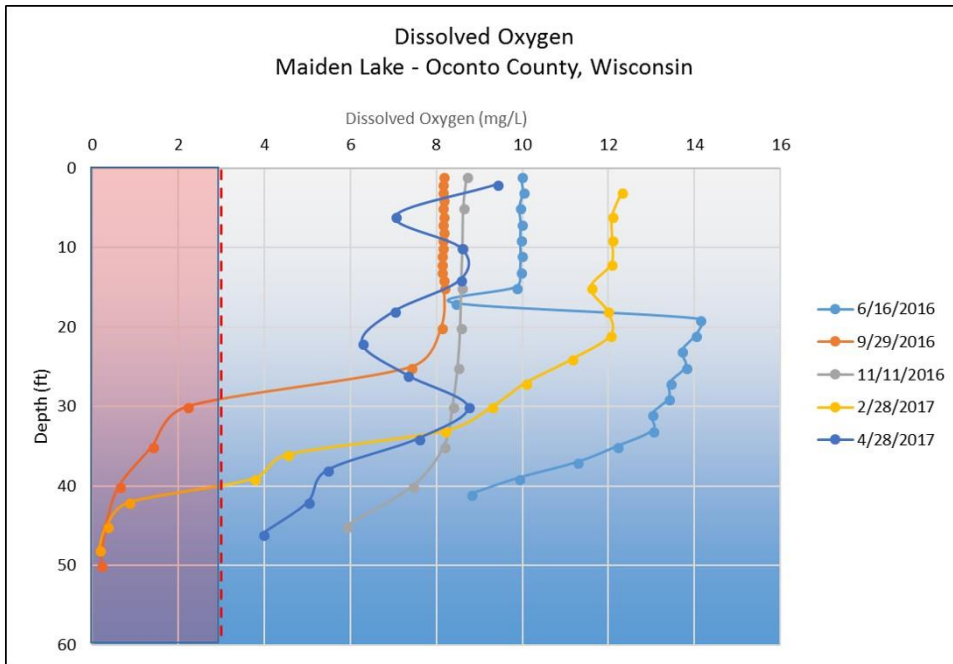
- ◆ Sufficient oxygen is available in the top 30 feet of the water column in Maiden Lake throughout the year.
- ◆ Bumps in dissolved oxygen concentrations at 15-30 feet suggest mild algal activity.

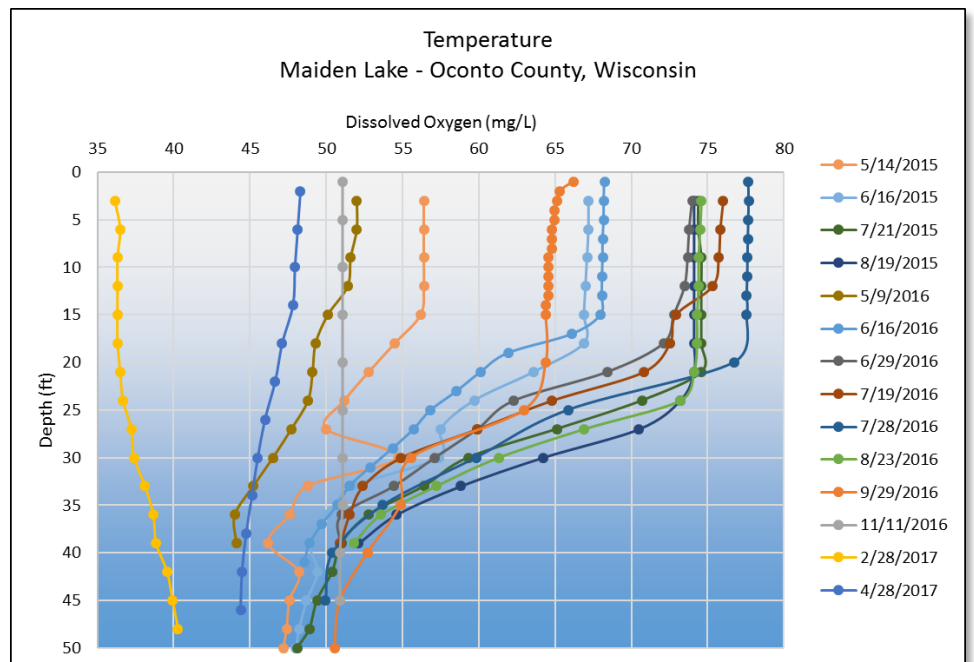
- ◆ The temperature gradient in Maiden Lake exhibits a clear thermocline between 20 and 30 feet during the growing season that separates warmer oxygen-rich water at the top from colder oxygen-poor water below.

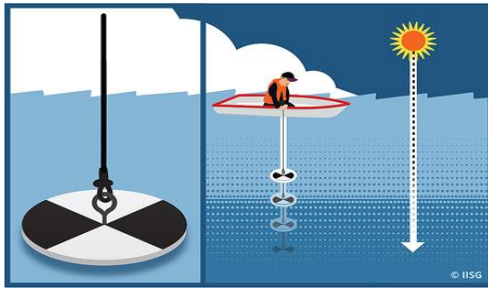
- The graph to the left shows water clarity measurements taken between April and November.
- During 2016-17, on average, the poorest water clarity in Maiden Lake was in July and the best was in May. This is consistent with previous observations and demonstrates an increasing depth trend over the long term (based on July data).

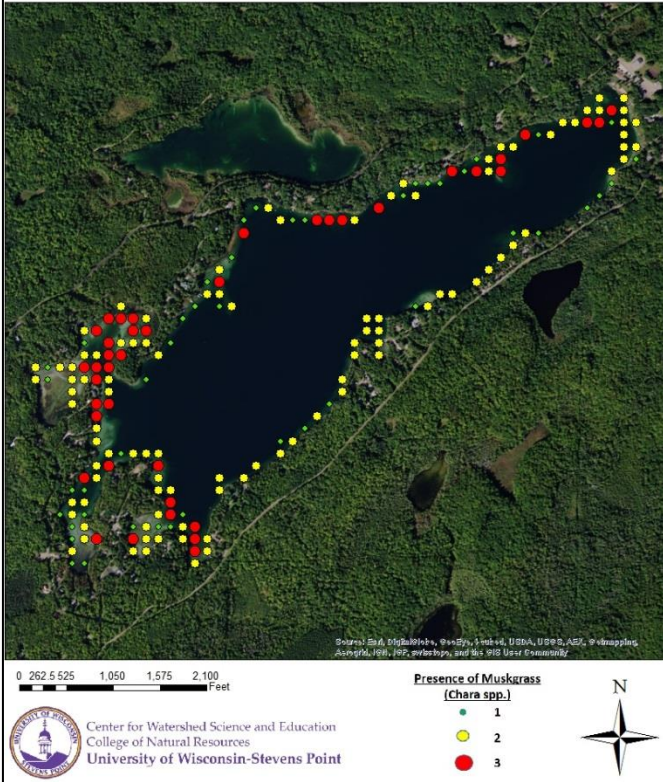
Maiden Lake Aquatic Plant Survey 2016:
Muskgrass (*Chara* spp.)

Chara is a type of macro algae that grows attached to muddy lake bottoms and has a musky odor. Muskgrass, as it is known, filters the lake water and is helpful in preventing the establishment of invasive species.

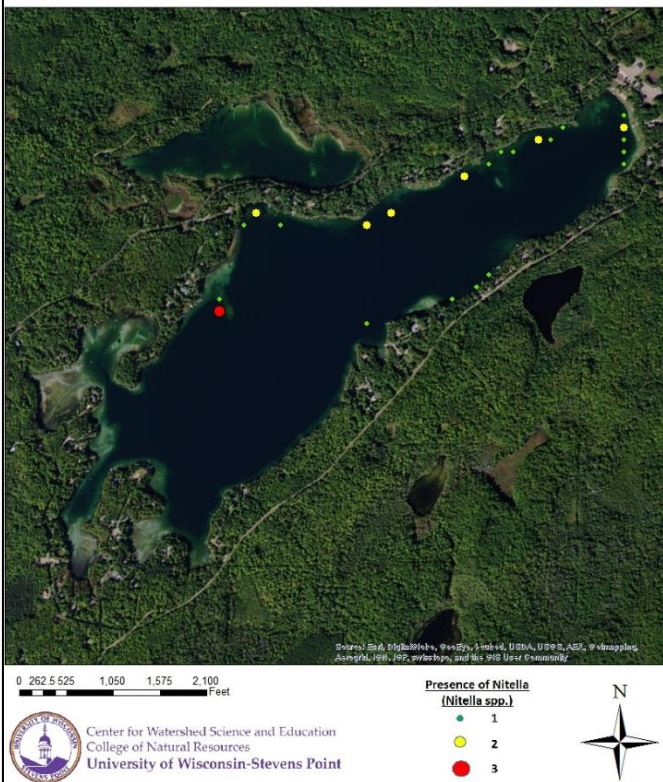
Maiden Lake Aquatic Plant Survey 2016:
Nitella (*Nitella* spp.)

Like chara, **nitella** is a macroalgae that similarly grows along lake bottoms and can benefit a lake by filtering nutrients from water and preventing establishment of invasive species.

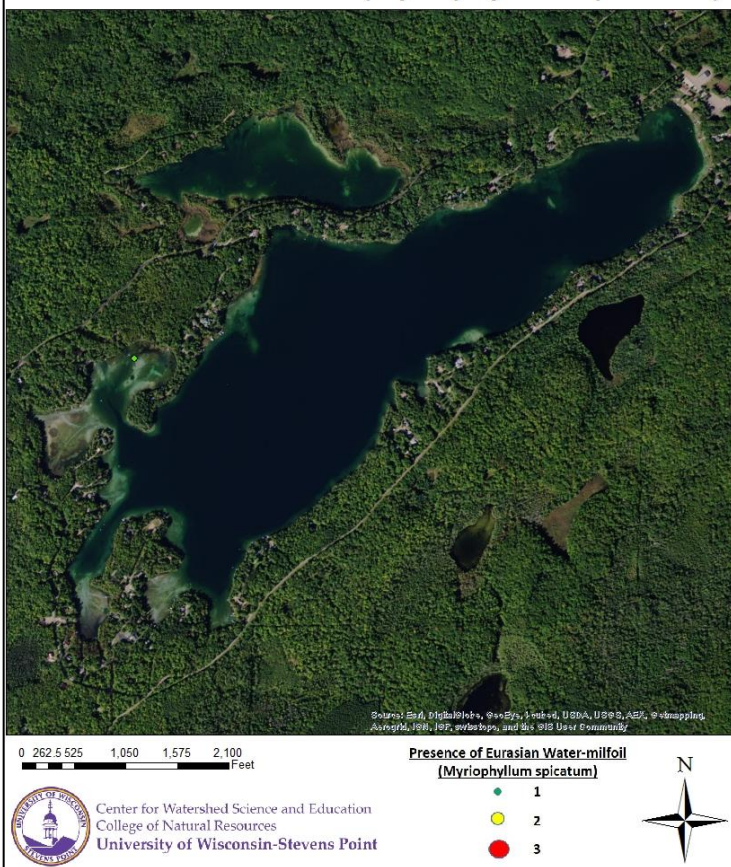
Maiden Lake Aquatic Plant Survey 2016: Eurasian water-milfoil (*Myriophyllum spicatum*)

Eurasian water-milfoil was observed in one location during the July 2016 aquatic plant survey.

Eurasian water-milfoil is one of the most common invasive aquatic plants in Wisconsin. It can form dense mats that choke out native plants and inhibit navigation. New plants can grow from stem fragments that root on contact with the substrate.
