# Oconto County Lakes Project

## LEIGH FLOWAGE STUDY

### SUMMARY REPORT

2018

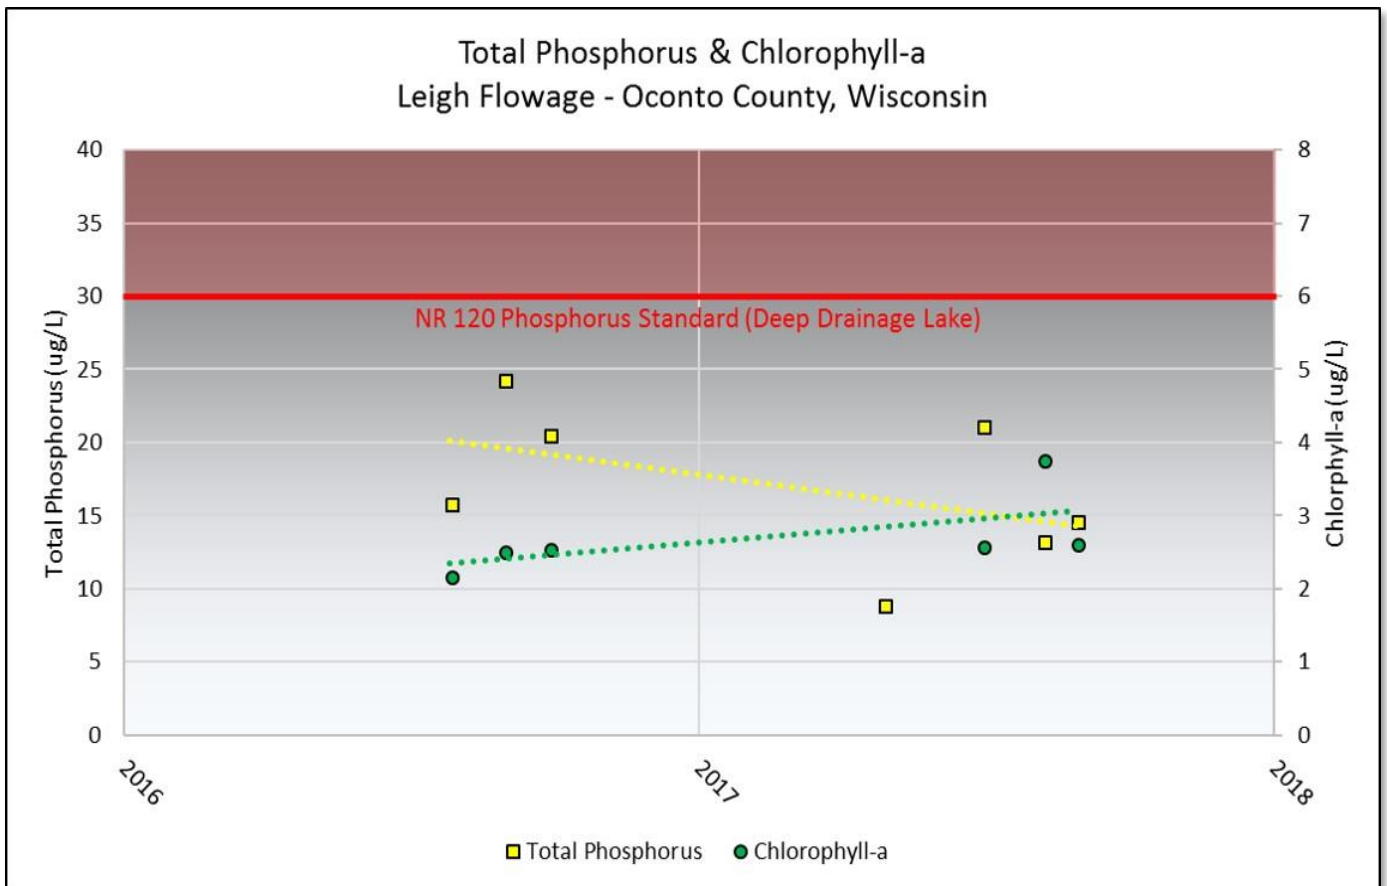
- ◆ Total Phosphorus remained well **below** the Wisconsin state phosphorus standard of 30 ug/L for deep drainage lakes during the two-year study. The 2-year trend is decreasing.
- ◆ Inorganic nitrogen (0.07 mg/L) remained below the threshold of 0.3 mg/L when algal blooms increase.
- ◆ Chlorophyll-a, an indirect measure of algae, remained well below the threshold of 6 ug/L, but shows an increasing trend.

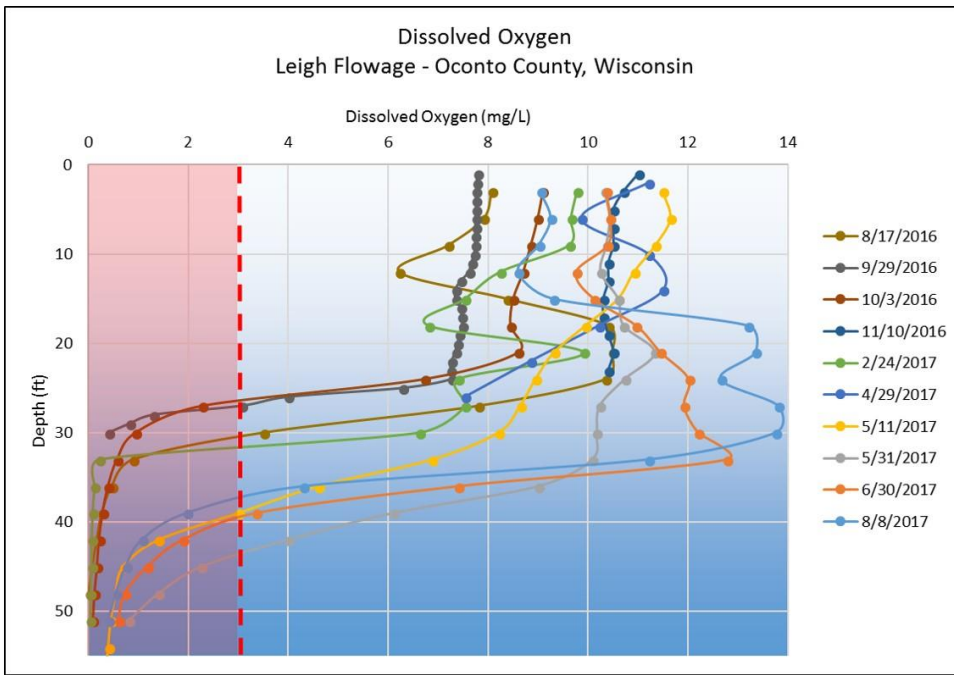
- ◆ Sufficient oxygen is available in the top 25 feet of the water column in Leigh Flowage throughout the year.
- ◆ Bumps in dissolved oxygen concentrations at 15-30 feet suggest mild algal activity.

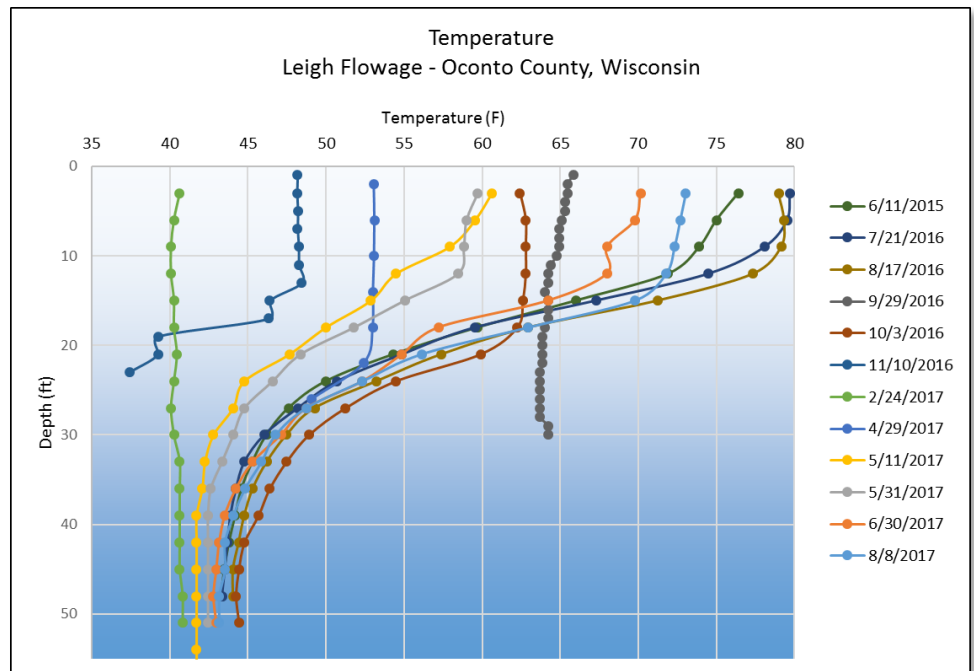
- ◆ The temperature gradient in Leigh Flowage exhibits a clear thermocline between 15 and 25 feet during the growing season that separates warmer oxygen-rich water at the top from colder oxygen-poor water below.

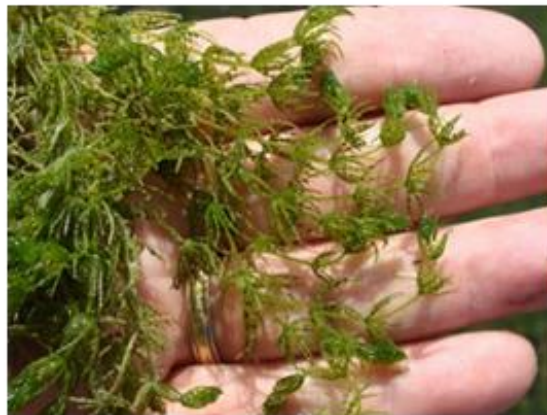
**Chara** is a type of macro algae that grows attached to muddy lake bottoms and has a musky odor. Muskgrass, as it is known, filters the lake water and is helpful in preventing the establishment of invasive species.

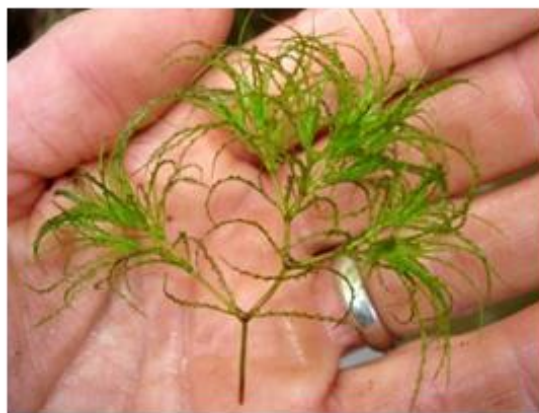
**Slender naiad** has glossy, finely toothed leaves appearing as whorls near the end of stems. Also known as the water-nymph, the whole plant is eaten by waterfowl and provides shelter for small fish and insects.

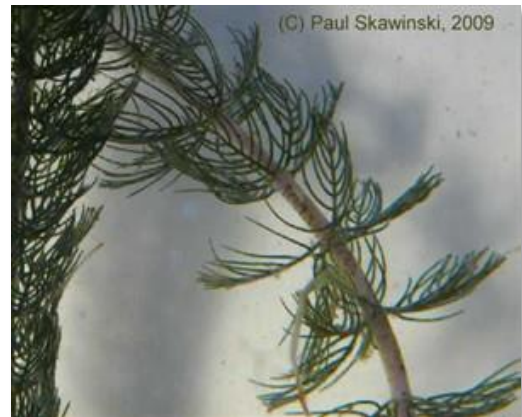
Northern water-milfoil is important forage and cover for aquatic animals and an important food source for waterfowl.

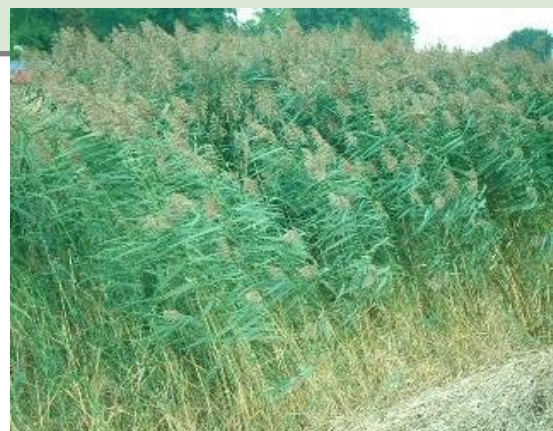
**Phragmites**, a restricted species in Wisconsin, invades moist areas and can alter hydrology and choke out native species and wildlife habitat.
