Big Bass Lake

Eastern Marathon County Lake Study

Final Study Results 2013

University of Wisconsin-Stevens Point
and
Marathon County Staff and Citizens

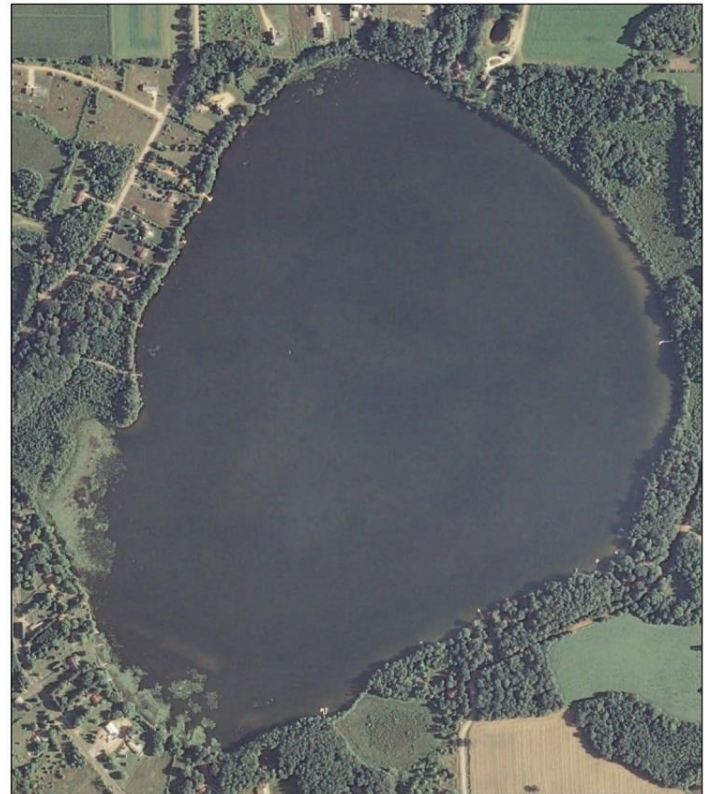
Big Bass Lake, Marathon Co.

Water Flow

- ◆ Big Bass Lake is a seepage lake with most of the water entering the lake from groundwater.
- ◆ Surface water runoff and direct precipitation also contribute water, but to lesser extents.
- ◆ Water exits Big Bass Lake through groundwater.

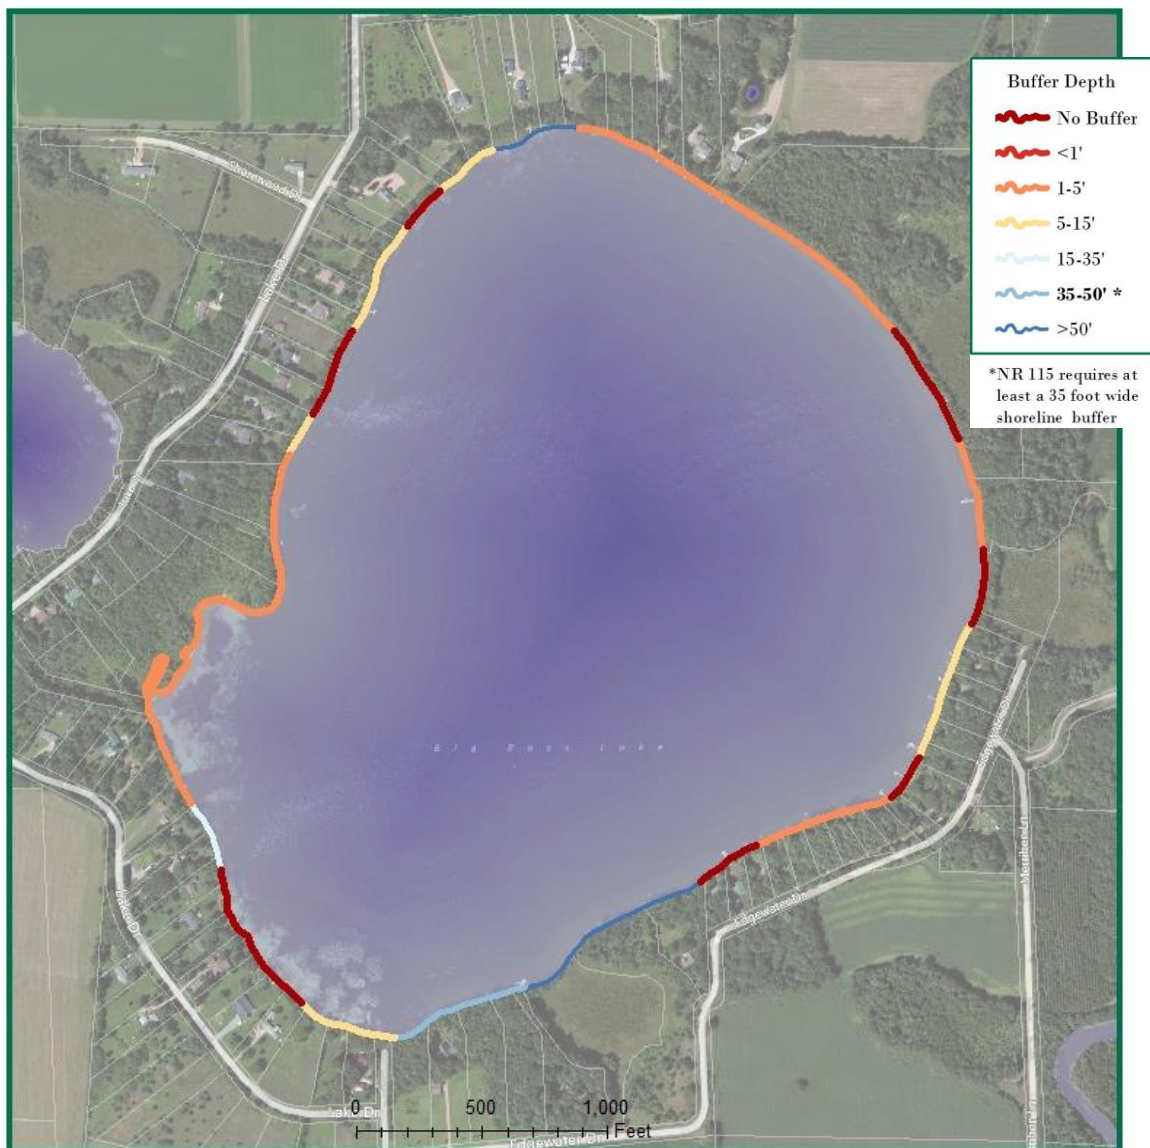
Big Bass Lake – Shoreland Vegetation

The map below shows how far the 0.5 to 3 foot tall vegetation exists landward from the edge of Big Bass Lake. A greater vegetative buffer produces more habitat and better water quality. There are many areas around Big Bass Lake with minimal or no vegetative buffer. Restoring these areas would provide habitat and improve water quality.

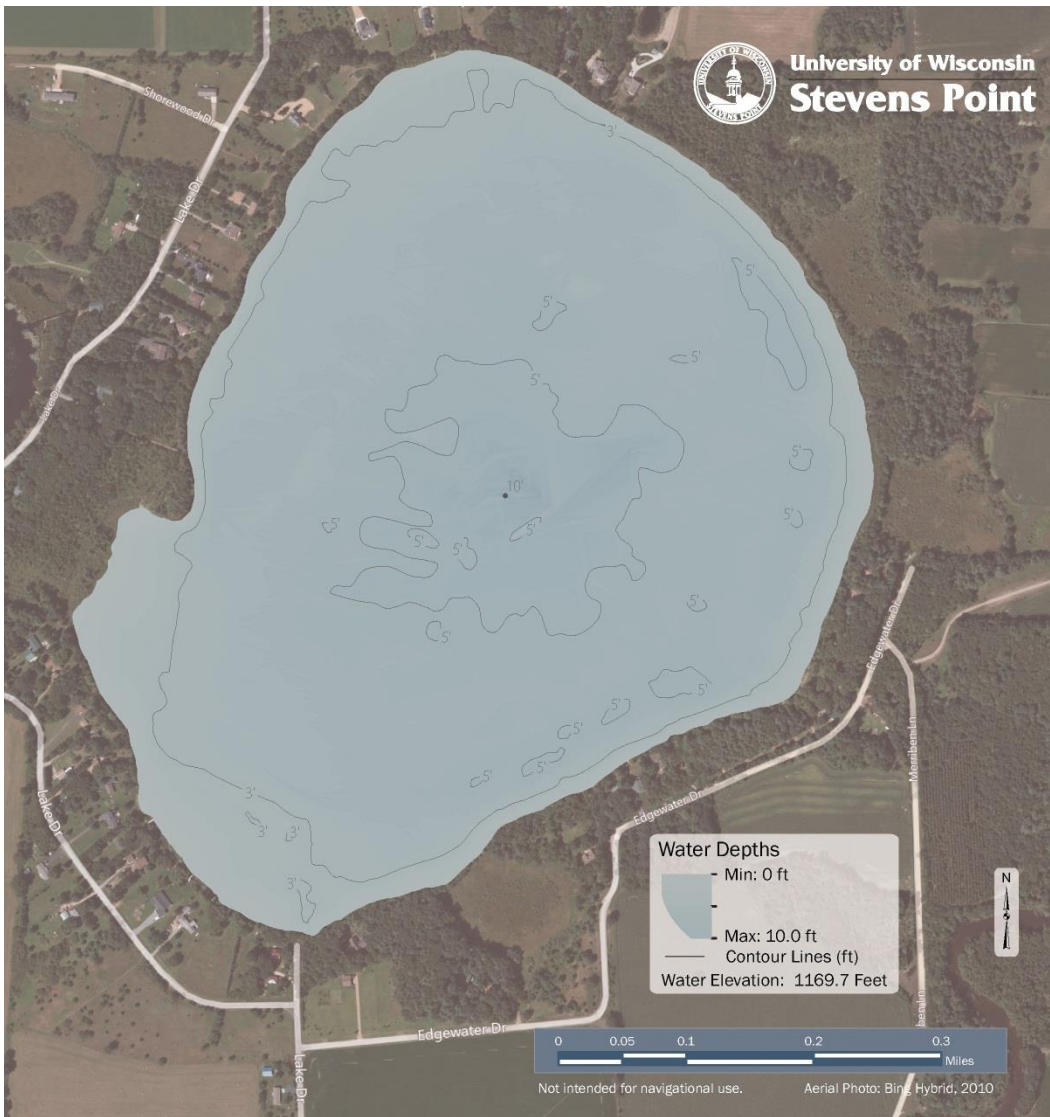
BIG BASS LAKE BATHYMETRIC MAP

GPS and Sonar Survey
 May, 2012

LAKE AREA	180 Acres
Under 3 Feet	31.6 Acres (17.6%)
Over 20 Feet	0 Acres (0%)

VOLUME	686 Acre-feet
SHORELINE	2.1 Miles
MAX DEPTH	10 Feet

Big Bass Lake's shape and depth play major roles in determining:

- ◆ Where aquatic plants can and cannot grow
- ◆ Types of fish and where they live
- ◆ How fast water in the lake warms up and cools down
- ◆ The water quality of the lake
- ◆ Abundance of habitat for species living in the water and on the land

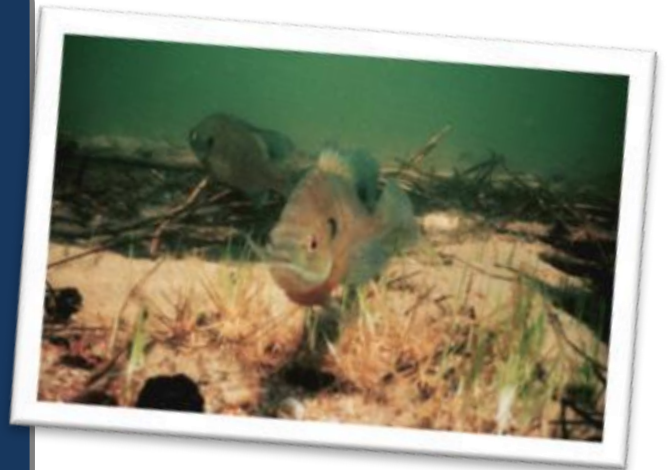
Big Bass Lake – Fishery

- ◆ Big Bass Lake supports a warm water fish community.
- ◆ In 2012, nine fish species were identified out of the seventeen total species that have been recorded in Wisconsin DNR surveys dating back to 1955.
- ◆ Yellow bullhead and Iowa darter were newly documented species in the 2012 survey.
- ◆ The presence of young bass and abundant sunfish indicates successful reproduction is occurring in Big Bass Lake.
- ◆ Conclusions cannot be made about walleye and northern pike reproductive success without additional sampling efforts.

Species occurrence in Big Bass Lake in 2012 and historical Wisconsin DNR records

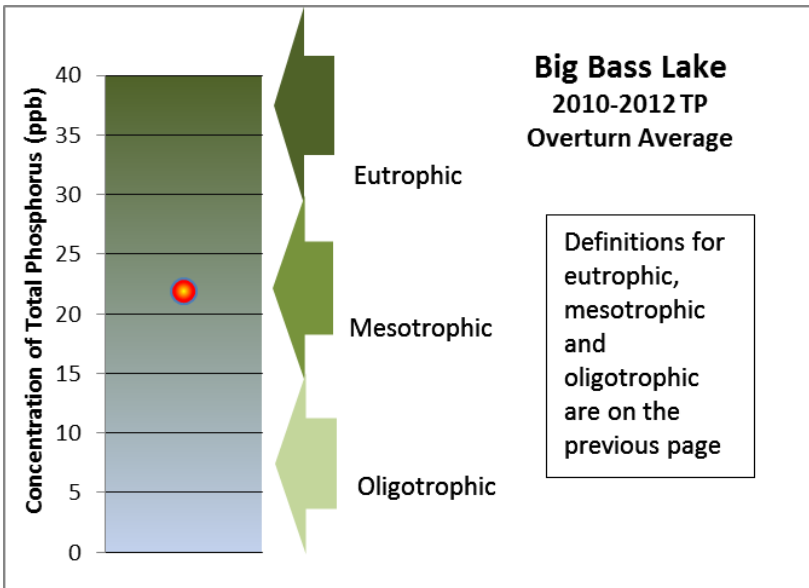
- Total phosphorus levels measured when Big Bass Lake was well-mixed (overturn) are displayed in the graph to the left.
- Overturn sampling during the 2010-2012 monitoring period indicate that Big Bass Lake is a mesotrophic lake with an average concentration of total phosphorus in the mid-range.

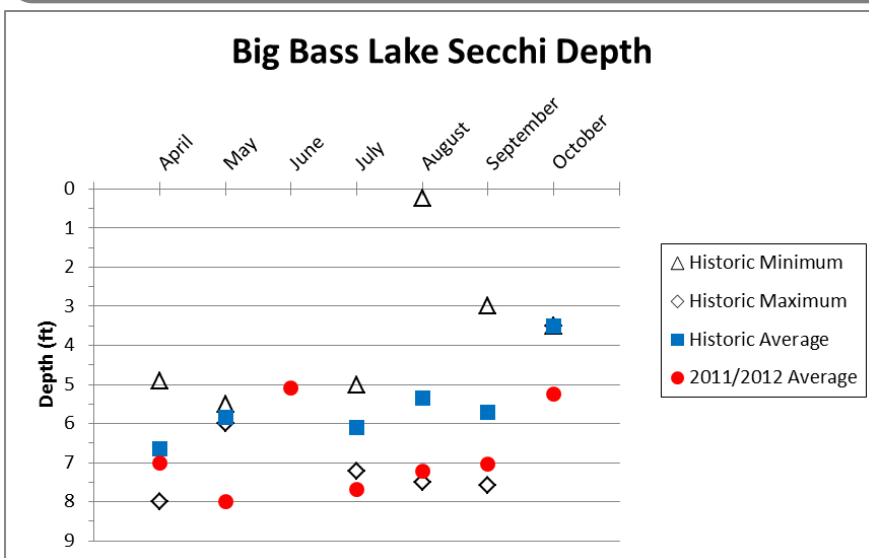
Water clarity is a measure of how deeply light can penetrate (Secchi depth). Clarity is affected by water color, turbidity (suspended sediment), and algae. Water clarity helps determine where rooted aquatic plants can grow.

- The graph to the left shows water clarity data collected during the growing seasons in 2011 and 2012. It is typical for water clarity to vary throughout the year.
- The 2011/2012 average Secchi depth readings were slightly deeper than historic averages, suggesting a possible recent improvement in water clarity.

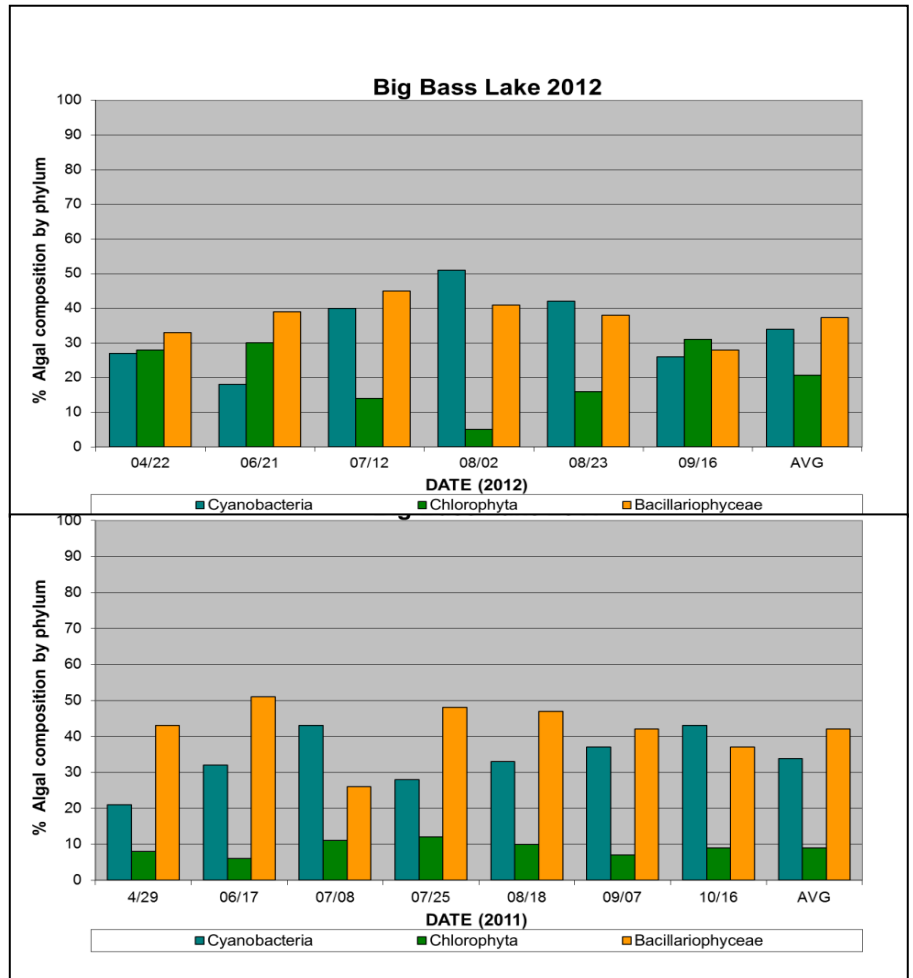
PERCENT ALGAL COMPOSITION FOR BIG BASS LAKE IN 2011 AND 2012

- The 2011 and 2012 algal communities were diverse and primarily dominated by diatoms.
- The algal data found during the study period may indicate one of two possible shifts in water quality. The first possibility, supported by the lake’s moderate total phosphorus value, is of a late-stage oligotrophic lake that is transitioning into a mildly mesotrophic lake. The second possibility, supported by the increase in water clarity, is that this is a moderately mesotrophic lake that is seeing some improvement in water quality conditions.
- Big Bass Lake displays many indicators of good or improving water quality. Two small but troubling indicators were identified that deserve continued attention: an increase in blue-green algae and a small green algae community of relatively few species.

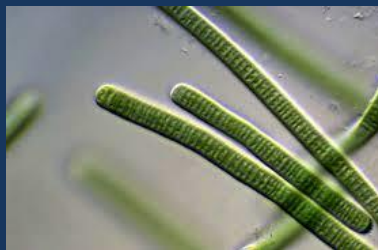
Blue-green algae have the widest tolerance range for temperatures and nutrient concentrations. A few varieties of blue-greens can produce toxins that are potentially harmful to livestock, pets and humans.

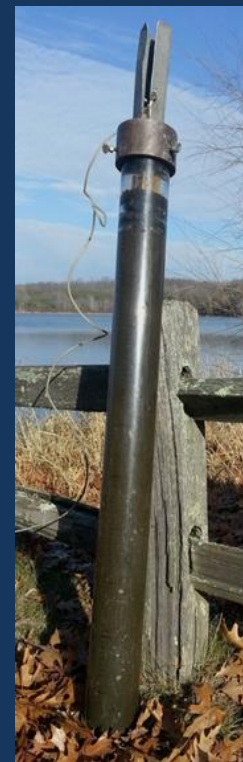
- ◆ Analysis of Big Bass Lake’s sediment core suggests increased disturbance in the lake basin since the time of European land clearing.
- ◆ Over this time period, there have been increases in nutrients to the lake, including phosphorus, and substantial habitat changes.
- ◆ Elevated ragweed pollen counts found deeper in the core probably reflect early logging in the area; the peak of ragweed higher in the core indicates widespread transition to farming near the turn of the 20th century.
- ◆ Diatom species communities and sediment properties reflect an increase in phosphorus, aquatic plants and filamentous algae in the top of the sediment core.
- ◆ Properties at the top of the sediment core indicate that some shoreline stabilization has occurred in recent years.

This sediment core was collected from Big Bass Lake. The darker layers indicate organic-rich sediments often due to increased growth of aquatic plants and/or soil erosion. Additional analysis of these layers can help to confirm the source(s).
