Aquatic Plant Management Plan for Lower Spring Lake 2018

Jefferson County
Land and Water Conservation Department

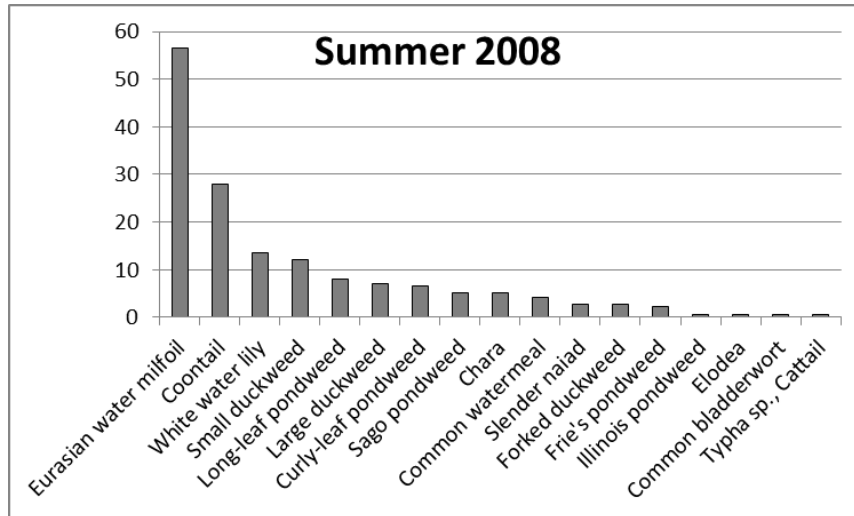
Chart 5. Frequency of Occurrence of Plants in Lower Spring Lake, 2008

The frequency of occurrence for a plant species is the number of times a species is observed, divided by the total number of sampling points contained within the area

shallower than the maximum depth of plants in a lake. The frequency of occurrence is expressed as a percentage and the results from the summer 2008 and 2017 surveys are displayed in Chart 5 and 6. The frequency of occurrence does not factor in plant species that were visually noted in the survey and not sampled with the rake.

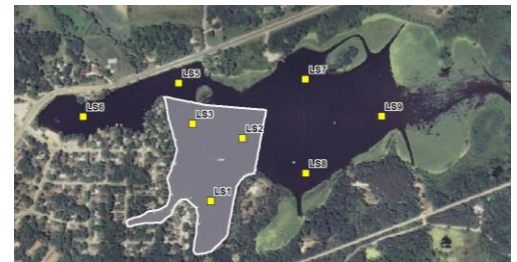
2010 Treatment for Eurasian Water Milfoil

- May 4, 2010, whole-lake treatment
- 25 acres (10 acres adjacent to riparian lots, 15 acres in middle of lake)
- Liquid 2, 4-D
- Target application concentration of 0.33 mg/l ae

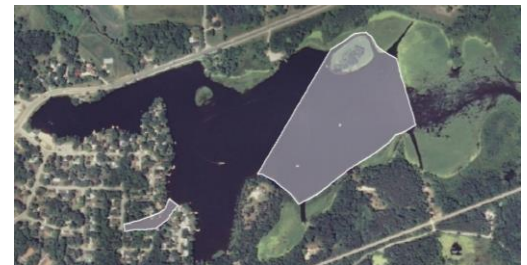
2012 Treatment for Eurasian Water Milfoil

- April 11, 2012, whole-lake treatment
- Liquid 2, 4-D
- 27.3 acres on east side of lake; target application concentration of 1 mg/l ae
- 1.1 acres in finger bay; target application concentration of 0.5 mg/l ae

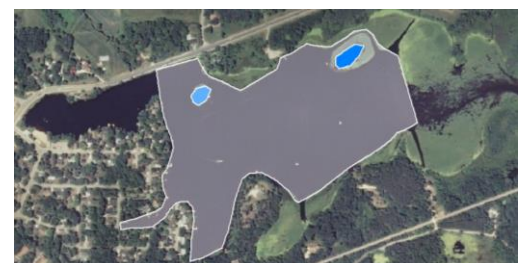
2012 Treatment for Curly-Leaf Pondweed

- April 11, 2012, whole-lake treatment
- Endothall (Aquathol K)
- 61 acres
- Target application concentration of 1 mg/l ai (0.71 mg/l ae)

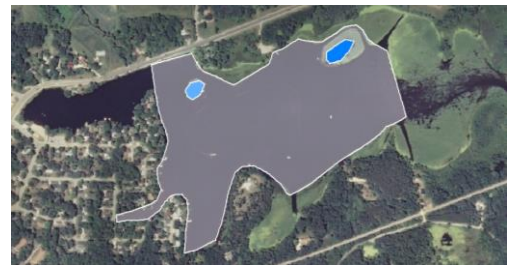
2013 Treatment for Curly-Leaf Pondweed

- May 13, 2013, whole-lake treatment
- Endothall (Aquathol K)
- 61 acres (chemical placed in entire lake except for northwest finger)
- Target application concentration of 1 mg/l ai (0.71 mg/l ae)

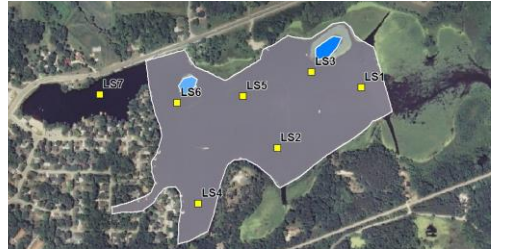
2014 Treatment for Eurasian Water Milfoil

- May 19, 2014, whole lake treatment
- Liquid 2, 4-D applied
- 66 acres
- Target application concentration of 0.35 mg/l ae

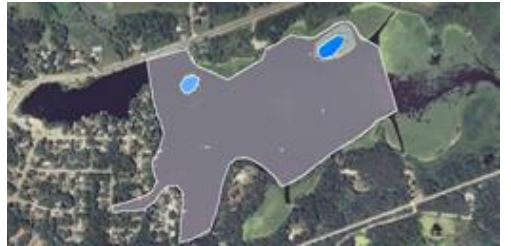
2015 Treatment for Curly-Leaf Pondweed

- May 12, 2015, whole lake treatment
- Endothall (Aquathol K) applied
- 61 acres
- Target application concentration of 1 mg/l ai (0.71 mg/l ae)

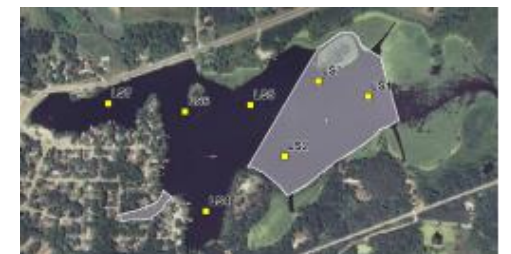
2017 Treatment for Eurasian Water Milfoil

- May 10, 2017 whole lake treatment
- Liquid 2, 4-D
- 27.3 acres on east side of lake with a target application concentration of 1.25 mg/l ae
- 1.1 acres in finger bay with a target application concentration of 0.5 mg/l ae

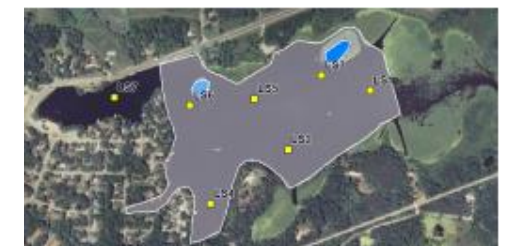
2017 Treatment for Curly-Leaf Pondweed

- May 10, 2017, whole lake treatment
- Endothall was applied
- 61 acres
- Target application concentration of 1 mg/l ai (0.71 mg/l ae)
