Menomonee River Fish Passage

Identifying Stream Passage Impediments and
Opportunities to Address Aquatic Habitat
Fragmentation in the Menomonee River Watershed

Milwaukee Riverkeeper

August 30, 2013

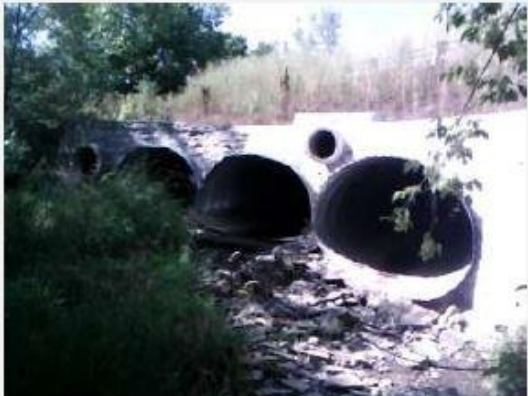
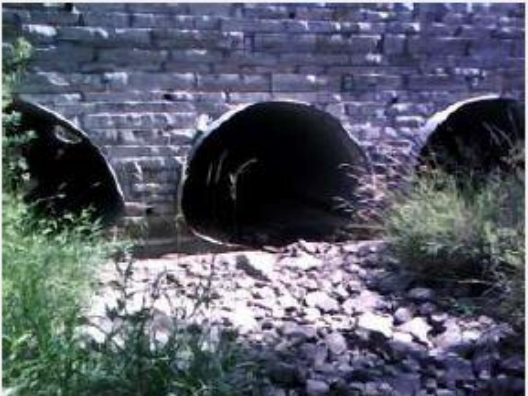
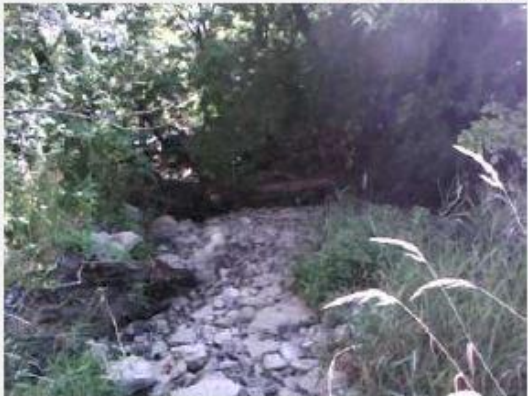
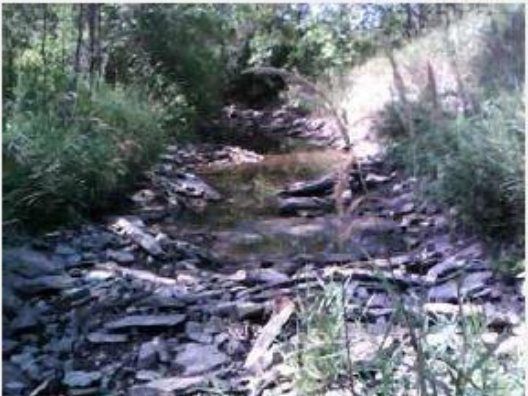
Figure 2: Stream Crossing Inventory Example Data Sheet (Butler Creek at Campbell Drive)

Notes
3 large metal corrugated culverts (perched), 3 small concrete stormwater outfalls. Rock blockage upstream of inlet.
