Menomonee River Fish Passage Barriers

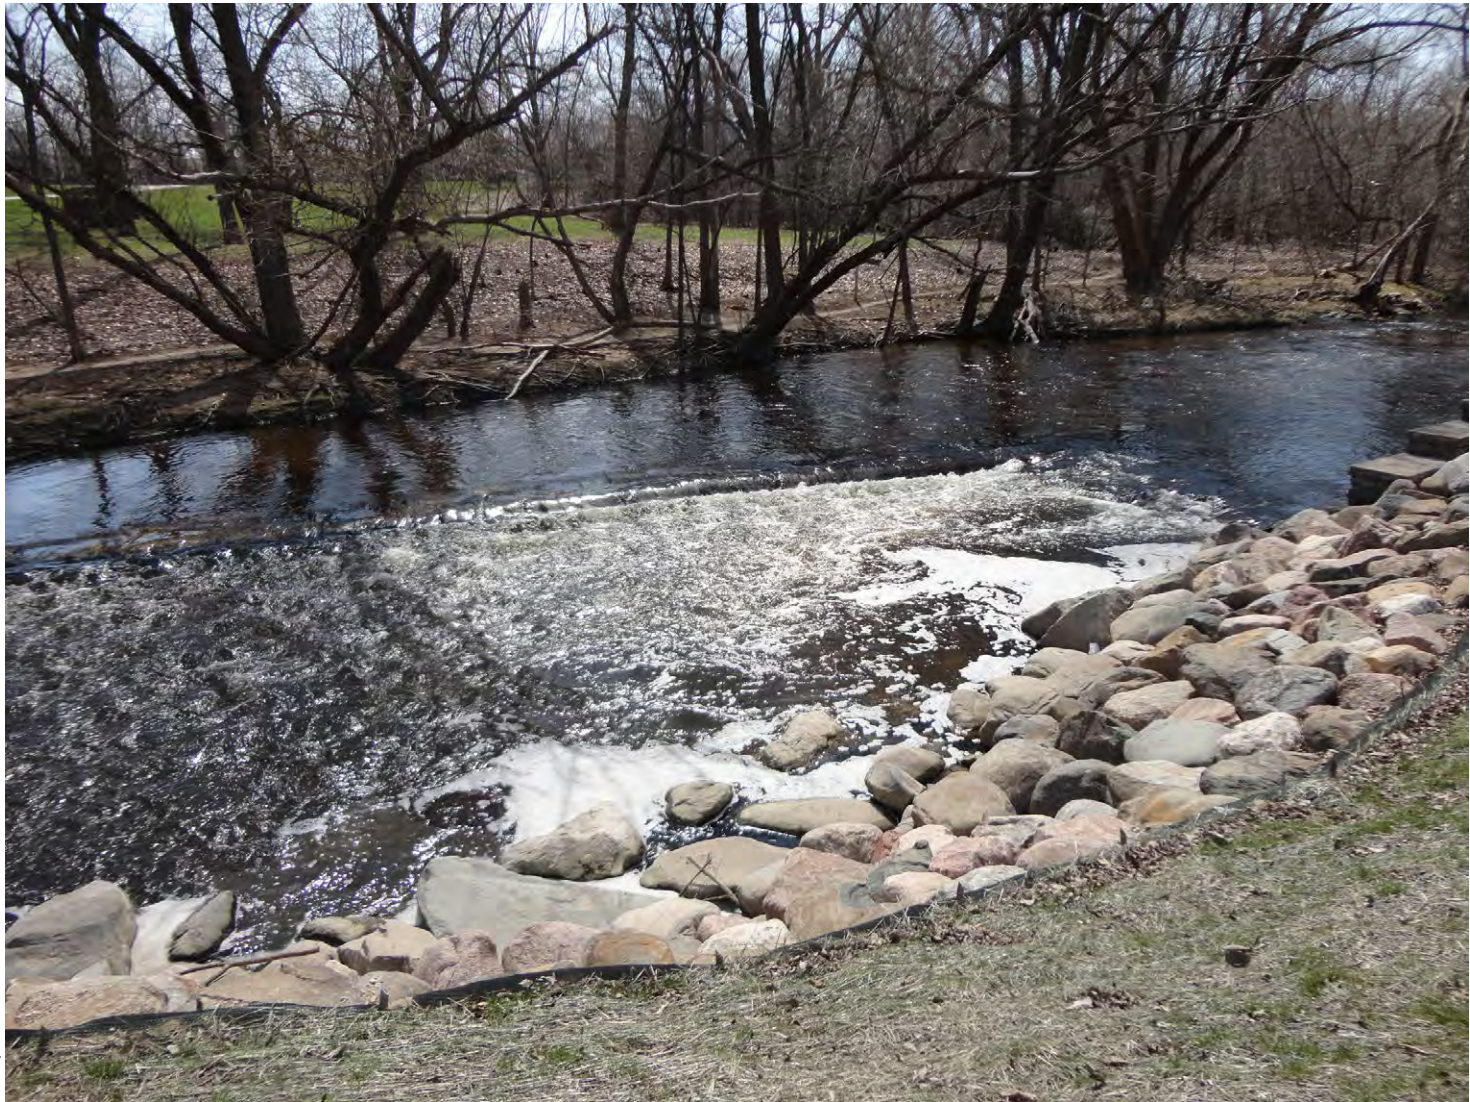
Crossing #1 - Sewer Crossing

Before.....

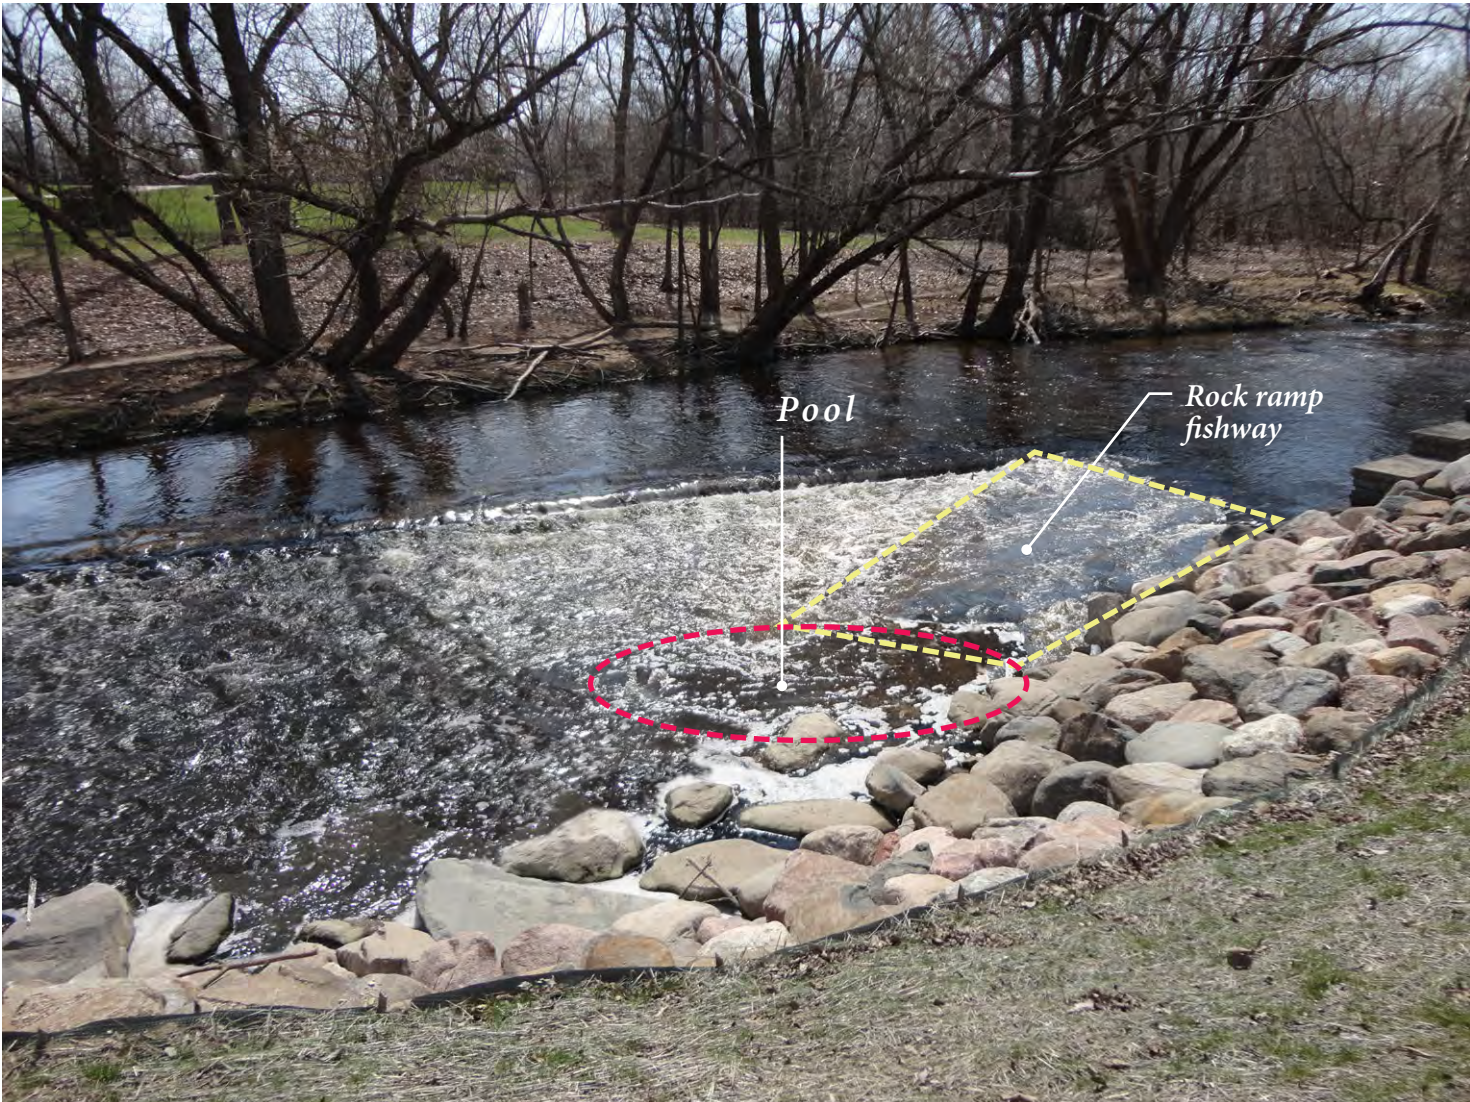
.....After

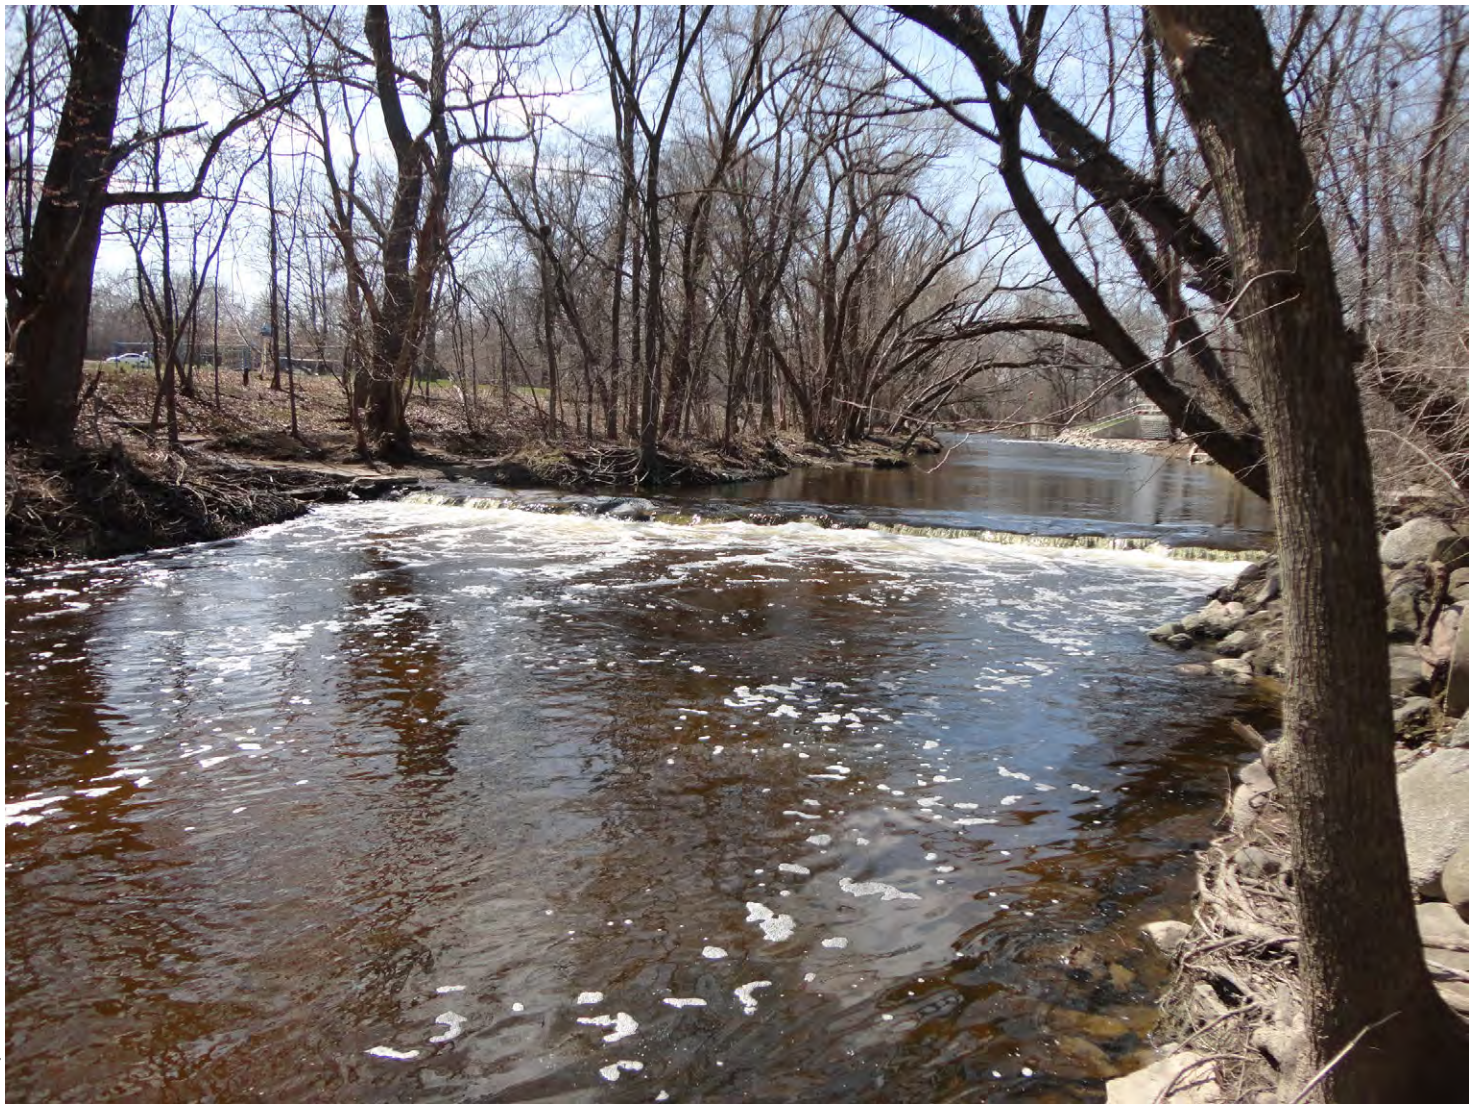
Crossing #2 - Stone Walking Path

Before.....

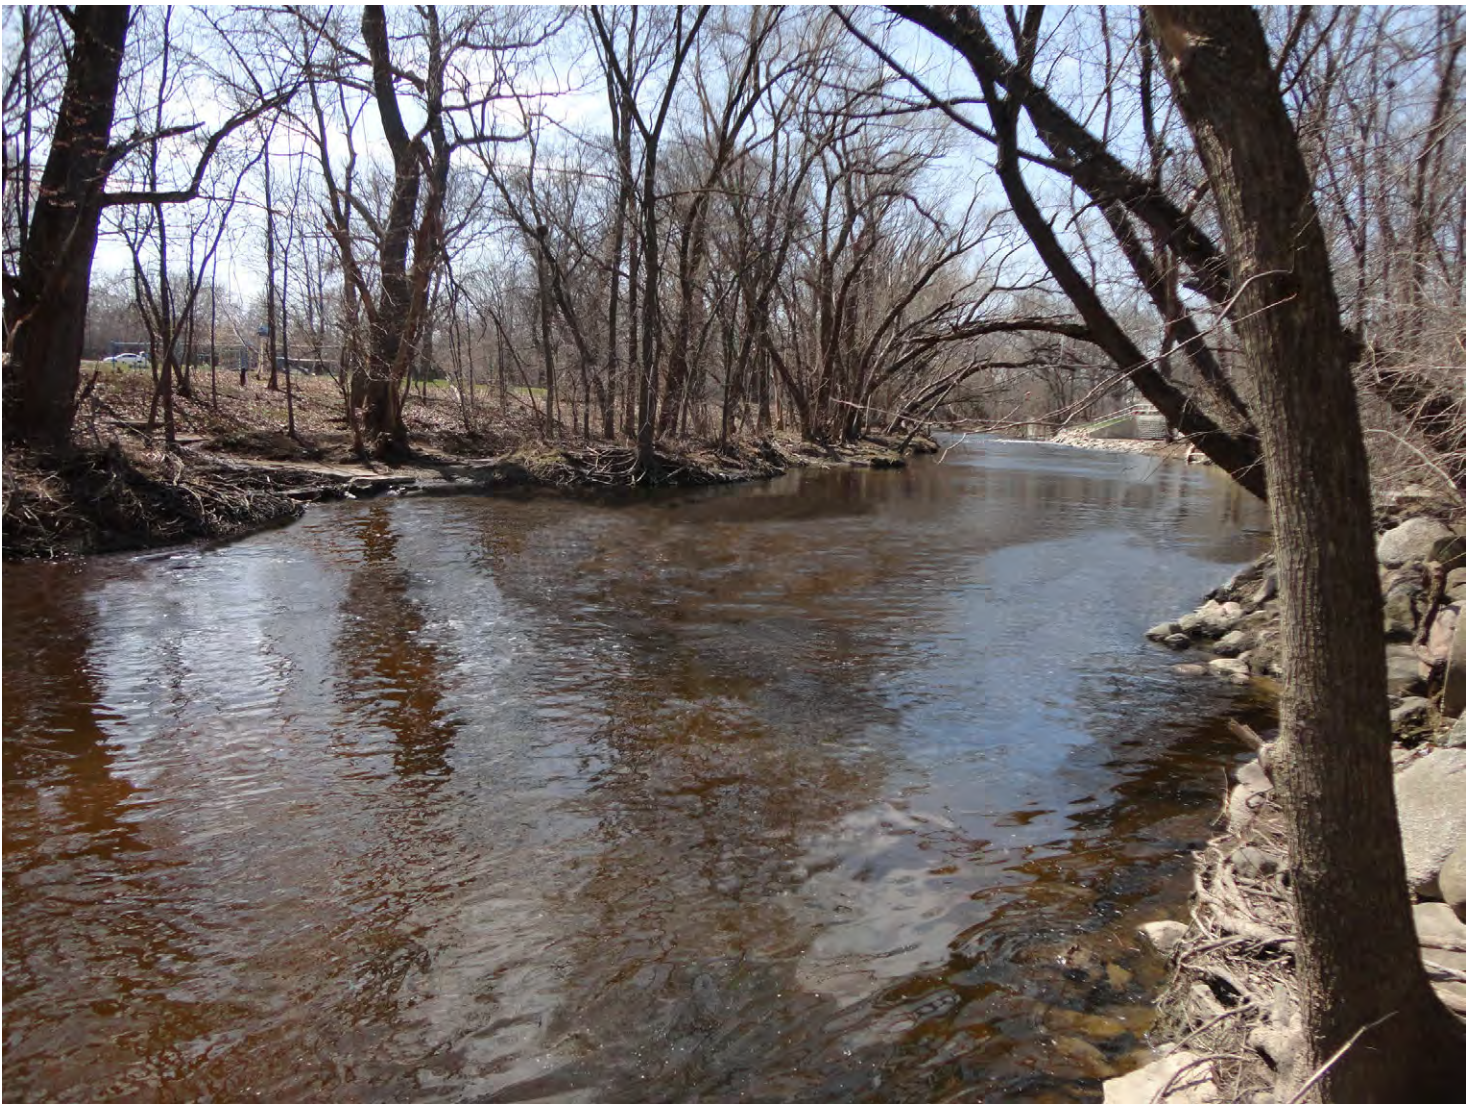
.....After

This image can also serve as an example of the removal of Crossing #5 – Old Stone Road.

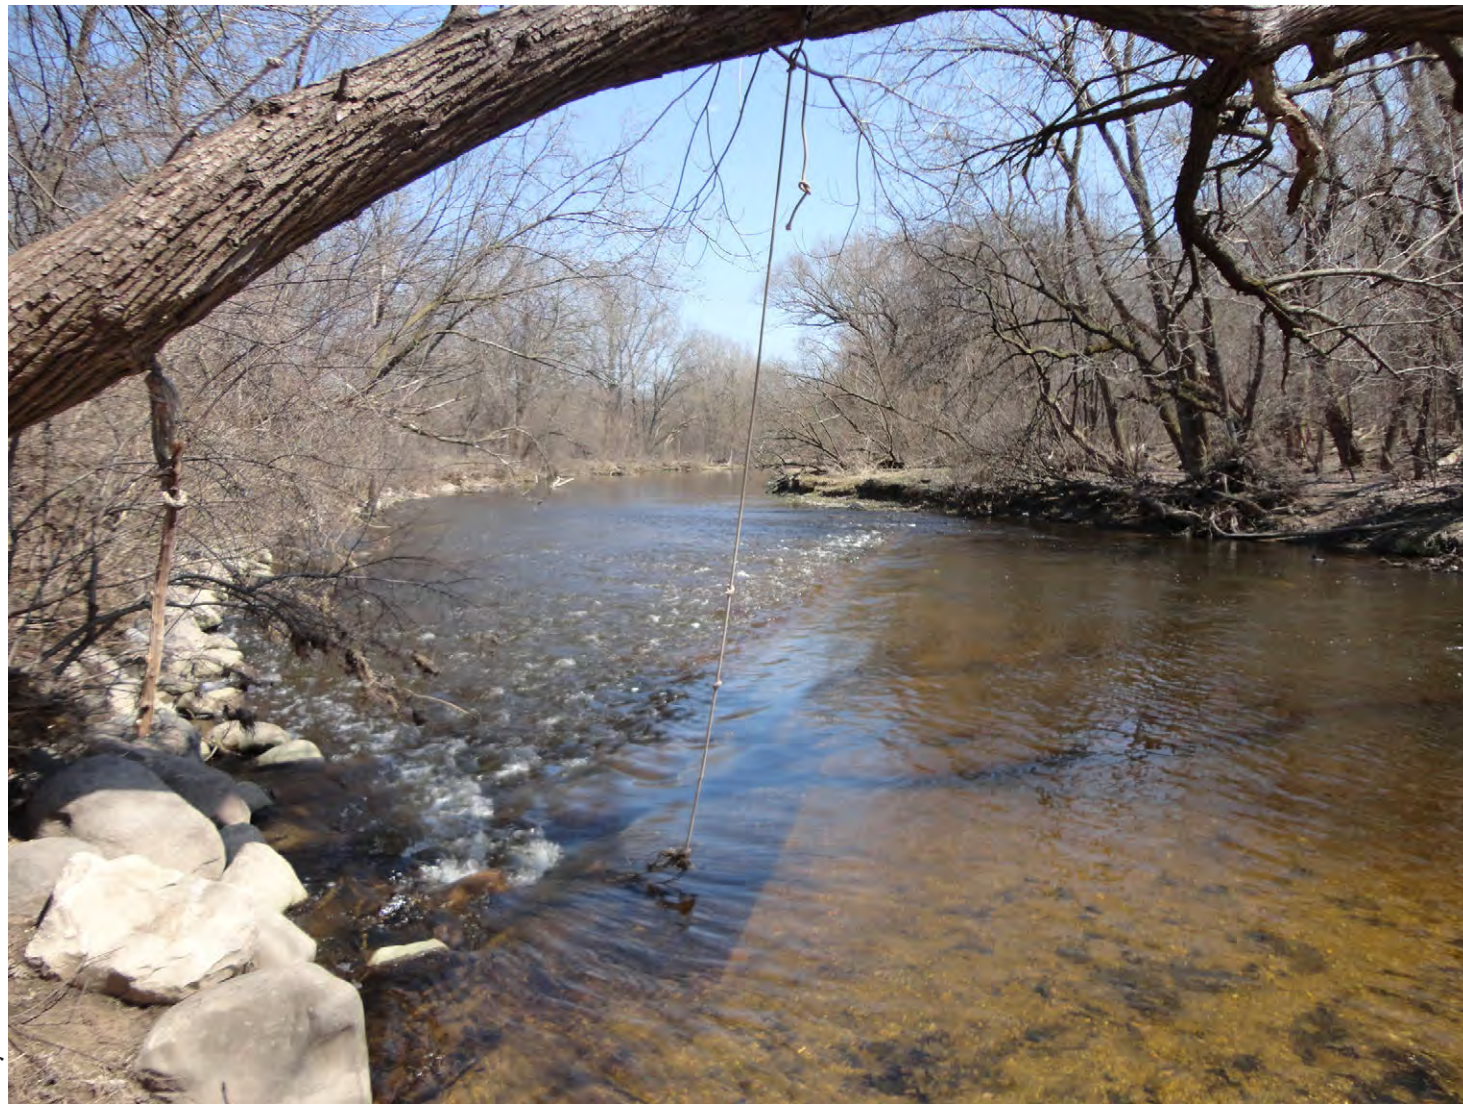
Sewer Crossing #4 - Existing Photos

Looking downstream from left bank

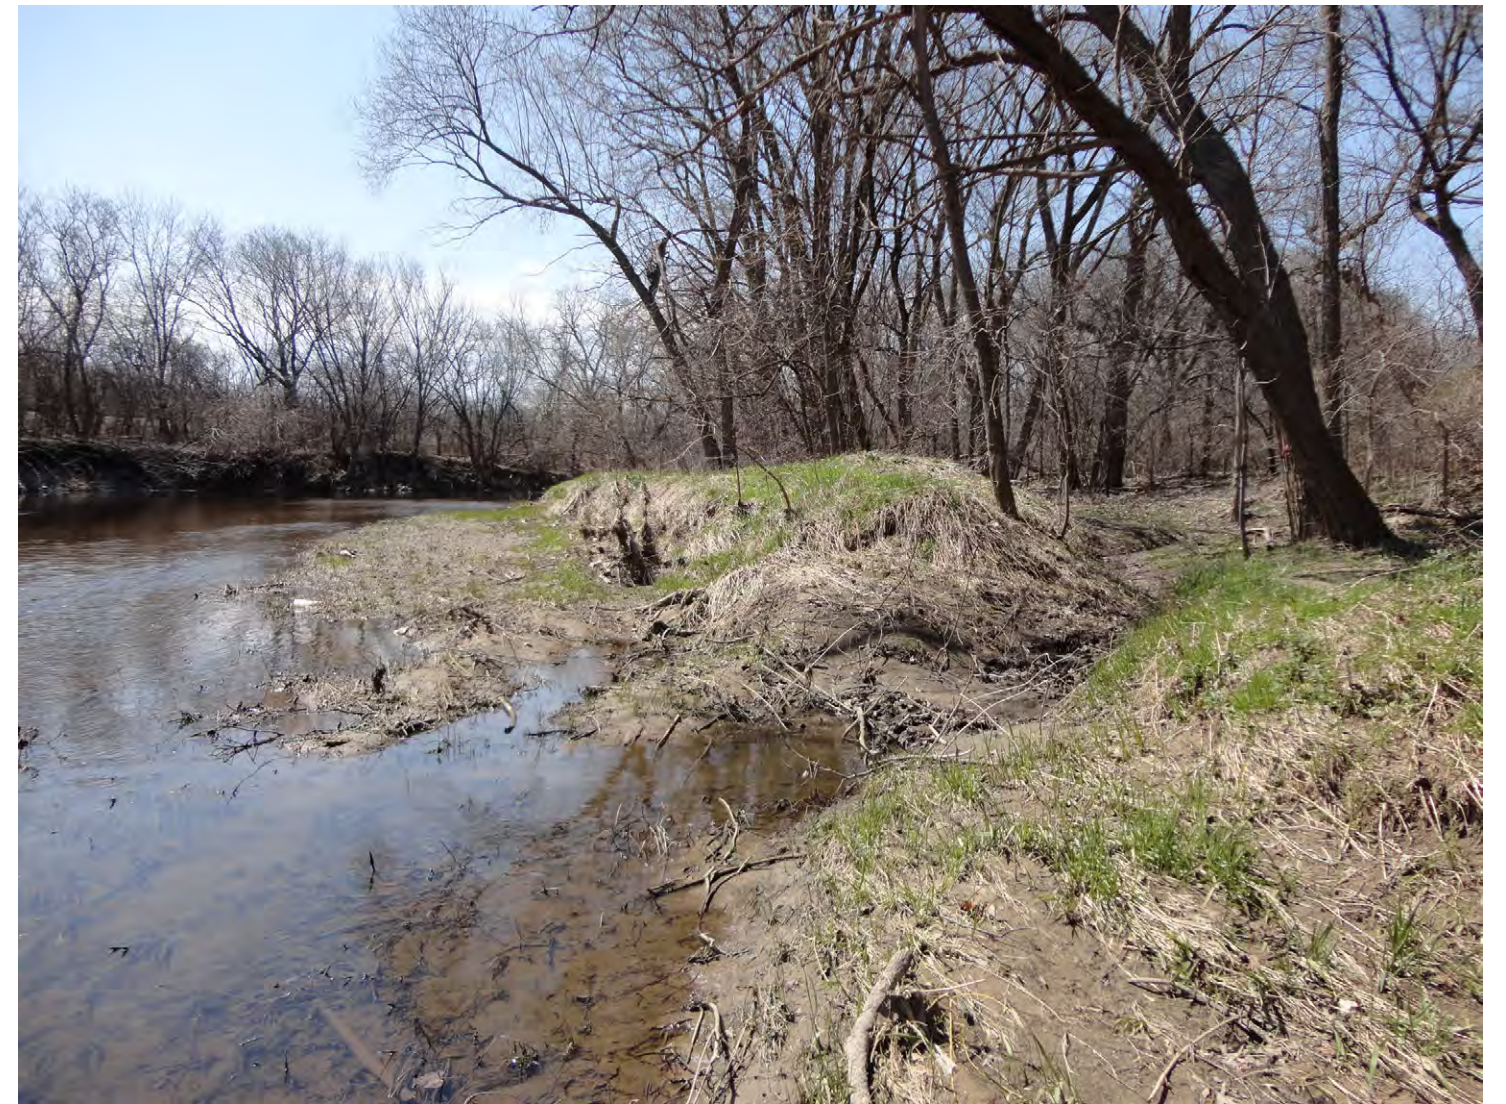
Looking upstream from left bank at backwater channel

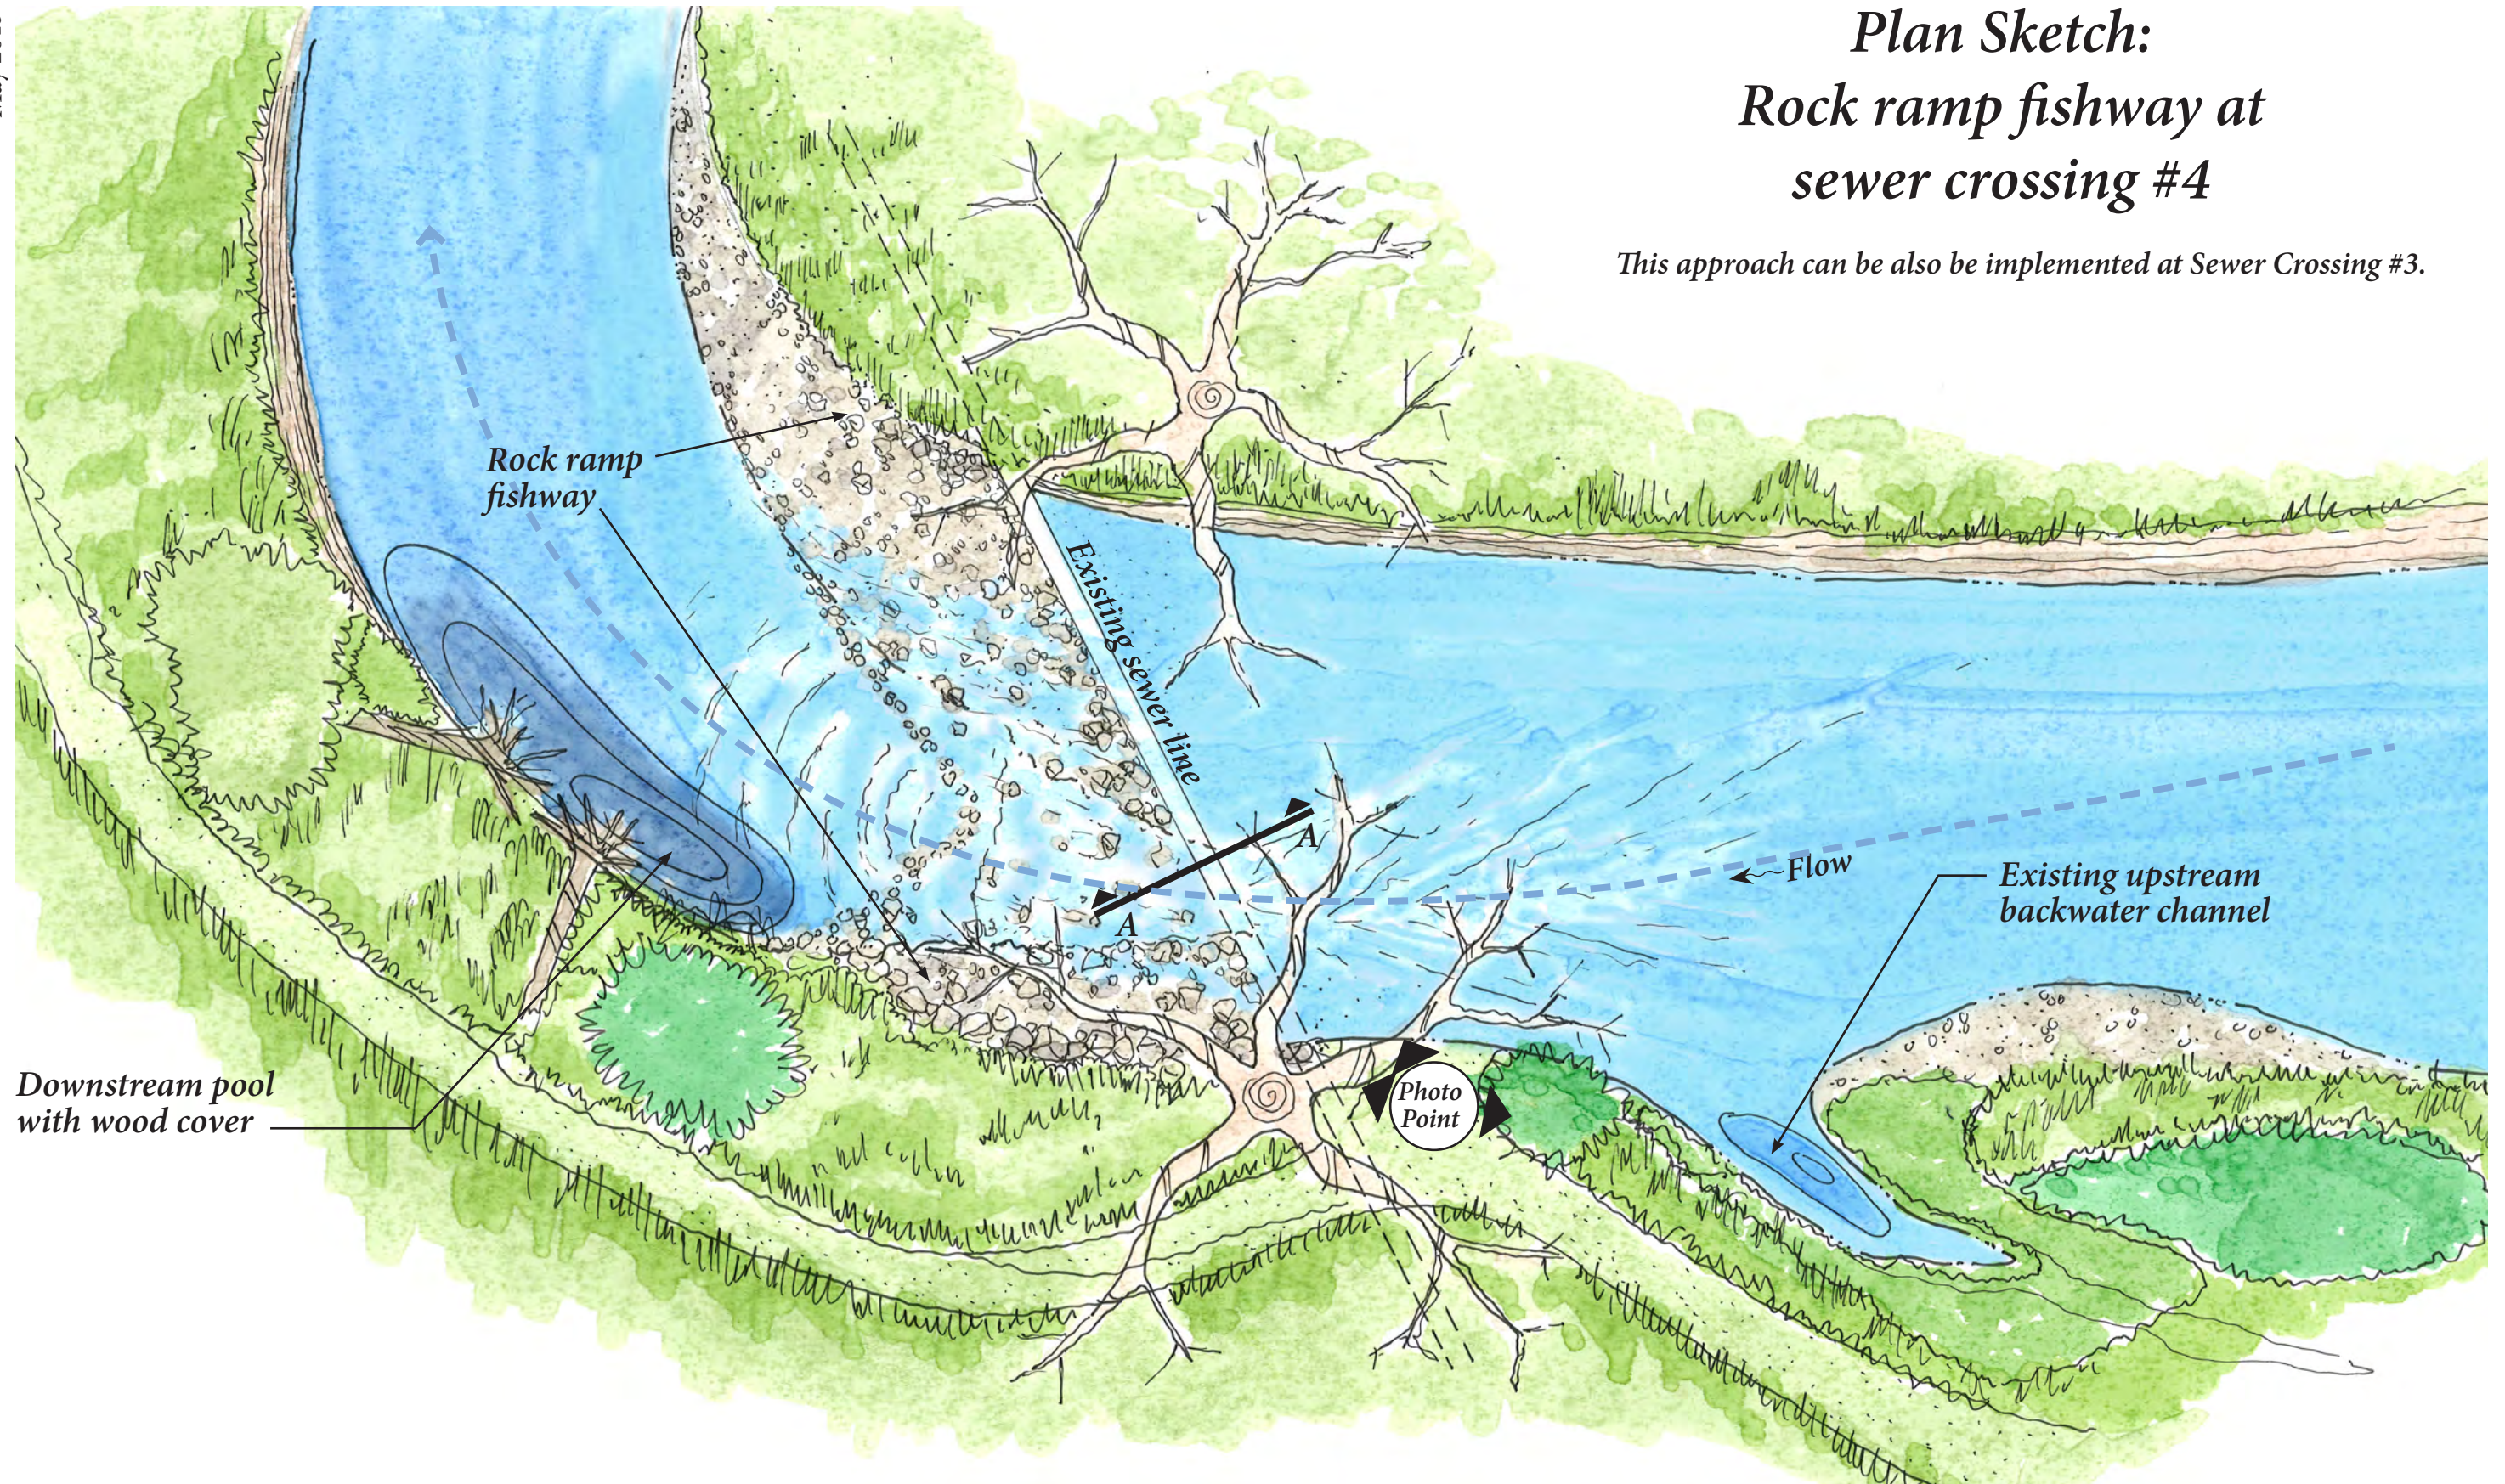
Plan Sketch: Rock ramp fishway at sewer crossing #4

This approach can be also be implemented at Sewer Crossing #3.
