SUBJECT: Invasive Species Monitoring Plan

2017 Purple Loosestrife Survey Results

2017 Eurasian Water Milfoil Survey Results

2015-2017 Zebra Mussel Sampling Results

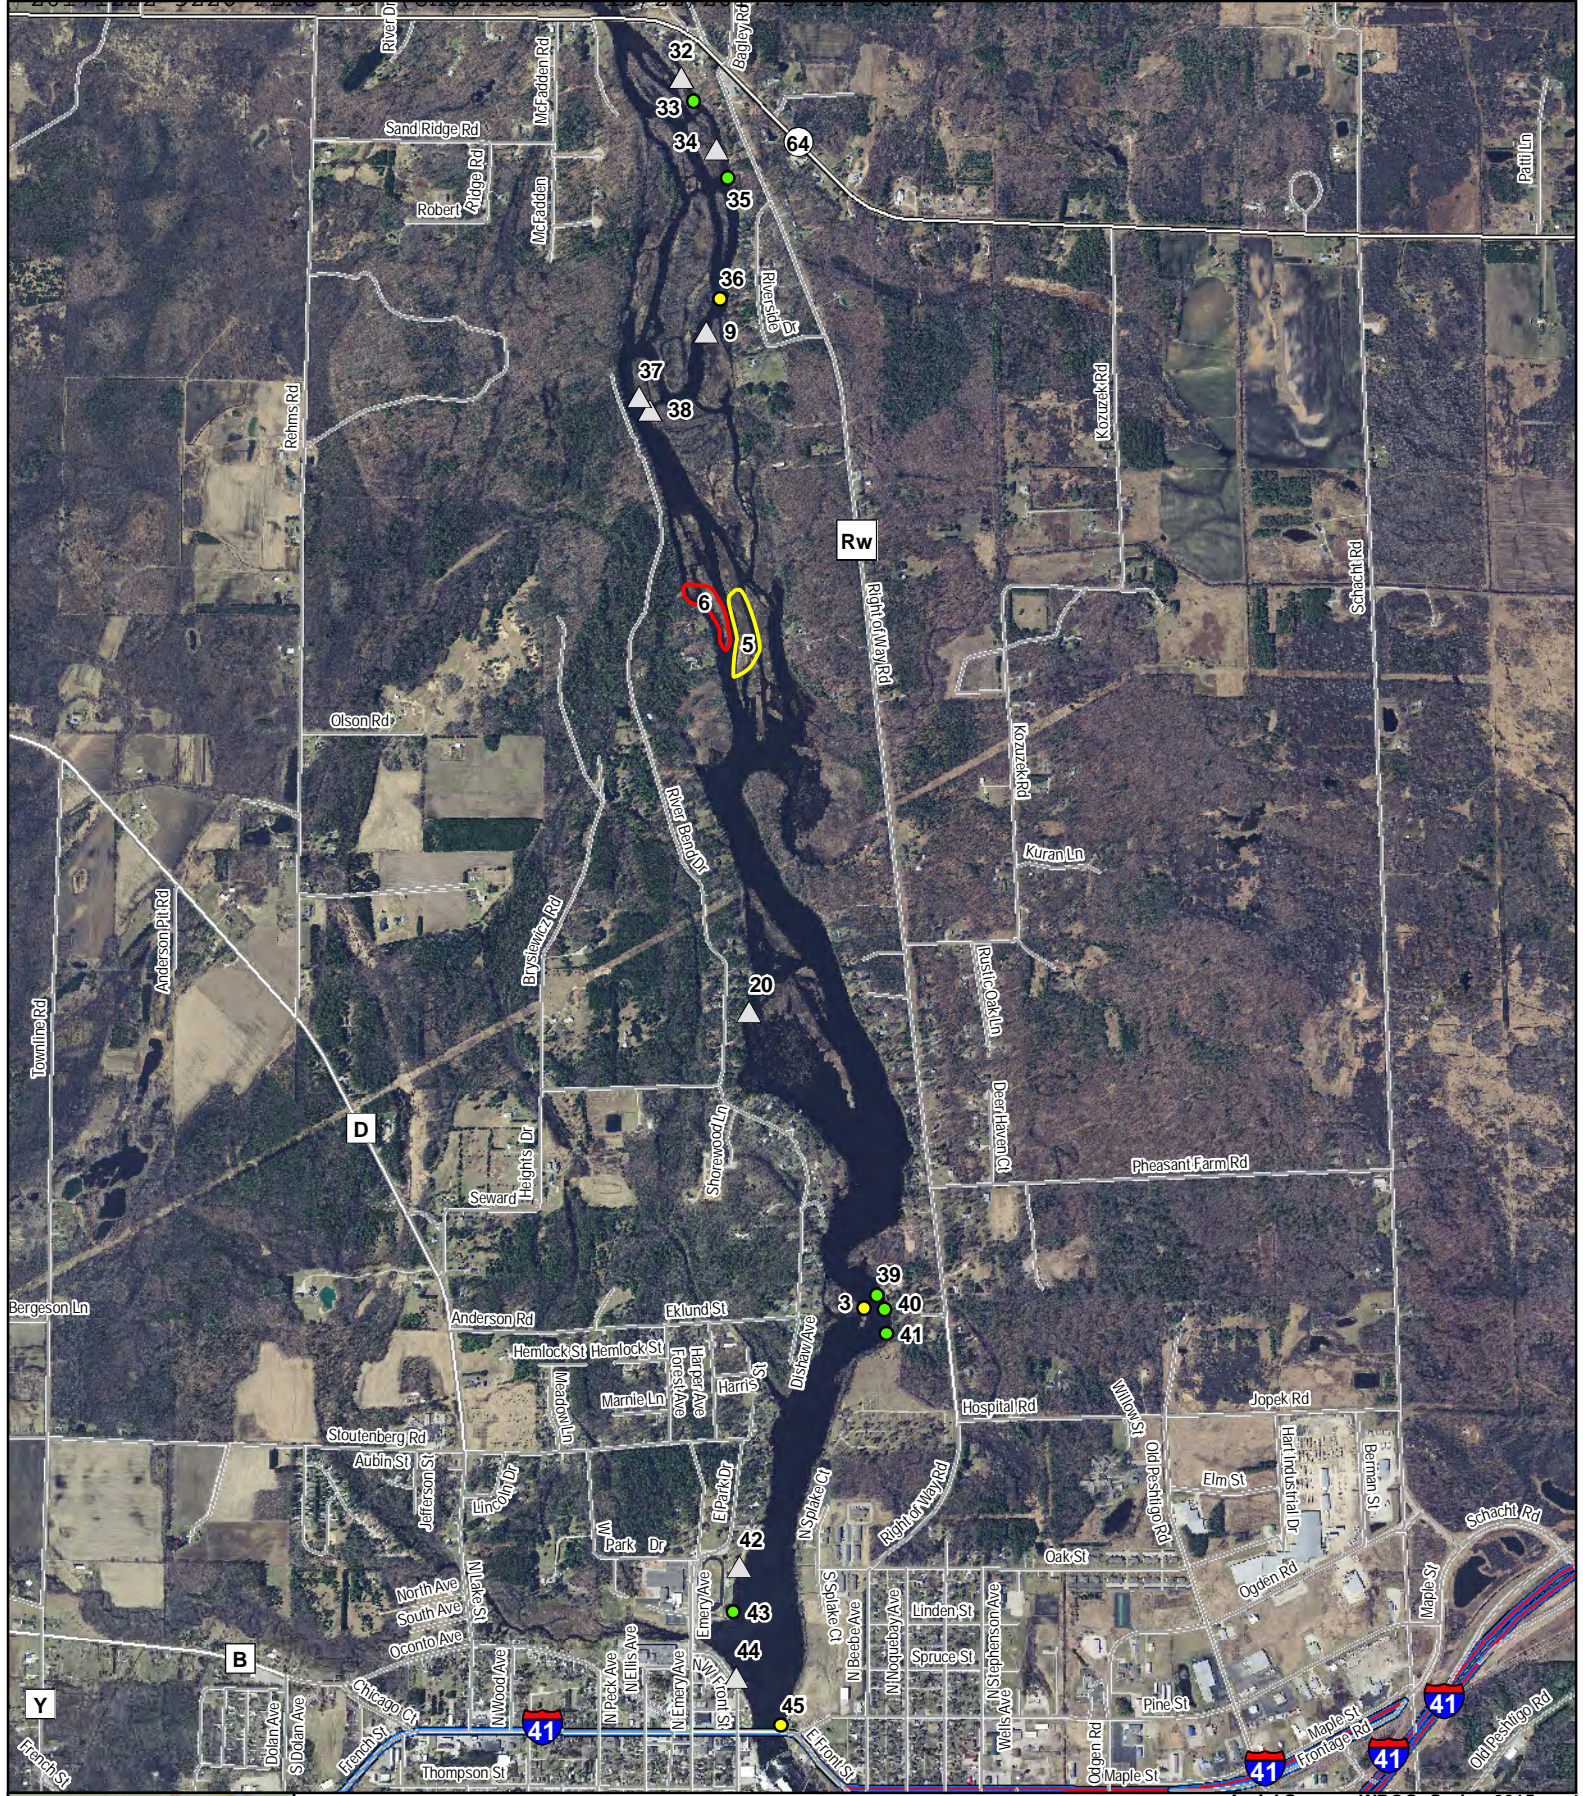
Peshtigo Hydroelectric Project Purple Loosestrife Survey-2017

A purple loosestrife (PL) survey was completed on the Peshtigo River Hydroelectric Projects (Projects) from July 13 through August 15, 2017. Twenty colonies of PL were identified at the Peshtigo Hydroelectric Project. Of the twenty colonies, eight were small colonies and were completely hand pulled and disposed of onsite. No other PL colonies were identified at any of the other Projects. Appendix A includes the PL survey results for the Projects.

WPS observed beetle feeding on sixteen of the twenty identified colonies. WPS will complete the next PL survey in 2020, in conjunction with the Eurasian water milfoil (EWM) surveys for all of the Projects.
