**Subject: 2018 Purple Loosestrife Monitoring Report
Holcombe Hydro (P-1982), Cornell Hydro (P-2639), Jim Falls Hydro (P-2491),
Wissota Hydro (P-2567), Chippewa Falls Hydro (P-2440) and Dells Hydro (P-
2670)**

PURPLE LOOSESTRIFE ASSESSMENT – 2018

**Dells Pond, Chippewa Falls Flowage, Lake Wissota, Old Abe Flowage,
Cornell Flowage, Holcombe Flowage, and Jim Falls Spillway Channel**

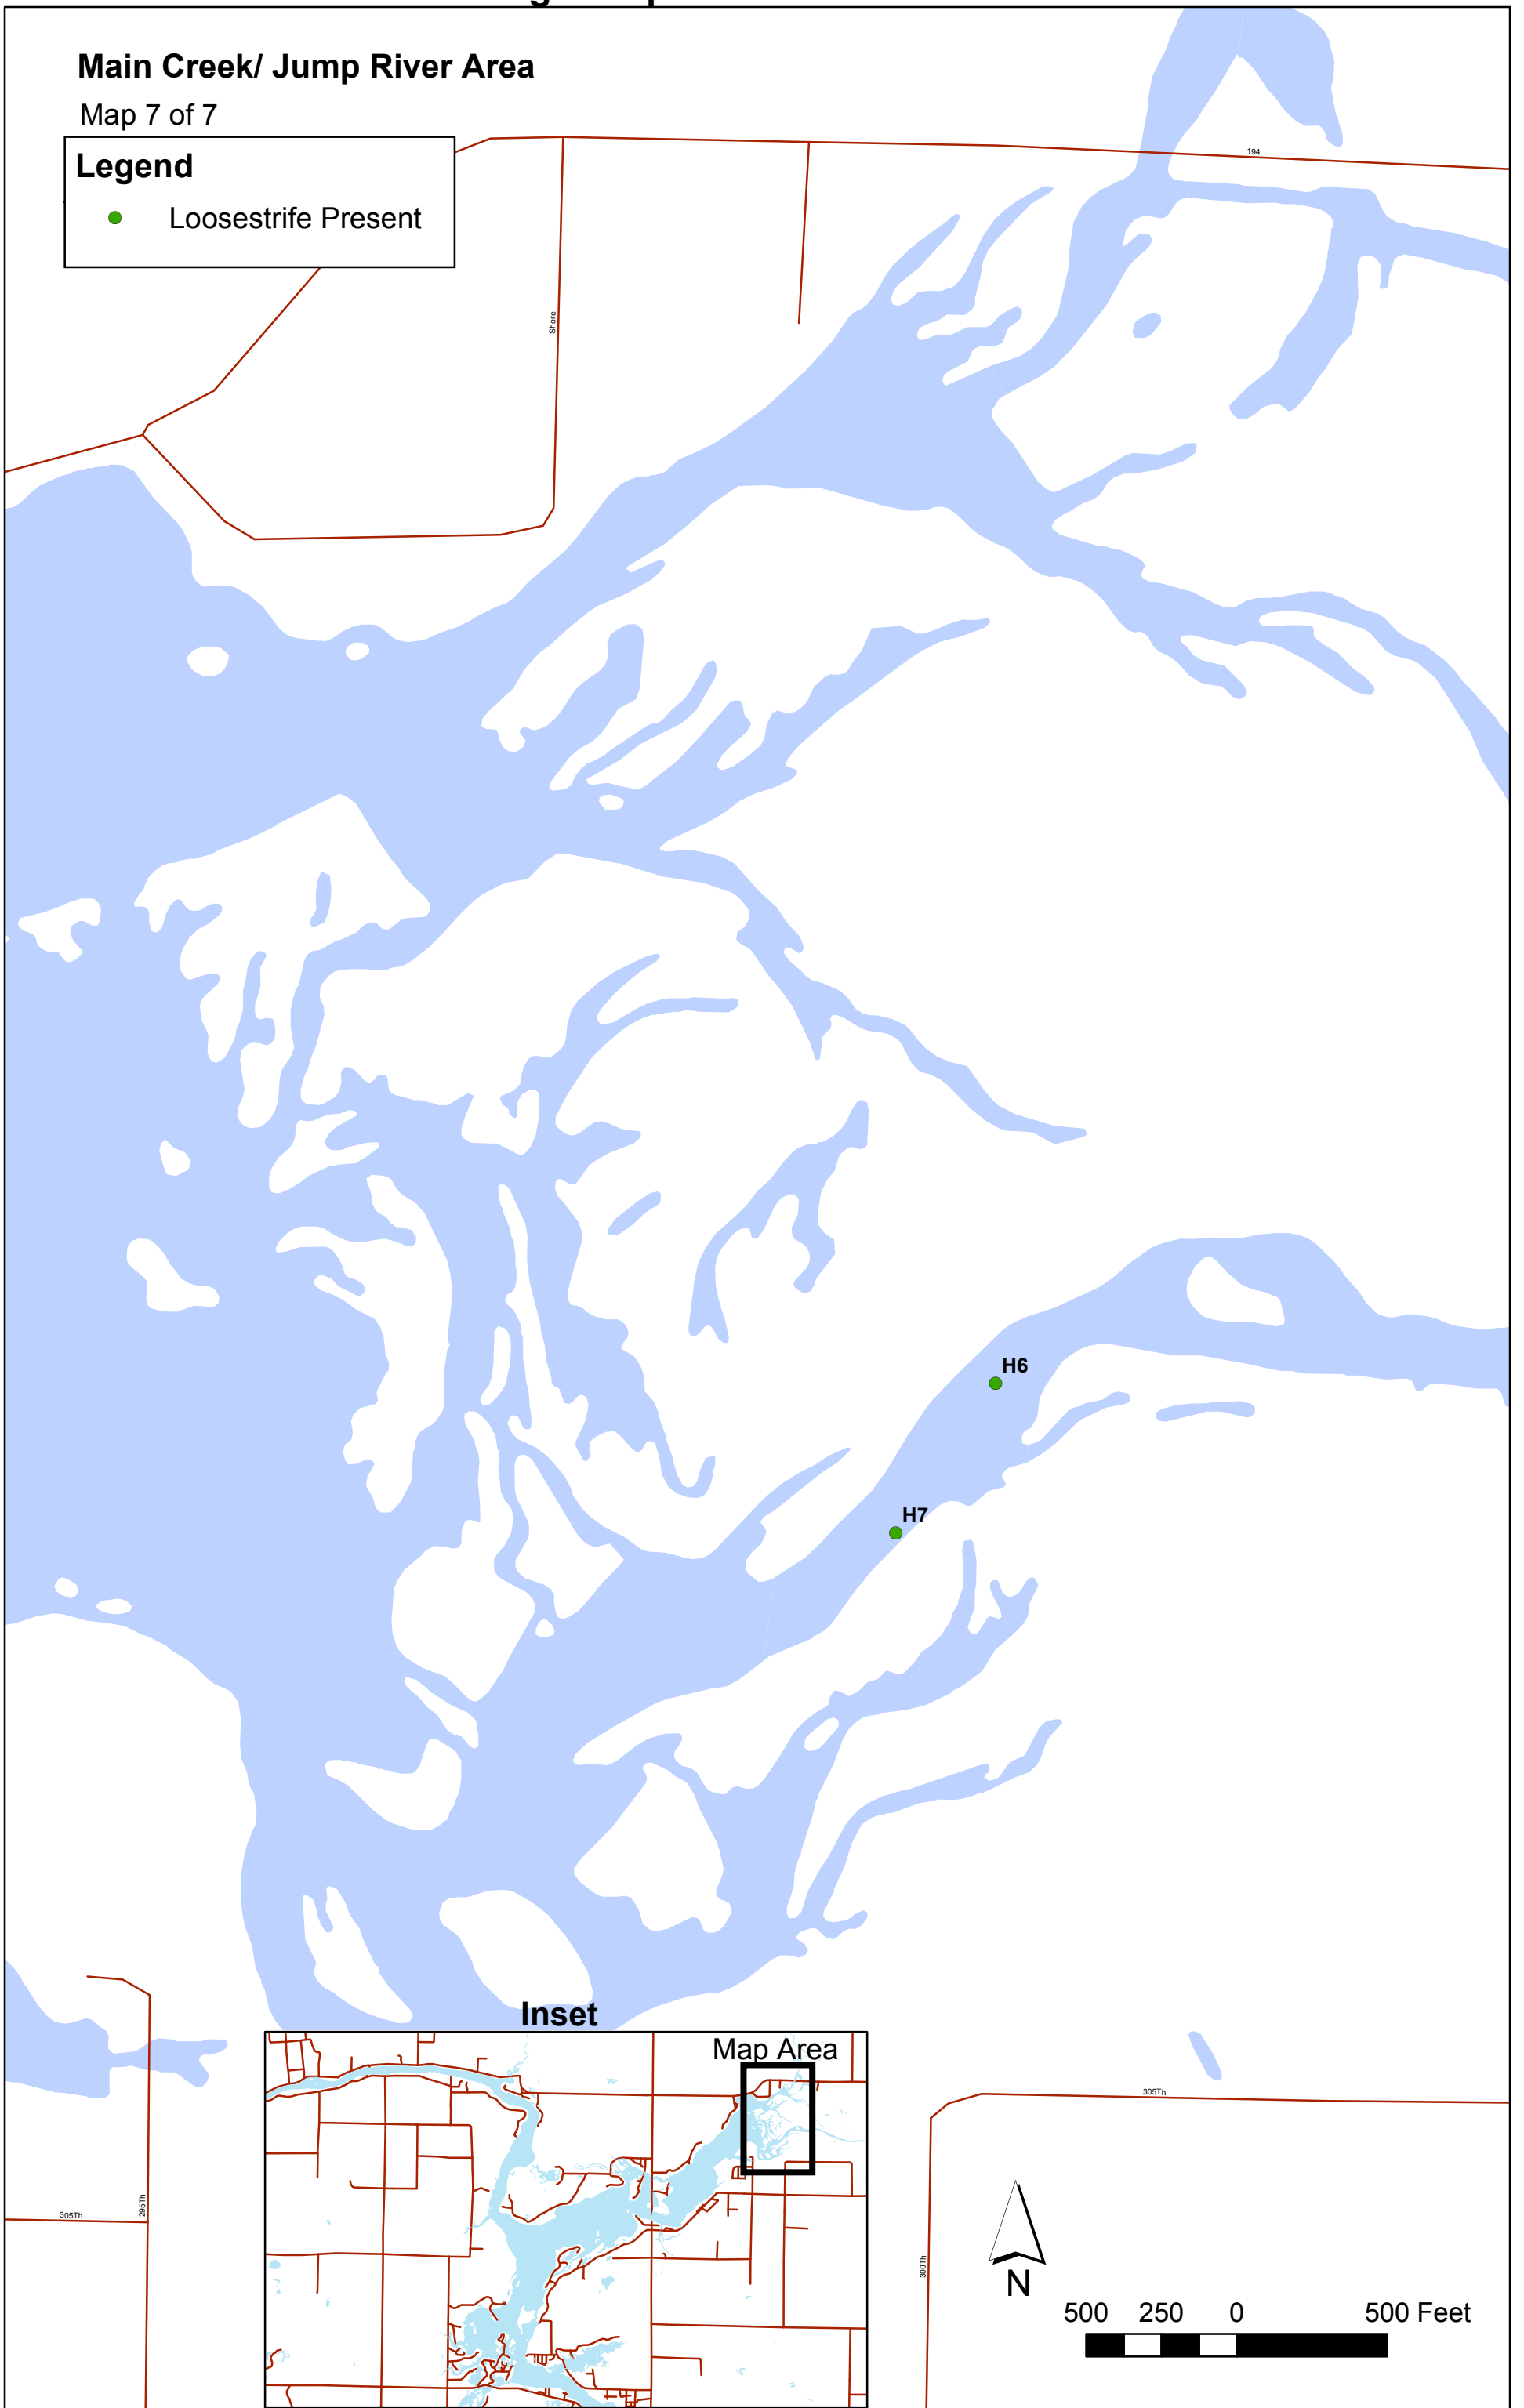
Map 7 of 7

The upstream reach of the flowage (see Holcombe Maps 5 and 6) also contains a number of purple loosestrife plants that have been noted in past surveys. The overall plant density in these areas was slightly less than what was documented in 2017. A few plants were noted in the eastern part of the flowage (see Holcombe Map 7), each of which have been seen in some of the previous years' surveys.

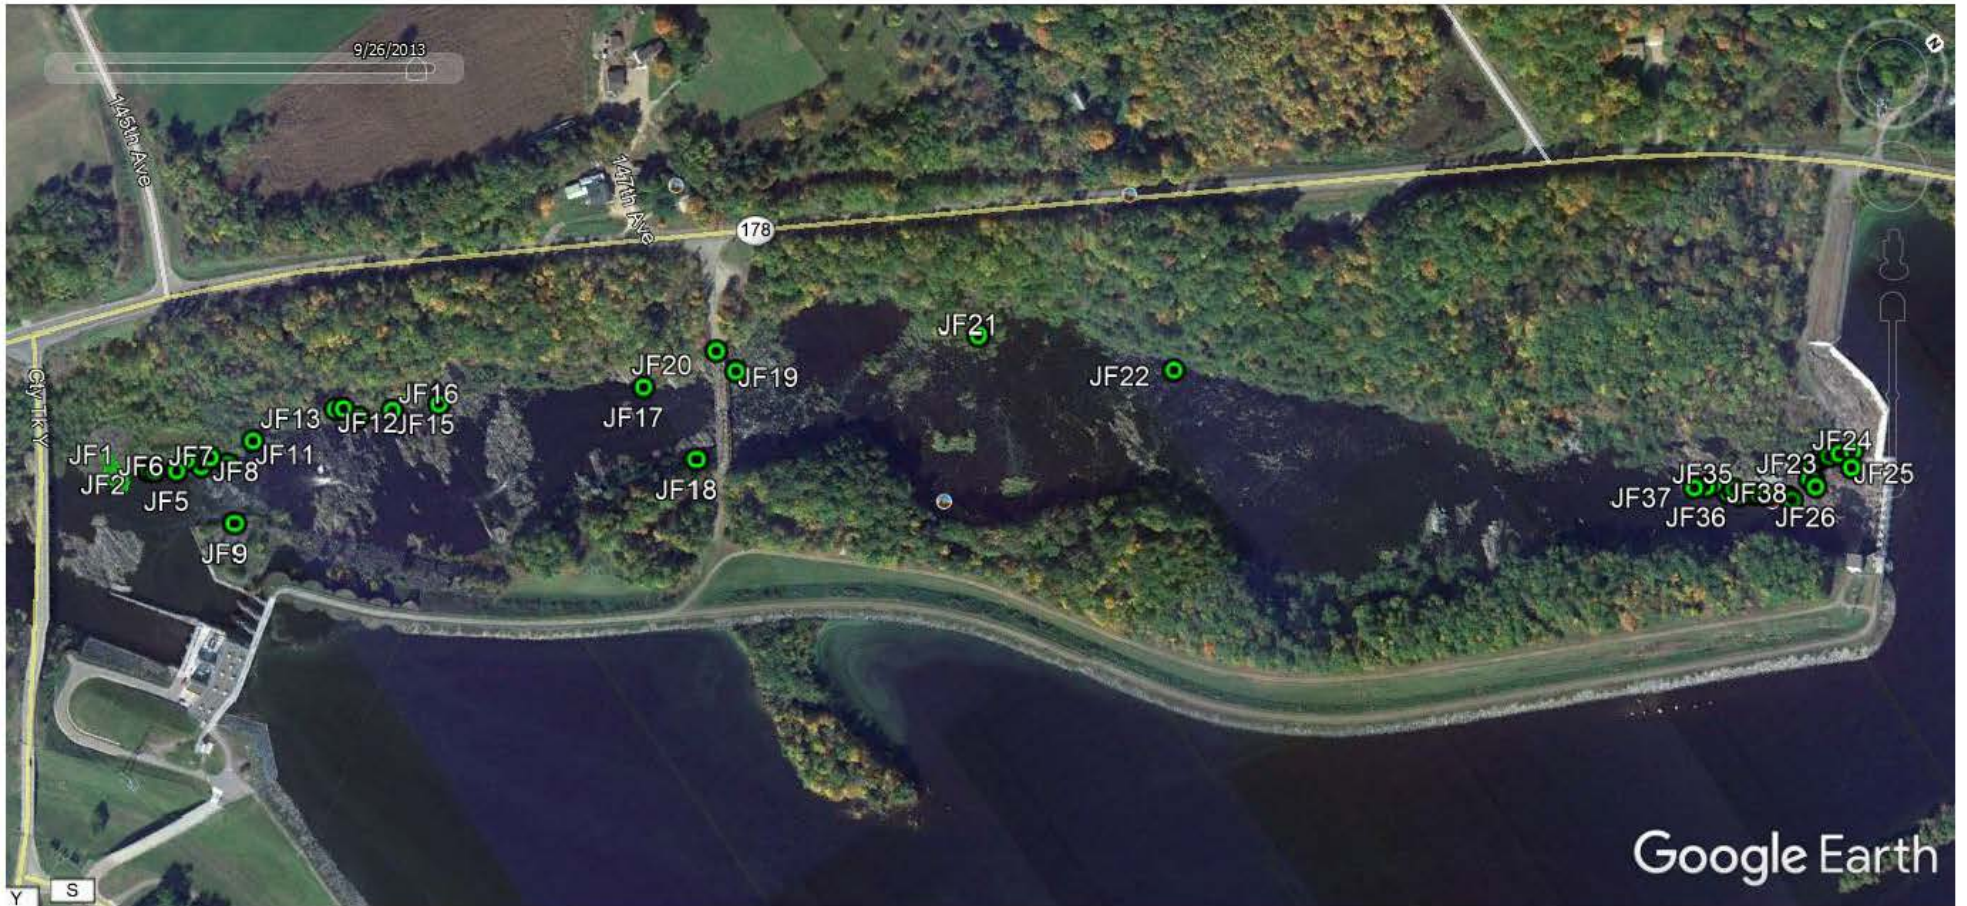
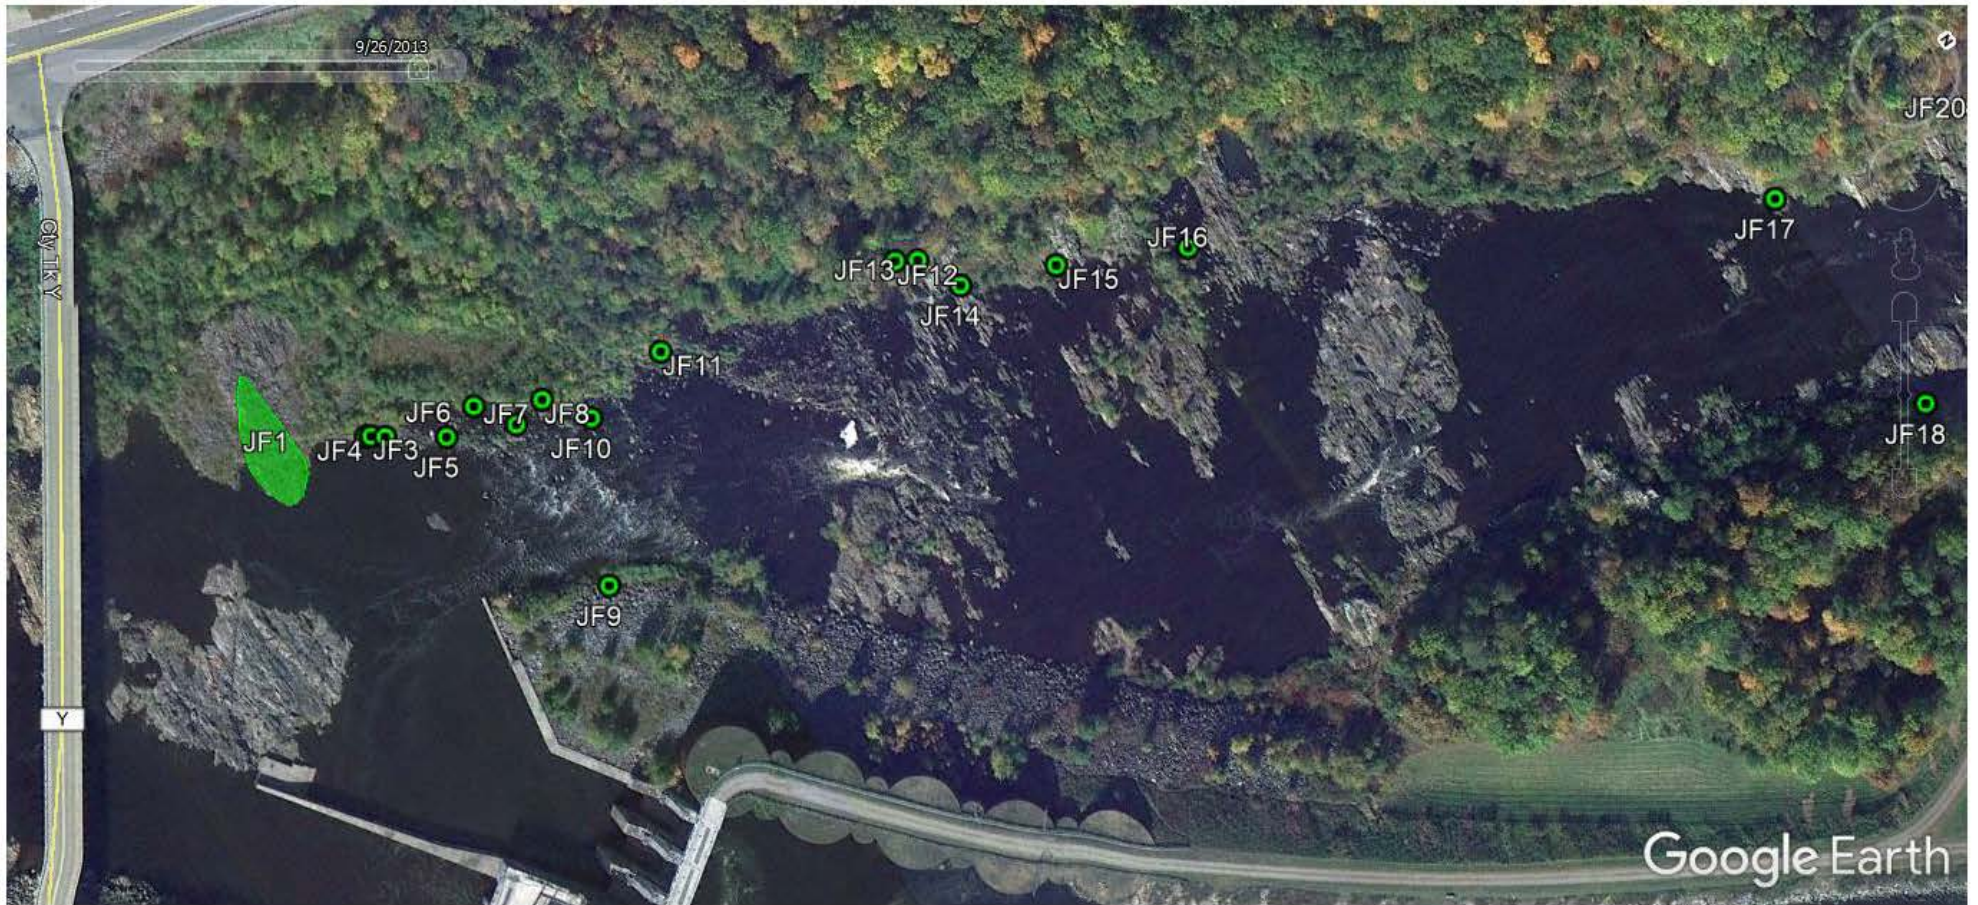
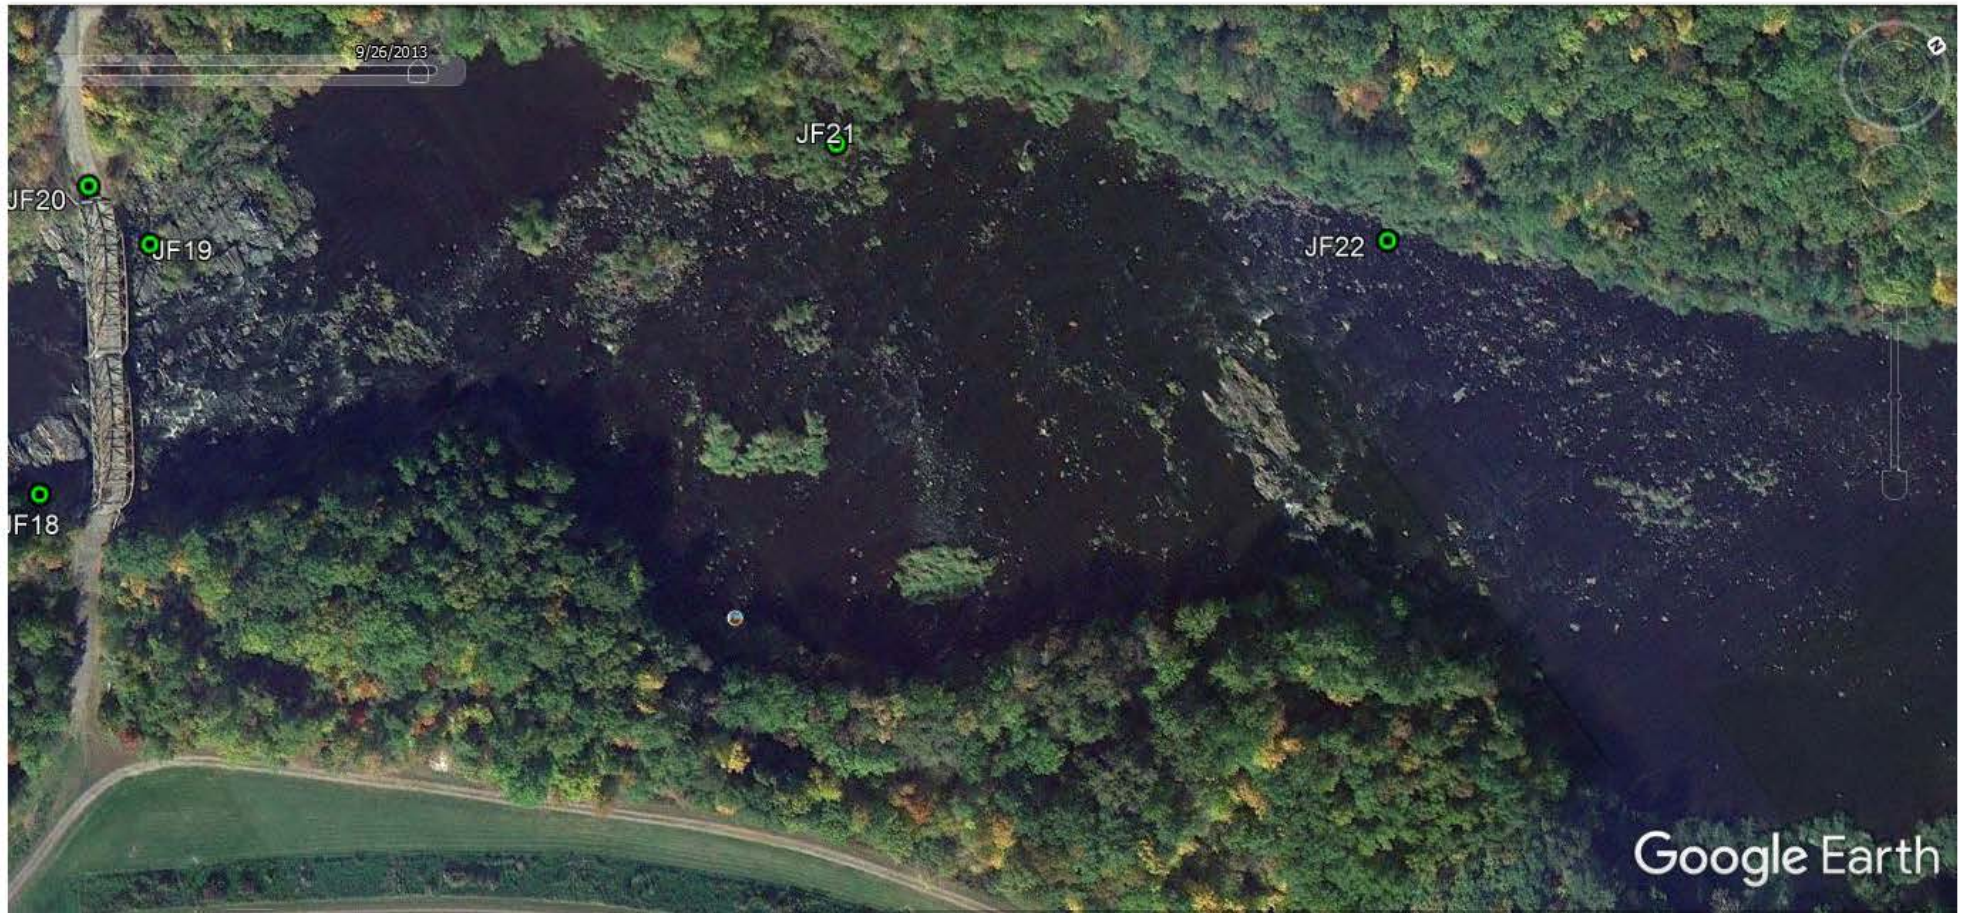
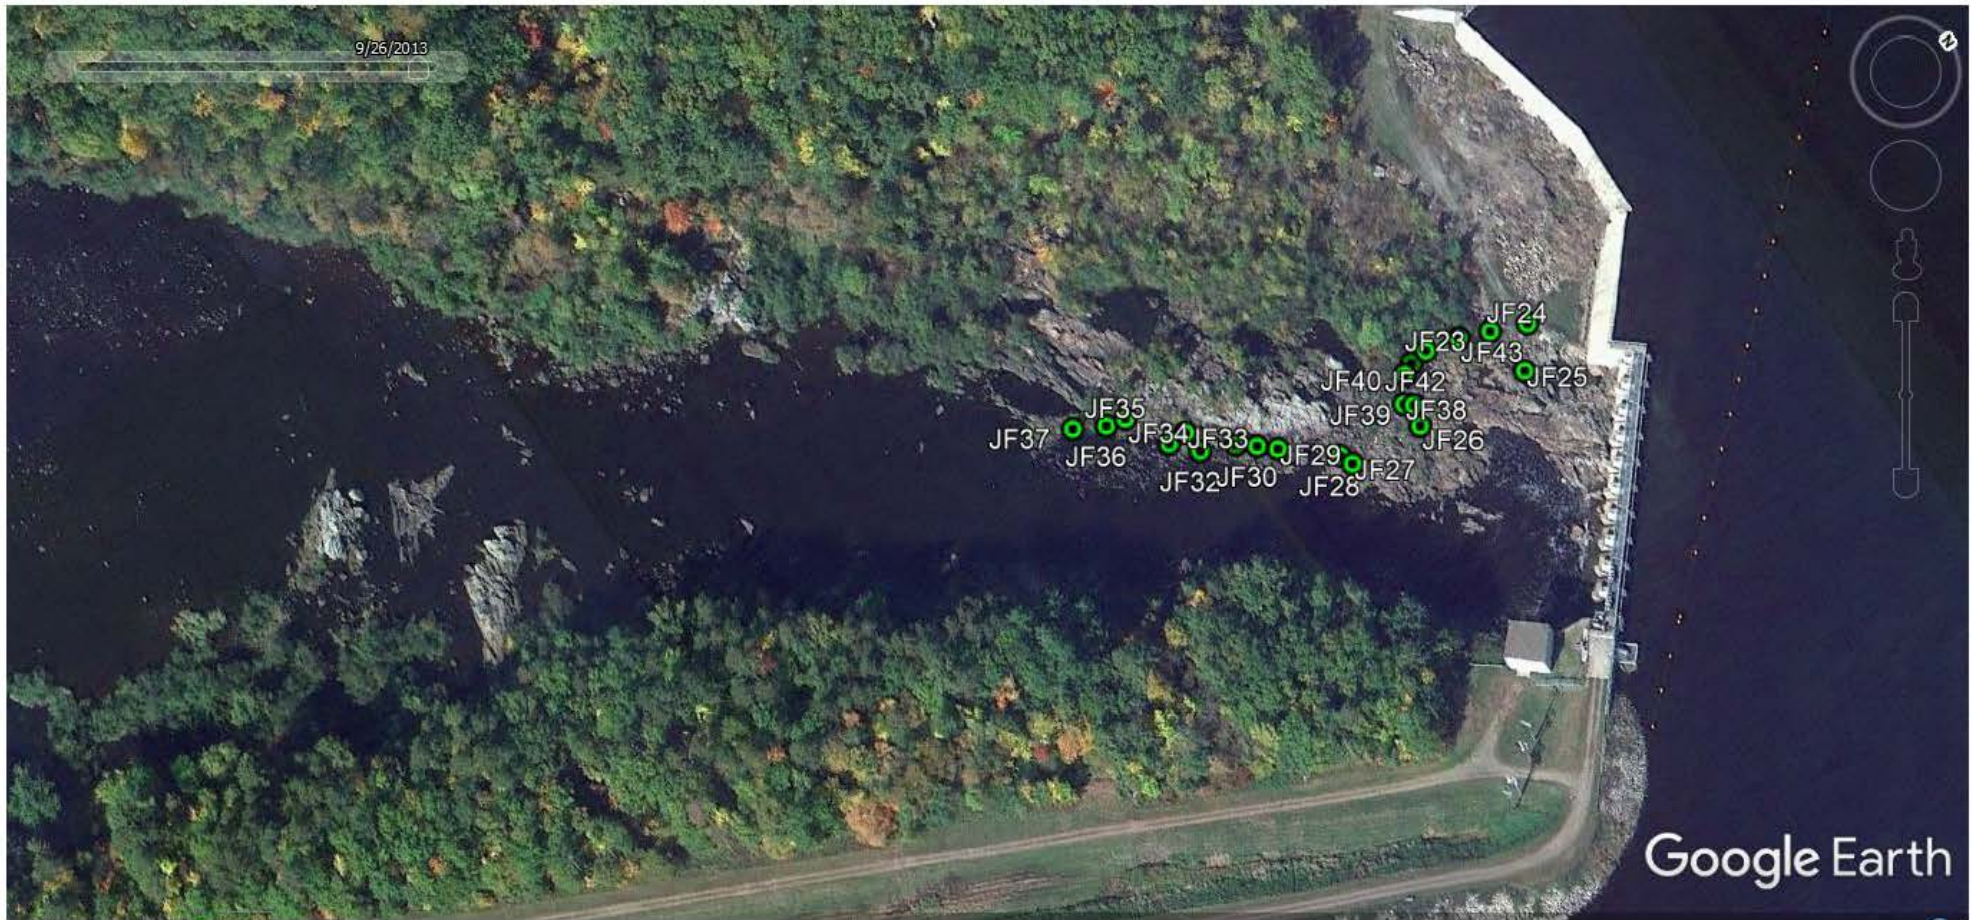
The minimum flow channel at Jim Falls Hydro remains infested with a relatively high concentration of purple loosestrife plants. A significant decrease in the number of plants was noted in 2012 followed by a rebound in 2013 and 2014 before another decline in 2015. The number of plants subsequently increased in 2016 (Table 3). In 2017, the amount of loosestrife again was seen to decrease while the 2018 survey revealed almost no change from the previous year. Loosestrife was found scattered throughout the channel, with the lower third being moderately infested (see maps of Jim Falls Spillway Channel). The area of greatest concentration occurs just upstream from the County Highway Y Bridge (see Jim Falls Spillway map 2). The coverage of loosestrife in this area has decreased from approximately 5,431 square feet in 2017 to 3,600 square feet in 2018 (Table 4). The loosestrife is scattered throughout the area and therefore is not classified as abundant. A steady decline in the overall density of the plants in this area has also been noted over the last several years. The number of loosestrife sites in both the upper and lower portions of the spillway channel decreased slightly from last year while the amount of shoreline affected increased slightly. Collectively, these locations accounted for 262 feet of infested shoreline versus 222 feet in 2017. Most of

these locations were comprised of small plant clumps infesting between one and ten feet of shoreline, with a few more significant areas of infestation.

Eight years have passed since the introduction of the bio-control beetles into the minimum flow channel. While it is difficult to make a determination as to their success, the fact that the density of loosestrife in the lower area of the spillway channel is continuing to decrease, and the fact that loosestrife infestation in the remaining portion of the channel appears to be stabilizing is encouraging.
