The Aquatic Plant Community

Half Moon Lake

Eau Claire County, Wisconsin

May, 1996

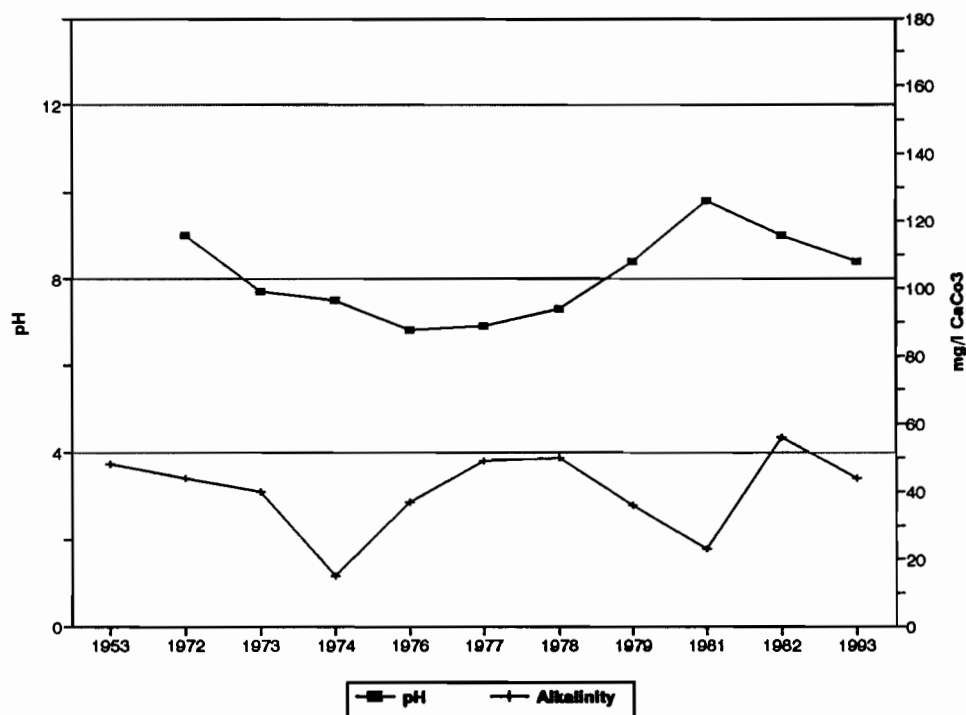
Figure 6. Alkalinity and pH of Half Moon Lake.

Alkalinity levels in Half Moon Lake have varied between 15mg/l CaCO₃ and 58mg/l CaCO₃ (Figure 6). Water with a hardness level less than 60mg CaCO₃/l is considered soft. Soft water lakes tend to have less plant growth.

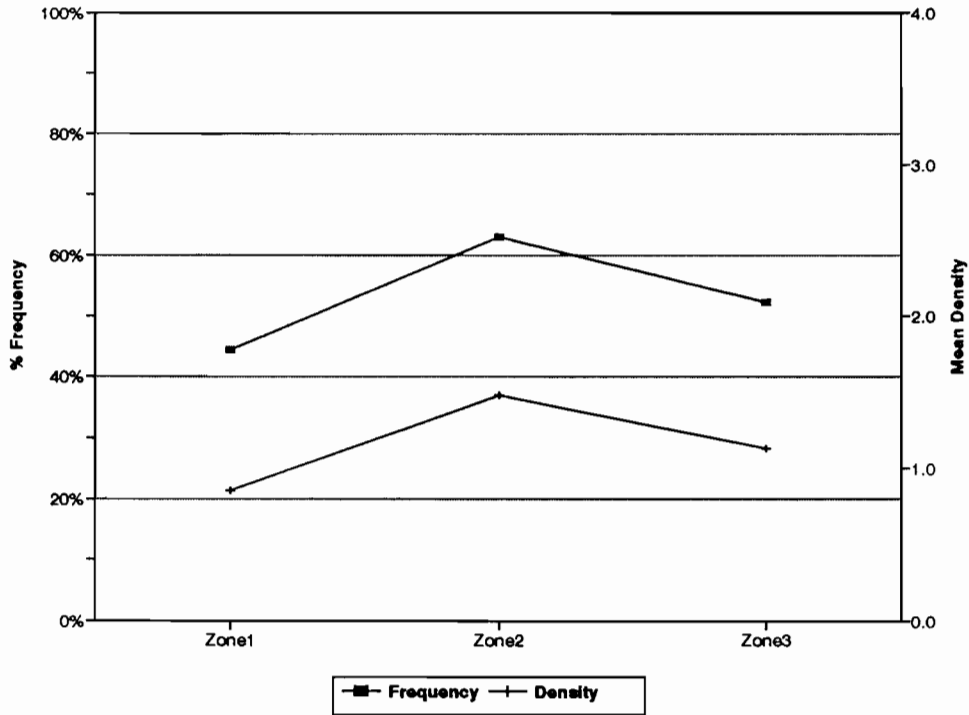
Figure 13. Frequency and Density of *Ceratophyllum demersum* by depth zone.

In addition, *Ceratophyllum demersum* had its highest frequency and density in the 1.5-5 ft. depth zone (Figure 13). Its frequency and density declined in the shallower and deeper depth zones.
