# **PIKE LAKE PLANNING GRANT REPORT**

## **INVENTORY & RECOMMENDATIONS**

**RAND ATKINSON  
AQUATIC RESOURCES, INC  
BIRNAMWOOD, WI**

**NOVEMBER 1998**

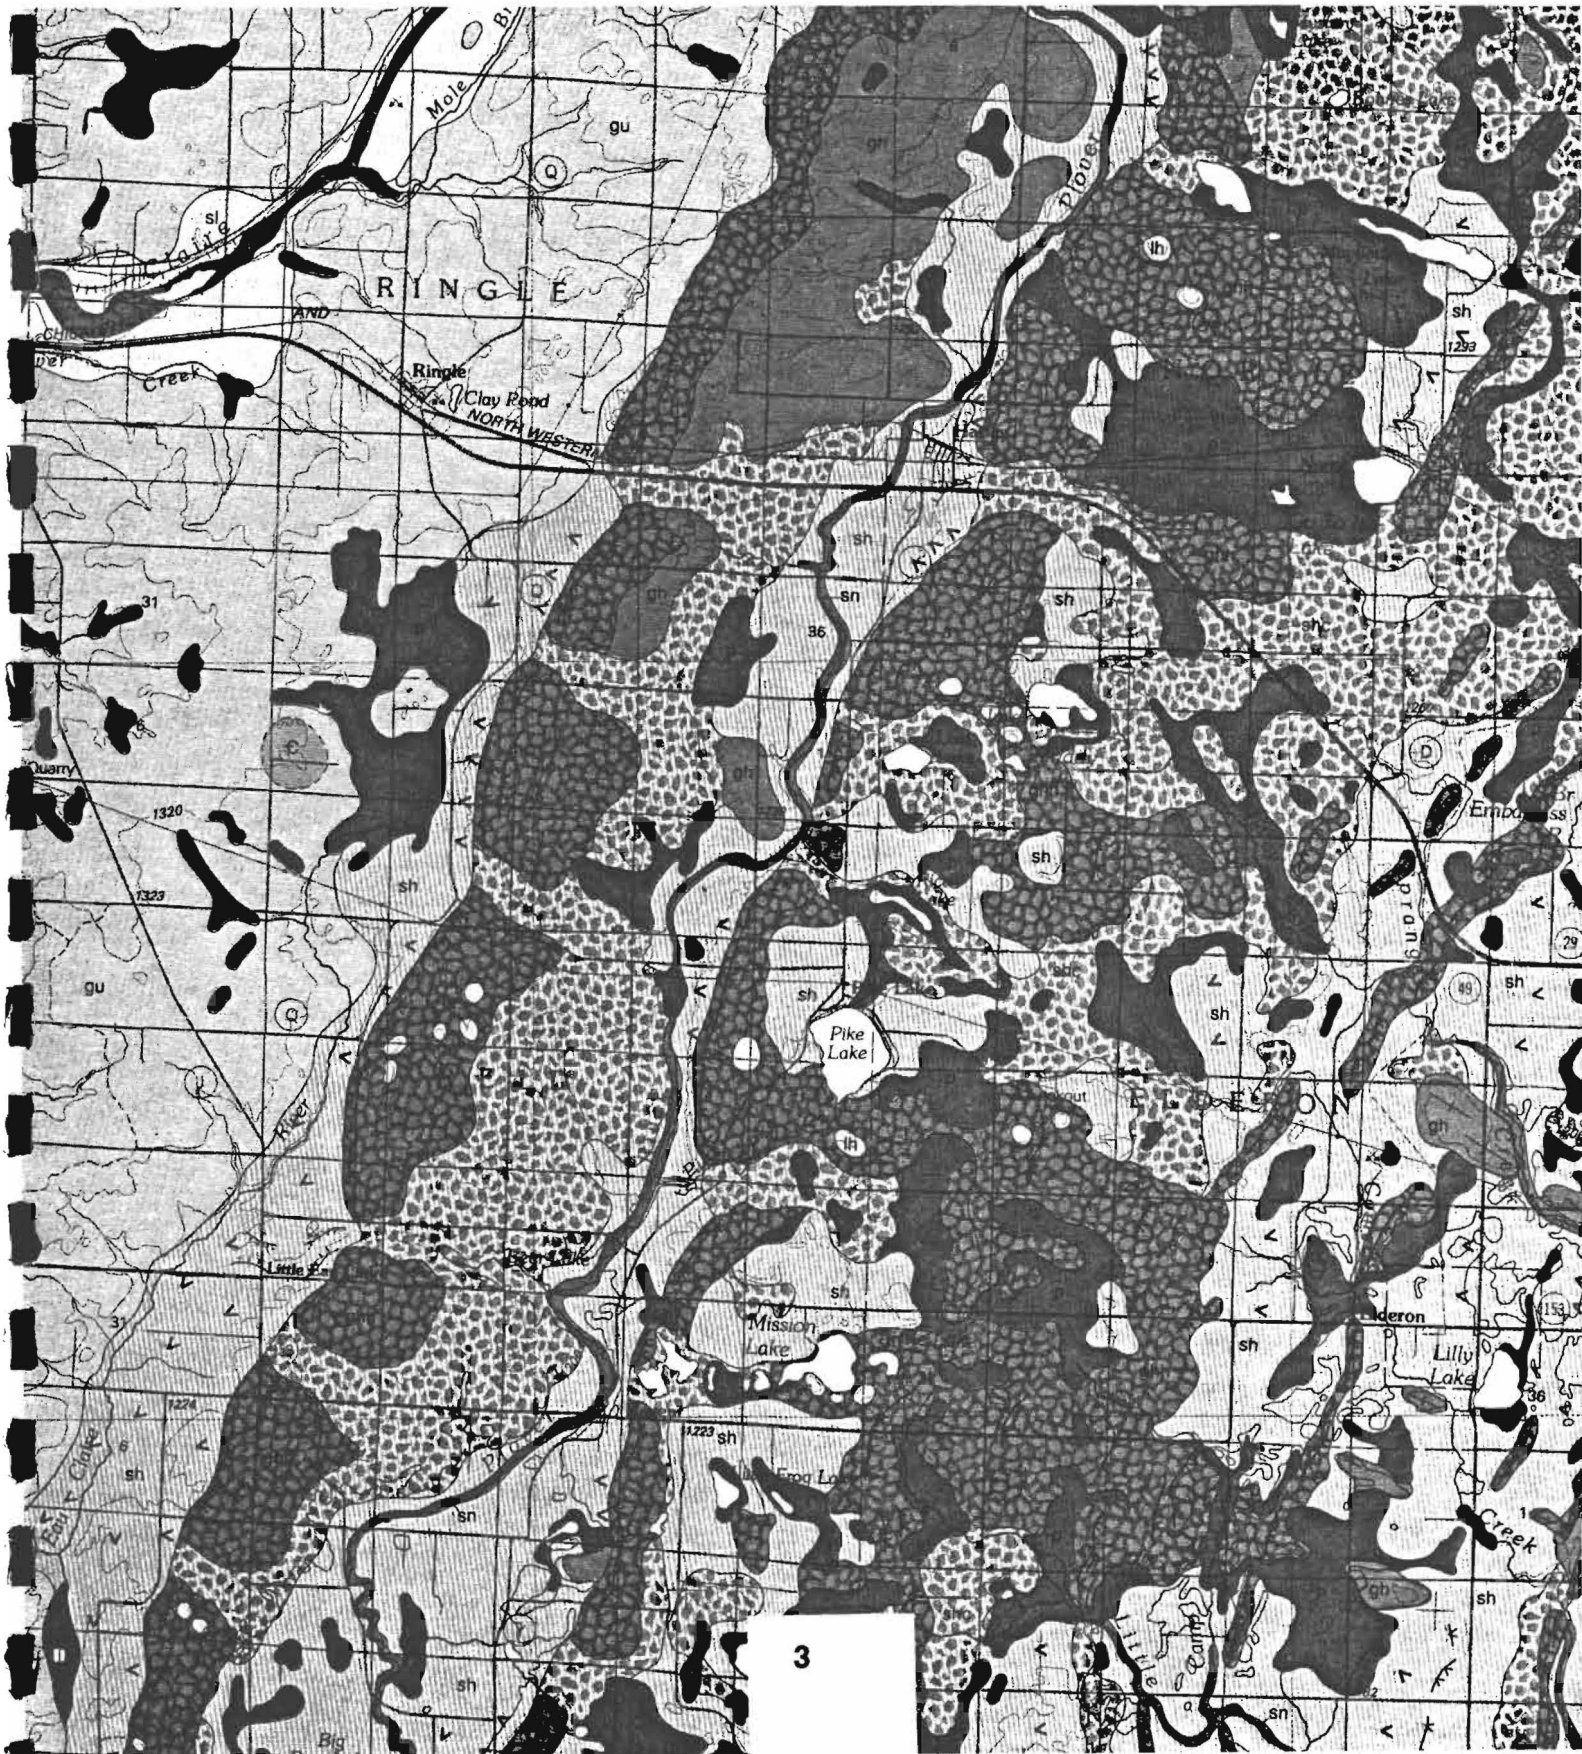
FIGURE 2. Map of Pleistocene Geology of the Pike Lake Area.

Stream sediment consists of glacial melt water stream sediment made of dolomitic sand, gravely sand, and sandy gravel. In the Pike Lake area these deposits can be over 50 feet deep. On the map these areas are marked either as sh or shc. The unit sh indicates the original deposited surface today is much the same as it was after the retreat of the glacier. The irrigated fields in the Pike Lake watershed are examples of this type of sediment area. The unit shc shows where the original deposited surface has been destroyed by collapse due to melting of buried ice. Typically, the areas immediately adjacent to the upper end of wetland areas that drain to Pike Lake have these collapsed soils.

Glacial sediment is till or non-sorted, non-stratified sediment deposited directly by glacial ice. This till is made up of brown, gravely to slightly gravely, clayey, silty sand deposited as ice-marginal deposits, as broad areas of hummocky deposits, and in drumlins. The letters gh are shown in areas of gently rolling topography where the letters ghh is shown in areas of hummocky topography. This hummocky land form contacts Pike Lake on the southwest and make up the hills to the west, southeast, and northeast. These glacial till sediments created barriers that encompassed the glacial melt water sediment that Pike Lake was formed in.

Lake sediment is offshore lake sediment consisting of fine sand and silty fine sand, some slightly gravely. These soils can be found in areas called ice-walled-lake plains. A lake-plain consist of flat to nearly flat areas, the centers of which are underlain by offshore lake-bottom fine silt and sand. The flat areas are high in the landscape because these lakes were bounded by ice. When the ice melted the sediment that had accumulated in the lake basin was left as a high area. Most of these areas are marked with the letters lh. One of these hills can be found southeast of the Theodore Milanowski residence south of the lake.

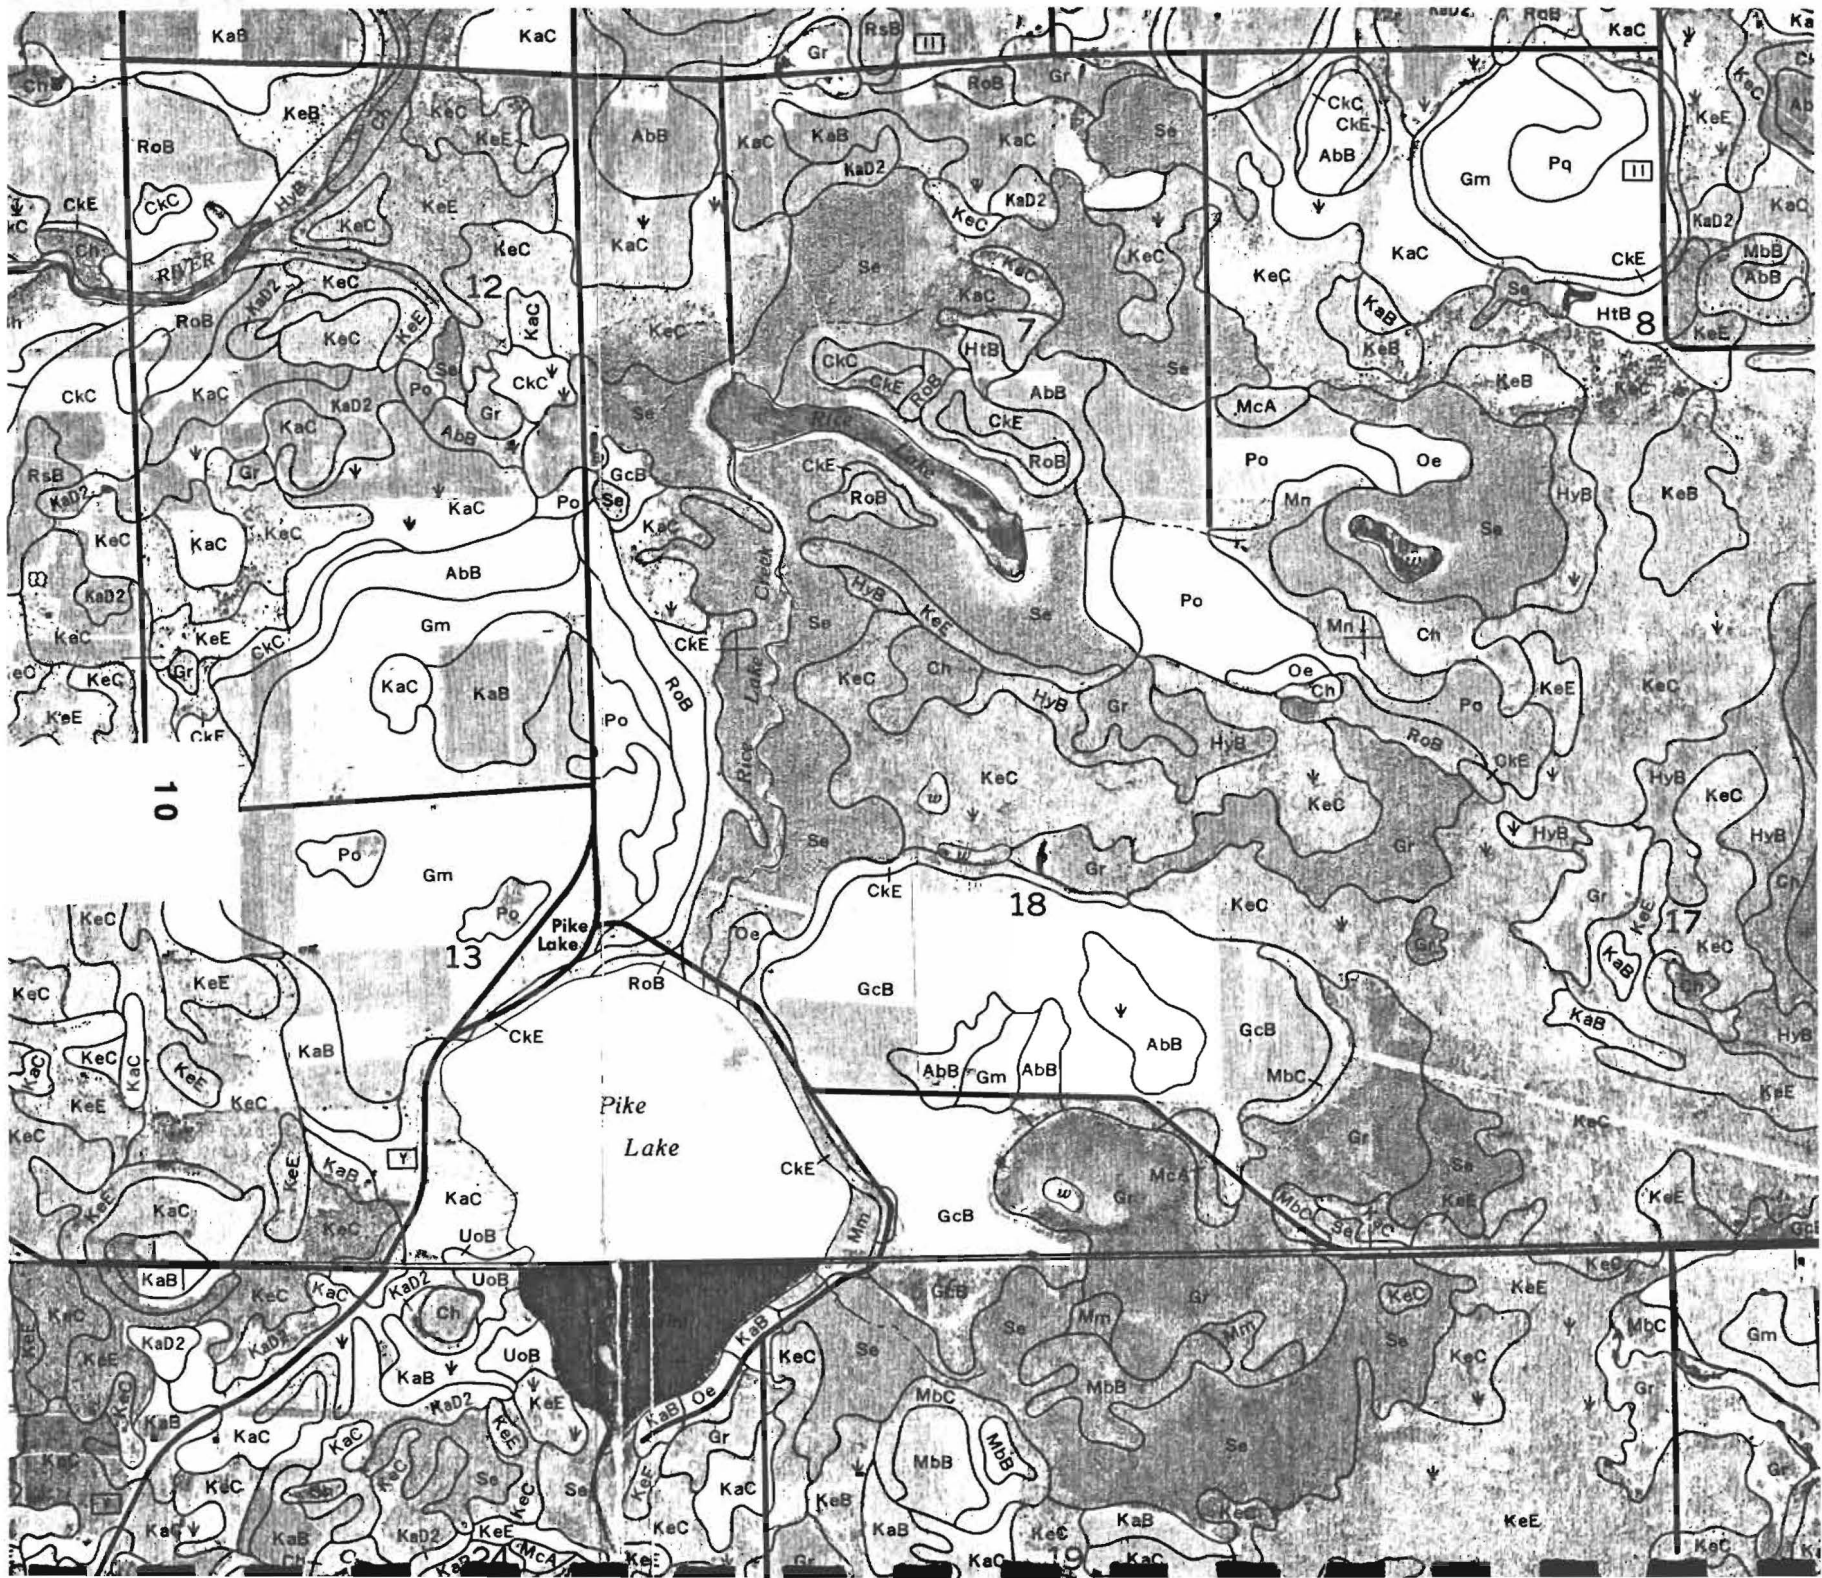
FIGURE 3. Soil Map of the Pike Lake Watershed.

The soils and corresponding land uses of the landscape of the Pike Lake watershed are reflective of the glacial deposits described above. Fifteen soil types are found in the watershed. **SEE TABLE 1**. The soil locations vary from level and low wetlands to steep slope areas with flattened rocky hilltops. Soil type symbols from Table 1 can be used to locate soil types locations in **FIGURE 3**. Slope of the land increases as suffix symbols proceed from A to D.
