COON FORK LAKE MANAGEMENT PLAN

August, 2001
Revised 11-5-07

COON FORK LAKE

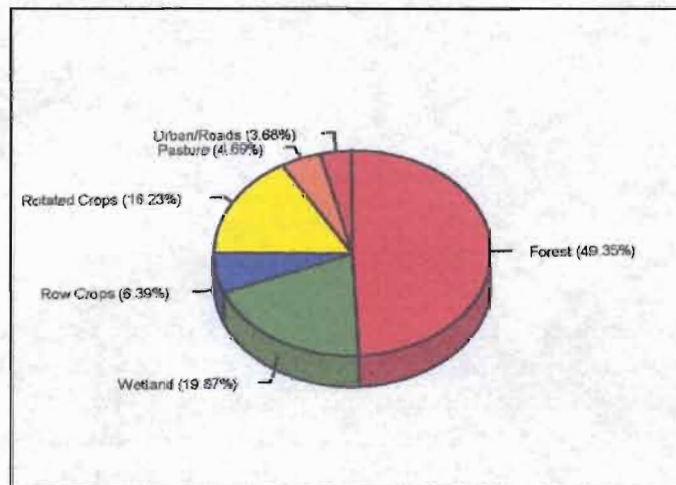
Figure 1. Land Use in the Coon Fork Lake Subwatershed.

The land use in the watershed is 49% forested and mostly managed by Clark and Eau Claire Counties. Twenty (20) percent is in wetlands. This is significant because almost 70% of the land use helps in protecting the lake from excessive nutrient input. Wetlands filter out nutrients carried in runoff water that otherwise cause weed and algae blooms in water bodies. Forested land has extensive canopy cover from the trees and low fertilizer inputs that lessens the nutrient loading into the lake. Runoff from wetlands and forest land contains tannin. This results in dark brown water that causes low light penetration that limits aquatic plant growth to the shallower portions of the lake (see Figure 1).

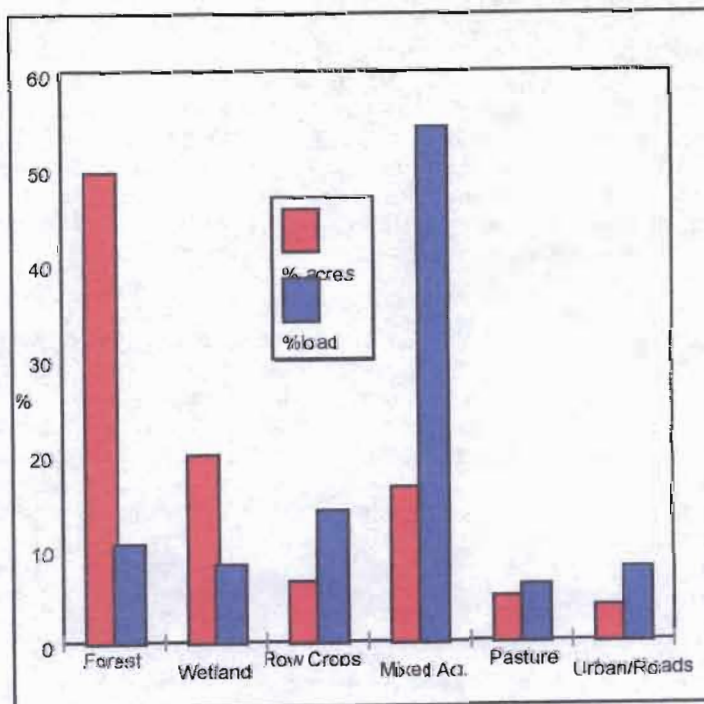
Figure 2. Coon Fork Lake subwatershed comparison of land use & phosphorous loads

Land uses change over time. Of concern are the development patterns because population increases can place additional pressure on the lake. With a larger population, increased runoff may contain lawn fertilizer and sediment from construction sites. Both sediment and nutrients will adversely affect the lake. Figure 2 depicts the relationship between land use and phosphorus loads. Agriculture in the watershed contributes the highest load.

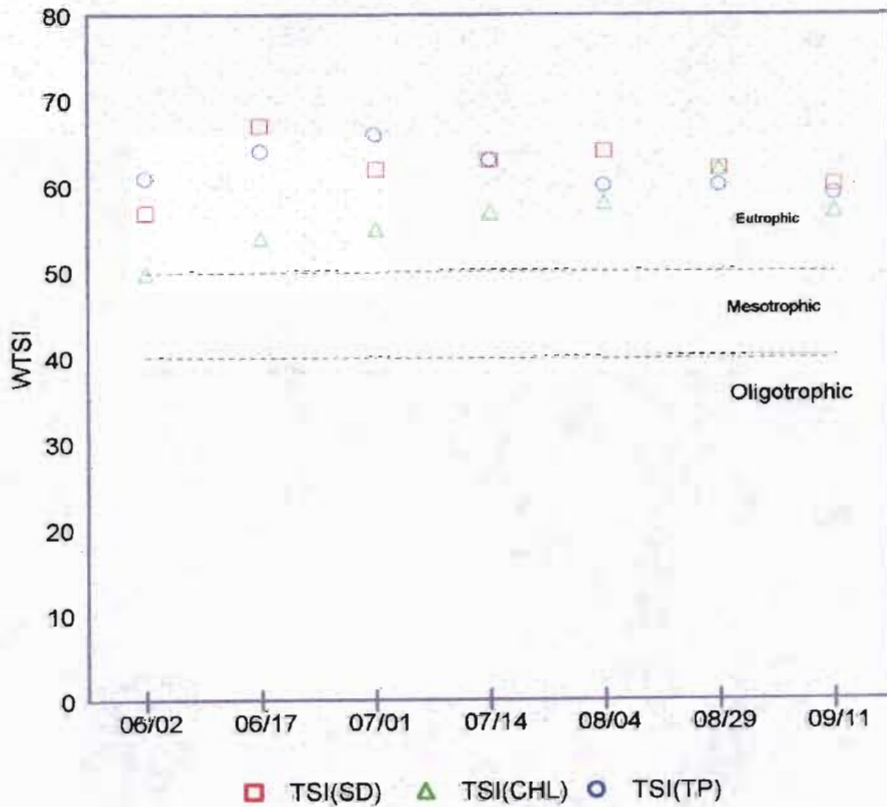
Figure 4. Wisconsin Trophic State Index for Secchi depth, chlorophyll a, and total phosphorus levels.

Data from Augusta High School, Fall Creek High School, and DNR are consistent. They all conclude the lake is eutrophic, based upon the Wisconsin Trophic State Index, although there are variations in the ranges for each parameter.

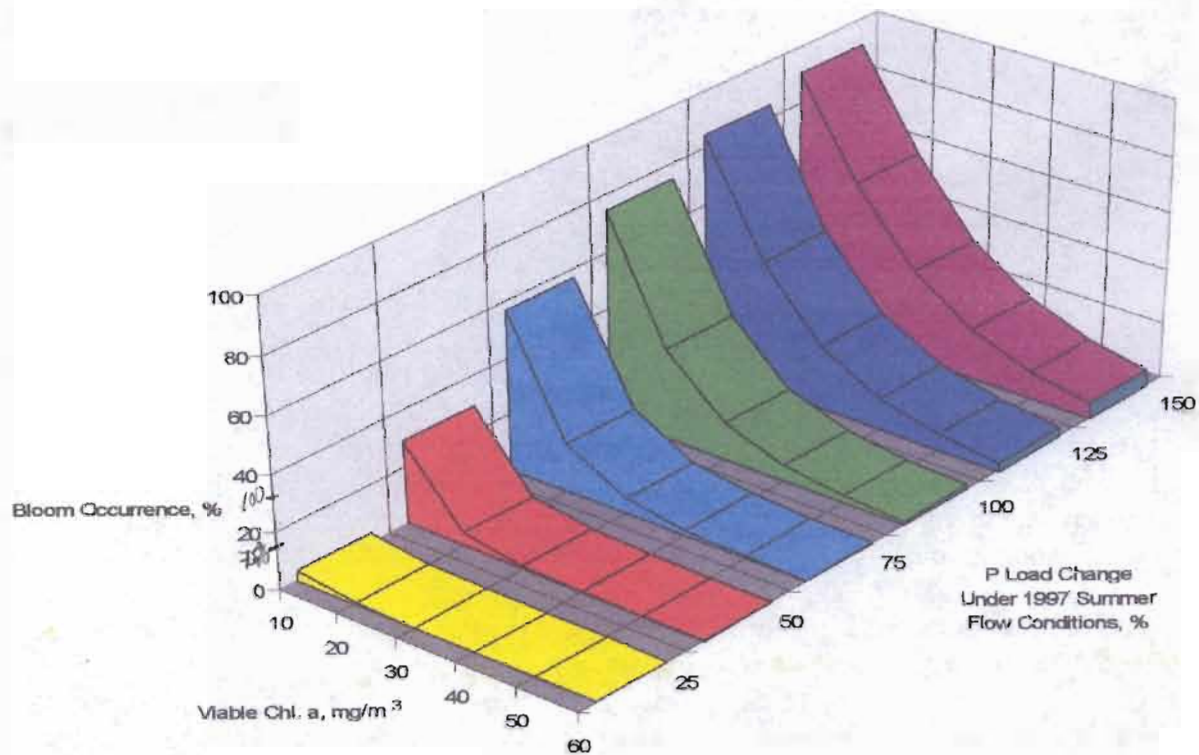
Figure 5. Estimated Bloom Frequency in Coon Fork Lake, Summer, 1997

Modeling results compiled by Erik Kampa, DNR, concur with Panuska's data. Figure 5 illustrates how the BATHTUB model uses phosphorus loading to predict blooming of algae. If phosphorus can be reduced by 25%, the number of blooms would be cut in half. But, if phosphorus loads increased to 125%, the algae blooms would increase during the growing season by 9%, compared to current conditions.

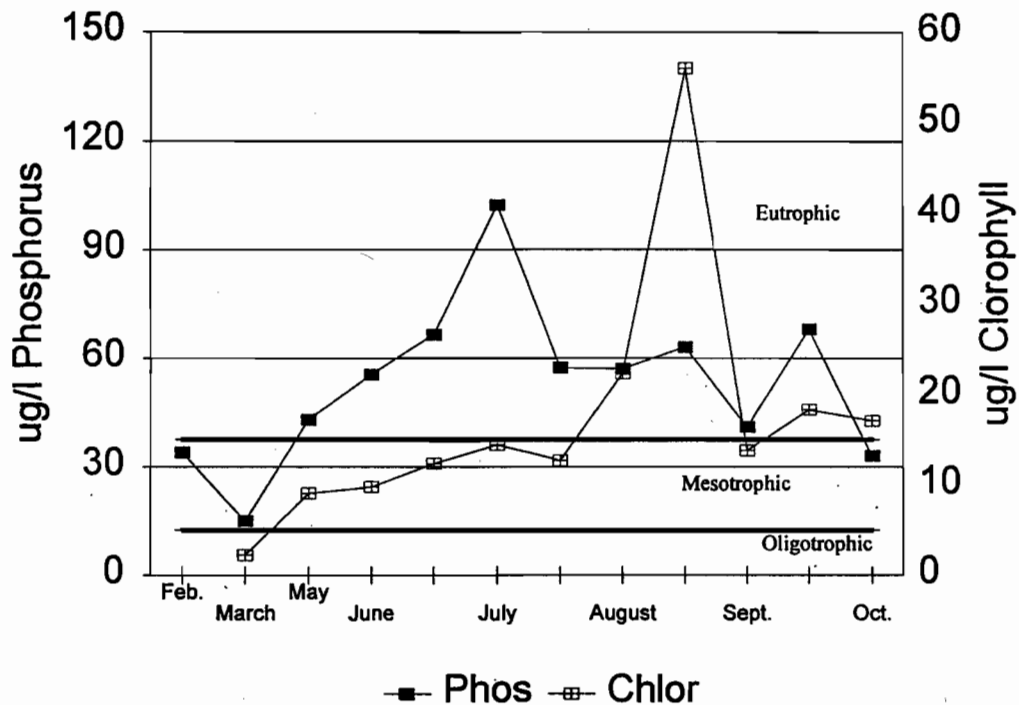
Figure 2. Seasonal change in phosphorus and chlorophyll levels.

There were variations in the phosphorus and chlorophyll levels from year-to-year and during the year. The phosphorus levels appear to increase steadily during the summer to a high point in July and then decline. (Figure 2). Chlorophyll also increases during the summer, but on average, reaches a high point in August before declining (Figure 2).

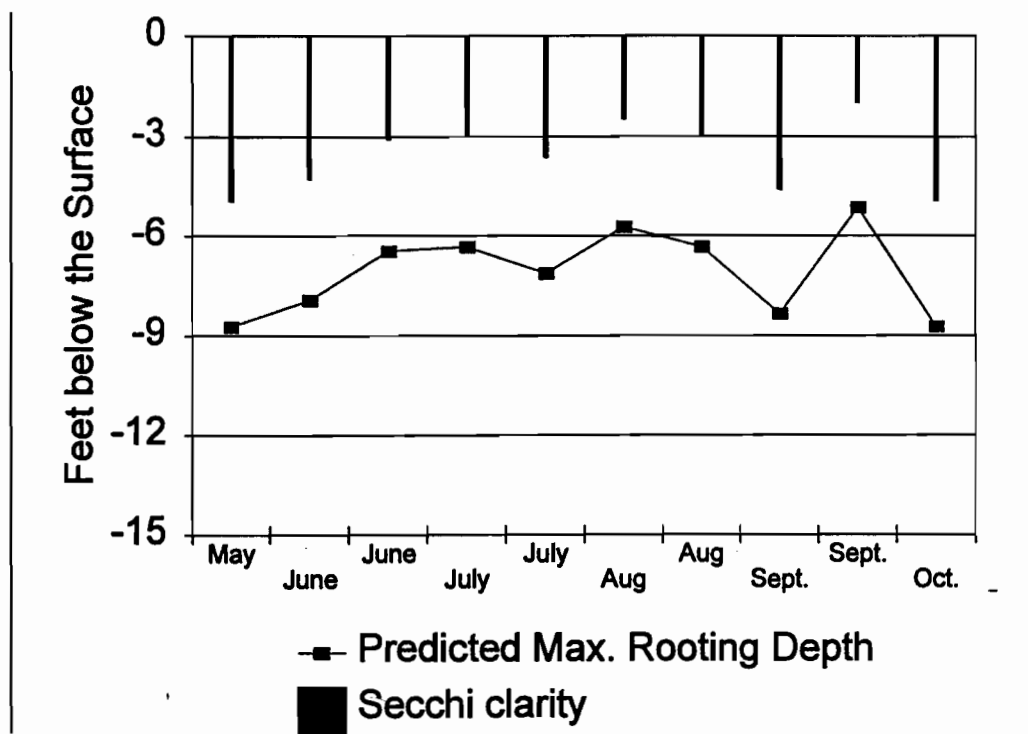
Figure 4. Water clarity in Coon Fork Flowage during the summer

The water clarity varied during the year; water clarity was greatest in spring and fall (Figure 4).

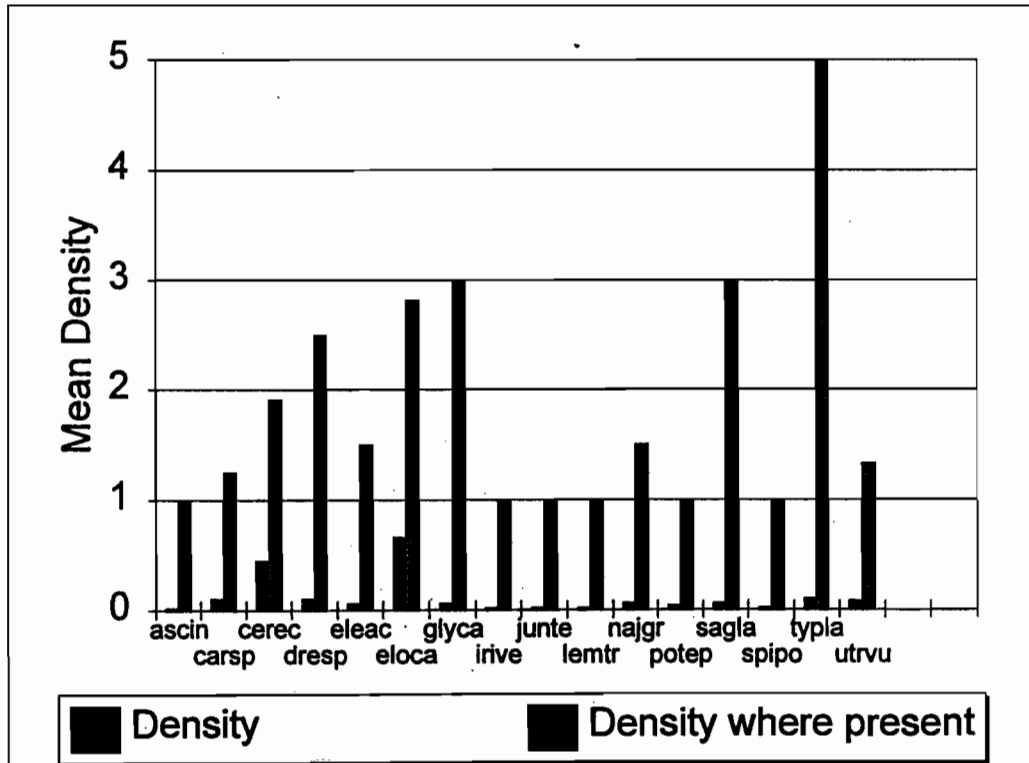
Figure 6. Densities of Macrophytes in Coon Fork Flowage

Density of plant growth in Coon Fork Flowage was low. *Elodea canadensis* had the highest mean density (0.66 on a density scale of 1-4) of any species in Coon Fork Flowage (Figure 7). *Typha latifolia* had the highest mean density at sites at which it was present (5.0). A high density at sites at which it was present indicates that these species had dense growth form in Coon Fork Flowage (Figure 6).

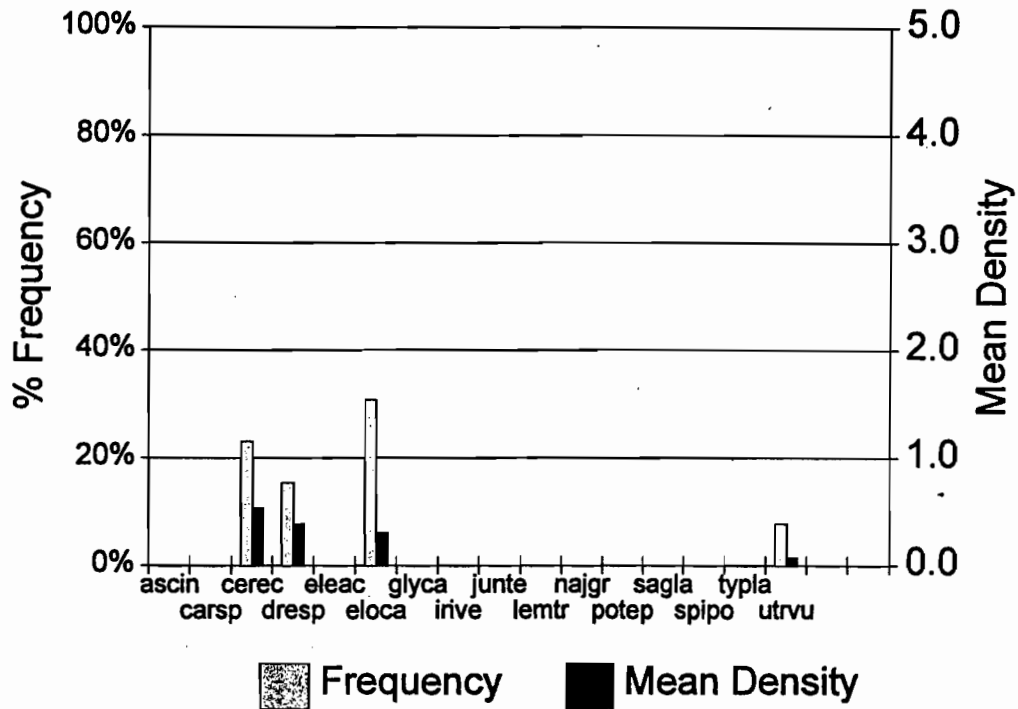
Figure 11. Macrophyte Frequencies in the 1.5-5 Foot Depth Zone.

Elodea canadensis was the most frequent species in the 1.5-10ft. depth zones and the most dense species in the 5-10ft. depth zone. *Ceratophyllum echinatum* was the most dense species in the 1.5-5 ft. depth zones (Figure 11).

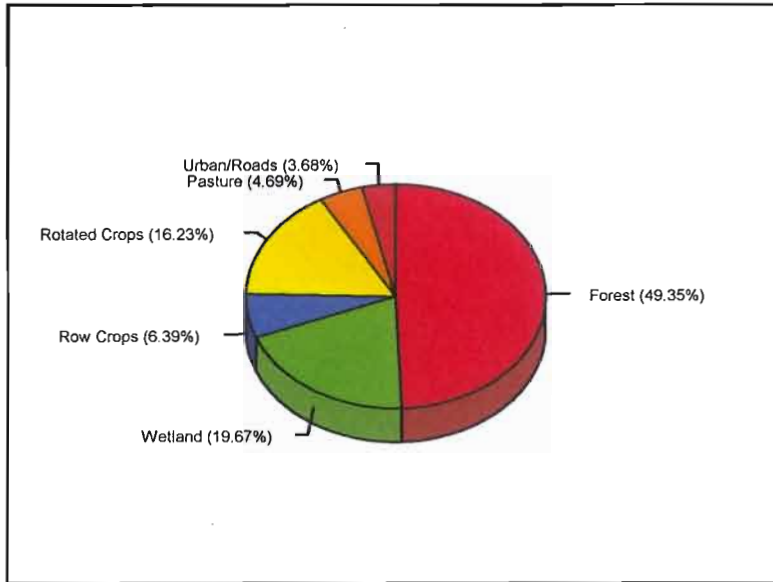
Figure 2. Land use in the Coon Fork Lake subwatershed

Forests and wetlands make up a majority (69%) of the land use within the watershed (Figure 2). There is also a significant percentage of land use in agriculture (26%).
