St. Louis River Estuary Wild Rice Restoration Monitoring (2015-2018)

Technical Report 19-02
January 2019

1854 Treaty Authority
Resource Management Division
4428 Haines Road
Duluth, MN 55811-1524
(218) 722-8907
www.1854treatyauthority.org

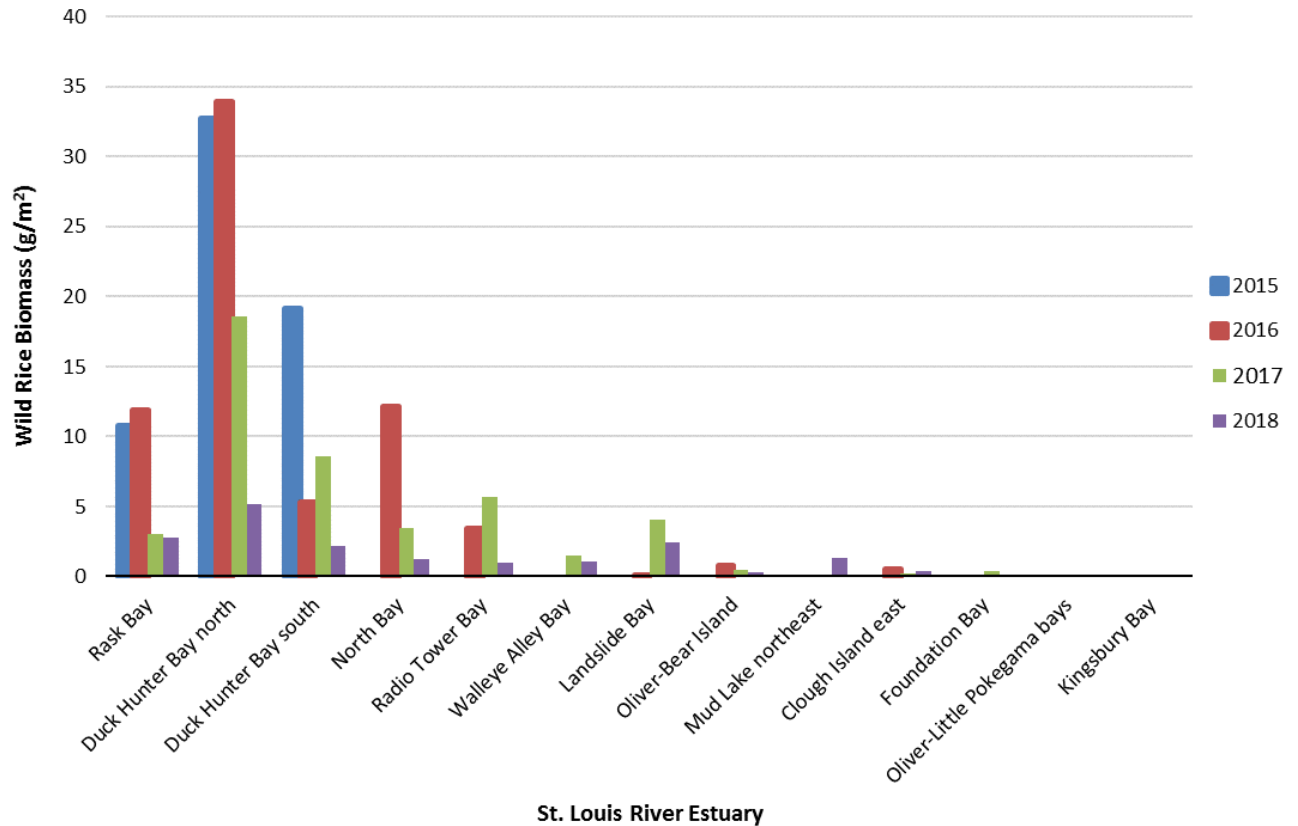
Figure 3: Wild Rice Biomass in Monitored Areas

Annual monitoring results show changes in wild rice density and biomass in each restoration area across years (Table 8, Figure 3). Monitoring completed in 2018 and future years will allow for wild rice to be tracked moving forward in all monitored areas.

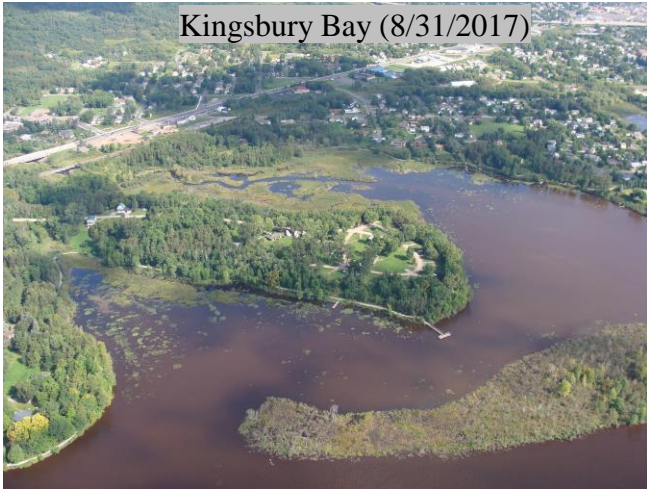
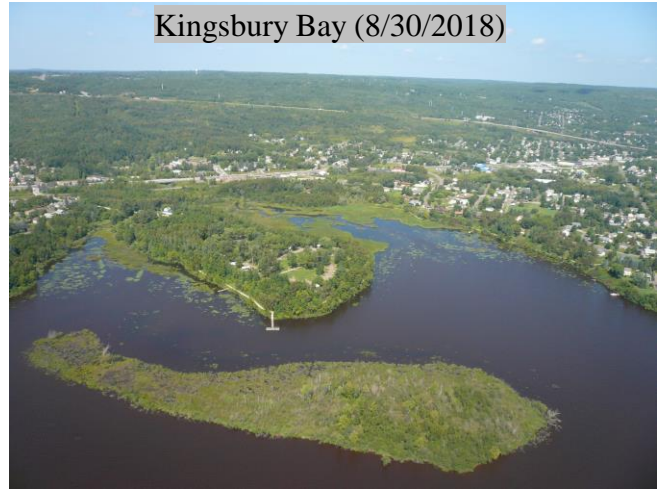
Kingsbury Bay (2017-2018)

Wild rice restoration work has not been started at Kingsbury Bay, but monitoring was initiated in 2017 to track conditions before potential future restoration efforts. Wild rice surveys were completed on 8/31/17 and 8/30/18. Scattered wild rice plants were located near the campground point. Wild rice was not present in any of the sampling points. The existing wild rice plants had moderate grazing impact with some leaves observed to be nipped during the August 2018 survey. Photo points have been established at five locations.
